**Sears Roebuck and Company Mail Order Store
(Landmark Center)
Boston, Massachusetts**

Preservation
Tech Notes

**WINDOWS
NUMBER 20**

**Aluminum Replacement
Windows for Steel
Projecting Units with
True Divided Lights and
Matching Profiles**

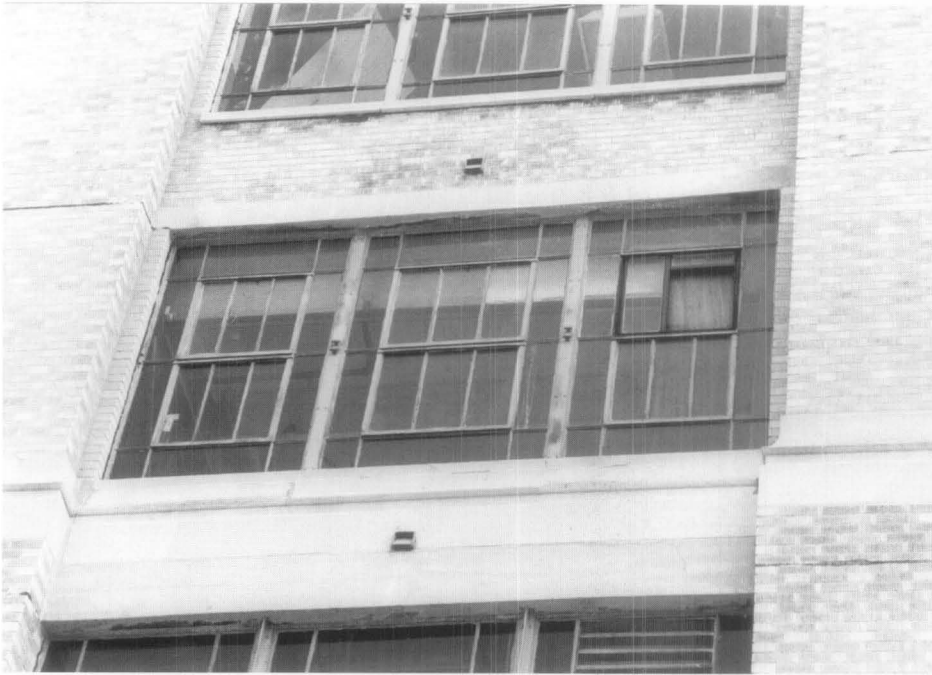
Figure 1. Many of the original Lupton windows incorporated a pair of stacked ventilators that projected outward. The vents were centrally located within a multi-light frame each of which was set either individually or in groups of two or three. Photo: Bruner/Cott & Assoc., Inc.

tor (or ventilators) framed by a group of fixed lights (*see figure 1*). Details such as muntin patterns, muntin widths and profiles, and the profiles of the operable vent were integral to the look of the windows and the building as a whole (*see figure 2*). Because of the distinctive character and prominence of the windows, any treatment plan required careful regard for the historic appearance of the original units.

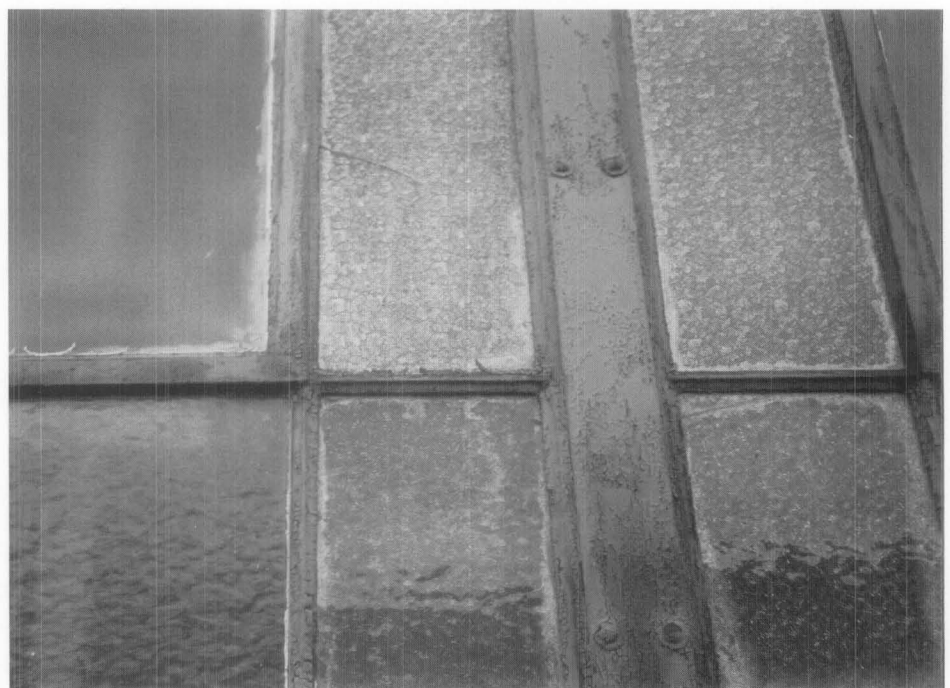
Figure 2. Narrow sightlines, ventilator weathering flanges and mullion boltheads were all distinguishing features of the original steel windows. Photo: Bruner/Cott & Assoc., Inc.

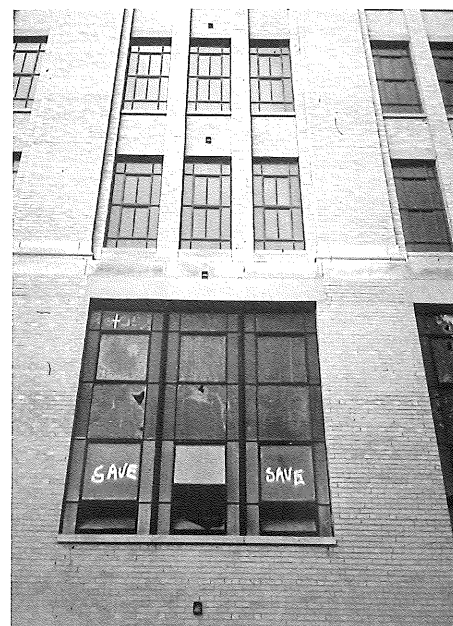
Figure 4. Among the retained and repaired original windows were these large units on the second floor level. Photo: Bruner/Cott & Assoc., Inc.

Existing historic windows in areas that were not to be continuously occupied, such as common lobbies and fire stairwells, were retained and repaired in situ. In addition, all of the tall windows on the second level (which would be devoted to retail functions) were repaired and reglazed where needed with historic glass salvaged from other locations in the building (see figure 4).

While the new windows were being manufactured, a local contractor began the three month long process of stripping, repairing, repainting and reglazing the historic second floor windows and other retained units in stairwells and other non-office locations. As the new windows began to arrive in Boston, the general contractor removed the original units that were slated for replacement and a team of eight to ten workers started installing the new windows.

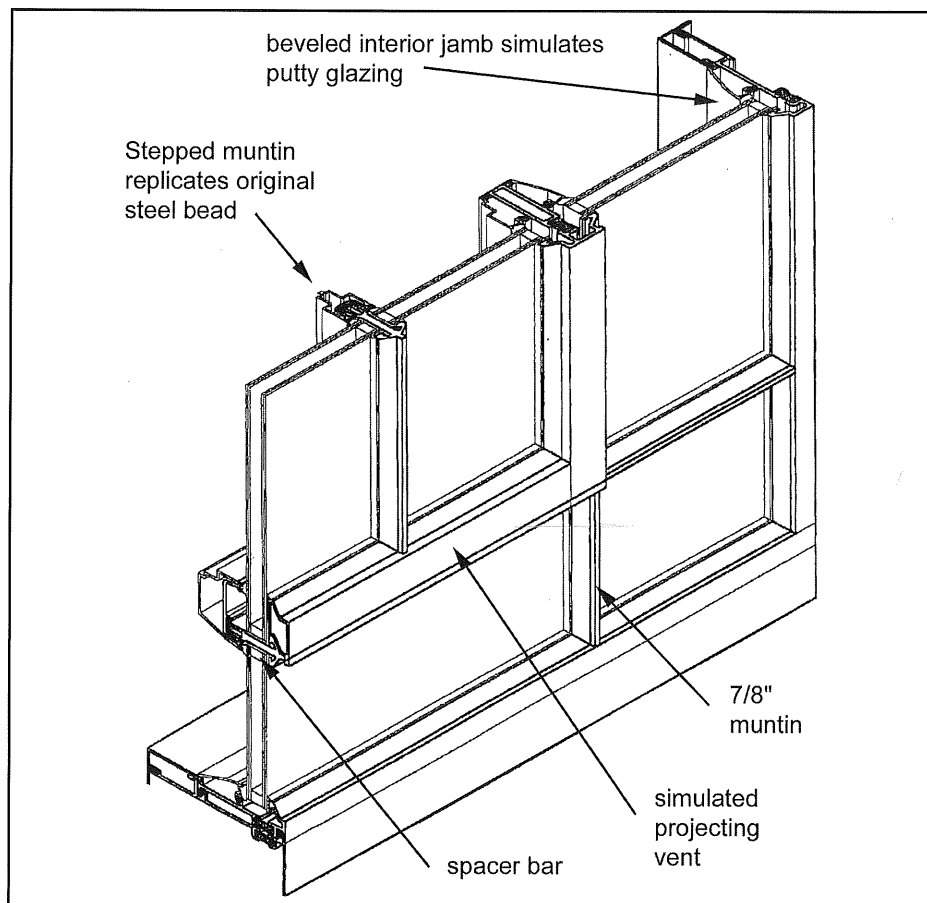
Figure 3. Isometric drawing of aluminum replacement window. Drawing: Greg Gibson.

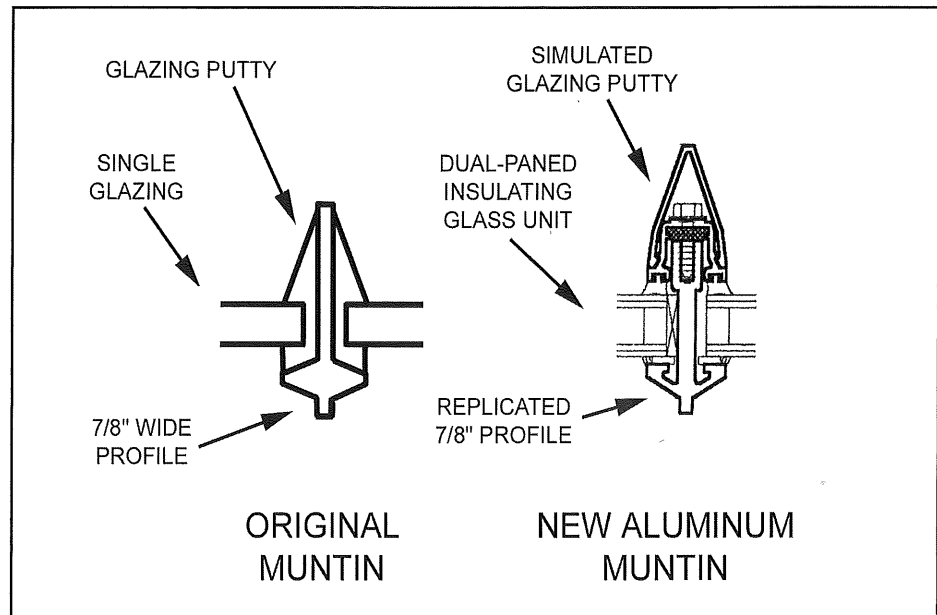
replication of the original 7/8" muntin (see figure 5). Substituting a dark bronze anodize finish further reduced the visibility of the spacer making it appear as a shadow line when viewed from an angle.

Figure 5. The replacement aluminum muntin accurately replicated original profiles while accommodating insulating glass and thermal stops. Drawing: Bruner/Cott and Custom Window.

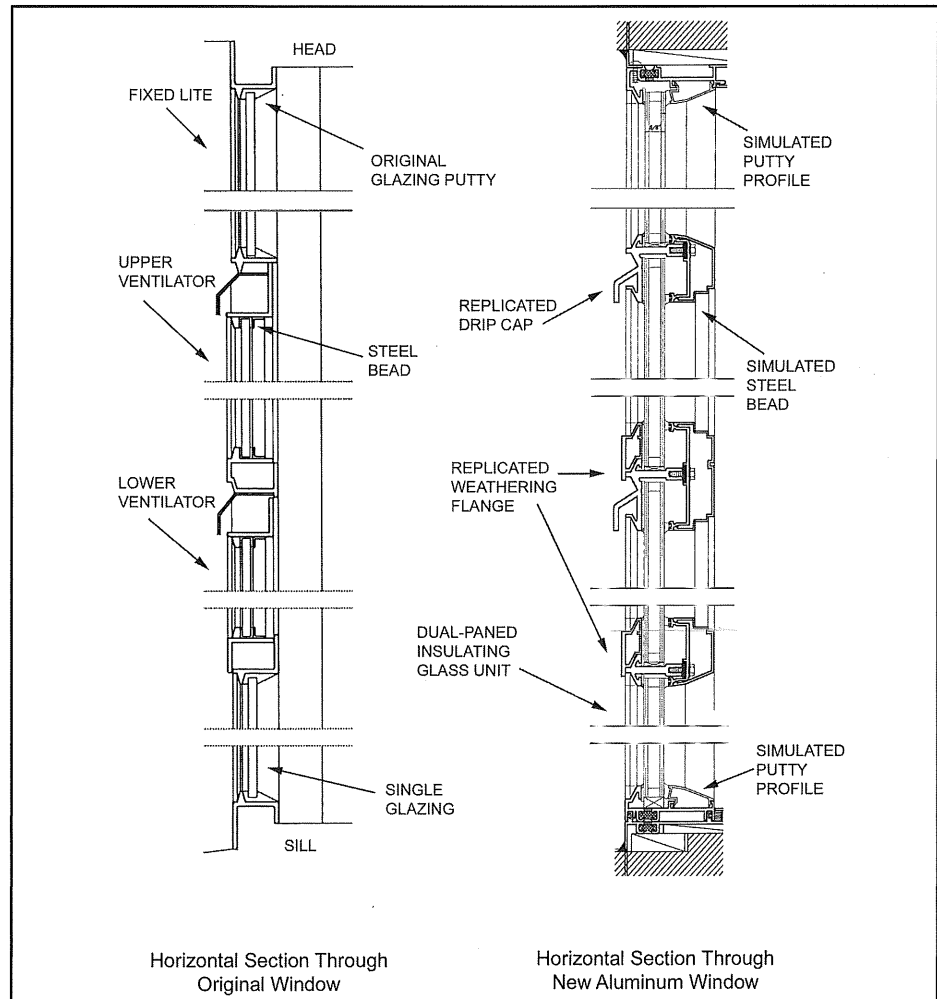
the original interior putty profiles, the fixed-light muntins were tapered to the same 1/8" thickness of the original sections while stepped muntins were used in the central vent where steel beads had originally secured the glazing. Jambs in the replacement units were also beveled to recall the shape of the old glazing putty (see figure 6).

Figure 6. Sections of original and replacement windows. Drawings: Bruner/Cott and Custom Window.

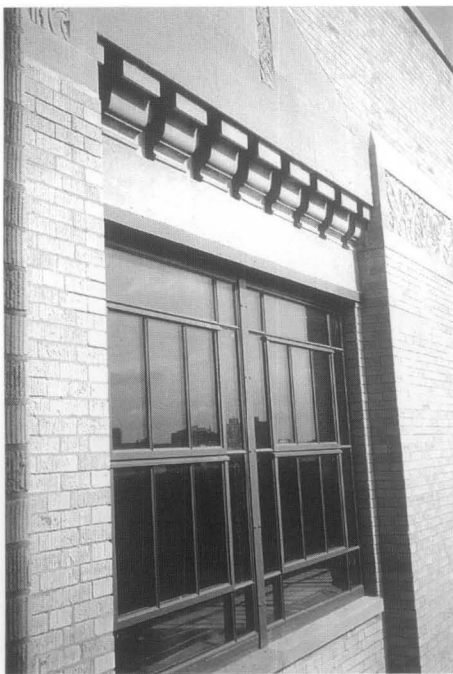
Decisions involving the treatment of the original Sears building windows were reached after understanding the significance of the windows' historic appearance and by evaluating their condition and the requirements imposed by the rehabilitated building's new function. Various proposals were explored to determine how well they reconciled these factors. The process suggested that the most appropriate solution was to retain approximately 18% of the original windows while replacing the remainder with aluminum true divided light units that carefully matched the originals in both detail and general appearance (see figure 7).

Figure 7. Installed replacement window. Photo: Bruner/Cott & Assoc., Inc.

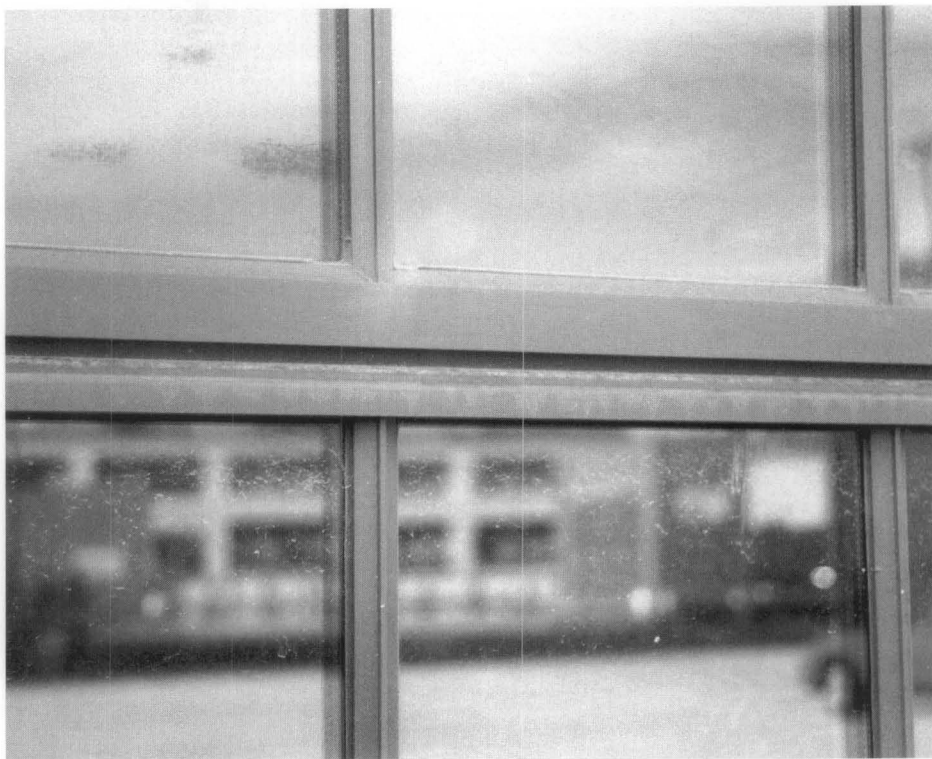
as drip caps and the interior appearance of the window proved crucial to the success of the replication effort (see figures 8 and 9). This understanding led to a new engineered window that met the challenge of combining narrow muntins with insulating glass units and true divided lights.

Figure 8. A close up view of the replacement window showing the replicated ventilator drip cap and narrow muntins. Photo: Bruner/Cott & Assoc., Inc.

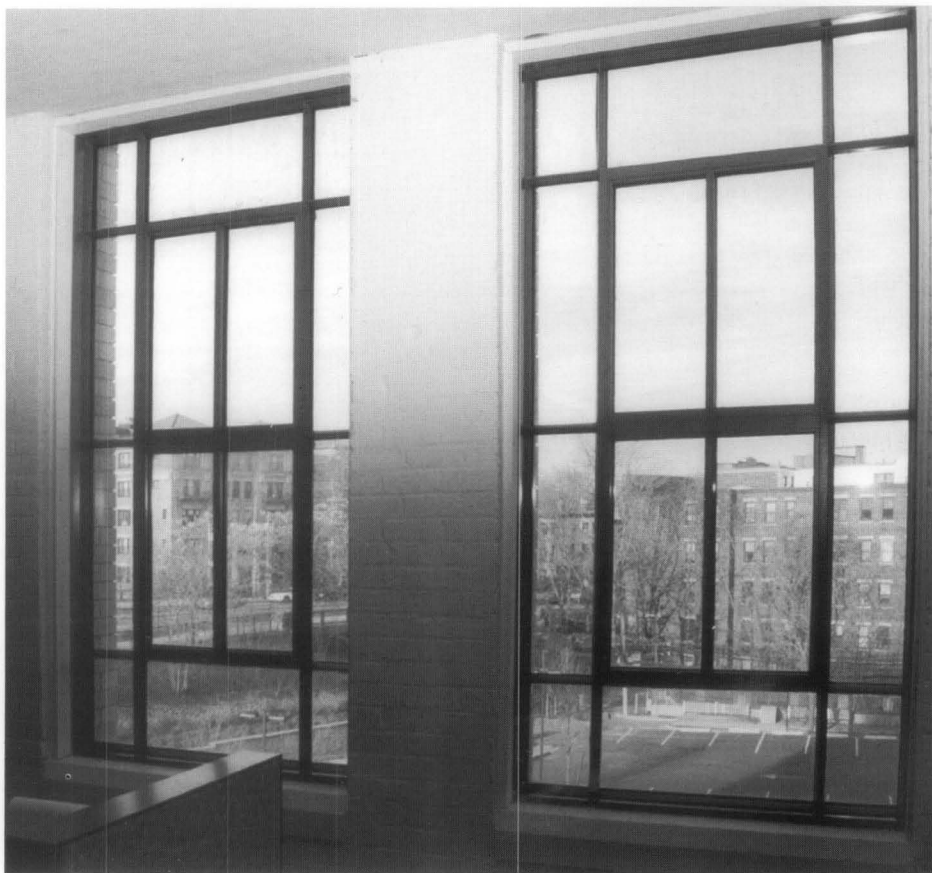
Figure 9. The interior profiles of the original windows were accurately reproduced in the aluminum replacement units. Photo: Bruner/Cott & Assoc., Inc.

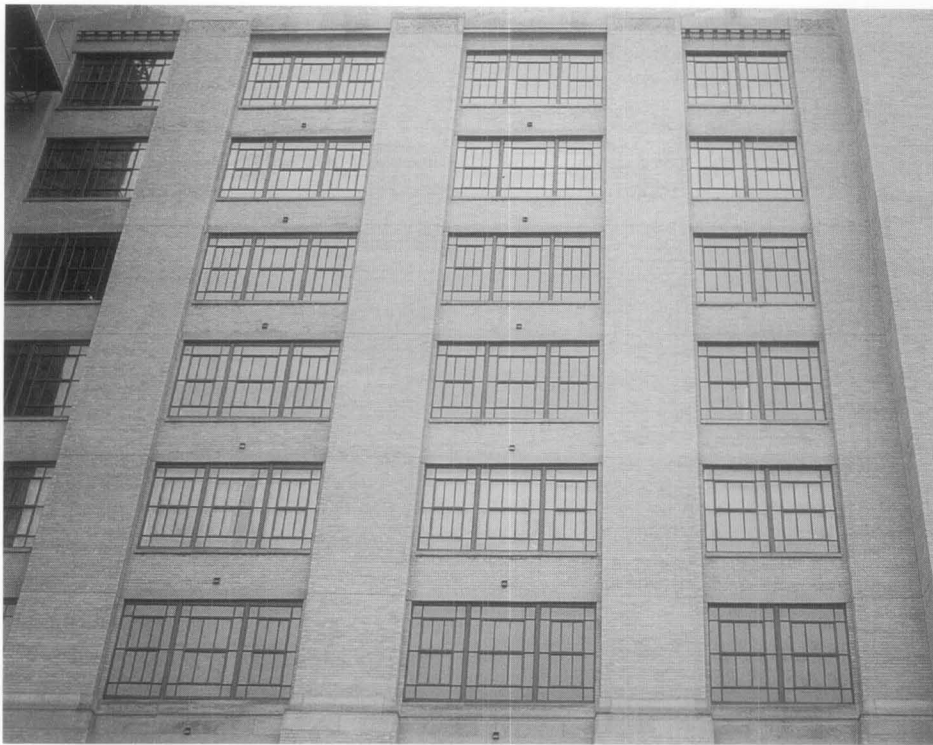
Figure 10. The replacement windows designed for the Sears building rehabilitation met energy efficiency and aesthetic goals while providing for the continued historic appearance of the structure. Photo: Bruner/Cott & Assoc., Inc.

The Sears project illustrates that a combined approach of window repair and replacement with a custom window designed to match the historic unit is a viable alternative when large-scale building rehabilitation is undertaken (see figure 10). Such a solution provides the opportunity to retain significant historic fabric and a wholly authentic original appearance in the most visible locations. In areas where the original windows have experienced significant deterioration, are in less prominent locations and where there are no suitable alternative means of enhancing thermal performance, replacement windows that are intended to match the originals in detail and appearance are acceptable. The window solution devel-
