**BUILDING 149
CONSTITUTION PARK
Boston Navy Yard
(Charlestown Navy Yard)
Boston, Massachusetts**

**WINDOWS
NUMBER 12**

**Aluminum
Replacements for
Steel Industrial Sash**

Charles E. Fisher
Preservation Assistance Division
National Park Service

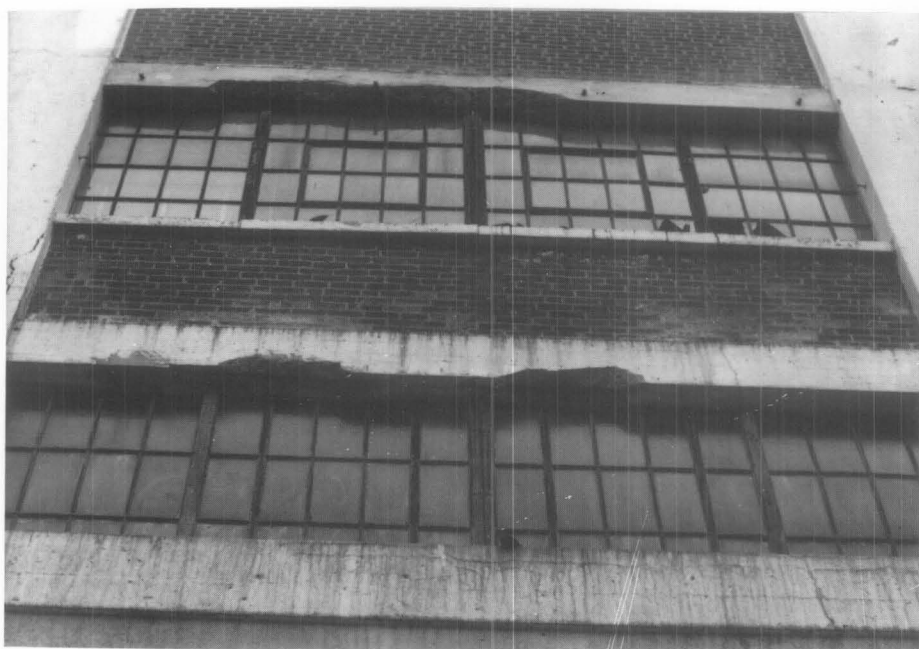
muntins with an exterior cove bead shape profile to the muntin. Most of the openings consisted of a bank of 4 side-by-side window units. Each of the middle two units consisted of 20 divided lites, including a 6-lite center hopper; the two end units were fixed and contained only 16 lites (see figure 1). Typical of pre-World War II steel windows, the glass panes had a narrower width than height. The vertical mullion connecting each unit was approximately 3" wide, noticeably dividing each opening into 4 window units.

Figure 1. Most of the openings consisted of a bank of 4 side-by-side steel window units. Each of the middle two units consisted of 20 divided lites, including a 6-lite center hopper; the two end units were fixed and contained only 16 lites.

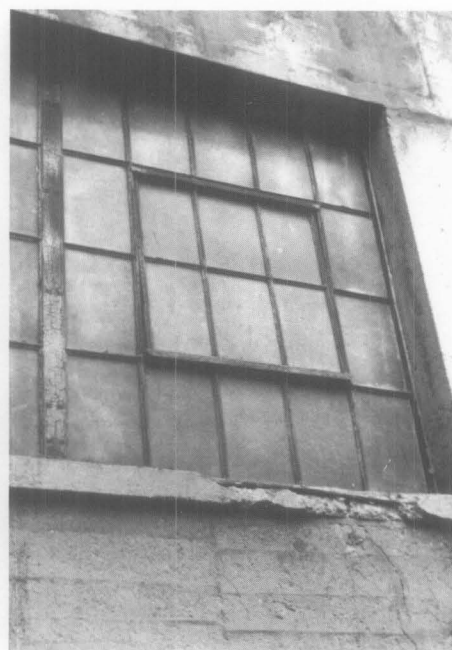
The contractor's survey of the historic windows in the spring of 1984 revealed that extensive rusting of the frames had occurred and that many were racked. The severe rusting had also contributed to the spalling of sections of the concrete sills, jambs, and spandrels (see figure 2). Repair and upgrading options to maintain the historic windows were quite limited due to the size of the glazing bars. The shallow depth of the metal glazing bars (muntins) seemingly precluded the installation of sealed insulating glass within the existing lites, even if the windows could structurally support the additional weight. The only practical way of double-glazing would have involved the use of interior storms with units that were either operable or were removable for ease of cleaning. Even then, however, the severe deteri-

Figure 2. Due to lack of maintenance, severe rusting of the steel frames had occurred, which contributed to the spalling of sections of the concrete sills, jambs, and spandrels. **Photo: Charles Fisher**

oration of the steel windows still would have needed to be addressed. Considering the size of the bay openings, the decision was made to replace the windows.

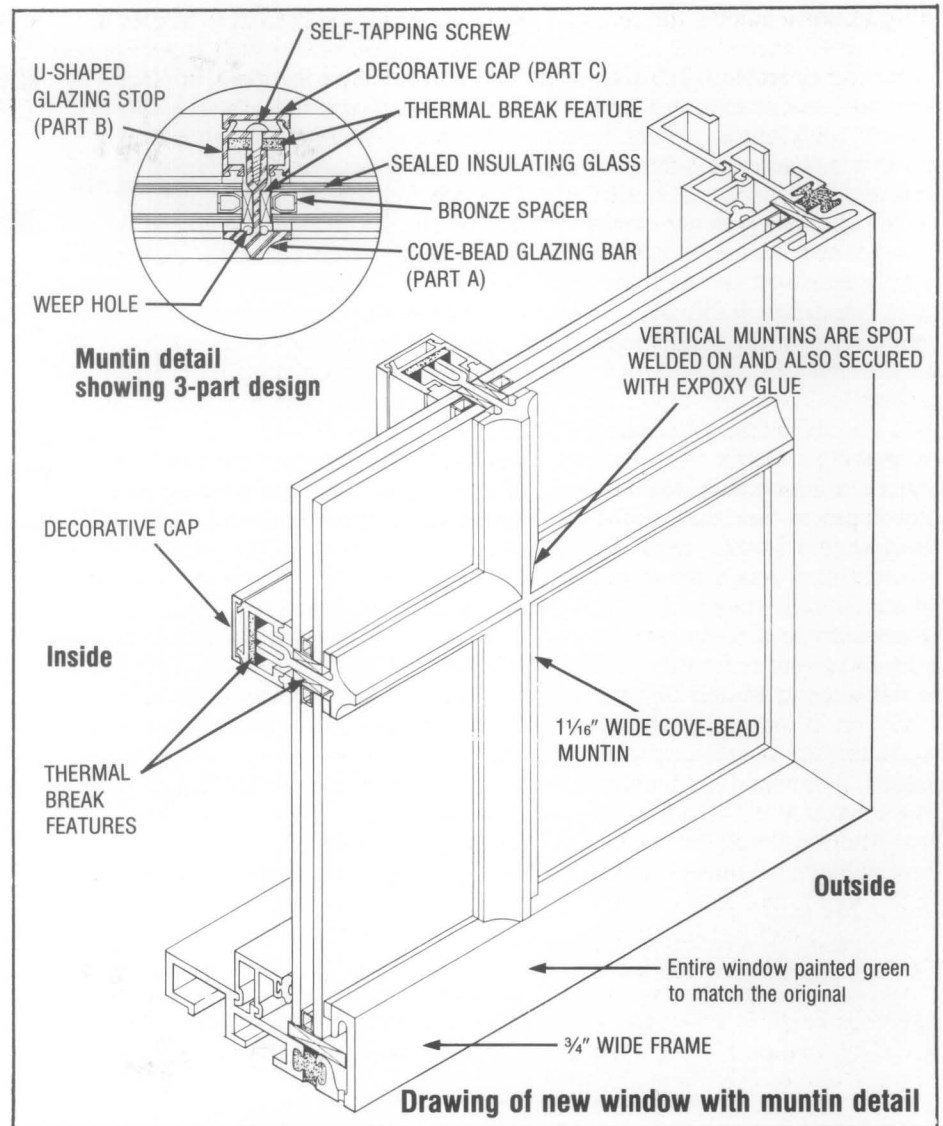
Figure 3. Drawing of the aluminum replacement windows shows how the cove-bead muntin profile of the original steel windows was closely matched in the integral muntin system designed for the aluminum replacement window. A series of spacers and gaskets were used as the principal means of obtaining a thermal break in the window for energy purposes. Drawing: Peter Charles

One of the first major design issues to be resolved concerned the need to match as closely as possible the shape and dimensions of the original 7/8" wide glazing bar (muntin) with its decorative cove-bead exterior profile to simulate the profile of the original steel window muntins. The project team concluded that in order to keep the muntin on the aluminum window as narrow as possible, the traditional cast thermal break (cast plastic) feature of most modern windows could not be used. Instead, a series of spacers and gaskets principally would be utilized to achieve a thermal break for energy conservation. By using this approach, the window fabricator would be able to use a 1/16" wide integral cove-bead muntin. The only short circuit in the thermal break would be at the point where screws were used to connect the inner and outer portions of the muntin (see figure 3).

designed to ensure that moisture build-up behind the glazing tape would seep outside, rather than inside the building (see figure 3). A twenty-foot mockup was eventually constructed and successfully tested according to accepted industry standards.

The basic aluminum window unit consisted of 9 different aluminum extrusions, including the decorative cove-bead muntin. The muntin assembly actually consisted of 3 extruded aluminum sections. The principal muntin section was the cove bead portion that had a long glazing channel with a receptor at the end (see figure 3). Attached to the interior-facing side of the muntin was a U-shaped glazing

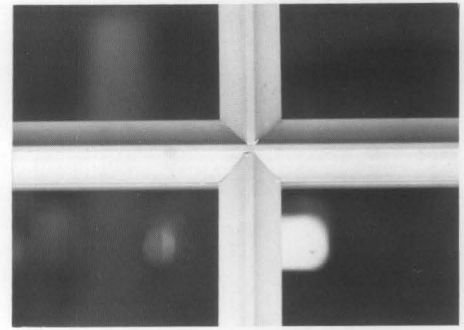
Figure 4. The vertical muntins had mitre joints where they intersected the horizontal muntins and were secured through a combined use of epoxy glue and spot welding. Photo: Charles Fisher

While the horizontal muntins were continuous across the window unit, the vertical muntins had mitre-joints where they intersected the horizontal muntins. The vertical muntins were secured through a combined use of epoxy glue and spot welding (see figure 4). A system of weep holes and channels was provided to ensure that any water trapped between the glazing tape and the glass and muntins would be diverted to the outside of the windows.

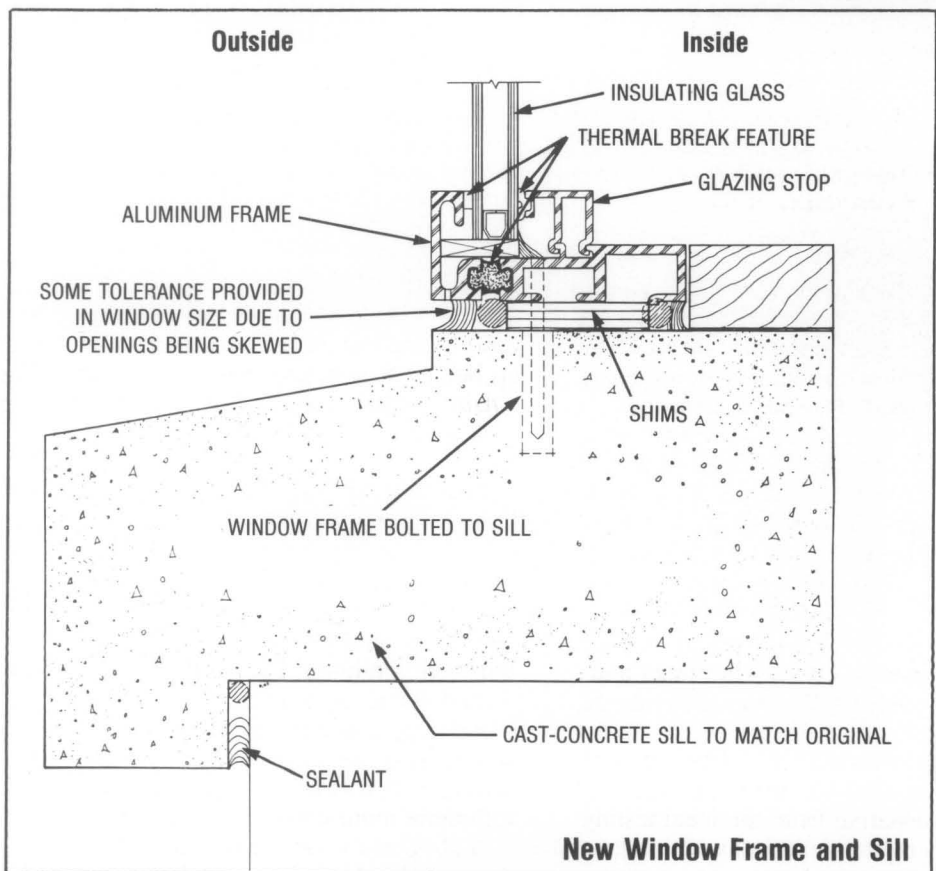
New Window Frame and Sill

Figure 5. The frame of each window unit was designed with a width of $\frac{3}{4}$ " in order to closely match that of the original windows. The frames were bolted to the face of the jambs, sill, and head of the masonry opening. Drawing: Peter Charles

The overall window unit was not set into reglets as were the original steel windows but rather were bolted to the masonry because of the greater depth of the aluminum jambs. To keep the width of the frames sufficiently narrow to match the historic appearance, a $\frac{3}{4}$ " wide jamb was designed, narrower than standard window jambs (see figure 5). Due to high wind loading requirements for Boston, steel reinforcing bars were needed at certain corner windows, but other-

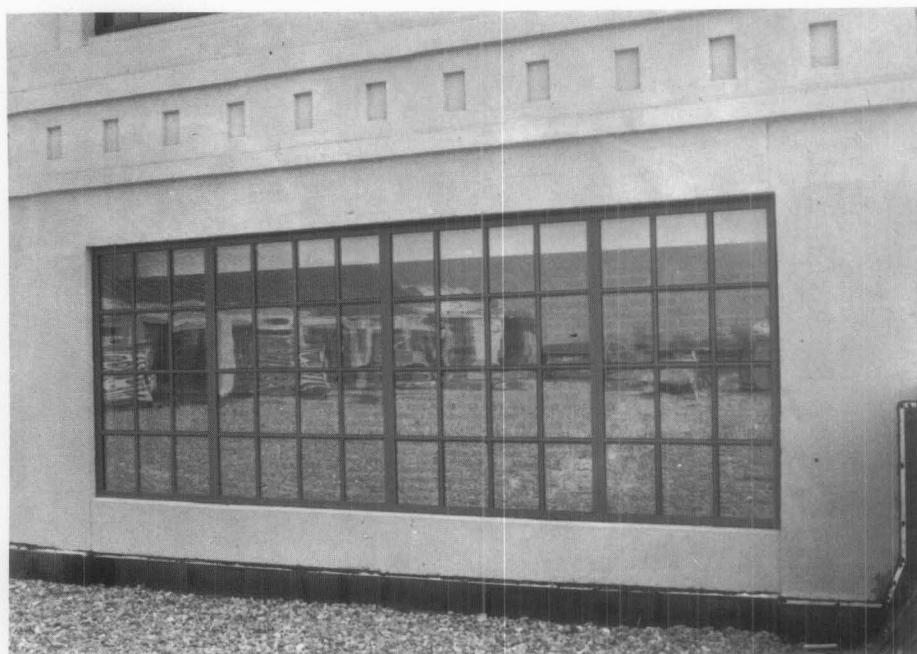
Figure 6. Fabrication and installation of the window units were complicated by the nine different types of windows in the building and by the considerable variations in the window heights for each type. Approximately 500 of the 2000 window units were the same size. Photo: Chuck Parrott

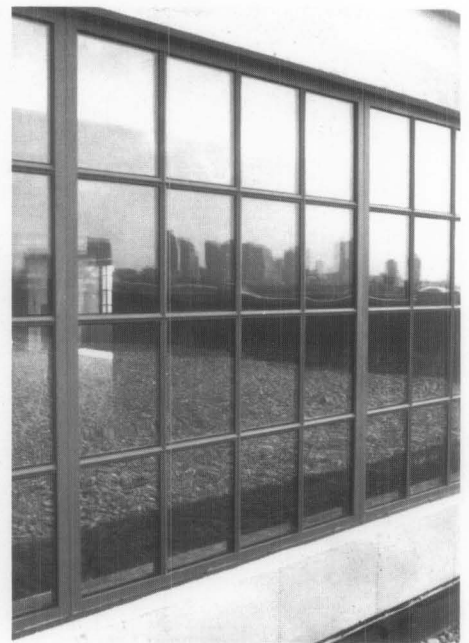
the greatest problem and biggest expense, since the limited tolerance for encroachment onto the glass area required very careful work (see figure 7).

Figure 7. Despite the difficulty encountered with proper glass sizing and spacer alignment in the sealed insulating glass, the end result is an innovative window that is both aesthetically pleasing and closely matches the historic appearance of the original steel design. The slight encroachment of the bronze spacer onto the visible glass area is not readily detectable from general view. Photo: Charles Fisher

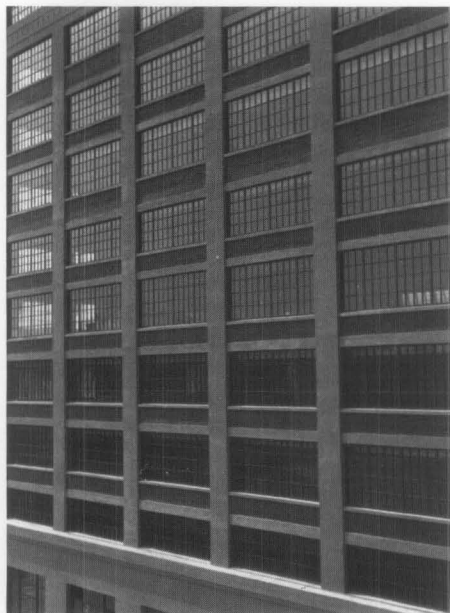
The window work at 149 Constitution Park was noteworthy in several ways. First, it represented a significant improvement over past attempts to recapture the distinctive qualities of a steel industrial window with narrow cove-bead glazing bars, using an aluminum replacement system with insulating glass (see figure 8). Equally important was the manner in which the new window system was developed for the project.

Figure 8. The window work at 149 Constitution Park represented a significant improvement over past attempts to recapture the distinctive qualities of a steel industrial window with narrow-bead glazing bars, using an aluminum replacement system with insulating glass. Success was achieved through careful and well coordinated planning. Photo: Charles Fisher.
