Preservation Tech Notes

WINDOWS NUMBER 22

Maintenance and Repair of Historic Aluminum Windows

Kaaren R. Staveteig
Technical Preservation Services
National Park Service

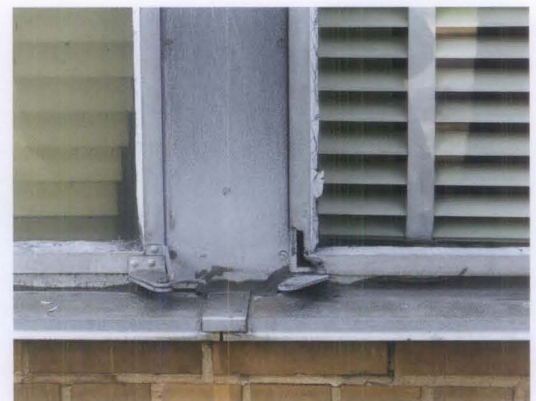
Figure 6. Deferred maintenance can result in a series of problems, such as broken hardware, cracked or missing glazing putty, and missing perimeter caulk (all shown above). All of these problems can be corrected. Note the uneven nature of the surface deposits of pollutants and grime on the mullion and sill of this window due to weathering and lack of cyclical cleaning.

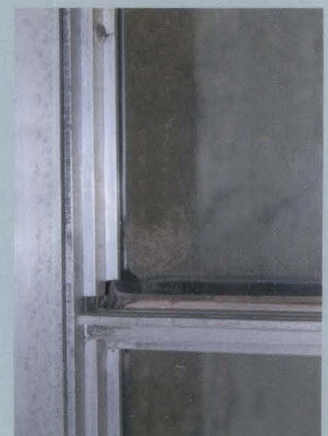
Figure b. The panes of glass were secured into the frame with aluminum glazing stops, each individually cut, drilled, and fixed in place from the inside. Here the vertical stop is in place while the horizontal is missing.

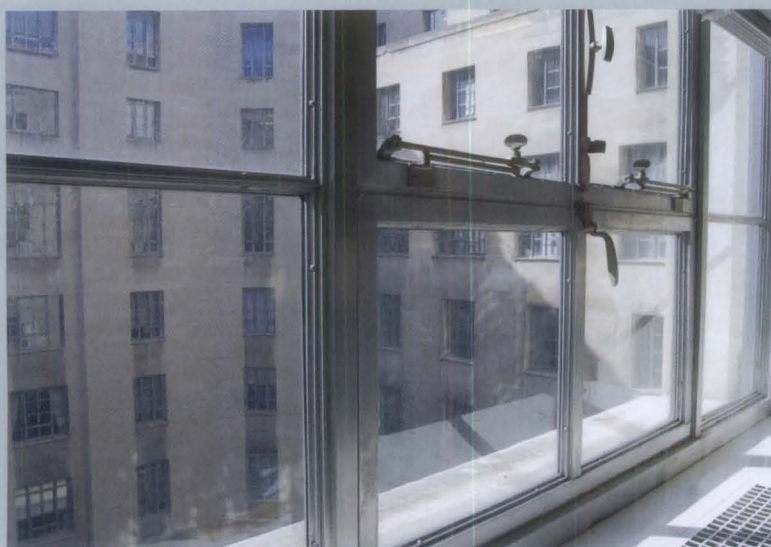
Figure c. In cleaning historic aluminum windows, the gentlest means possible should be used. More aggressive cleaners should be used only where necessary. The interior surface of this window was cleaned ten years ago with an aluminum jelly cleaner, rinsed and then dried thoroughly. The original mill finish still retains its luster.

needed. The aluminum was then rinsed to remove the cleaner residue (Figure c). For the exterior surfaces of windows that were more heavily corroded, the aluminum restoration company proposed a more aggressive chemical cleaner be used. This necessitated that the surrounding limestone surfaces around each window be well protected. During a mockup cleaning exercise, this chemical cleaner proved too acidic, difficult to control, and damaging to the adjacent stone. After testing some alternate products, the team found that a diamond abrasive pad used in combination with the Duro Aluminum Cleaner in jell form, worked the best. Special care was still necessary to protect the surrounding limestone.

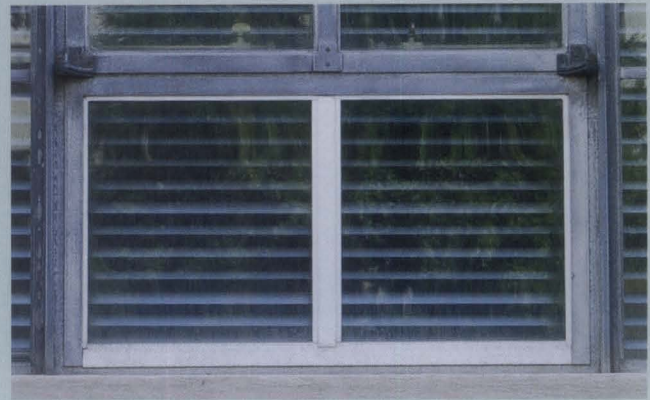
Figure d. Numerous hopper units have been removed over time to accommodate air conditioning units. Replacement hopper units were manufactured, as needed, to match the original hoppers elsewhere in the building.

An aluminum company reproduced the vertical muntin that historically existed in the hopper unit but was missing from numerous units. After the muntins were cut to size, each was slotted at the end and fitted into the hopper frame, and then welded at the tip. The same company also made custom extrusions for the rails and stiles of the hopper units for use in fabricating entire hoppers where missing (Figure d).

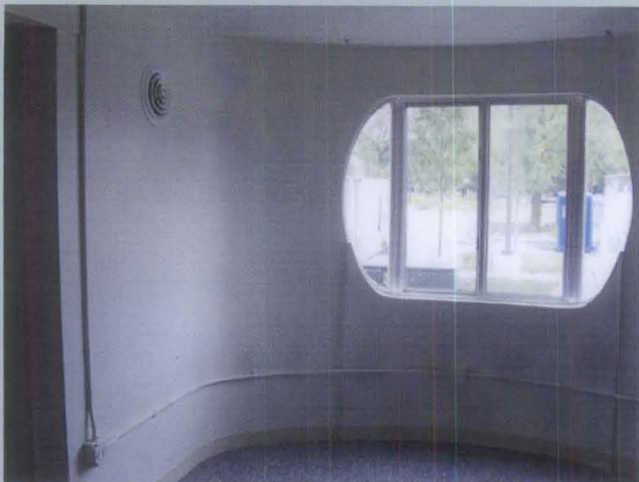
Figure e. Both interior and exterior aluminum surfaces had become dull, soiled, and oxidized as a result of traffic exhaust and air pollution. Cleaning the aluminum stabilized any further deterioration and brought back the luster of the original mill finish. (Photo: Holsten Real Estate Development Corp.)

The aluminum surfaces needed to be cleaned and taken back closer to their original appearance. Because of the effect of weathering and use, it was considered acceptable in this project to use certain cleaning techniques not normally recommended for more ornamental architectural aluminum. A common chemical cleaner and/or

denatured alcohol were used to remove the general residue on the aluminum. Wearing rubber gloves, the crew wiped on the cleaner with a damp cloth, allowed it to stand for 3-5 minutes, and then wiped it off with a clean damp cloth. Scouring pads and scrapers were sometimes used on more encrusted areas, as needed. The removable sash units were cleaned in the basement shop, while any frames that remained in situ were cleaned in place (Figure e).

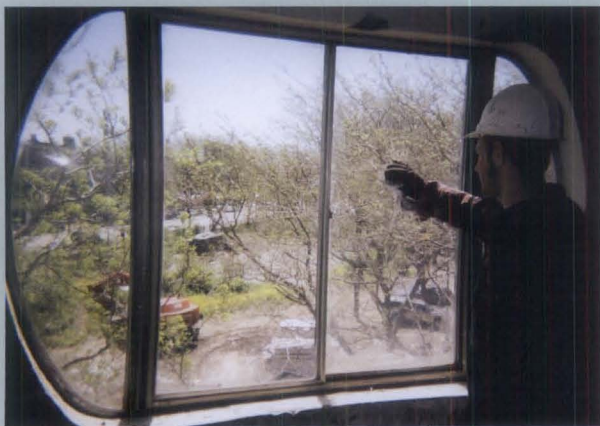
Figure f. Repair and replacement work was done from the inside to lessen the risk of damage to the outside finish. (Photo: Holsten Real Estate Development Corp.)

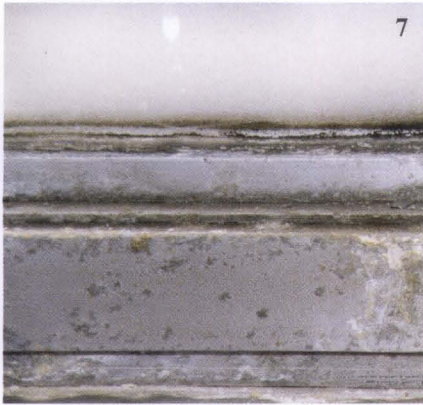
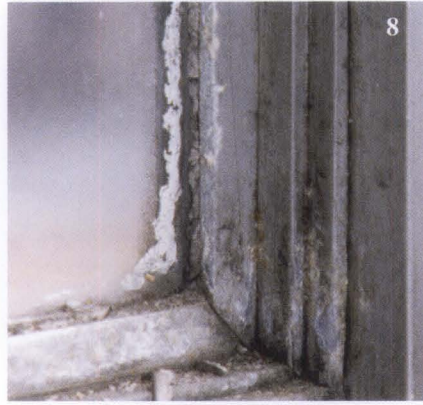
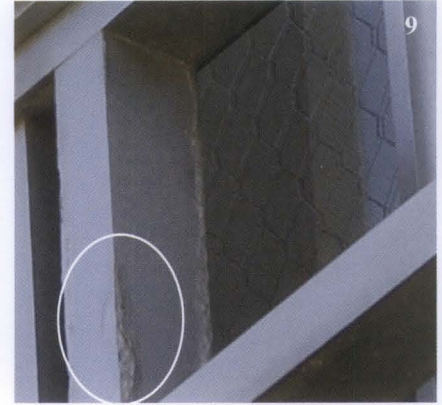
Figures 7 and 8. Aluminum corrosion can appear as a white discoloration and forms on the surface as the protective oxide film breaks down, as seen in these 60 year old windows in the PSFS Building, Philadelphia, before they were replaced. The small dark bumps are where surface dirt, grime, and pollution particles collect. Over time, pits form beneath these dark areas as the surface continues to corrode. This corrosive action is further encouraged by foreign particles, such as dirt and chlorides, which hold moisture next to the surface. (Photo: Powers & Company Inc.) Figure 9. Some aluminum alloys are less corrosion resistant than others. Delamination, as seen on this aluminum railing in front of a window at the Folger Shakespeare Library, can occur when an aluminum-copper alloy is introduced and used in an outdoor setting. The original specifications called for aluminum and chromium, but were not followed.
