Tech Notes

WINDOWS

Planning Approaches to Window Preservation

MARQUETTE BUILDING

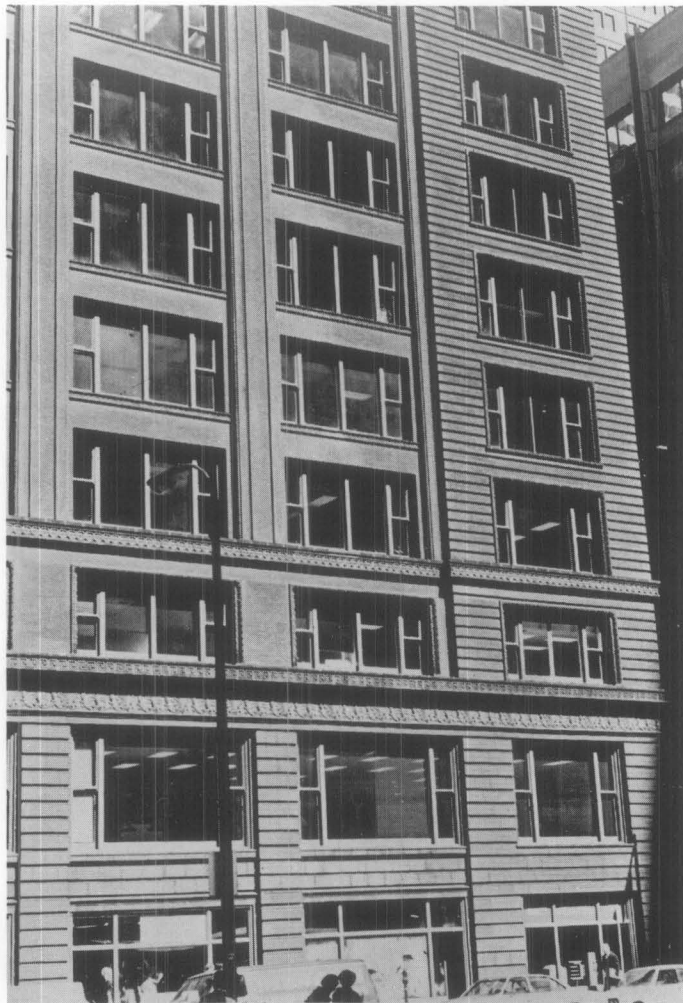
ing on an alley, the 182 Chicago style windows are of greatest interest here because of their style, prominence, and large size. Although the windows vary in size, most measure about 12' wide by 8' high (see figure 1).

Figure 1. The Marquette Building has both Chicago-style windows, as shown above on the second floor, and a modified Chicago-style window consisting of two fixed lights in the center section. Photo: Charles E. Fisher

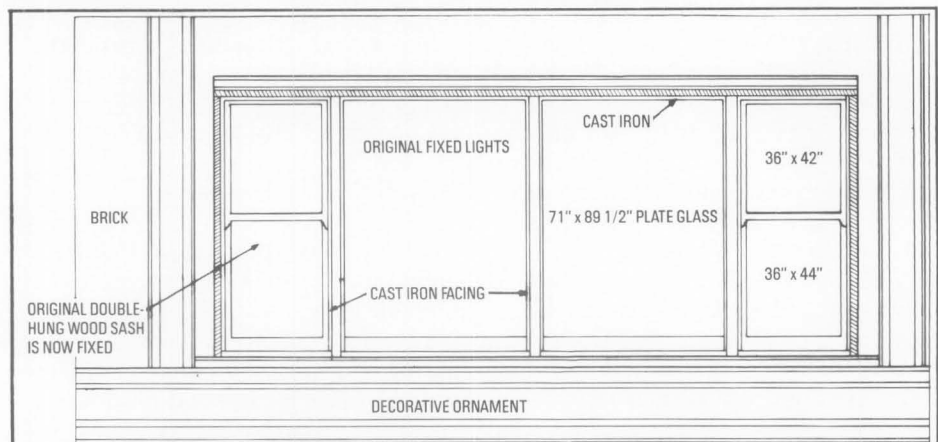
Constructed out of good quality mahogany, the windows were still in sound physical condition despite over ninety years of exposure to Chicago's winter weather and years of neglect due to deferred maintenance (see figure 2). While some of the sills needed repair, the windows primarily needed to be repainted and to have some interior trim replaced. Recaulking around the frames was necessary, but otherwise there was very little air infiltration. The windows had already proven to be very durable and, except for periodic painting, long-term maintenance was expected to be minor. The project architect, Walker C. Johnson, AIA, of Holabird and Root, estimated the life of the windows to be in excess of another ninety years. Even with this information, the architect and owner still had other factors to consider in examining alternatives for the repair or replacement of the windows.

Figure 2. The window sash were well-constructed of mahogany and the frames were faced on the outside with cast iron trim. Drawing: Martha L. Werenfels

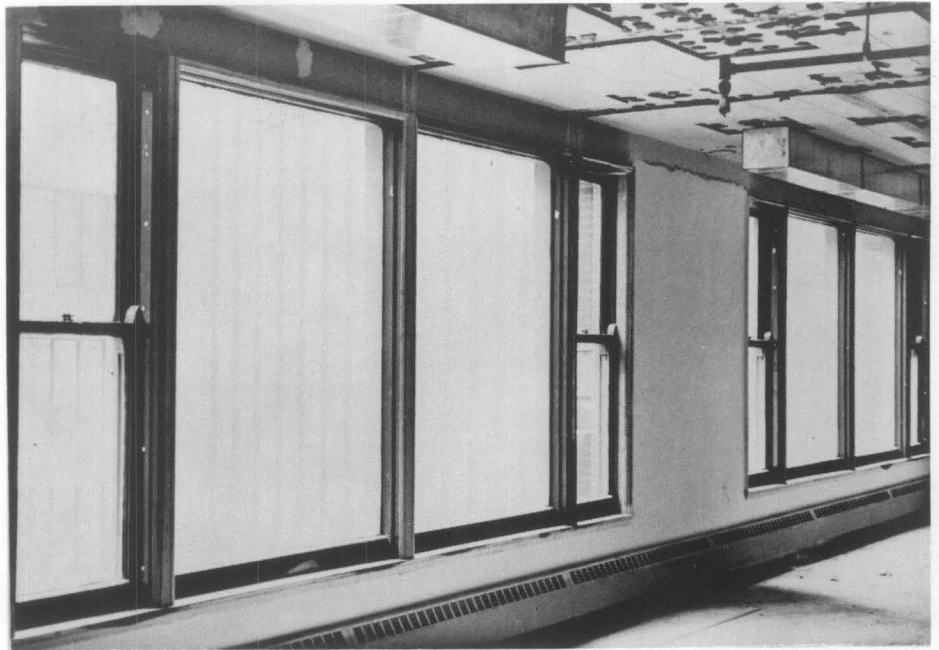
Figure 3. Approximately 1000 linear feet of matching window casing trim had to be installed. In many cases, damage had occurred where later partitions had intersected the windows. Lighter color wood shown in the photograph is the new trim prior to painting. Photo: Charles E. Fisher

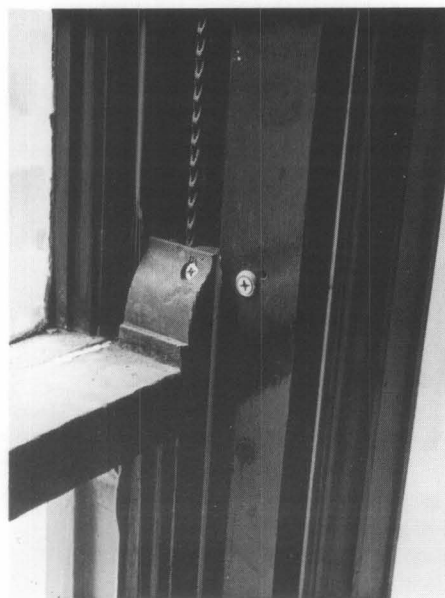
Figure 4. The only modification made to the windows was the addition of a screw through the decorative end of the sash stile to fix closed the operable portions. This decision grew out of the recommendations by the mechanical engineers. Photo: Charles E. Fisher

To prevent tenants from opening the windows, a screw was secured through the decorative extension of the stiles of both upper and lower sash (see figure

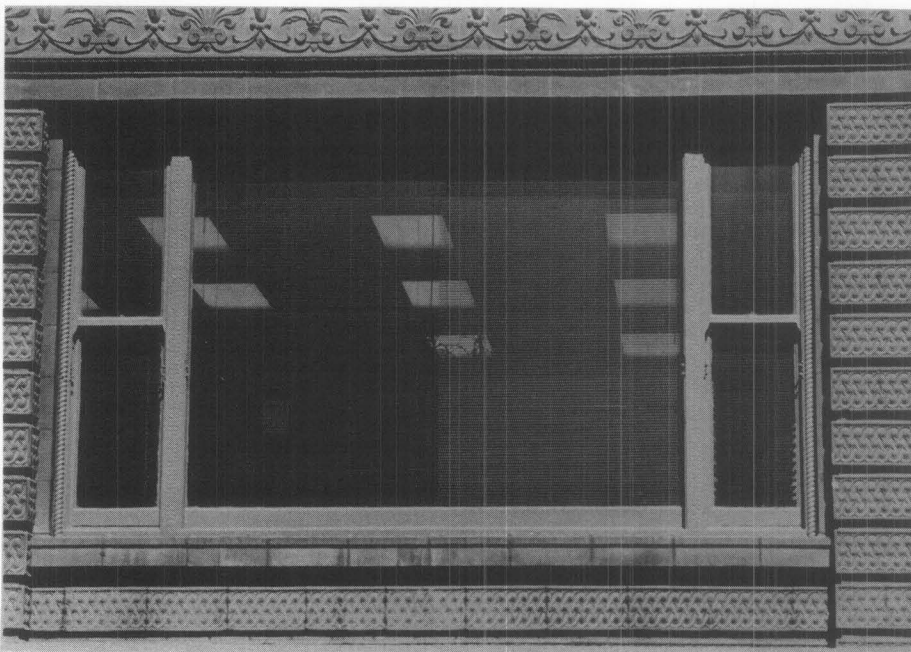
Figure 5. Careful planning and evaluation led to the conclusion that the most cost-effective approach was merely to repair the windows rather than undertake measures to upgrade their performance. Photo: Charles E. Fisher

This and other rehabilitation projects have shown the value of careful and objective evaluation of existing window conditions (*see figure 5*). Sound planning can result in window decisions that take into account good preservation decisions and the realities of the marketplace.
