HISTORIC STRUCTURE REPORT

THE BARNES HOUSE

Independent Hill vicinity
Prince William County, Virginia

OCTOBER 2004

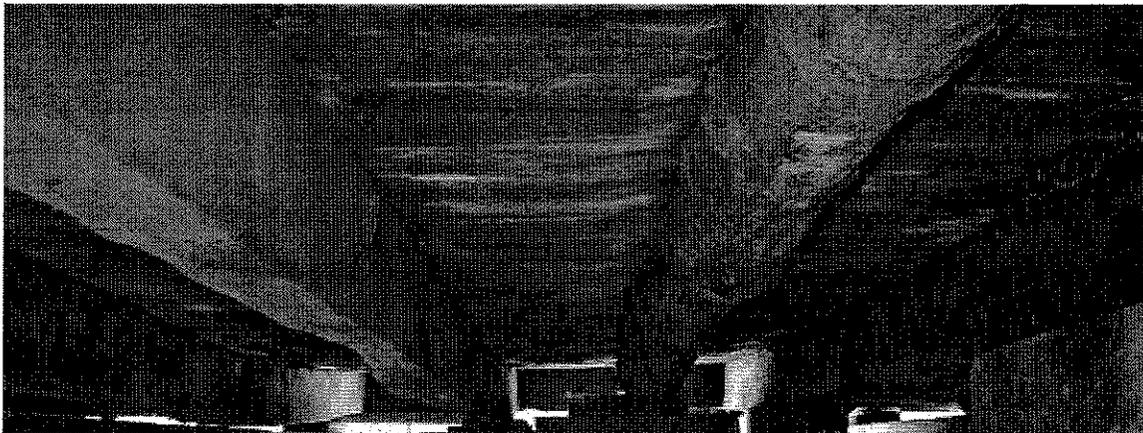
Figure 9: The joists, though similar in size, vary from hewn members to round "log" joists.

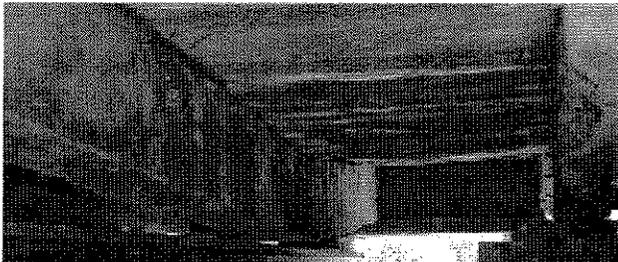
Figure 12: Two or three of the joists represent extreme examples of warping, as seen on the left. Depending upon how the building is to be used, it may be necessary or desired to replace this joist or shore up the flooring to create a level floor surface.

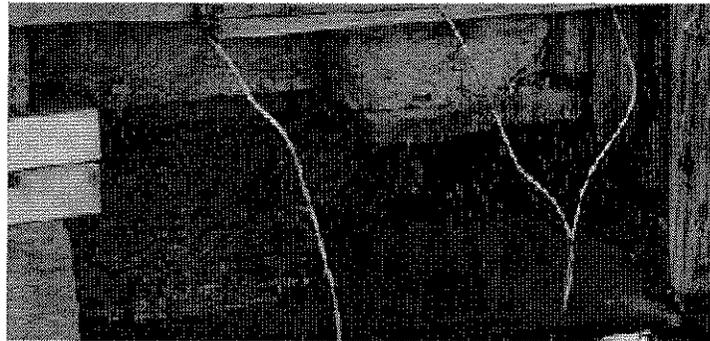
Figures 13 & 14: The building's worst structural condition is rotting and/or termite damage at the corners of the sill plate. Although the sills (bottom horizontal member of each wall) along most of the two long walls are generally in good condition, the corner sections of the sills, along the short walls between each corner of the house and the nearest chimney, are missing.

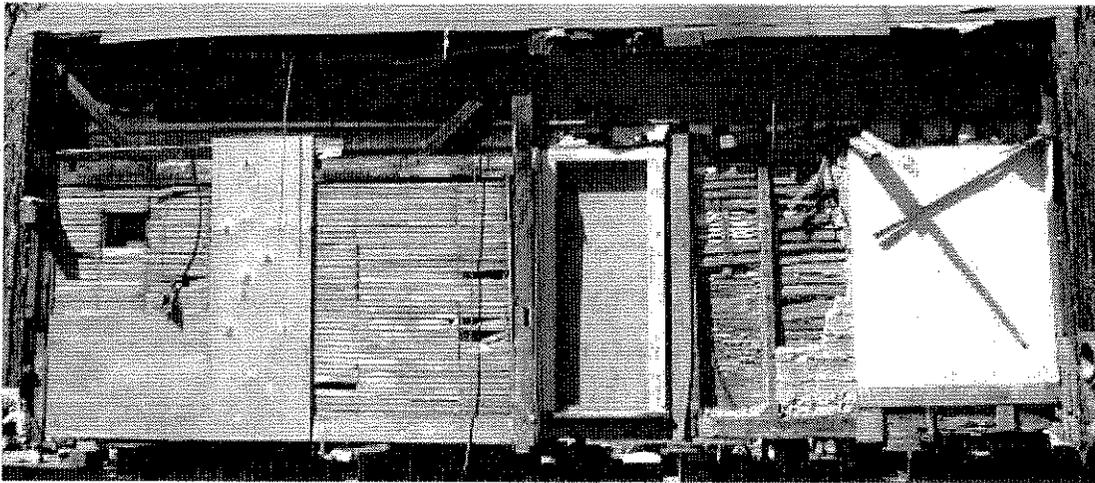
Figure 15: The rear wall of the house, as exposed when the catslide kitchen and bathroom additions were removed, shows layers of materials and construction techniques from several different periods. The main studs are visible in some areas, particularly in the right half of this view, where some of the clay nogging between the studs is also now exposed. Behind the nogging there are two layers of wood lath. The layer touching the nogging (and the not-quite parallel strips above it) is the riven lath from the original construction. Spanning from stud to stud, it is held in place by narrow ledgers nailed to the edges of the studs. Newer sawn lath is on the inside side of the studs, also visible in this photo (bottom half of the space between the studs just to the right of the door). It holds the plaster that was added to finish the interior at some point in the nineteenth century. In the left half of this view, the sawn lath is a remnant of the interior finish of the now-demolished kitchen. The heavy framing and diagonal bracing were the wall of the kitchen wing, framed independently from the presumably older wall of the original house, just beyond it. In the sandwiched materials where these walls come together are some of the remnants of the original beaded weatherboarding. The weatherboarding is visible (in shadow) across the top of the wall in this view.

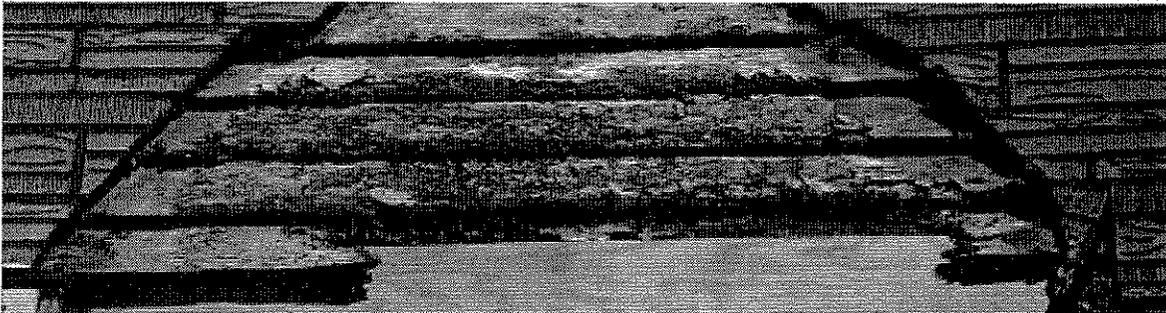
Figure 20: Plain lap siding used when the built was re-sided about 1900, as seen at the top of the area where the chimney has been removed. Note the deterioration from water trapped behind the masonry.

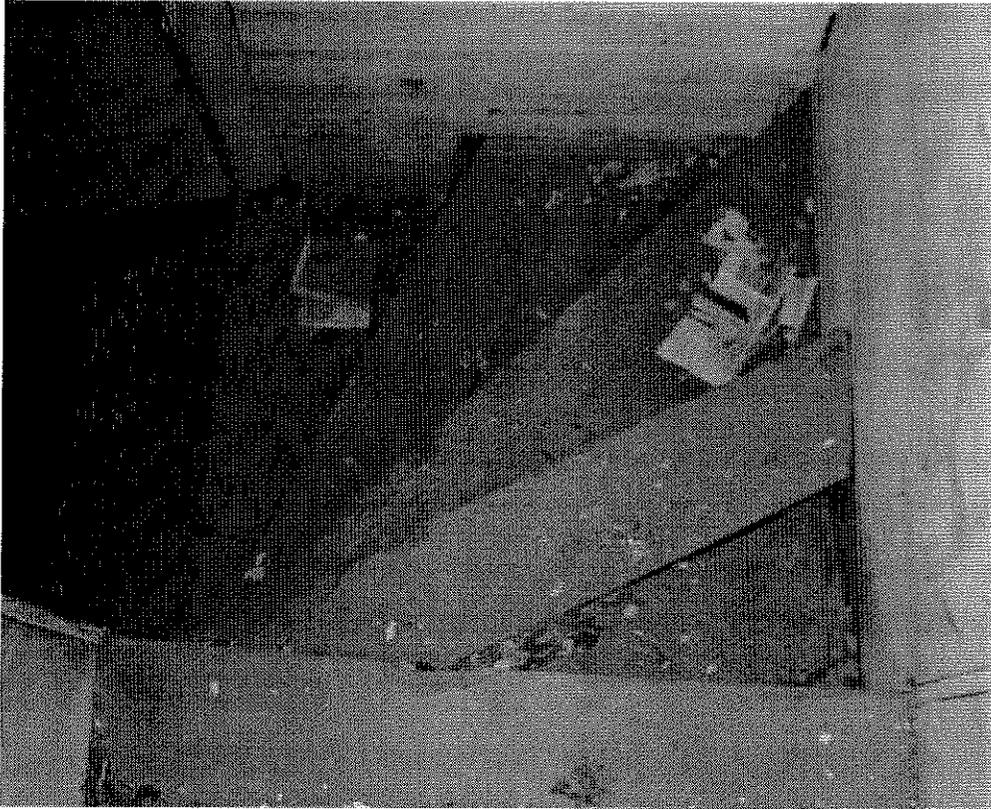
Some sections of the stairs are in good condition, while others are not. One wedge-shaped tread is completely broken and needs to be replaced. There is also some unevenness in the riser heights, which could be a problem if the building is restored for a use that involves allowing the public to go to the second story.

Figure 28: Some of the stair treads, particularly in the winding section, are broken.
