# Tech Notes

### NUMBER 11

### Installing Insulating Glass In Existing Wooden Sash Incorporating the Historic Glass

### DELAWARE BUILDING

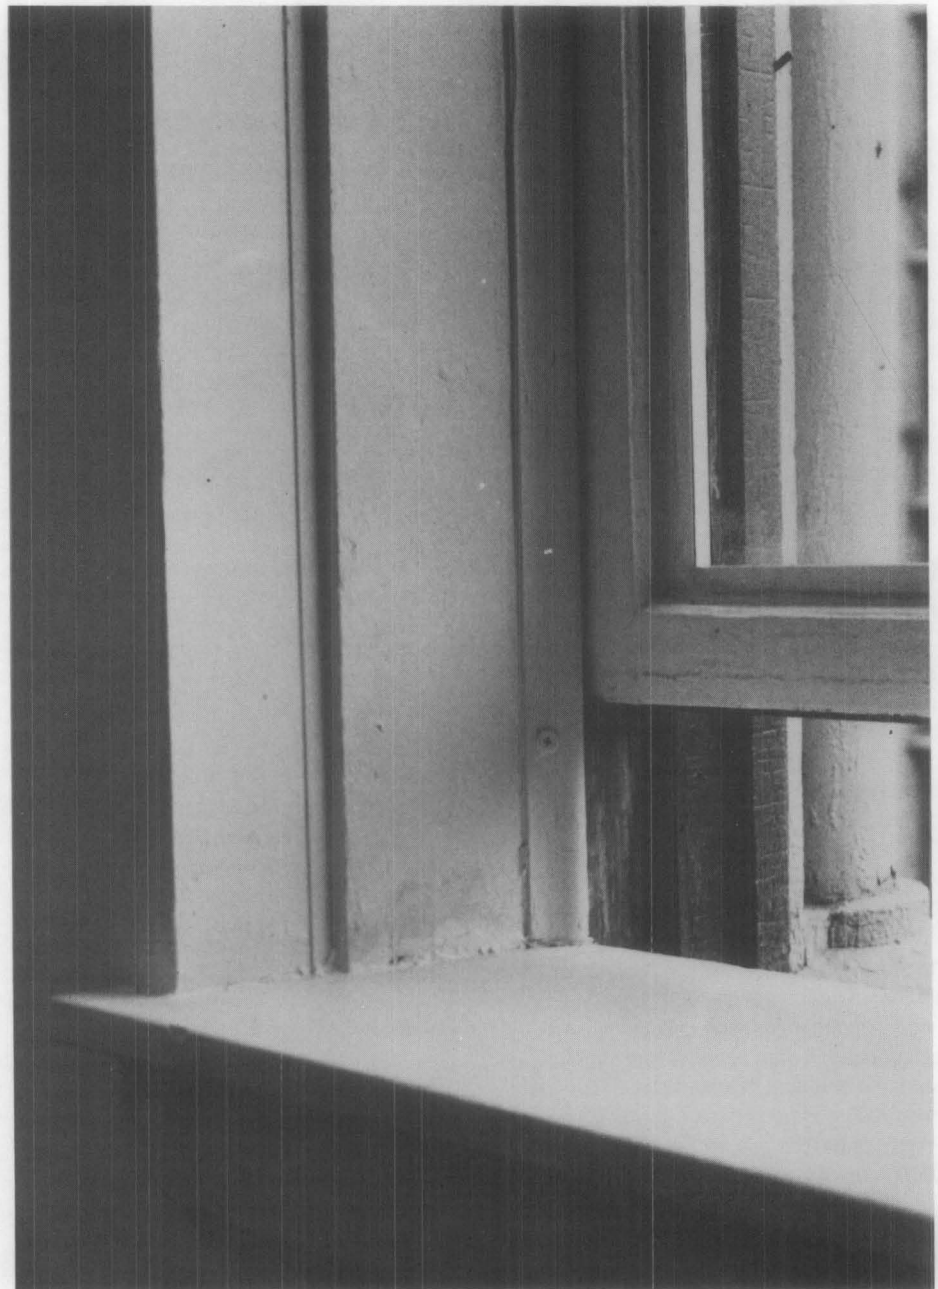
The technique used for double glazing the windows, incorporating the existing glass, was developed in Europe and in use there since the mid 1970s. This technique uses only one additional sheet of glass, placed off the inside edges of the rails and stiles, to create a sealed insulating unit. Since the metal spacer placed between the glass sheets is set slightly off the edges of the rails and stiles, the retrofitted insulating unit reduces the historic glass exposure by about 1/2" along all sides. This tends to limit the applicability of this technique for double glazing to upper floor windows with large lights since at such distances the reduction in exposed glass area is not readily visible (see figure 1). At the third floor level and

**Figure 1.** Since the metal spacer placed between the glass sheets is set slightly off the edges of the rails and stiles, the retrofitted insulating unit reduces the historic glass exposure by about 1/2" along all sides. This change on large windows is hardly noticeable particularly once the flat trim piece is glued in place. Photo: Charles E. Fisher.

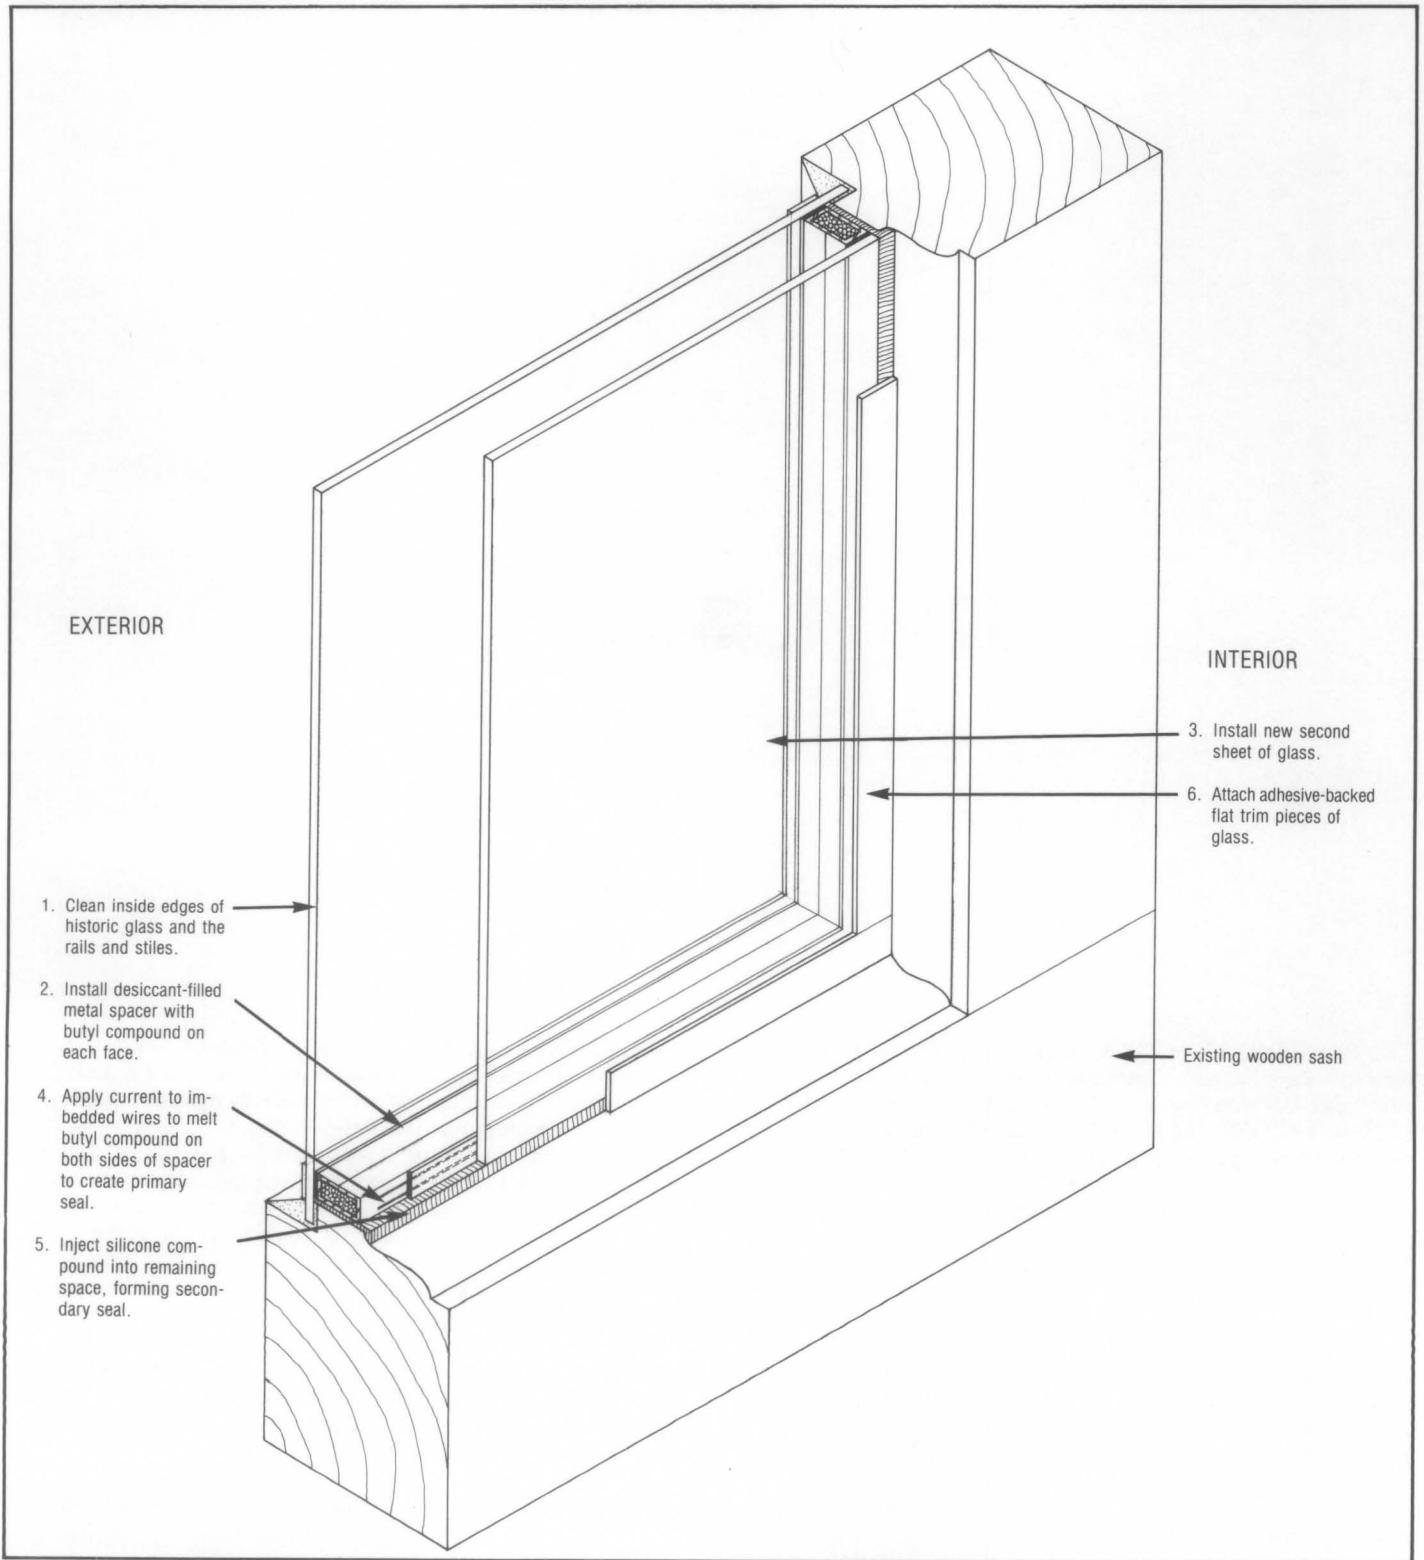
lene. The polyisobutylene strip on the room side also had two parallel copper wires running the entire length, terminating through one corner (see figure 2). With the sash lying flat, the spacer was set snugly up against the inner surface of the existing glass, then the sheet of new glass was placed upon it. Small setting blocks

**Figure 2. The isometric drawing of the window shows the manner in which the insulating glass units were created utilizing the existing glass without any damage to the wooden sash. Drawing: Christina Henry.**

The primary seal for the insulating unit was then created by applying an electrical charge for about 5 to 10 minutes through the two copper wires. The wire-resistant heating melted the butyl compound on both sides of the spacer since the aluminum spacer easily conducted the heat generated by the wires to the polyisobutylene strip on the opposite face. As a secondary seal to retard moisture collection between the glass and help secure the new glass in the sash, a silicone compound was applied in the space between the wood frame, the old glass and the edge of the new glass and the metal spacer (see figure 2).

To complete the glazing work, a flat piece of 5/8" wide painted aluminum trim was adhered with silicone along the inside perimeter of the light as trim to cover the spacer (see figure 2). A similar trim piece, normally applied to the outside, was judged not to be necessary in this instance.

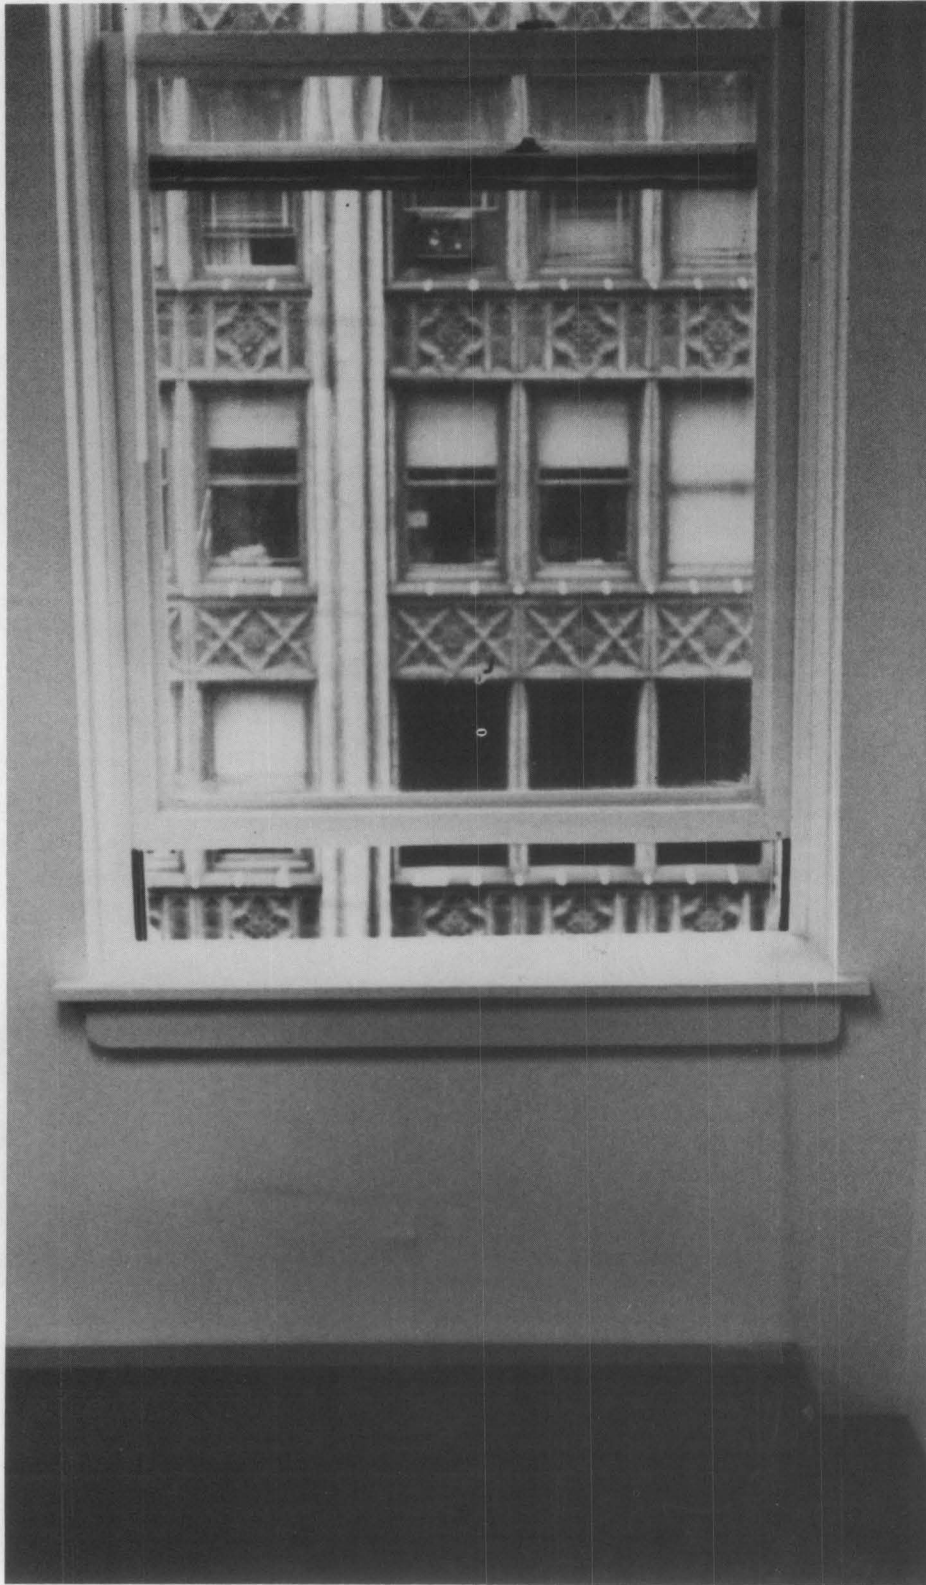
**Figure 3. View of the window with the lower sash partially raised following completion of the work. Due to the large size of the sash, the small flat aluminum trim piece covering the spacer had little noticeable effect on the appearance of the windows as viewed from the typical office area. Photo: Charles E. Fisher.**

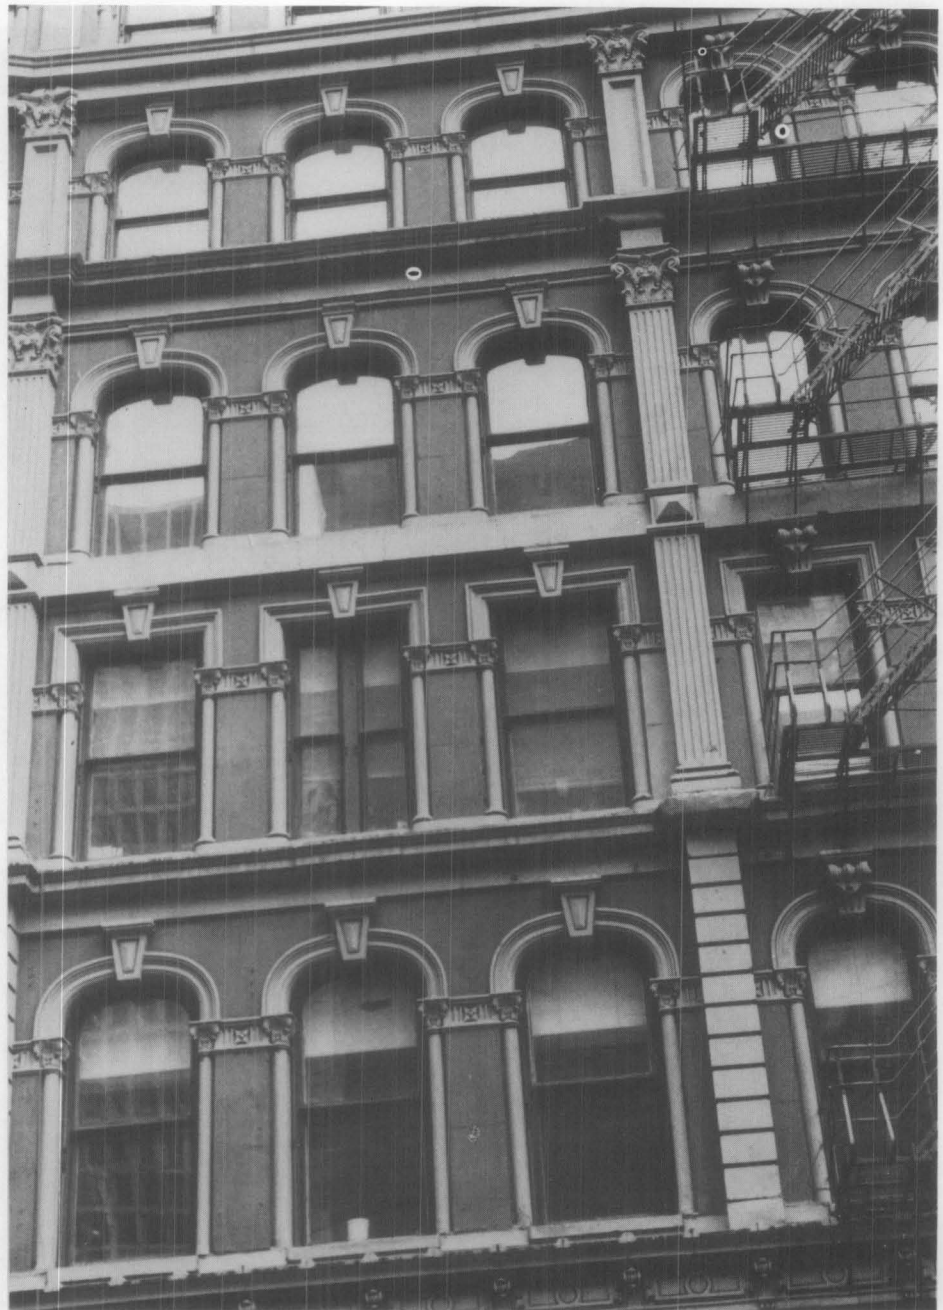
The incorporation of the existing glass into a sealed insulating unit was accomplished in the Delaware Building without any damage to the historic sash and without any loss of historic material (see figure 4). The retrofit work, which is easily reversible, has performed well since its completion in 1982.

**Figure 4.** View of the windows on floors 3 thru 6 shows that the technique used for creating sealed insulating glass units in the existing wooden sash had no noticeable impact on the historic appearance of the windows as seen from the street below. Photo: Charles E. Fisher.
