Tech Notes

WINDOWS

Installing Insulating Glass in Existing Steel Windows

MERGENTHALER LINOTYPE BUILDING

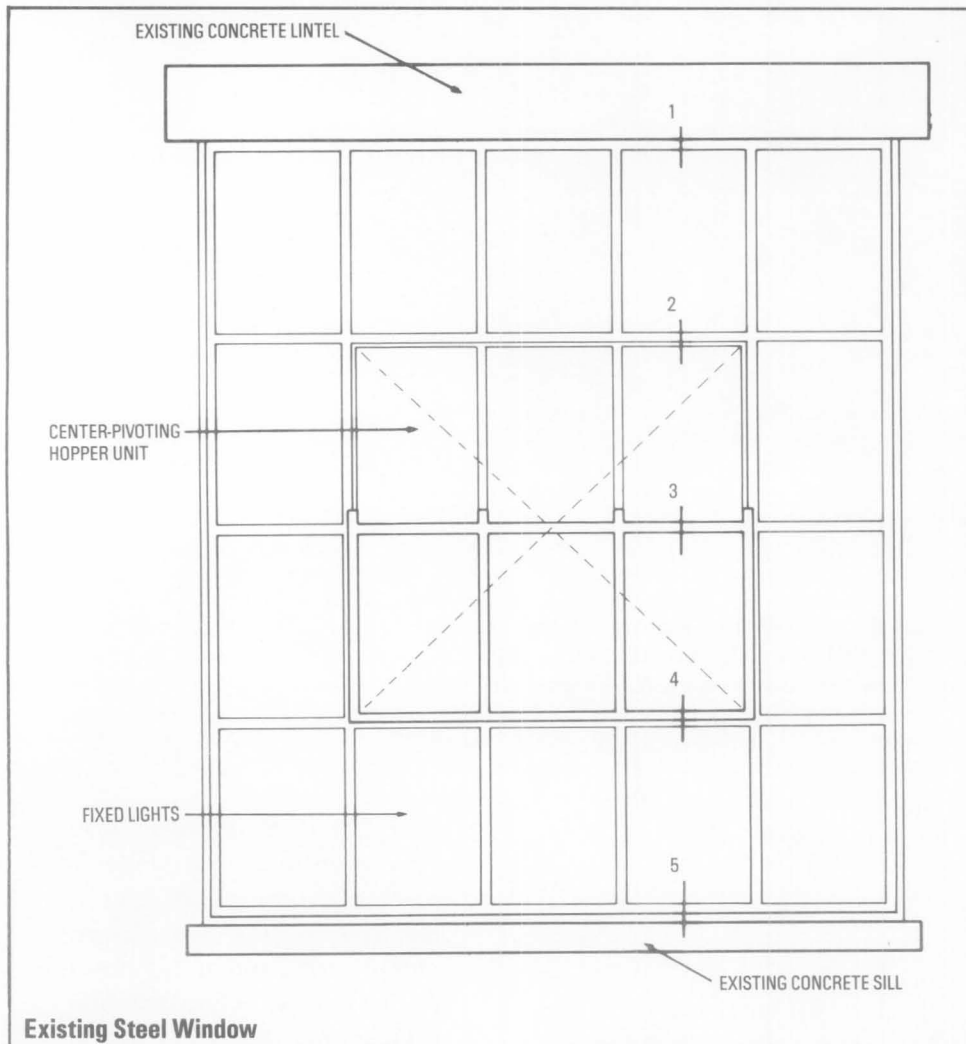
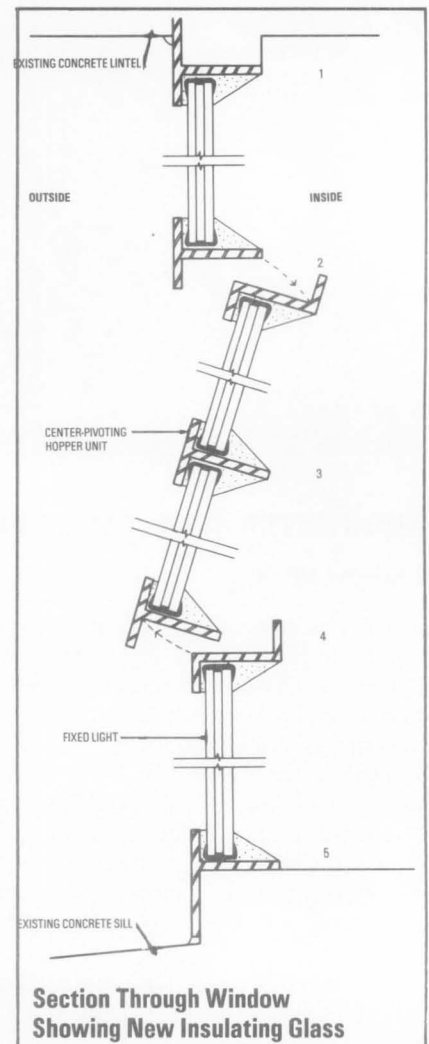
Figure 1. Insulating glass was installed without changing the appearance or operation of the steel window. Drawings: Martha L. Werenfels

Only about half of the glazing cost was directly attributable to the use of insulating glass since from the outset, the residential use of the building tended to dictate from a marketing perspective that the existing wire glass be replaced. Thus it was decided that in lieu of only repairing and reglazing with clear 1/4" glass, which would have been the cheapest of the four identified window options, sufficient benefits could be derived by using double glazing to improve the window's energy performance (see figure 1).

In deciding what type of glazing to install, the depth of the T-shape muntin bar was a constraining factor. Since at least the 1930s, companies have been manufacturing double-glazed steel windows. In such cases, however, the depth of the muntin bars was usually greater than the 1 1/4" found on the windows in the Mergenthaler Linotype Building. By using 3/8" glass instead of the 1/4" wire glass, it was possible to use insulating glass in the existing windows, though an optimum distance between the double

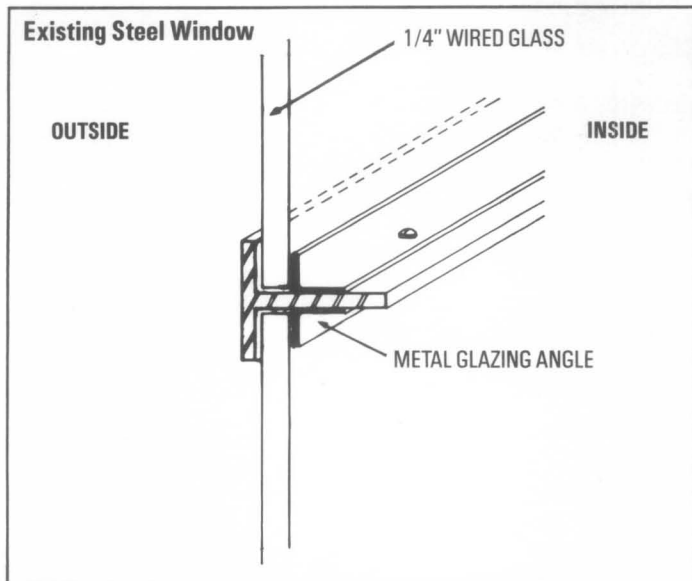
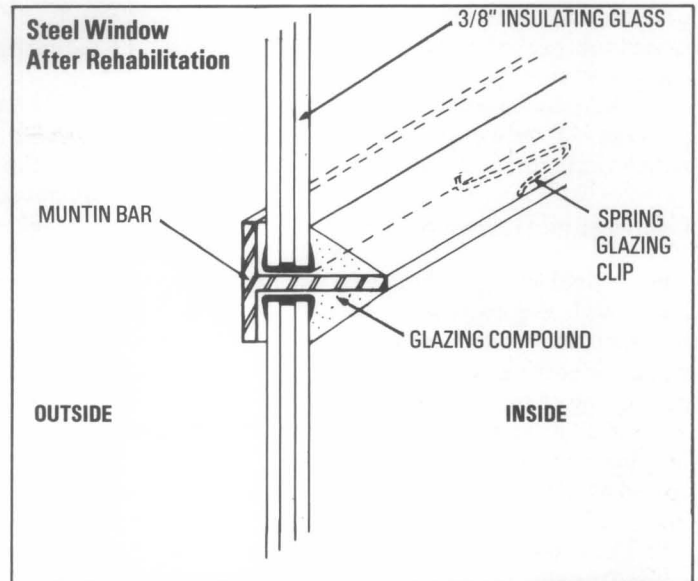
Figure 2. Spring glazing clips and face putty were used instead of the original metal glazing angles in installing the new glass. Drawings: Martha L. Werenfels

The original wire glass had been held in place by glazing angles bolted to the muntin bars. In removing the glass it was decided, due to deterioration of the glazing angles and the labor-intensiveness of reinstallation, that new spring glazing clips and steel sash glazing compound would be used instead (*see figure 2*).

The insulating glass had been delivered to the site, vacuum sealed and with a continuous glazing edge. After the bed putty was applied to the sash, the insulating glass was installed with glazing clips and face putty.

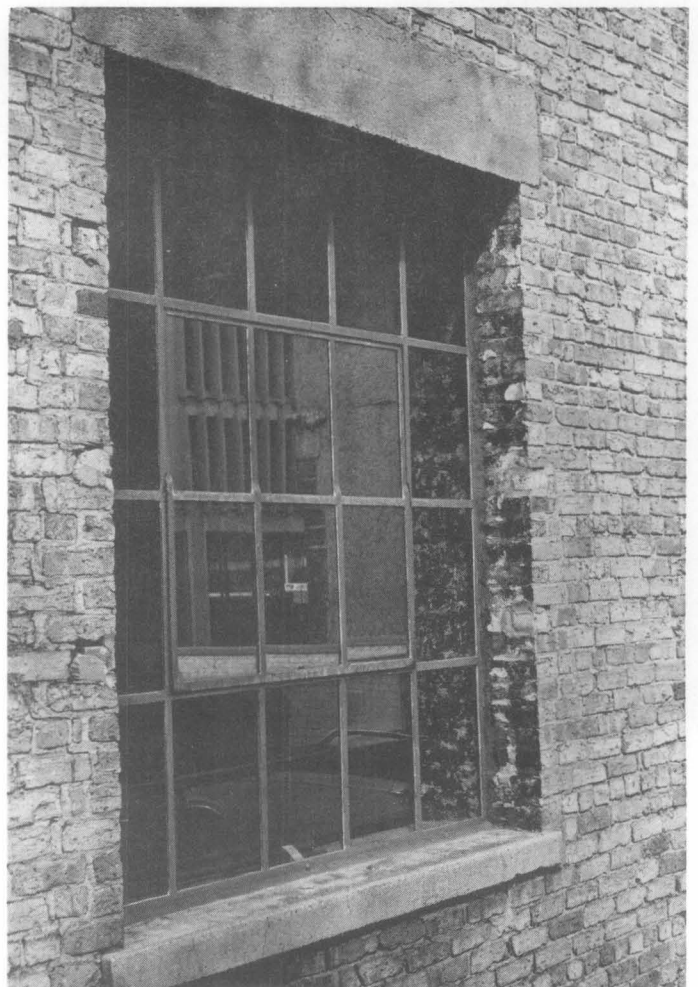
Figure 3. The historic steel windows were repaired and then upgraded through the addition of insulating glass. Photo: Charles E. Fisher

On the whole, the reconditioned windows are performing well and are providing the desired improvements in personal comfort (*see figure 3*). There was no real problem in marketing the condominiums and residents have capitalized on the interior design opportunities provided by the large windows and the loft space.

After the metal glazing angles and glass were removed, the old frames were scraped off and existing paint layers and rust were removed using sand under air pressure. After cleaning, sections from several old windows that had been removed were welded into the remaining windows to replace missing

or deteriorated metal pieces. At the same time, racked metal sections, especially the center-pivoting hopper units, were realigned by applying heat and pressure. All the metal was then painted with an anti-corrosive paint.
