# Tech Notes

## THE DRAKE HOTEL (DRAKE TOWER) Philadelphia, Pennsylvania

### NUMBER 15

### Interior Storms for Steel Casement Windows

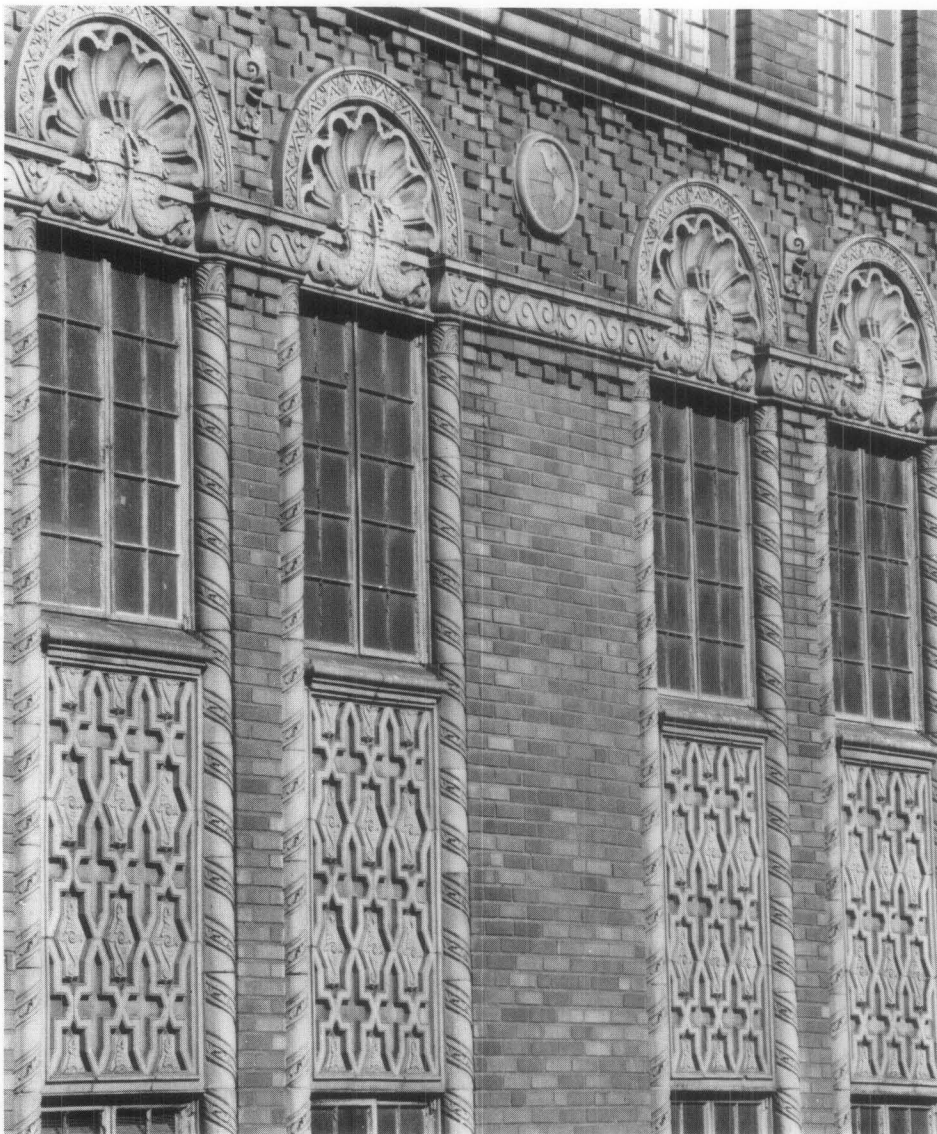
**Figure 1.** The steel casement windows on the lower and uppermost floors were richly adorned with terra cotta detail. Photo: Mort Bond/National Register Collection.

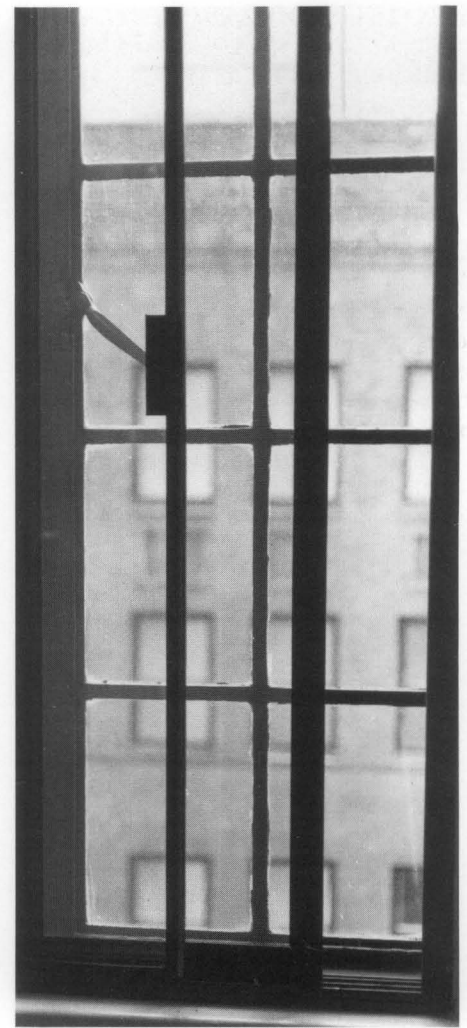
Figure 3. View of the storm unit showing a screen panel and one of the glazed panels partially opened. Photo: Christina Henry.

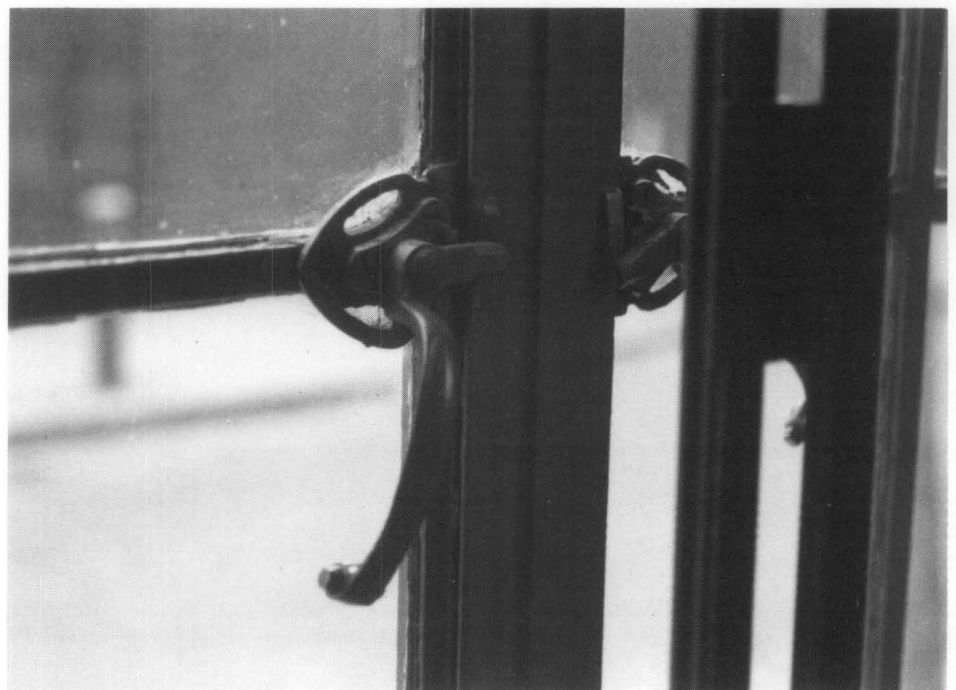
Figure 4. The hardware was cleaned and oiled as part of the maintenance and repair work undertaken on the steel casements. Photo: Charles Fisher.

The steel casement windows required basic maintenance work. This work included cleaning, reputting where necessary, limited replacement of cracked glass, and the application of an anti-corrosive paint. The hardware was cleaned and oiled (see figure 4), and the frames caulked on the exterior both to keep water from entering and rusting the steel subframe as well as to reduce air infiltration. The relatively tight closure of the cleaned and repainted casements, coupled with the planned installation of the interior storm unit, rendered the additional expense of retrofitting weatherstripping to the casements unnecessary.

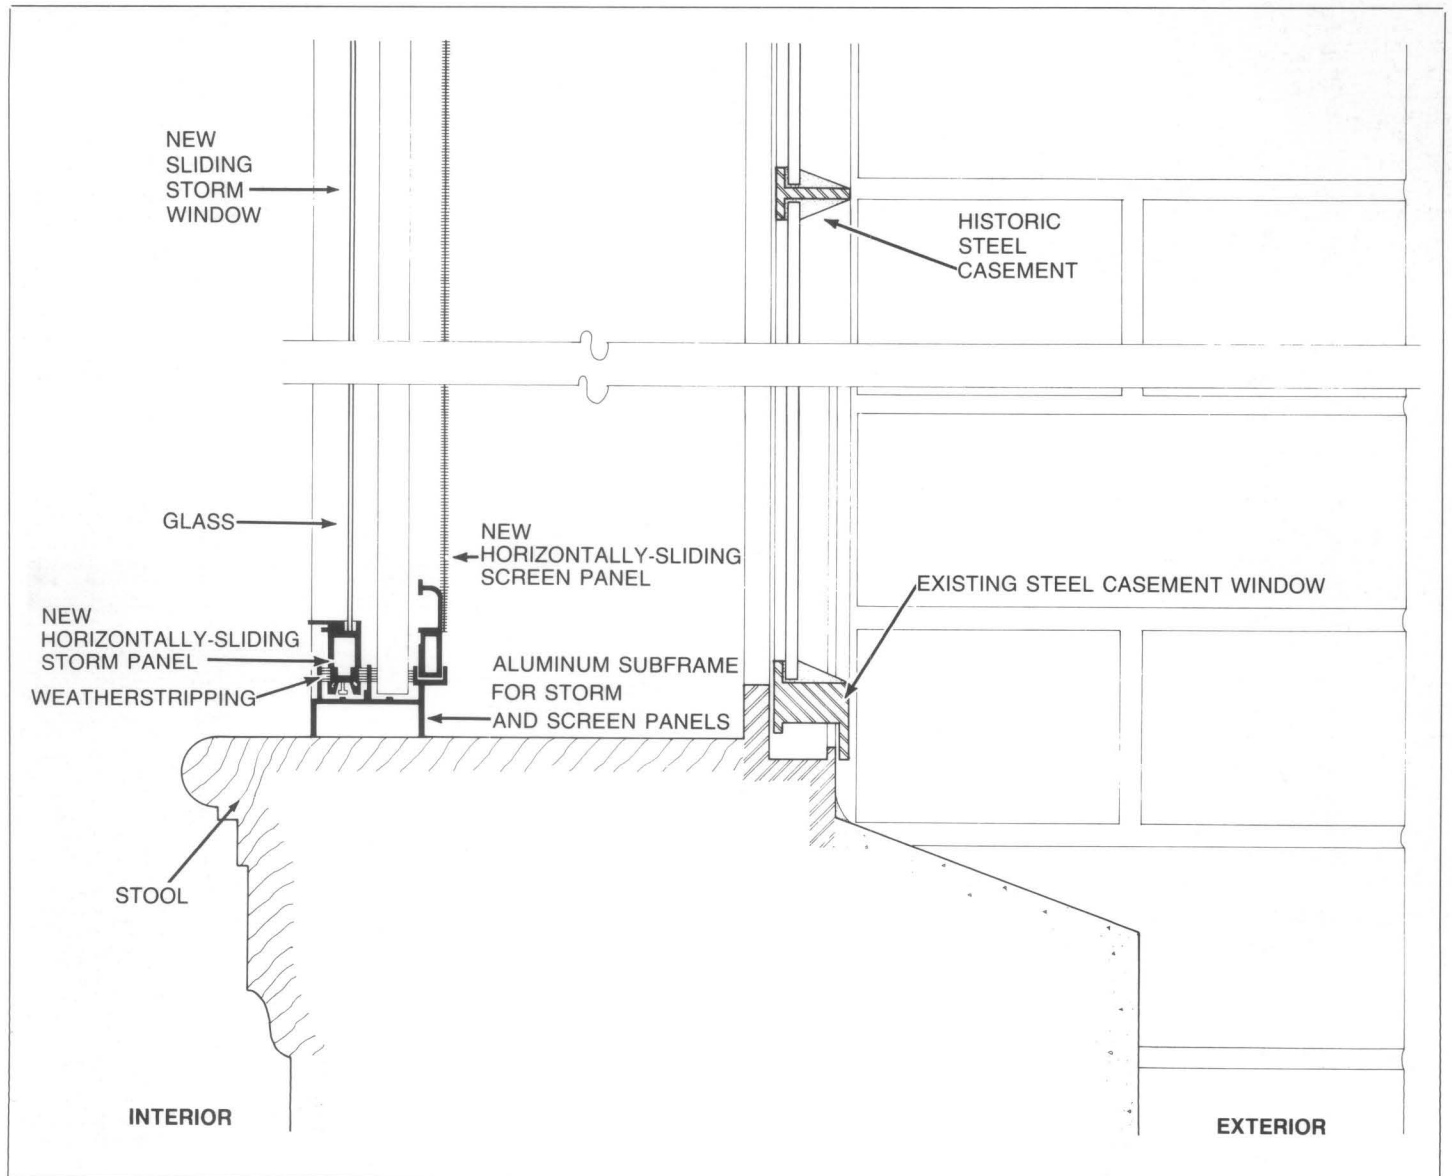
Figure 5. The interior storm window system consisted of an aluminum subframe and sliding aluminum-frame panels with glazed and screened units. Drawing: Christina Henry.

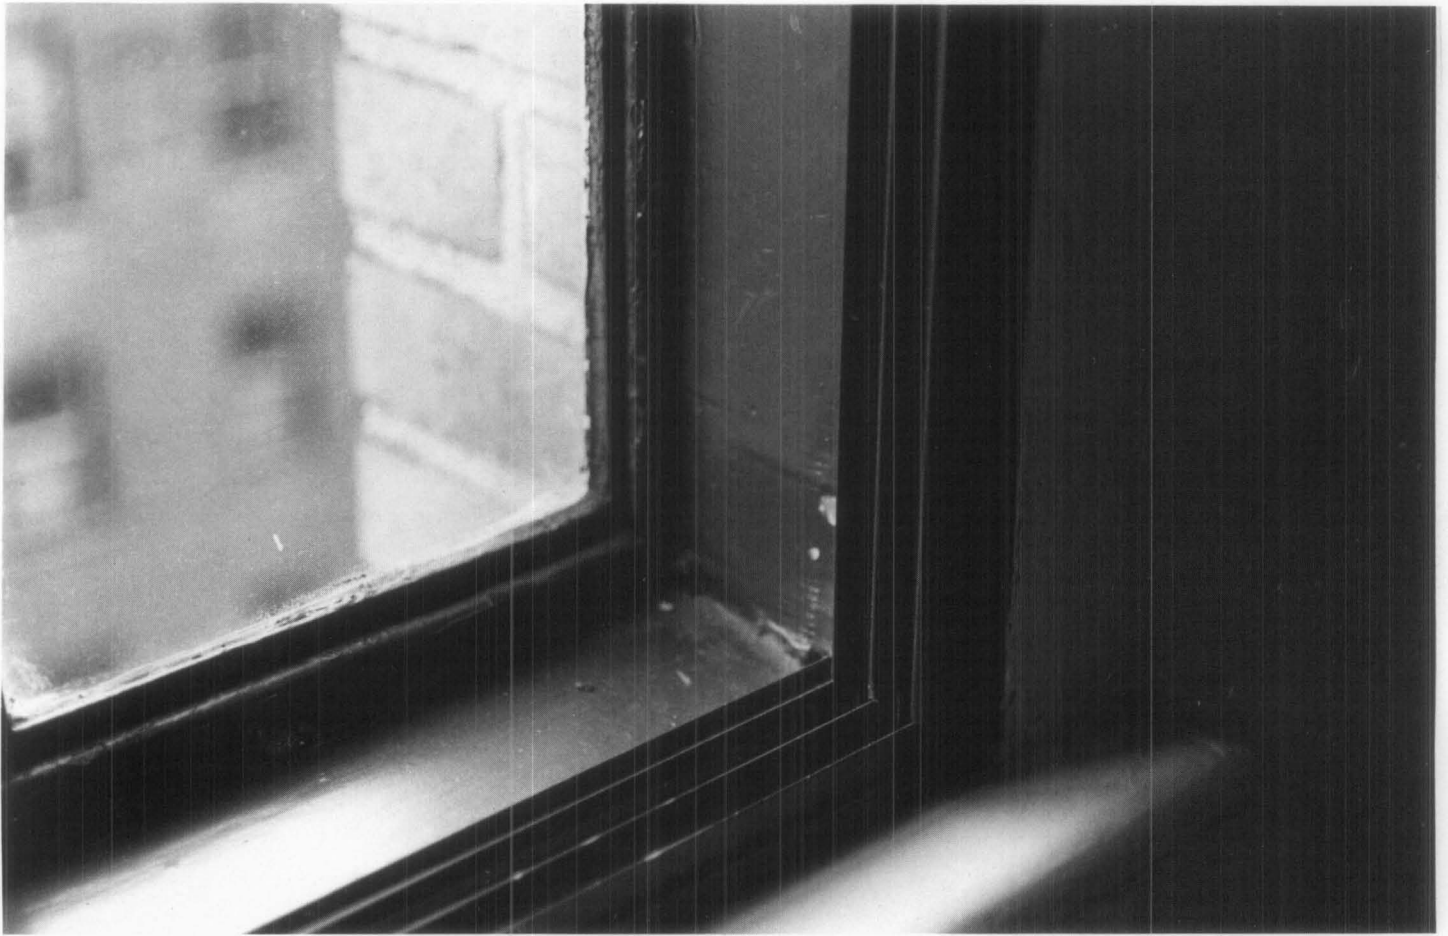
Figure 6. The subframe had to be squared off when installed in each window opening to prevent racking of the sliding panels.  
Photo: Christina Henry.

Several important factors were taken into account to ensure the successful installation and operation of the storm windows. First, care was taken to make sure that the aluminum window section was thick enough to prevent racking of the sliding sash. For the 3' by 4¾' opening, a 5/8" thick sash frame was used, set into an aluminum 1⅜" subframe screwed to the existing jamb (see figure 5). Openings larger than these may require thicker frames. Second, correct installation procedures were essential to ensure that the slider unit functioned properly. This required that each subframe be squared off when installed in the existing jamb, since changes in alignment may have

occurred to the window opening over the years (see figure 6).

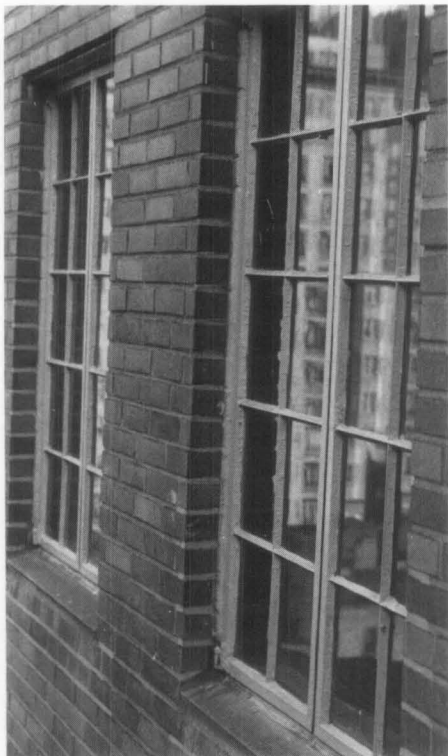
The installation of the storm units had little visual impact on the exterior appearance of the Drake (see figure 7). This is largely due to the selection of an interior application, use of a dark color for the storm frames, the alignment of the intersection of the two storm panels at a point behind the steel mullion on the historic window, and the setback of the storm unit nearly flush with the interior wall. On the inside, the storms are neatly set within

Figure 7. The dark frame color and careful installation of the interior storm window resulted in little visual impact on the exterior appearance of the building.  
Photo: Charles Fisher.

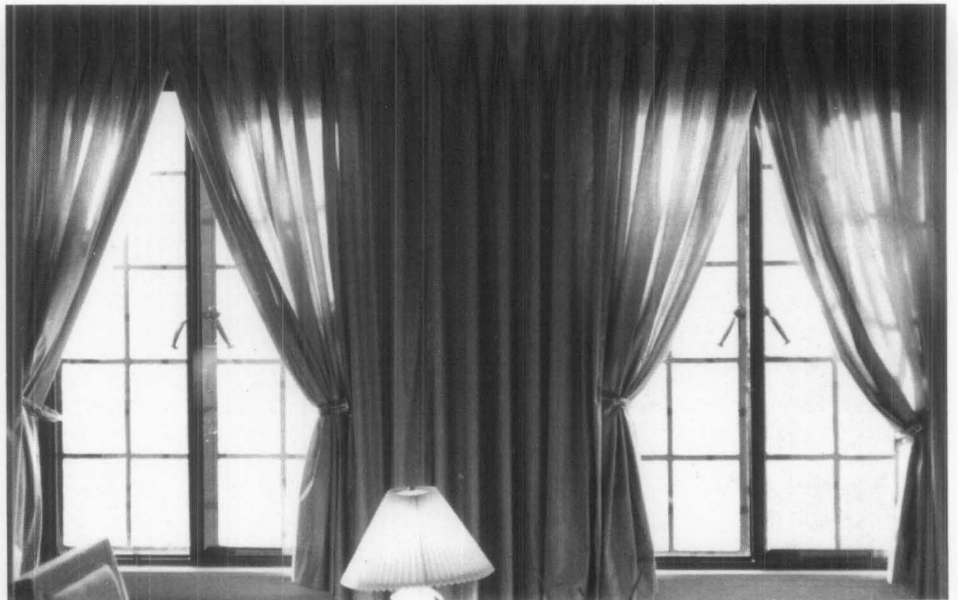
the opening and aesthetically are not disruptive (see figure 8).

Figure 8. The storm units are neatly set within the opening and aesthetically are not disruptive. Photo: Charles Fisher.
