## CHALMERS UNITED CHURCH

### Kingston, Ontario

# Tech Notes

### Reinforcing Deteriorated Wooden Windows

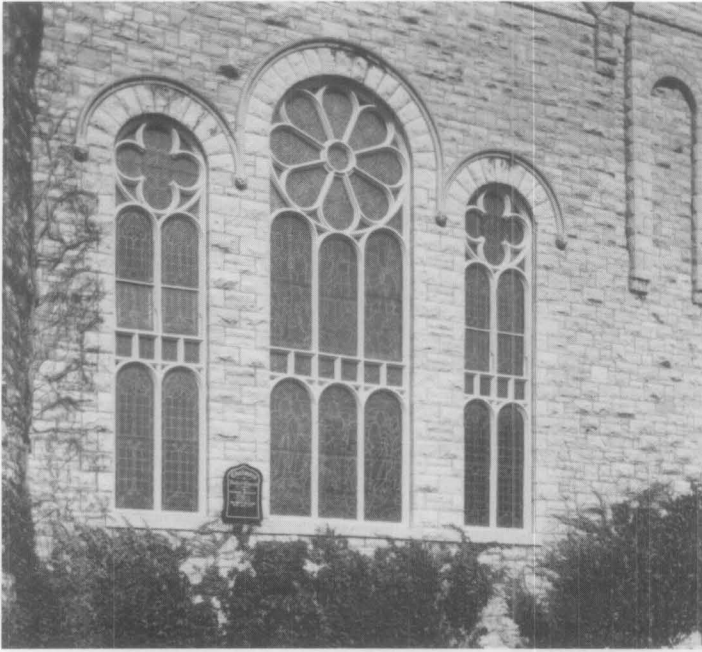
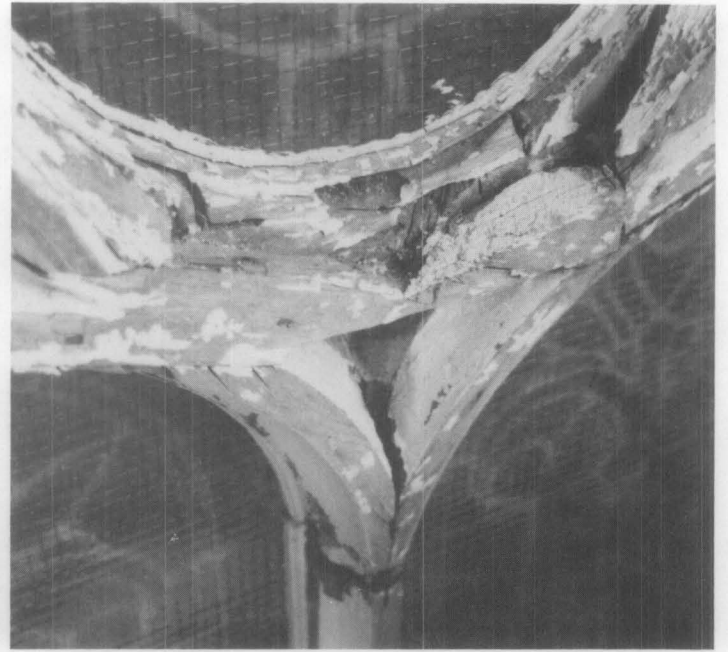
Over time the windows had suffered severely on the southern facade of the church, which is exposed to sun and constant strong winds blowing in from nearby Lake Ontario (*see figure 1*). This wind not only carries dust and dirt, but also has a high moisture content. Because of weathering and the lack of regular maintenance, the wooden frames which secured the stain glass panels had gradually deteriorated. The decay finally became so acute that by 1982 the windows were in imminent danger of collapsing. The parishioners at that point had no choice but to ar-

**Figure 1.** Considerable deterioration had occurred to the tripartite windows as shown in the close-up view of a portion of the mullion. (The stained glass is protected by individual sheets of wire glass set within the wood mullions)

of damage during removal and transportation. Instead of making new mullions, the decayed frame was reinforced in an unusual manner, using a method developed by Paul Stumes, the consulting engineer for the project. The method involved the use of epoxy consolidants along with steel reinforcement rods (see figure 2). To permit the work to take place undisturbed by the weather, a "cocoon" formed out of vinyl sheet was attached to the temporary bracing installed to stabilize the windows while the restoration work was underway (see figure 3).

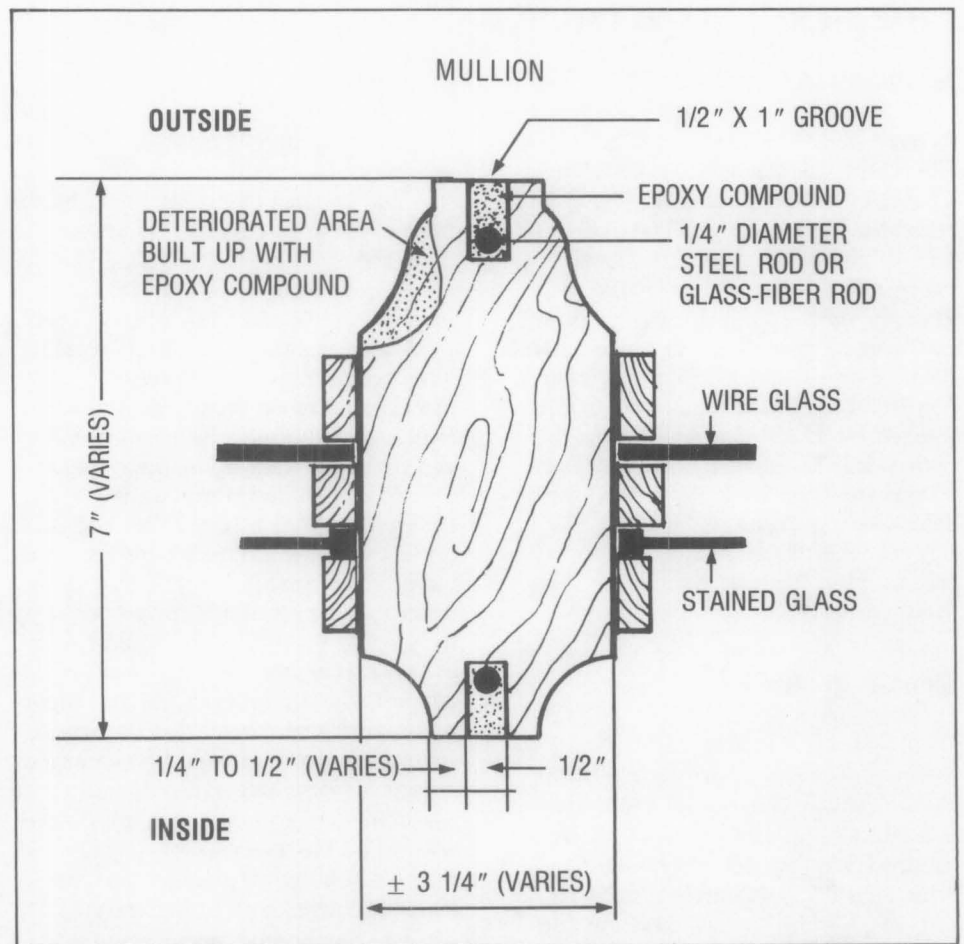
**Figure 2.** Cross section of the historic mullion shows the manner in which the pre-formed steel reinforcing bars were inserted in order to strengthen the windows. The grooves that were cut for the steel bars were filled with an epoxy compound.

For reinforcement, 1/4" diameter steel bars (the same type used to reinforce concrete) were painstakingly bent to match the curves of the mullions. The shape of the bars had to be accurate, within a tolerance of 1/8" in any direction, in order to fit comfortably in the 1/2" wide grooves which followed the complex curves of the windows (see figure 5). Because of the deteriorated condition of the wood, the steel bars could not be forced into the grooves without the danger of splitting the frames apart. In a few instances where the steel rods could not be suitably shaped, braided fiberglass strands were used instead.

With the reinforcement in place, the grooves were filled with an epoxy compound, thus completely embedding

the steel in epoxy. The epoxy used for this project — the high-modulus, thixotropic Sikadur gel in which some Union Carbide phenolic microballoons had been added for more firmness and improved workability — had the consistency of a stiff paste. This mixture had the advantage of remaining in position and retaining its shape wherever it was placed. If a fluid epoxy had been used on these vertical windows, special molds would have had to be fabricated and positioned to prevent the liquid from spilling out before it hardened. After this paste epoxy cured, it achieved a strong adhesive bond with the wood of the mullions and the reinforcing steel bars, creating a sturdy composite window frame.

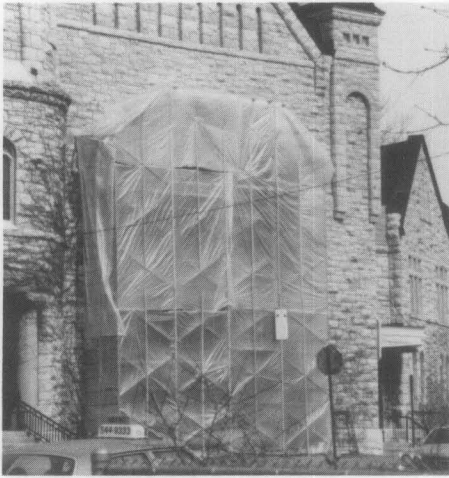
Figure 3. A vinyl cocoon placed over the windows allowed the repair work to be carried out even in inclement weather.

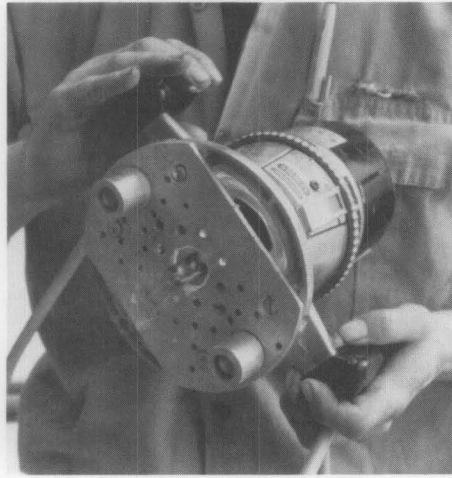
Figure 4. Once the old paint had been carefully removed, grooves were cut in the mullions using an electric router fitted with special guide rollers.

Next, a 1/2" wide groove was cut into the mullions on opposite faces to receive a steel reinforcement rod. The depth of this groove ranged from 3/4" to 1 1/4", depending on the location. This delicate exercise was carried out with utmost care. After some experimentation was carried out on scrap wood, a hand-held electric router was adapted for the job. Special rollers were installed to guide the rotating cut-

ting bit (see figure 4). Notwithstanding the usefulness of this apparatus, the real success of the operation can be attributed to the skill of the craftsman who guided the tool. The wooden mullions varied in size; on a typical 3 1/4" wide mullion, the outer edge where the groove was cut was 1 1/2" wide. In cutting a 1/2" groove on the outer edge, only 1/2" of wood remained on either side. A slight deviation of the tool could have seriously damaged the mullions.

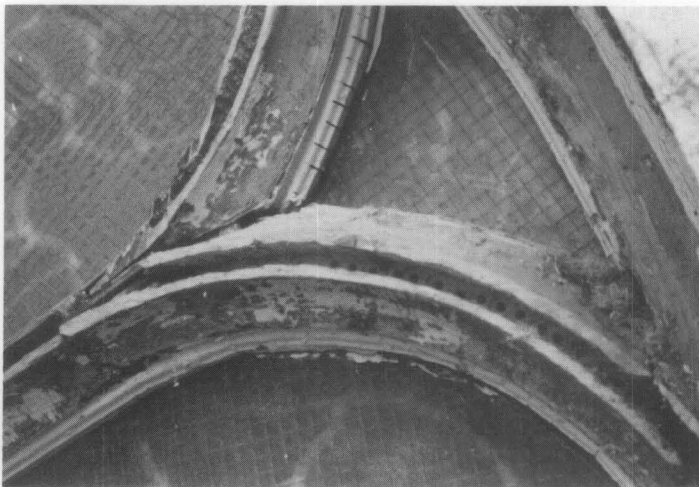
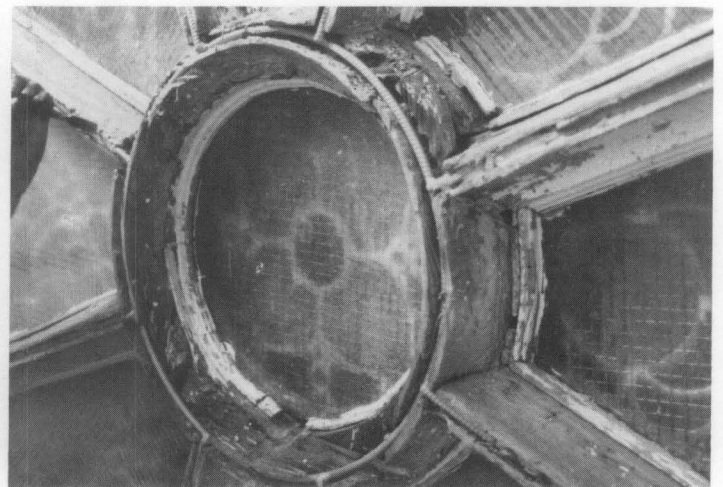
Figure 5. Details of the mullions as the strengthening process was carried out. Left: The grooves had to be carefully cut both because of the deteriorated condition of the wood and due to the relative thinness of the outer edge of the mullion. Right: Reinforcing bars are positioned in the grooves prior to being encased in an epoxy compound.

In many places, due to the advanced decay, the fine details of the mullions crumbled into unrecognizable shapes. In these areas, the original form was recreated using the epoxy

paste like modeling clay. Skillful hands of the craftsman sculpted fill-ins which blended perfectly into the curvature of the wooden mullions. After the epoxy paste hardened, only the color was different from the wood; the shape and the texture were the same. To complete the work, the windows were then primed and painted (see figure 6).

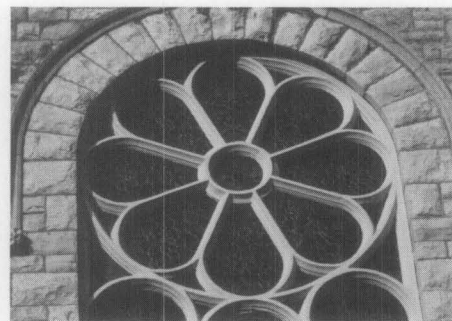
**Figure 6.** Repairing the historic frames resulted in a 25% savings over fabrication of new ones. The work included paint removal, reinforcing of the mullions, consolidation of the deteriorated wood, and repainting.

of the wooden frame as possible. Fortunately the frames were wide enough to permit the installation of reinforcing rods. Problems associated with placing a new frame into a usually deformed old opening were avoided. In addition to preserving the original architectural components, this method was successful in terms of church operations and budget. Since the windows were not removed, the functioning of the church was not disturbed during restoration, and the repair of the windows *in situ* was achieved at a cost 25% less than that of just fabricating a new frame.
