## 9 ROXBURY ROAD SCARSDALE, NEW YORK

### NUMBER 19

## Repairing Steel Casement Windows

Technical Preservation Services  
National Park Service

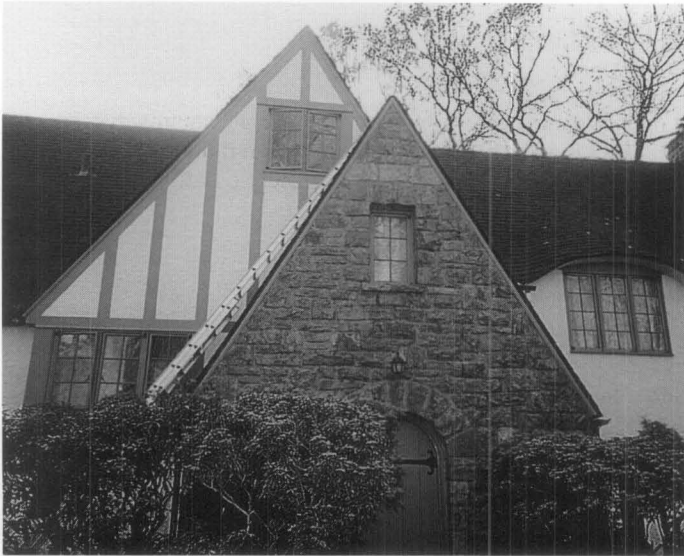
Figure 1. Steel casement windows were placed in various configurations throughout the house. Grouped windows open in opposite directions from each other, assuring that breezes can be captured, and a sash opened during rainy weather, regardless of the wind direction.

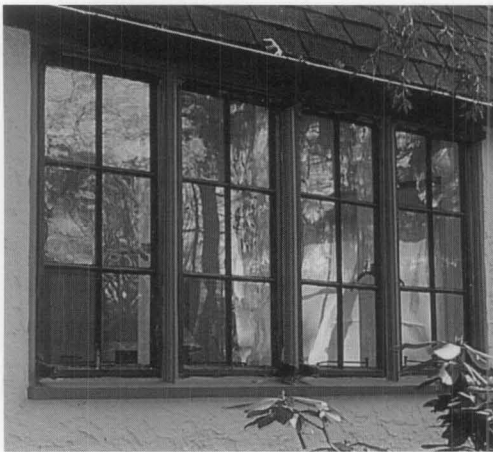
Figure 2. Each casement sash had six lights with projecting hinges that allowed the unit to open outward. Note the variation among glass panes as seen in the reflections. Caused by small differences in the positioning of panes within the sash and minor imperfections in the glass itself, this appearance is an important characteristic of historic windows.

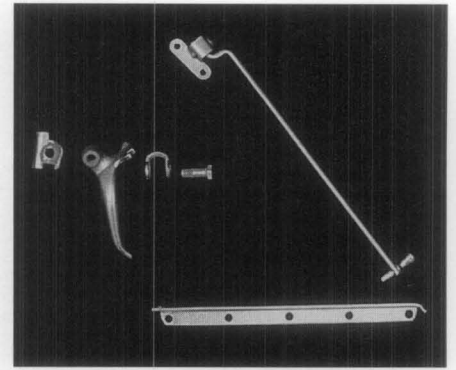
Figure 3. The window hardware at 9 Roxbury Road included a two-part "lift and stay" operator (right) and a common locking handle (disassembled at left). The hinged portion of the lift and stay (upper right) is attached to the sash while the perforated length is connected to the frame. To open the window, the pin is lifted from the hole on the far right, the sash is pushed open and the pin reset in one of the adjacent holes.

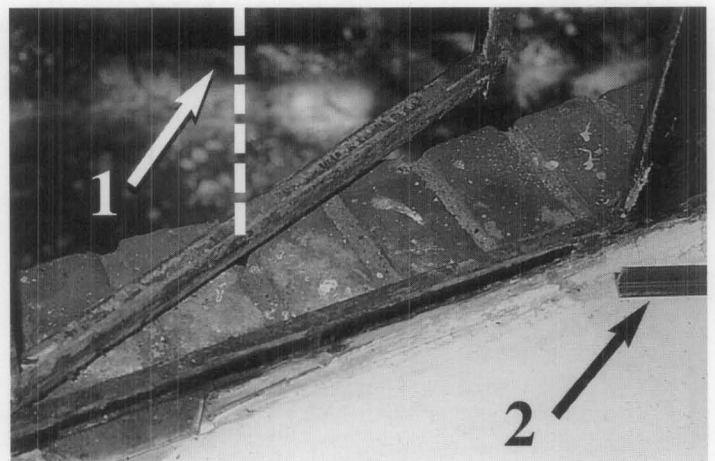
The windows on 9 Roxbury Road showed deterioration and damage typical of historic steel casements. In the course of over seventy-five years, corrosion, wear and some distortion of the sash and frame had occurred. Rust was particularly prevalent along the lower parts of the sash and frame where water had penetrated the distorted opening and the cracked perimeter

caulk (see figure 4). Originally tight fitting, all of the sash were bent out of alignment with resulting gaps from 1/16" inch to 3/4" inch between sash and frame. Hardware was corroded, stiff, and in some windows, seized shut. Prior attempts to force the distorted windows closed had also bent some of the locking handles and other hardware.

Figure 4. The sash and frame were most severely corroded along lower, horizontal members. A vertical glazing bar had previously been removed from the sash above to fit a window air conditioning unit (1). A replacement "T"-shaped length of steel that will be spliced in can be seen on the right (2).

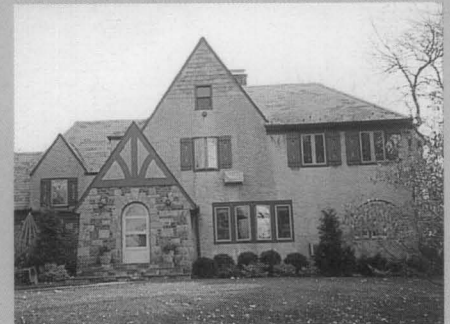
**Inappropriate replacement windows dramatically affect the appearance of a historic home that once featured steel casement windows.**

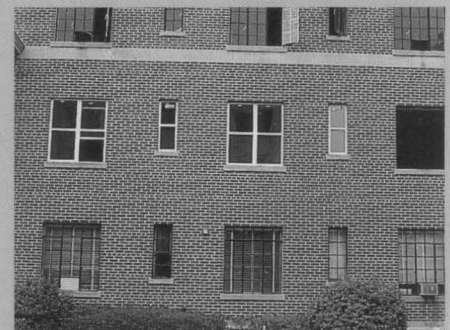
**Historic steel casement windows are in the process of being replaced with new units that compromise the character of this building facade.**
