### **NUMBER 17**

### **Repair and Retrofitting Industrial Steel Windows**

**Robert M. Powers**  
Mid-Atlantic Regional Office  
National Park Service

### **LIPPINCOTT PRESS BUILDING** **Philadelphia, Pennsylvania**

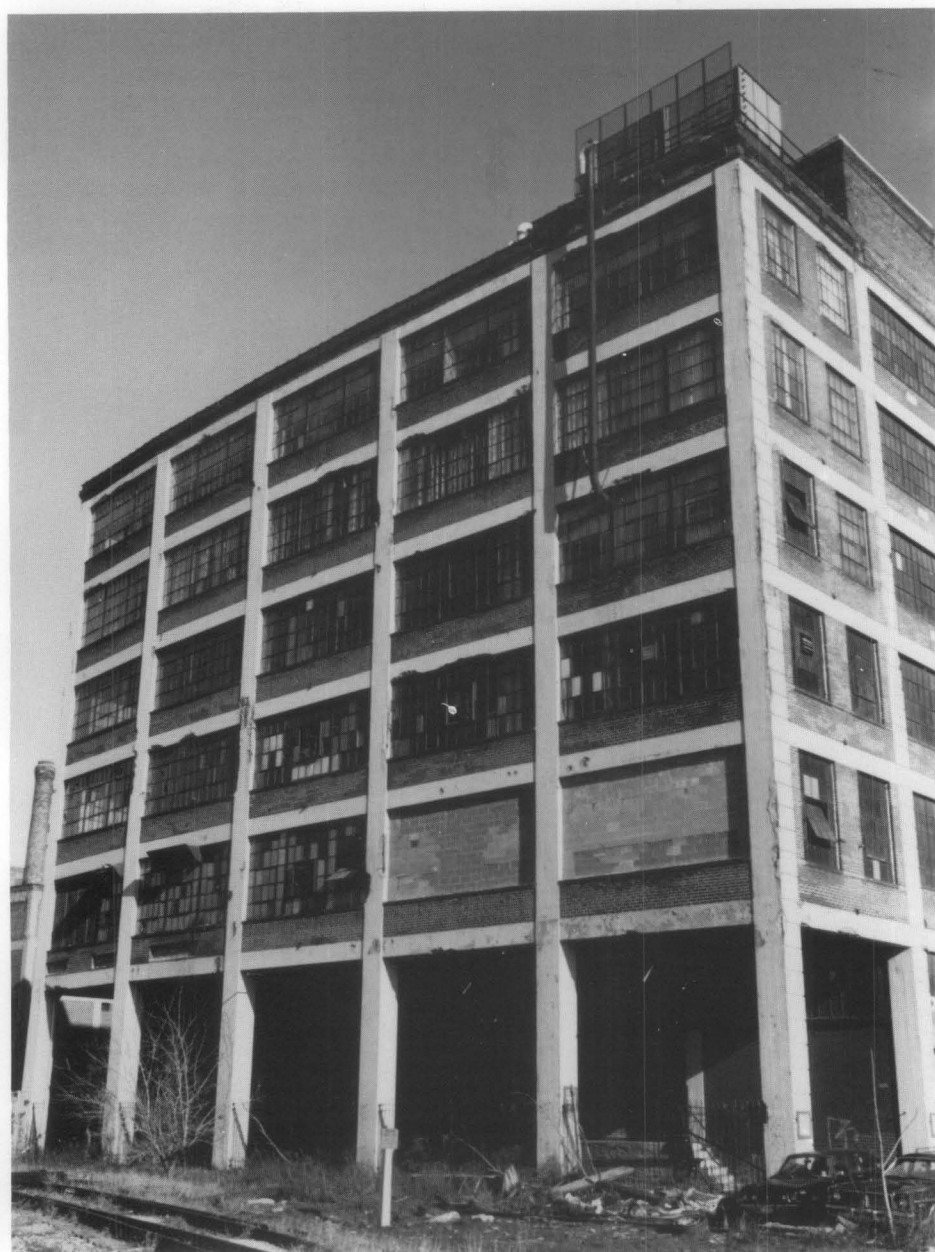
Since the Lippincott Building was used for a long time as a storage facility, the windows had not been painted, oiled, reglazed, or caulked, nor had missing or damaged parts been replaced in well over twenty years (see figure 1). Naturally, many of the windows exhibited problems typically found on inadequately maintained steel windows, including corrosion, bent and bowed metal sections, non-operable ventilators, missing or non-functional hardware and broken glazing. Furthermore, some of the original windows had been removed and replaced with double-hung aluminum windows, and other window openings had been infilled with glass and concrete block, metal louvered air vents, ductwork and other mechanical equipment (see cover photo).

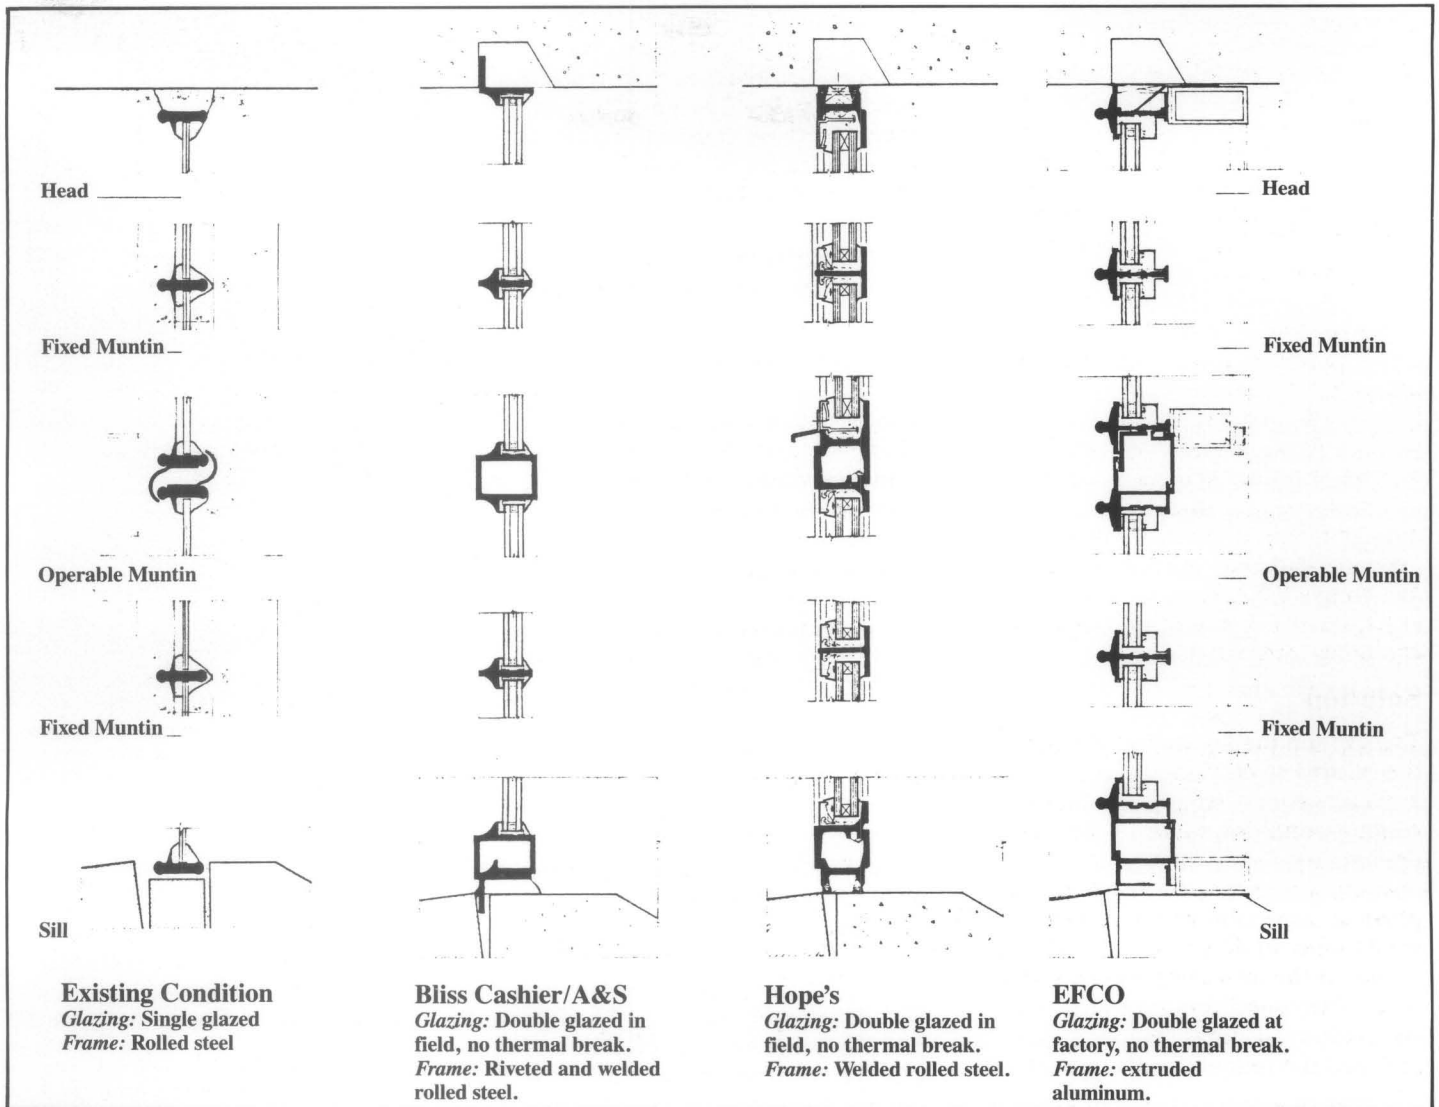
Figure 3. Comparative window sections showing the existing steel window on the left and the three thermally glazed replacement proposals on the right. Drawing: H2L2 Architects.

As seen in the comparative drawings and as evident from the mock-ups, the new double-glazed windows did not match the proportions, dimensions, thin profiles and sight lines of the historic steel windows due to the increased dimensions of the new window members. Thus, although the new proposed windows promised increased energy performance, the installation of these non-matching windows would

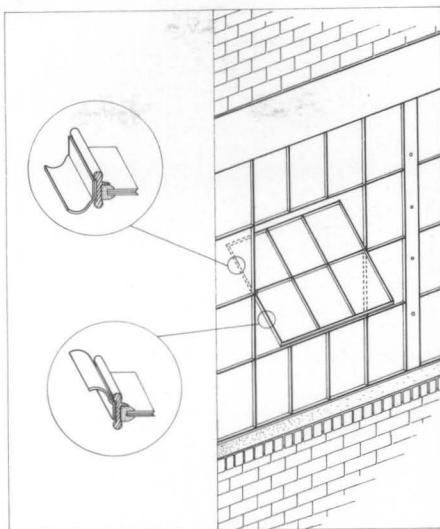
**Figure 6.** Pivot ventilators prior to retrofitting on the upper floors. Bullnose trim pieces to be modified as part of the retrofitting from pivot to projecting ventilators. Drawing: Martha Raymond.

Concurrent with the cutting out of the window's corroded steel members, each of the existing pivot window ventilators on floors two through six were cut from their jambs, labeled and brought to an on-site work station. At the work station, the pivoting ventilators were modified to operate as projecting windows (see figure 6). This was accomplished by cutting off the bullnose outside face of the side and bottom rails on the sash and riveting a new water-shed steel angle at the same locations. To allow the ventilators to swing out, two 16", heavy duty, 6 bar, zinc chromate plated steel, TRUTH hinges were screwed to each ventilator (see figure 7). New right-hand, cast iron, bronze lacquered, locking handles were installed on the bottom rail by face-mounting and screwing to each ventilator.

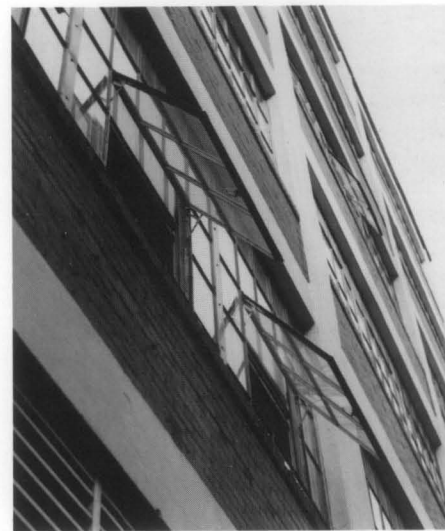
**Figure 7.** Retrofitting projecting ventilator with the TRUTH hinges. Photo: Robert Powers.

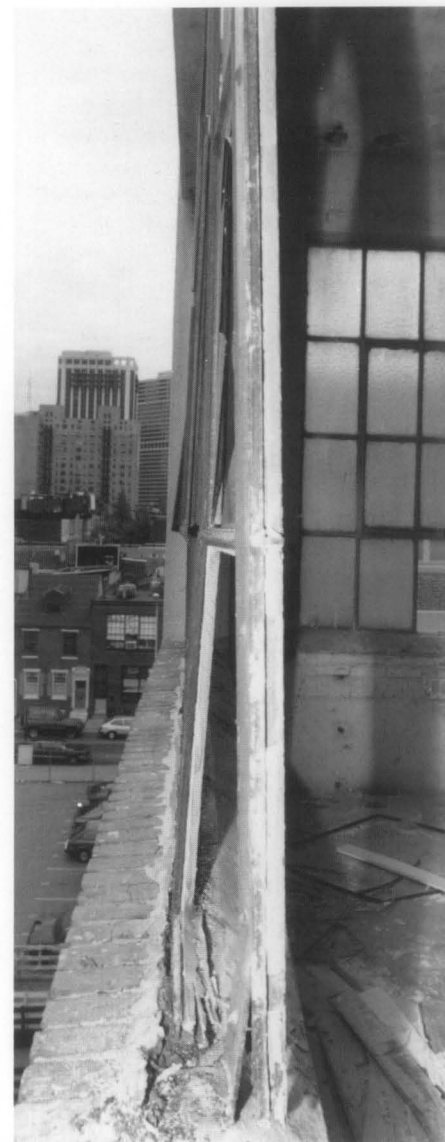
In addition to the retrofitting of the ventilators, many of the window muntins and structural mullions needed to be straightened, patched and repaired (see figure 8). Members that were seriously bowed and could not be adequately straightened were cut off using grinding wheels and salvaged;

**Figure 8.** Bowed and corroded window during construction. Photo: Clío Group.

replacement members were welded into place. Two relatively simple techniques were used to straighten the less seriously bent and bowed steel members. With mullions, a wooden brace (usually a two-by-four) was attached to the mullion; a wire cable was wrapped around the wooden brace and the mullion; and slowly the cable was pulled with a "come-along" winch hooked to the ceiling of the building. Since the mullions had typically bowed toward the exterior, the member was pulled in the direction opposite its bowing, towards the inside of the building. To straighten out bent and bowed muntins, the contractor applied constant pressure through the use of 14" bar-type clamps on the muntin. All indentations and gouges left in the steel members were filled with an auto-body patching compound containing steel fibers and an epoxy binder, sanded smooth and primed with a rust-inhibiting primer.

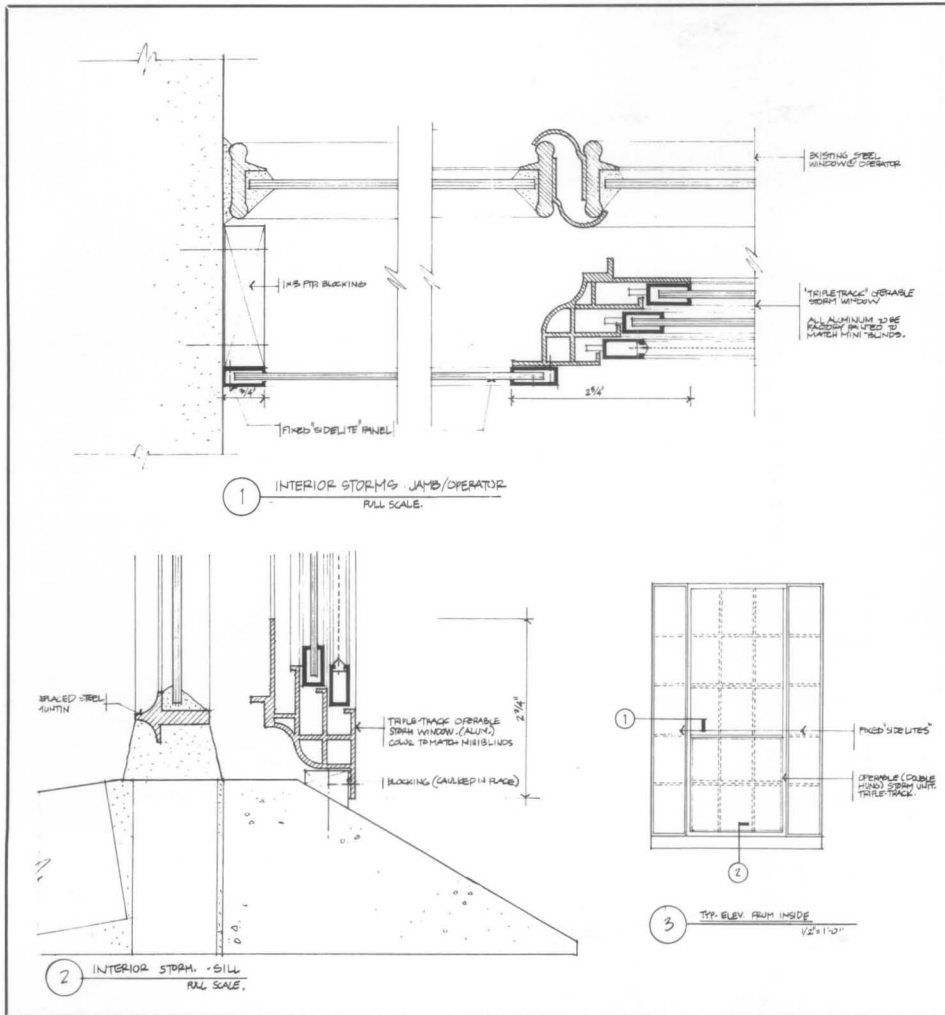
Figure 11. Interior storm window drawings, showing the alignment of the storm and steel window members. Drawings: H2L2 Architects.

the existing steel windows in and of itself was not sufficient in bringing the windows up to code. The development of an interior storm window system provided the additional thermal performance for code compliance. The solution involved an aluminum, triple-track, interior storm unit with flanking, fixed "sidelites" (see figure 11). A major consideration in the development of this storm system was the desire to minimize the outside visibility of the storm unit by aligning as closely as possible the meeting rails and other aluminum members with the steel window members (see figure 12). The exterior face of the storm windows was painted the same color as the steel windows so as to be as inobtrusive as possible (see figure 13). Although, the aluminum members do not match exactly the width of the opposite steel members, the storm windows were not readily visible from the exterior.

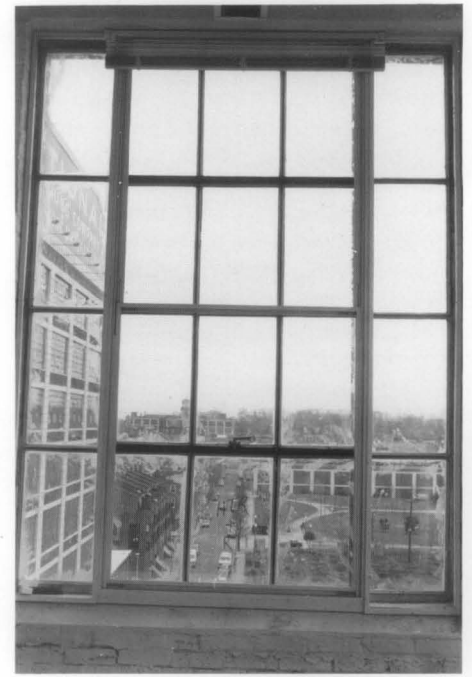
Figure 12. Installed interior triple-track storm window with fixed sidelights. Photo: Clio Group.

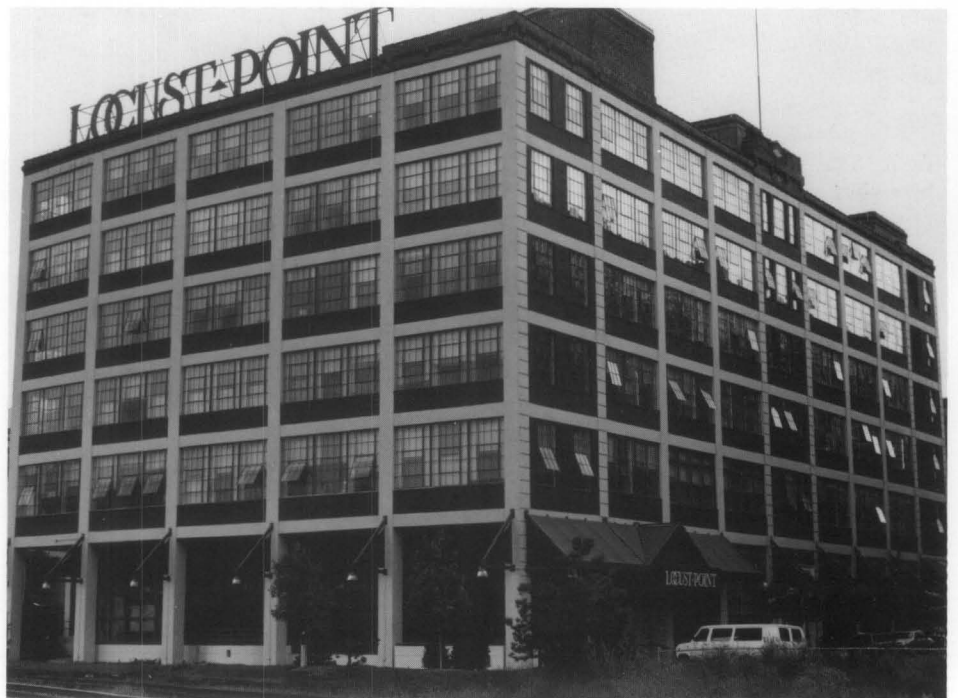
Figure 13. Lippincott Press Building (now Locust Point) after repair of the multi-light steel windows. Photo: Robert Powers.
