Tech Notes

NUMBER 16

Repairing and Upgrading Multi-Light Wooden Mill Windows

SAWYER MILLS Dover, New Hampshire

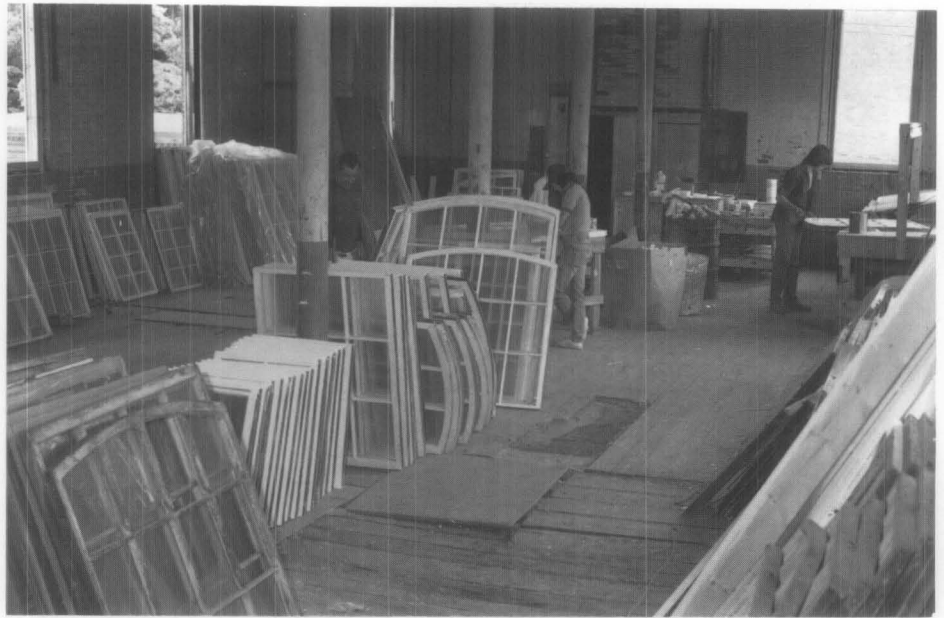
Figure 1. Window repair shop in operation. Photo: Christopher Closs

labor force in a logical sequence (see figure 1). The decision was made to undertake the work on the site and to establish a mobile millwork shop adjacent to the window repair shop so that the former could continuously supply the latter (see figure 2). The shops had to be relocated only once during construction. A key factor making the on-site window repair approach feasible was that the millwork shop's variable workload from window repairs was supplemented by specialty orders from outside contracts, eliminating costly down-time.

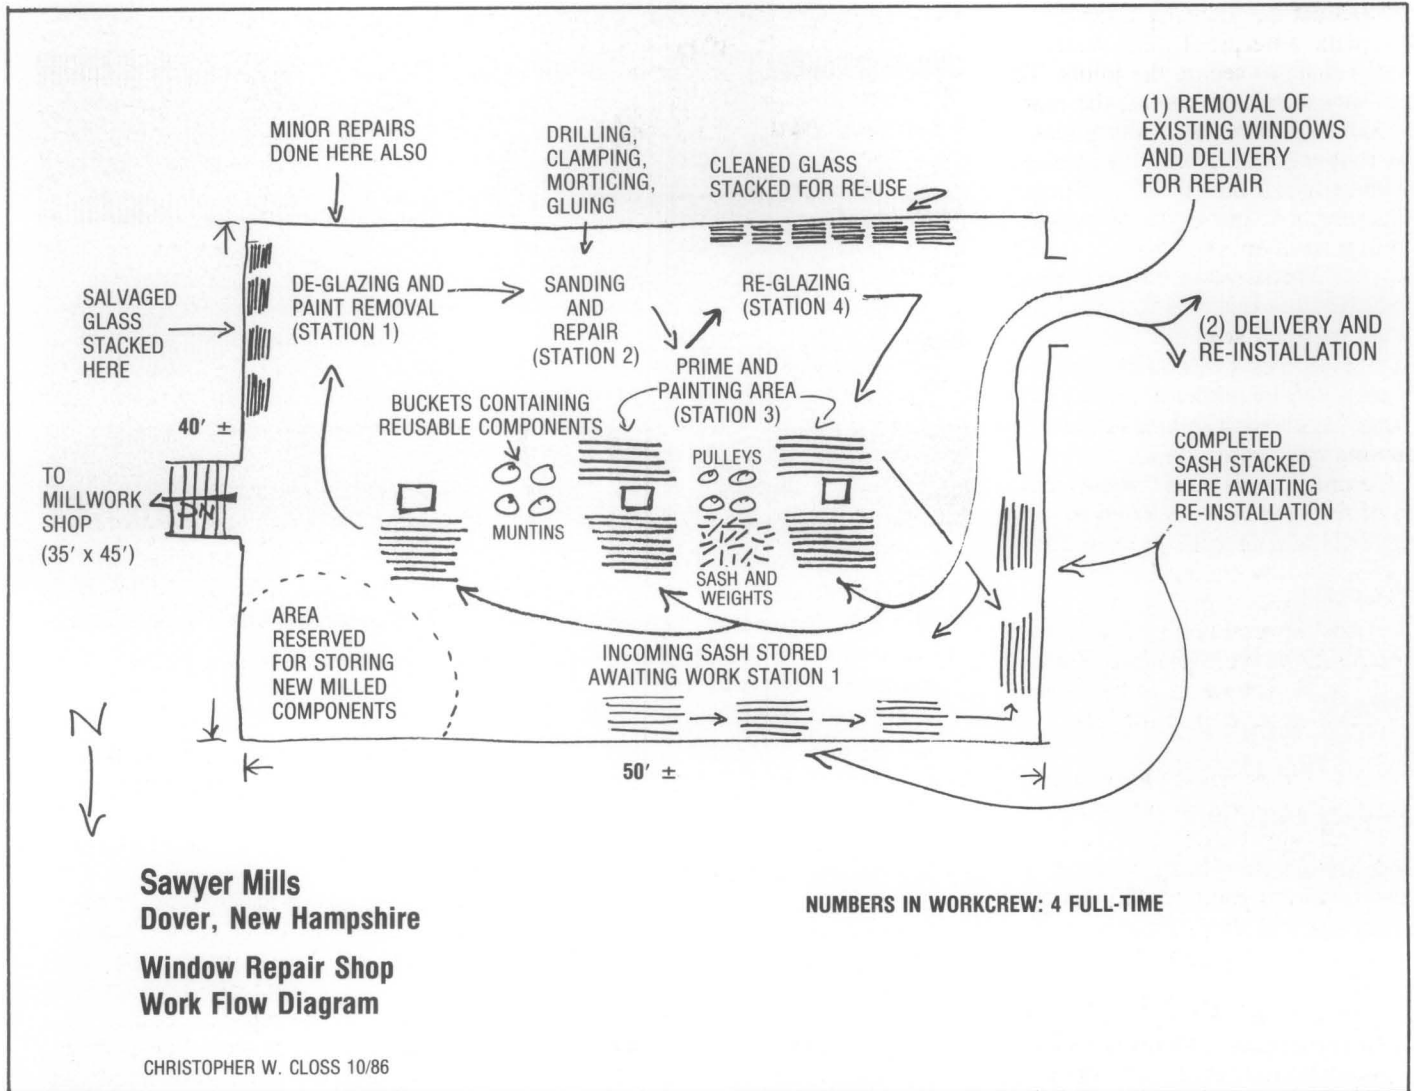
Figure 2. Drawing shows the plan of the window repair shop set up within Sawyer Mill during renovation work. The mobile mill-work site was located in a room immediately to the left of the repair shop. Drawing: Christopher Closs

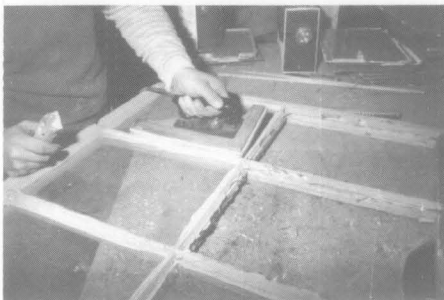
Figure 3. Electric deglazing irons were used to remove hardened putty so glass could be removed and the sash frames repaired. Photo: Christopher Closs

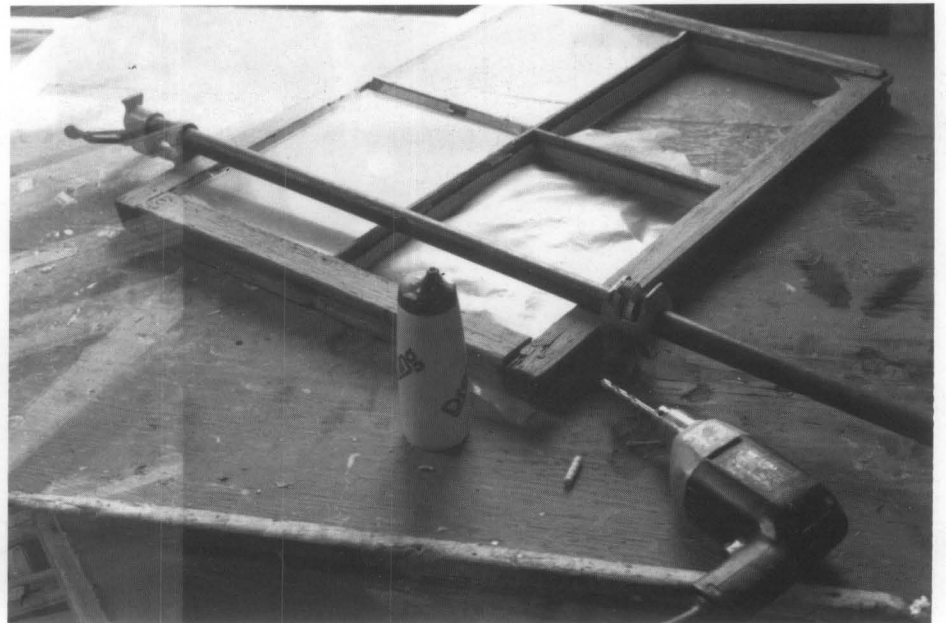
The most typical problem encountered was loose or failed mortise and tenon joints; this was remedied by drilling out the old pegs with a slightly oversize bit and then drawing the sash frame together tightly with pipe clamps (see figure 4). Fluted,

Figure 4. The basic repair: cleaning sash frame and drilling out pegs to tighten corner joints. Glue purchased in bulk was transferred to squeeze-bottles for ease of application. Oversize bit and new hardwood dowel shown ready for use. Glazing has not yet been completely removed. Photo: Christopher Closs

hardwood cabinet dowels, liberally coated with waterproof glue, were then driven in to secure the joints. To allow for natural movement, the mortise and tenon joints were not glued. In some instances, deteriorated tenons were cut off and bored out, and new tenons installed, using glue to secure the tenons in their seats but not inside the joints. This worked well providing the receiving mortises were sound. If muntins required selective replacement, this was done before clamping. It was critically important to "true" each sash square before re-pinning the corner joints.

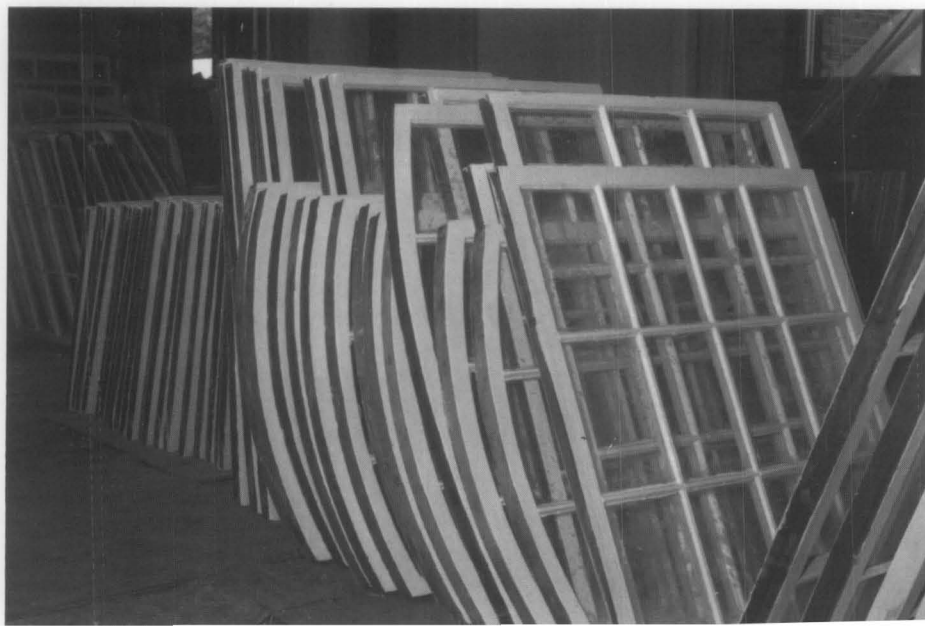
Figure 5. Repaired sash primed and awaiting reinstallation. Glass was cleaned of smudges after final installation. Photo: Christopher Closs

Once the sash for a complete window were made structurally sound, frames were hand-sanded and fully primed with a shellac-based sealer. Sash were then reglazed in conventional manner and stacked to await final finish with two coats of exterior-grade, oil-based paint (see figure 5). The wood edges of the sash were left

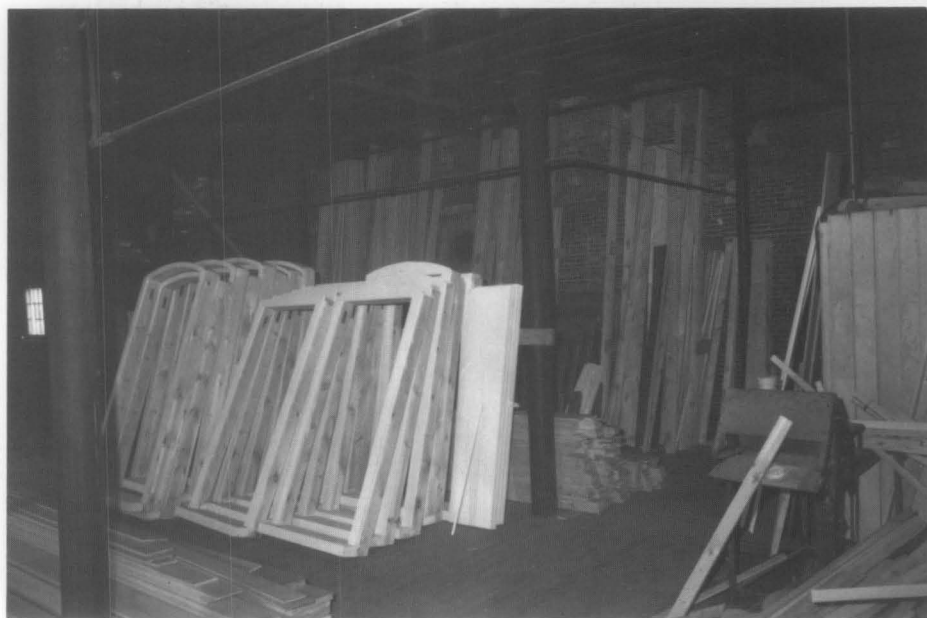
Figure 6. Newly milled replacement window frames awaiting installation. Photo: Christopher Closs

New matching wood sash, manufactured in Springfield, Massachusetts, were required to fill three hundred openings where the originals were missing or beyond repair (see figure 6). Deliveries of the new sash were scheduled to match the installation

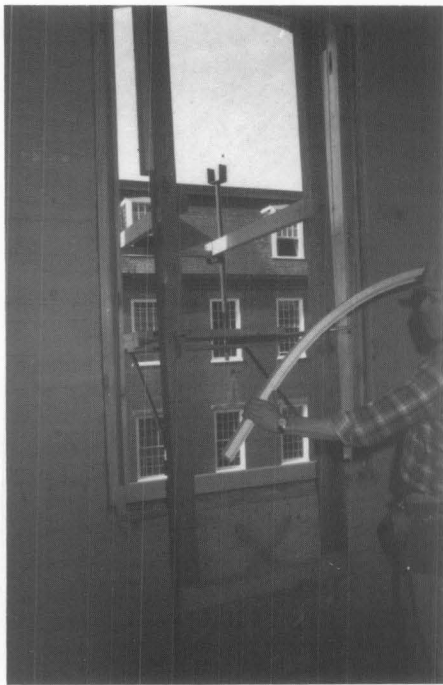
Figure 7. "Gun carriage" (scaffolding) in use by the window re-installation crew who are preparing to replace missing brickmold with replacement made by the millwork shop. Note saw kerfs used to create arc in molding for use in the window head (same method as used in the original molding). Photo: Christopher Closs

The re-installation crew was responsible for repairing or installing new frames, mounting brickmolds and installing repaired and new sash. Two "gun carriages" were constructed to facilitate frame installation and to ensure safety for the crews (see figure 7). Each carriage served as a cantilevered work platform (if fitted with dolly wheels they would have resembled a naval gun carriage). They permitted the installation crew to work safely on the exterior of the window opening without staging (much of this work had to be done over the river). The carriages had stops on the interior, were counter balanced, and were moved from opening to opening as frame repairs and brickmold work proceeded.

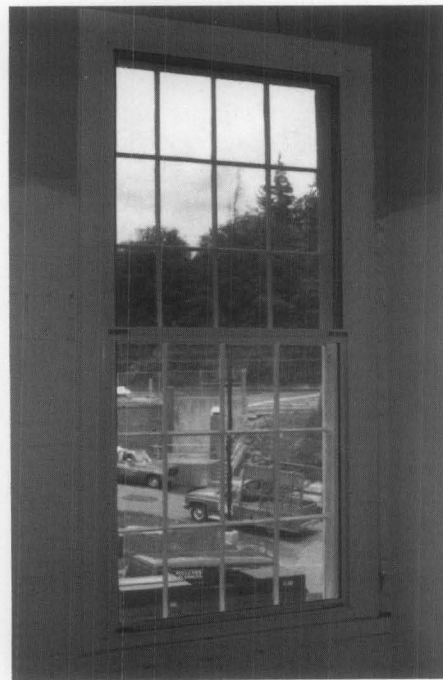
Figure 8. Typical interior aluminum combination storm window unit with insect screen shown at top. Beveled stops around the perimeter were added and the windows were caulked to provide for a good energy seal. Photo: Christopher Closs

The installation of the aluminum interior storms occurred after the primary windows were in place (see figure 8). Installation of the storm windows was monitored carefully to ensure that aluminum frames were set in a continuous bead of silicone caulk to provide a tight weather seal. This was made easier by the absence of decorative casing on all of the windows; storms were simply screwed fast to the flat, three-inch weight pocket covers (see figure 9). A new beveled 1" wooden strip was applied around the outside perimeter of the weight pocket covers and the heads, and caulked forming an uninterrupted seal with the brick masonry wall. Weight pockets were not insulated since the counterweights remained operable.

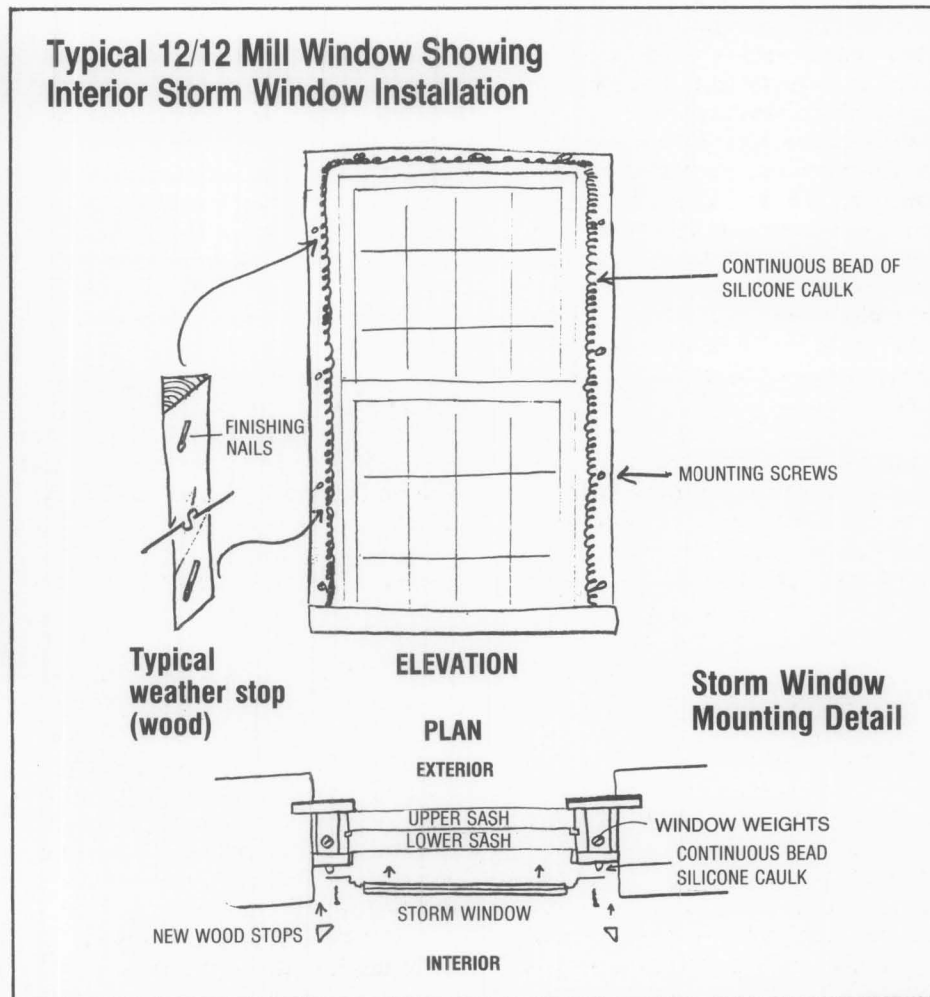
Figure 9. Drawing showing installation of the interior storm window. Drawing: Christopher Closs
