**BEATTY'S MILL  
(CORAL STREET ARTS HOUSE)  
Philadelphia, Pennsylvania**

Preservation  
**Tech Notes**

**NUMBER 21**

**Replacement Wood Sash  
Utilizing True Divided  
Lights and An Interior  
Piggyback Energy Panel**

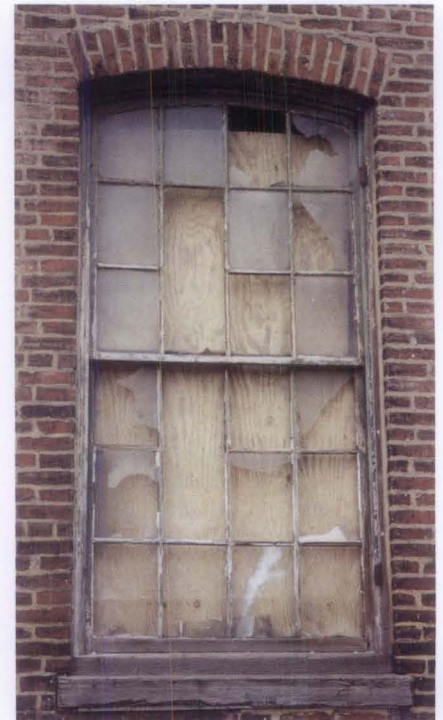
The large double-hung wood windows were one of the most prominent features of the mill. Each measured 48" by 96" with 12 lights of glass in both the upper and lower sash. Characteristic of many mill windows of the time, the sash frames were set in the masonry walls so as to minimize frame exposure on the outside. This provided for more light on the interior. It also enhanced fire safety through minimizing exposed wood on the outside, thus reducing the risk of flames spreading from an adjacent building fire (see figure 2). The outer face of the meeting rail was quite narrow.

The building had suffered many years of neglect, which was reflected in the condition of the windows. A condition survey determined that 40% of the sash were in poor condition; 45% were in fair condition; and only 15% were in good condition. Based on the window survey, the development team elected to replace the

**Figure 2.** The historic double-hung wood windows had narrow sash and frame members that contributed to the distinctive qualities of the windows.

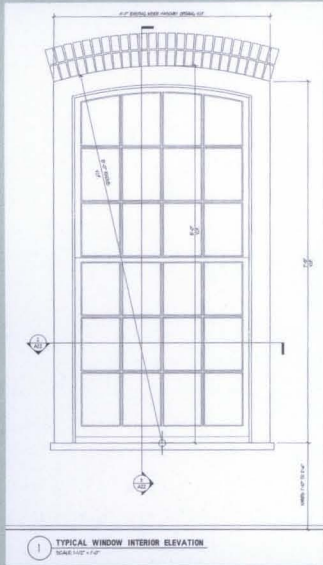
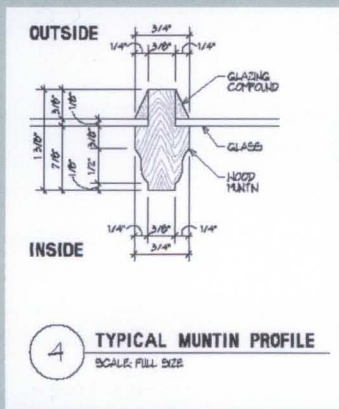
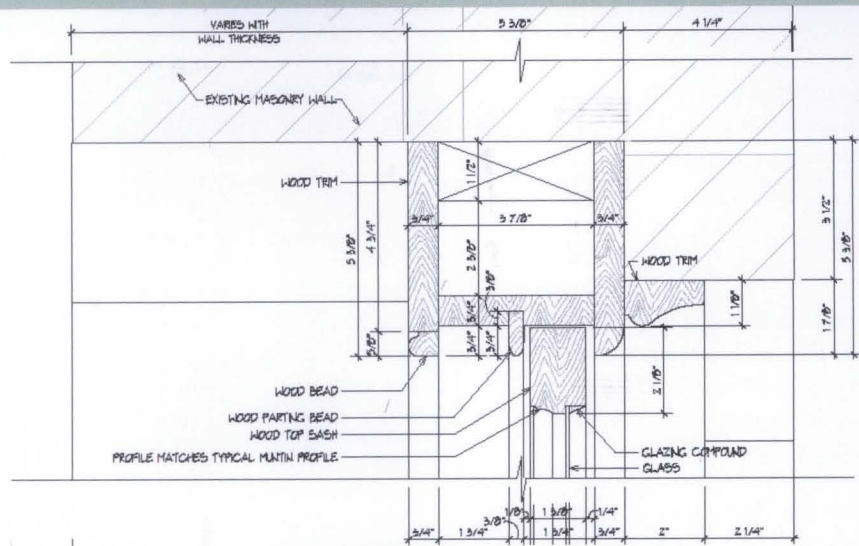
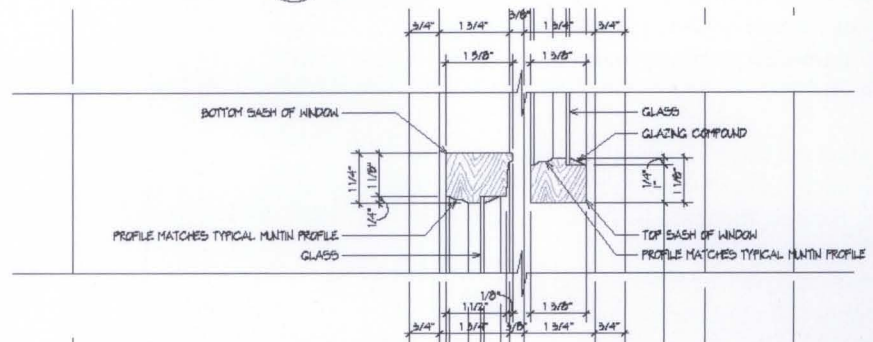
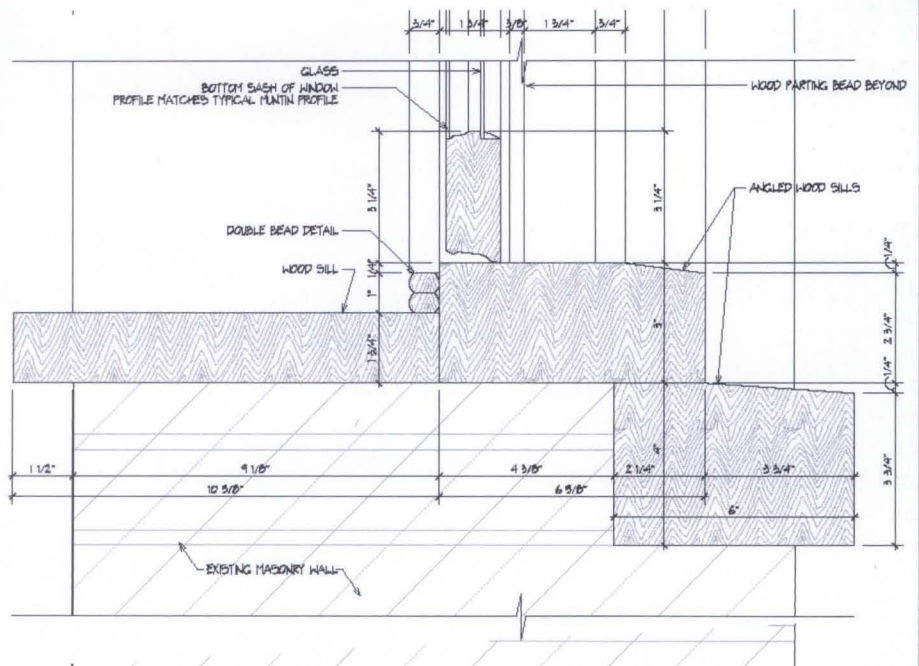
Figure 3. Drawings of the historic windows were prepared by the architectural firm based on field measurements to assist in devising an appropriate replacement window. Drawings: Courtesy of Kitchen & Associates Architectural Services.

The location of this building right on a street corner and the importance of the windows to the historic character of the building led the project team to select a window solution that closely matched both the detail and appearance of the historic windows. By selecting a new custom wood window, the narrow site lines of the historic windows could be closely replicated, the historic glass to wood ratio readily maintained, and other historic details easily reproduced (see figure 3).

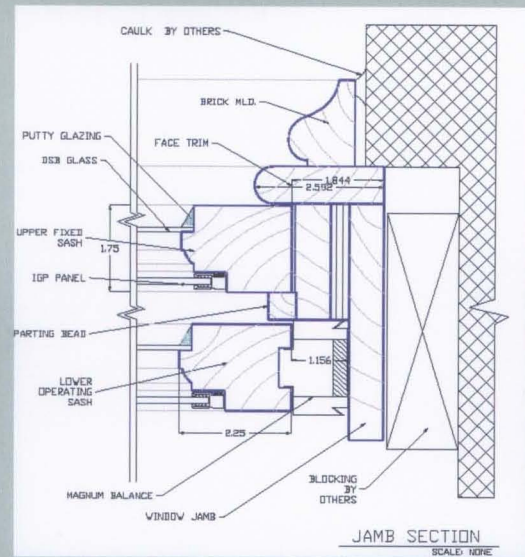
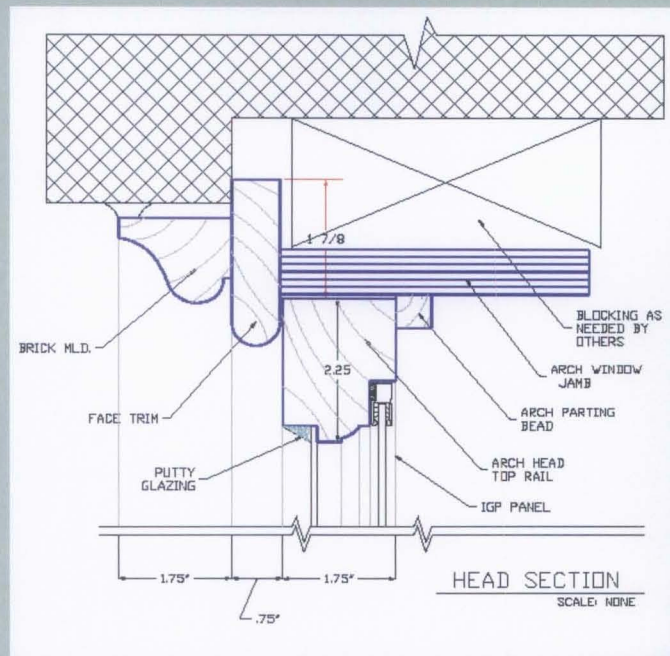
**Figure 4.** While using contemporary sash balances, the wood replacement windows had many traditional features such as putty glazing for the true wood muntins. Note the sash is rabbeted on the room side to a depth that permits the glazing panel to be set flush. Drawings: Courtesy of Seaquay Architectural Millwork.

To help retain the historic sightlines, the deteriorated frames were removed, permitting the new frames to be set close to the masonry (see figure 4). The alternate approach of retaining the existing frames, abutting new frames to them, and covering the outer face of the exposed portion of the older frames would have resulted in reduced glass exposure and a beefier frame appearance to the finished windows.

Several features of the new window were different than the historic windows in order to accommodate the dual glazing. The inside of the rails and stiles of the sash were rabbeted on the room side to a depth that permits the glazing panel to be set flush. To retain the depth of the original muntin and to accommodate the glazing panel on the inside, the thickness of the sash was increased to 1 3/4". In the bottom rail, weep holes were provided between the glazing panel and the outer glass, to allow water to drain from condensation that might on occasion develop between the two layers of glass.

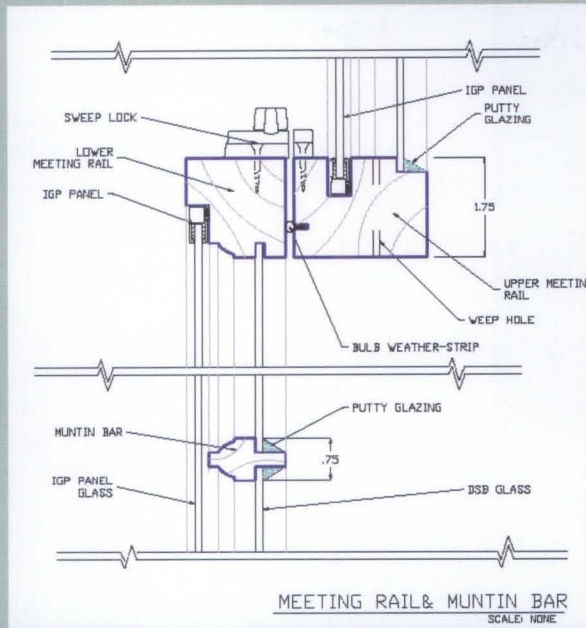
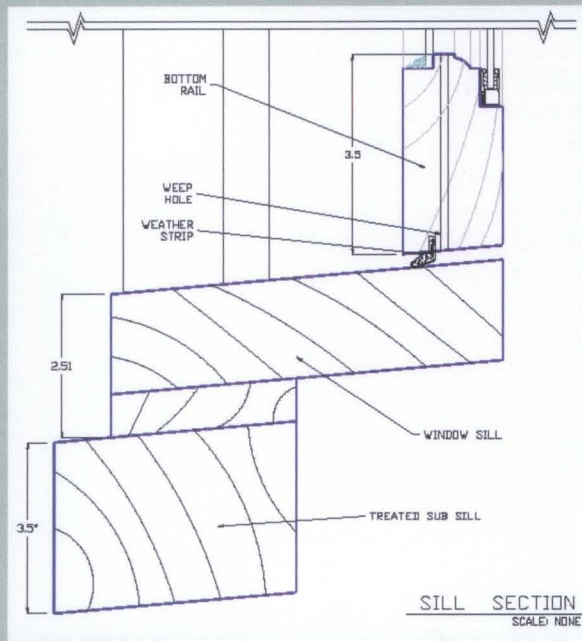
Figure 5. For the new windows to meet ASTM Standards, the face width of the meeting rail was increased 1/2 inch. To both accommodate the piggyback energy panel and match the historic muntins, the thickness of the wood sash was increased from 1 3/8" to 1 3/4". These two changes had minimal visual impact, considering the size of the windows. Drawings: Courtesy of Seaquay Architectural Millwork.

Somewhat more problematic was how close the bottom rail (meeting rail) of the new upper sash could match the narrow width of the existing window. Specifications for the project required that the replacement window meet three ASTM Standards: ASTM E283, the standard test for determining the rate of air leakage through an exterior window; ASTM E331, the test of water penetration; and ASTM E330, the standard test for structural performance of an exterior window. To meet ASTM E330 with the design pressure rating for the window set by the architect, a 1 3/4" wide meeting rail was needed (see figure 5). This was an increase of 1/2 inch over the historic sash. Fortunately because of the size of the window, this increase was considered acceptable, as the meeting rail still appeared relatively narrow even with the 1/2 inch increase.

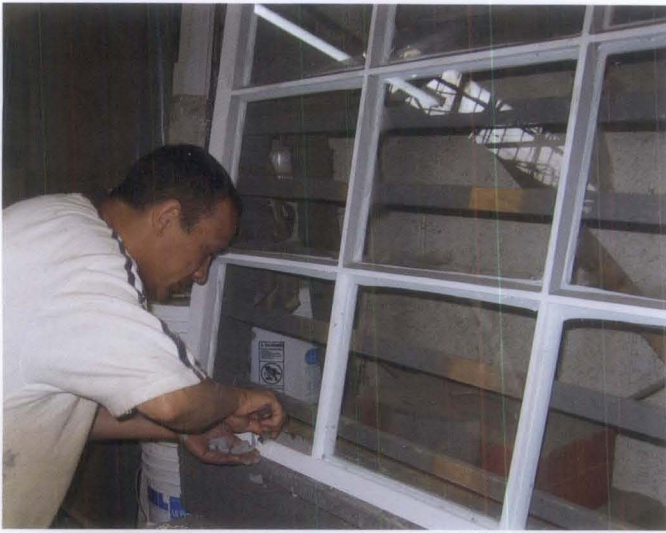
Figure 6. The outer glass was installed in the traditional manner, using exterior glazing putty. Photo: Charles Fisher.

The windows were then assembled and sanded. The outer glass was installed in the factory after the assembled sash were primed. Exterior glazing putty manufactured by C.R. Lawrence was applied in the traditional manner (see figure 6). Since the upper sash were to be fixed in the operable windows, weatherstripping and block and tackle balances were provided only for the lower sash. Each window was provided with two sweep locks and two sash lifts for the operable lower sash. Of the 188 replacement windows, 111 were single hung and 77 were fixed (see figure 7).

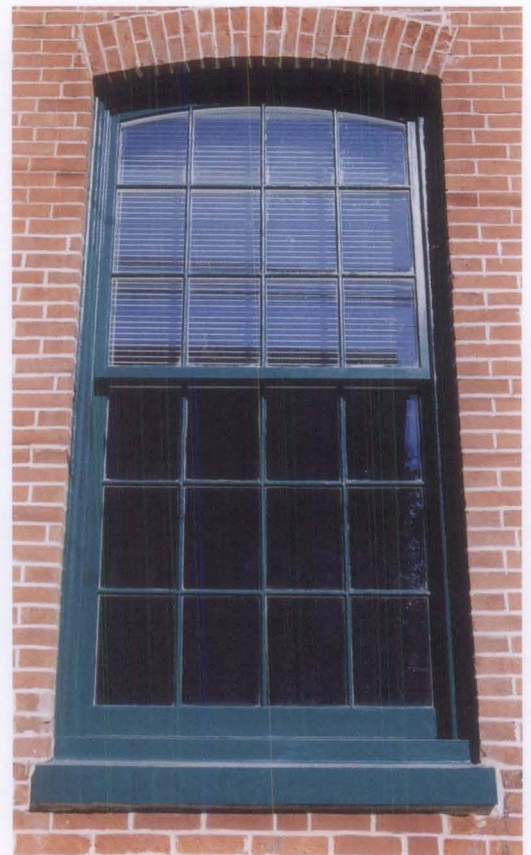
The new windows in Beatty's Mill successfully matched the historic units while providing enhanced energy conservation. There is little difference between the new and historic windows in terms of the characteristic features (see figures 2 and 7). The integral wood muntins, individual panes of glass, reflective qualities of the glass, glazing putty, and painted wood surfaces, along with the benefits of using a custom-wood window manufacturer that could duplicate

Figure 7. The new window's joinery, individual glass lights, reflective qualities, and painted wood finish all help to capture the appearance of the original units.

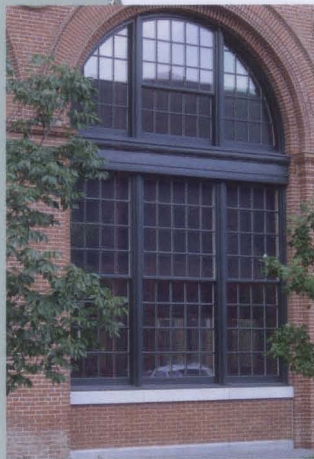
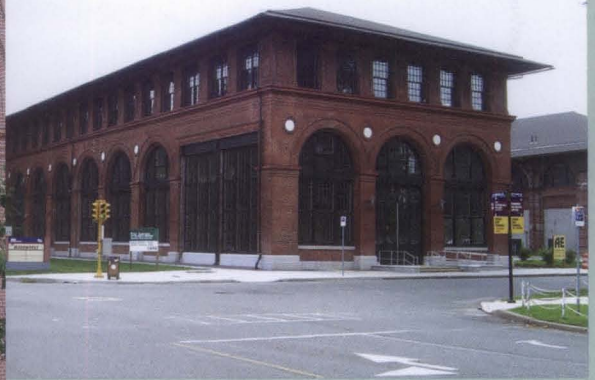
Figure A. Building 10 (headquarters of Urban Outfitters), former Philadelphia Naval Shipyard. New wood windows were made to match the original units, including true divided-lights, while incorporating a piggyback interior energy panel. Photos: Seaquay Architectural Millwork.

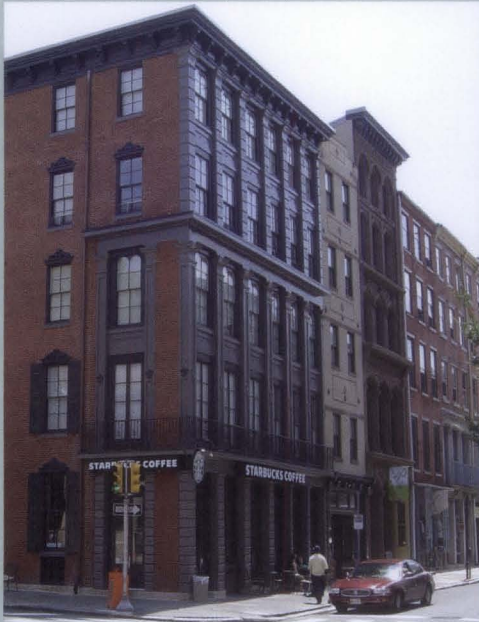
Figure B. 61-63 North Arch Street, Philadelphia (commercial and residential). Most of the historic windows were missing or severely deteriorated prior to the rehabilitation of this corner building. Based on surviving units, new non-clad wood windows were milled with matching true divided lights and piggyback energy panels. Photo: NPS file.

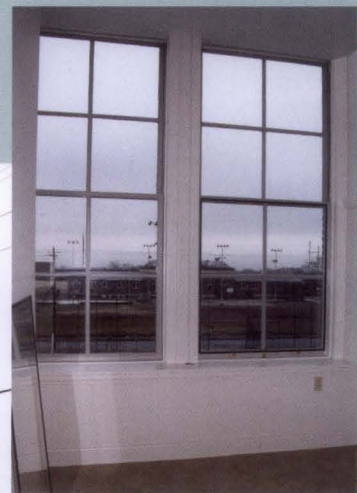
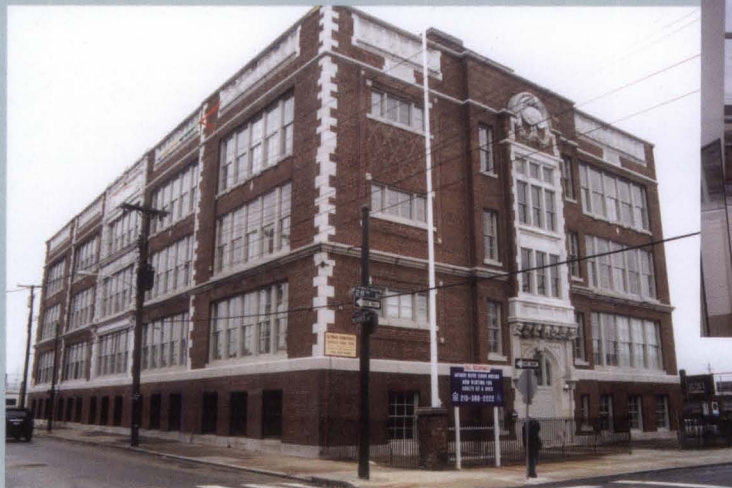
Figure C. Anthony Wayne School (affordable senior housing), former Philadelphia school. The predominant window type is a wood unit with four-over-four glass lights as shown in the lower right-hand photograph. The replicated wood window on the right is shown with the energy panels installed, while both sash in the left window have yet to receive the panels shown in the left forefront.

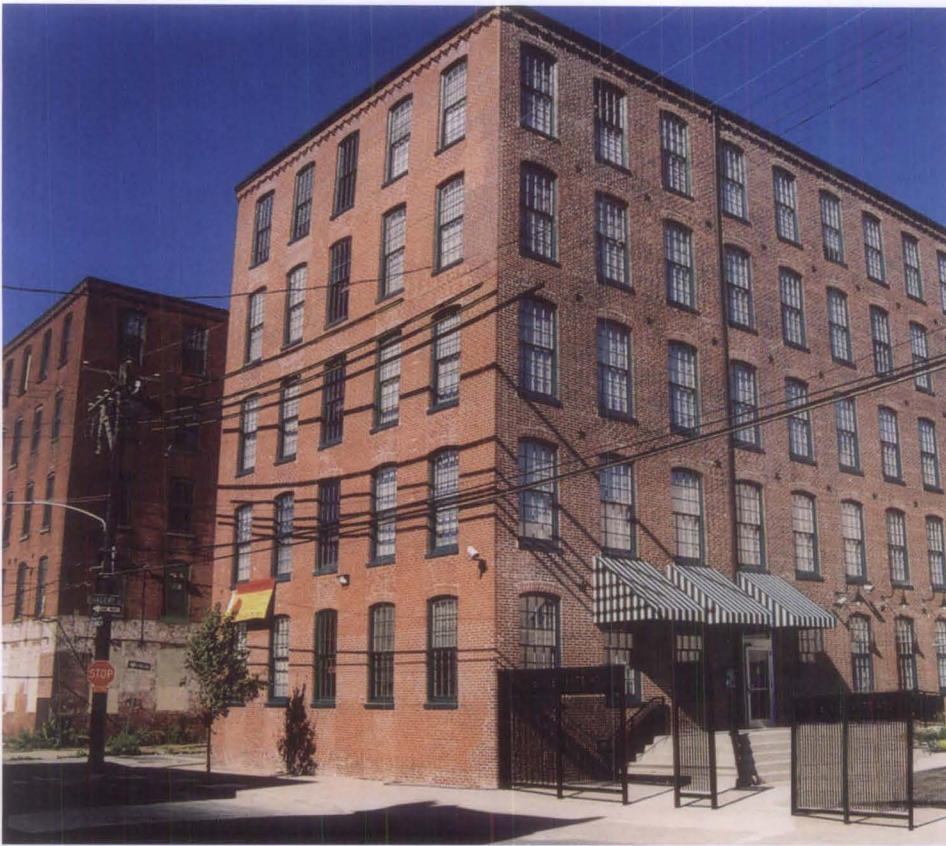
**Figure 8.** Upon completion of the work, the former mill now serves as low-income housing and artist live/work space. The new wood windows provide improved energy performance and enhance the visual qualities of the historic building.
