Tech Notes

MASONRY

Substitute Materials: Replacing Deteriorated Serpentine Stone with Pre-Cast Concrete

SIX LOGAN CIRCLE Washington, D.C.

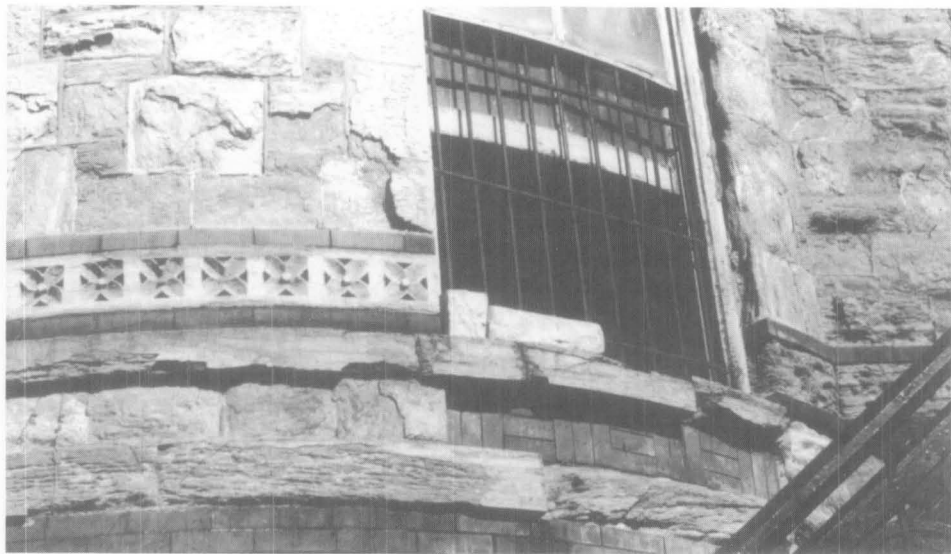
A stone consultant was retained to assess the condition of the serpentine stone and to recommend remedial work. The consultant conducted an in-depth visual inspection and evaluation and concluded that the serpentine stone was spalling extensively, due to the inherent softness and poor quality of the stone and the chemical forces interacting with the stone. The deterioration had been further exacerbated by the general lack of maintenance the building had received for the last forty years which had allowed large amounts of moisture to penetrate the stone. Moisture, laden with acids, had entered the stone through open mortar joints and the delaminated surface, accelerating the stone's deterioration. In this case, the problem was compounded by additional moisture spilling onto the surface of the serpentine from clogged, leaky, and inoperable gutters, downspouts and drains. Given the inherent problems with serpentine stone as an exterior building material and its overall advanced deterioration on Six Logan Circle, the consultant recommended that the serpentine stone, which was used as a veneer covering structural brickwork, be replaced rather than attempting a repair using traditional patching techniques. This conclusion was supported by a survey undertaken to determine how many of the stones

Figure 1. Close-up view of the deteriorated serpentine stone facade showing substantial surface delamination. Photo: Anne Grimmer

retained their integrity (i.e., how many remained substantially free of fractures and crumbling and retained their surface tooling, texture, and shape). The survey showed that 868 of the original 946 face stones which made up the facade no longer retained their integrity. In fact, many were so deteriorated that they could literally be pulled apart by hand (see figure 1).

Because only 78, or less than nine percent, of the stones remained intact, total replacement of the historic stone was justified in this particular case. However, the replacement material needed to closely match the historic stone in size, shape, dimension, texture and color in order to preserve the historic character of the facade. To meet these requirements, three replacement alternatives were considered:

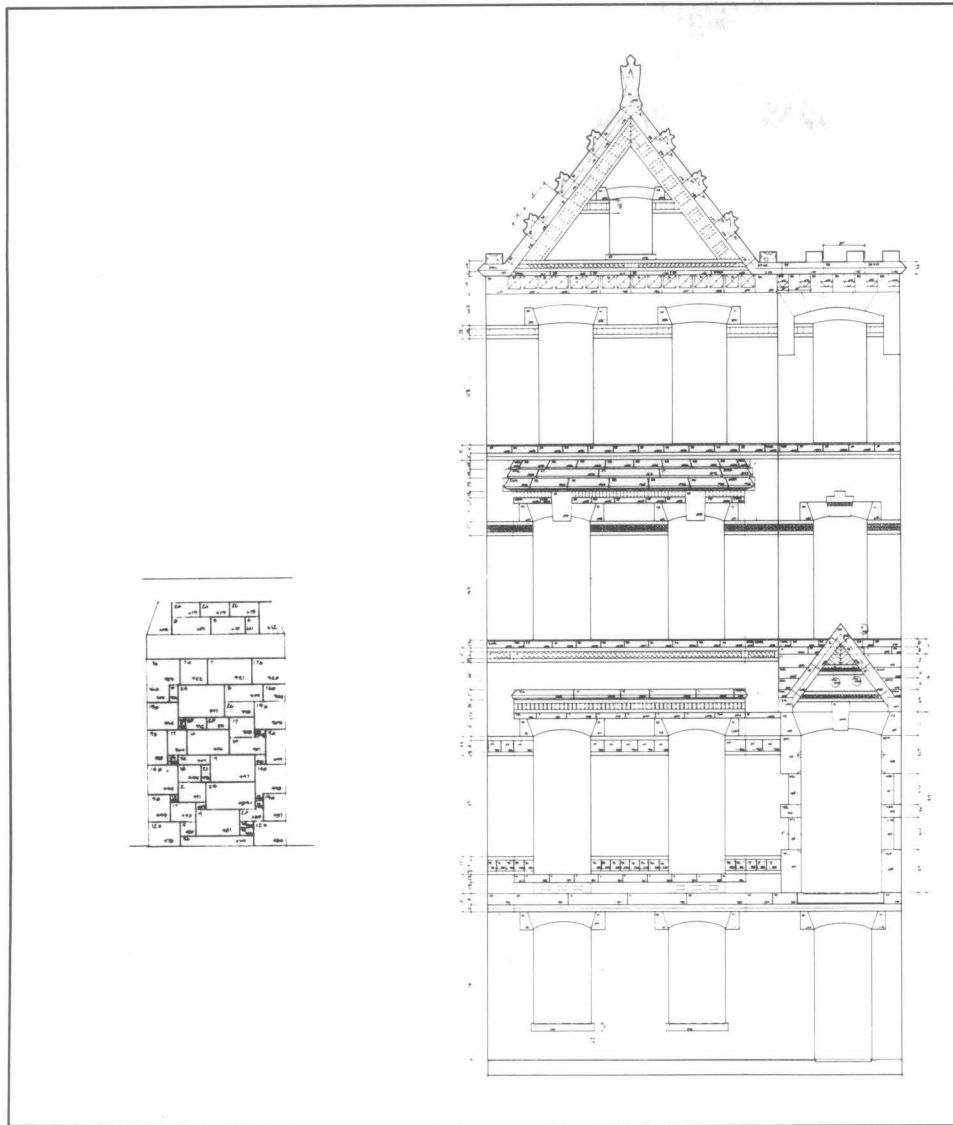
Figure 2. Two measured drawings were made of the facade, one showing the individual field and jamb blocks, and the other, the decorative trim stones. The identification number and the shape and size number of each stone were marked on the drawings. Drawings: Rich Layman

Before the new cast stone could be manufactured, the existing serpentine stone facade had to be recorded. An architecture student was hired to measure each existing stone on the facade and prepare precise drawings of the elevation, showing the size and location of each stone. Each stone was assigned two numbers—an individual identification number and a number indicating the stone's shape and size. These key numbers were marked directly on the measured drawings. Drawings were prepared for the plainer stones that made up the major portion of the facade as well as the decorative trim stones (see figure 2). From these drawings, a master list of all the stones and their sizes was compiled, which was used to guide the casting and manufacturing processes. Later, as each new stone was fabricated, it was noted on the drawings so that an up-to-date inventory could be maintained.

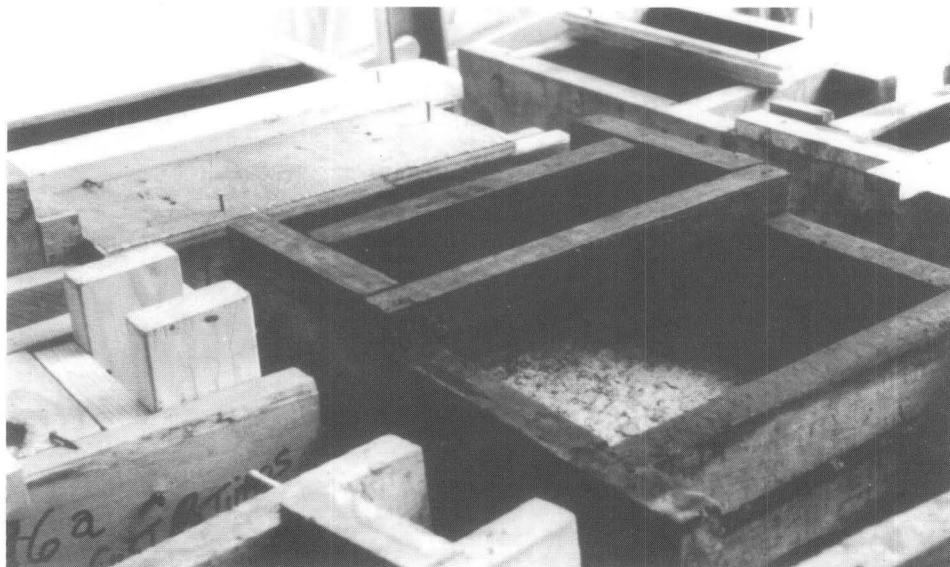
Figure 3. Concrete was poured into these wooden forms which were specially constructed, and reinforced with steel rods and bolts, to hold the built-up molds of the original stones. Once placed in the wooden forms, the built-up molds thus served as the casting models. Photo: Robert Powers

1. A release agent was sprayed on each stone of the facade to be reproduced.
2. Latex molding rubber was then brushed-on in layers to the surface of the stone, still *in-situ*, to obtain an impression of the stone's surface. From these latex molds, the surface qualities of the individual blocks of the serpentine facade could be faithfully reproduced in the casting process.
3. The latex mold was removed from the stone and in the workshop the mold was built up with plaster to increase the crispness of the details.
4. This built-up mold, when placed in a specially constructed wooden framework reinforced with steel rods and bolts, became the casting mold.
5. A release agent was applied over the formwork and the built-up mold. Then the concrete was poured into the casting mold (see figure 3).

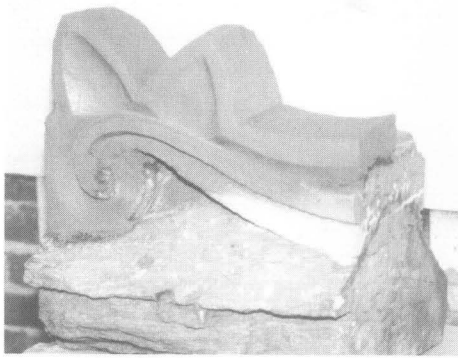
Figure 4. Most of the rubber castings could be made directly from stones still in place on the facade, but the more deteriorated stones first had to be removed from the wall. After their removal from the wall, a bonding agent was applied to the deteriorated stone surface, and a new stone surface was created replicating the original design details with concrete. Photo: James Smith

1. A bonding agent was applied to the surface of the stone to be reproduced.
2. Using the more intact stones as models, the stone's surface was built up with a mixture of portland cement and sand to approximate as closely as possible the stone's original surface, shape, and texture.
3. After the built-up stone was dry, the same process described earlier was followed to create molds of these stones (see figures 4-6).

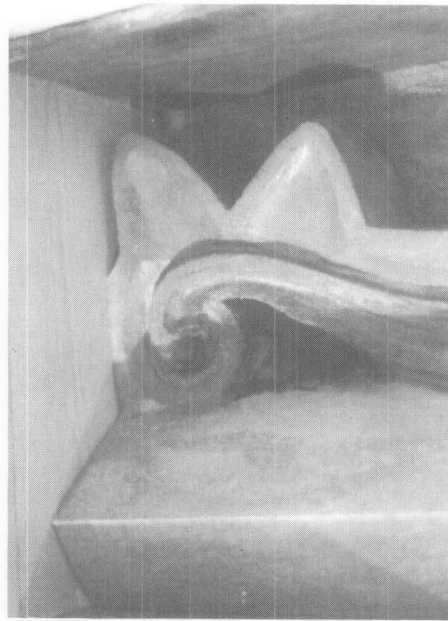
Figure 5. A latex casting mold was made from this recreated "built-up" stone surface by brushing on layers of latex molding rubber. Photo: James Smith

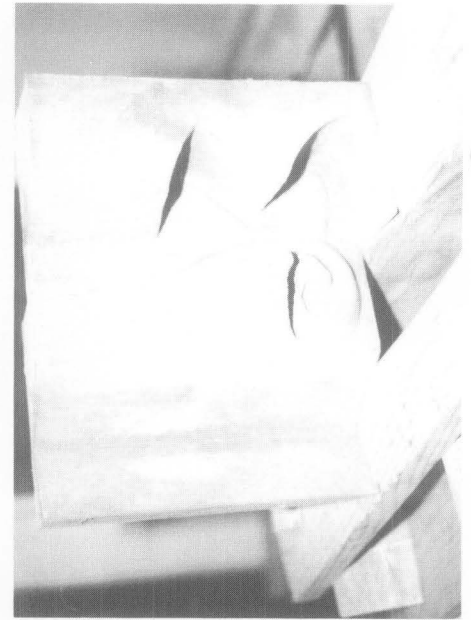
Figure 6. A rubber impression made from this latex casting mold then provided the mold into which the concrete was poured to create the new pre-cast units. Photo: James Smith

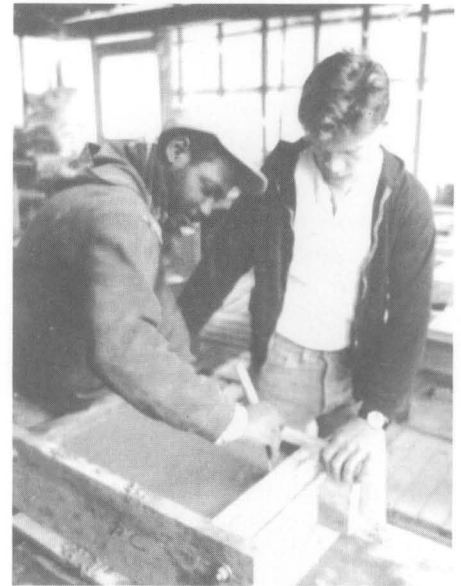
Figure 7. The workmen shown here are cutting the air bubbles from the sides of the mold using a cake spatula during the first 10 seconds of the vibration process. Photo: James Smith

The consolidated and homogeneous concrete mix was poured from the mixer into the specified mold which had already been placed on the vibration table. The vibrating process forces the entrained air and surface air out of the mold, eliminating in most cases the possibility of surface imperfections from air bubbles. Proper vibration of the newly poured concrete was extremely important to obtain a high quality pre-cast concrete. The vibration table operated at a rate of 2,600 vibrations per minute and could accommodate all the castings from a batch within thirty minutes after mixing. Small cast units required approximately sixty seconds of vibration and the larger ones required approximately ninety seconds. A cake spatula was effective in cutting many of the air bubbles from the surface of the sides of the mold during the first ten seconds of the vibration process (see figure 7).

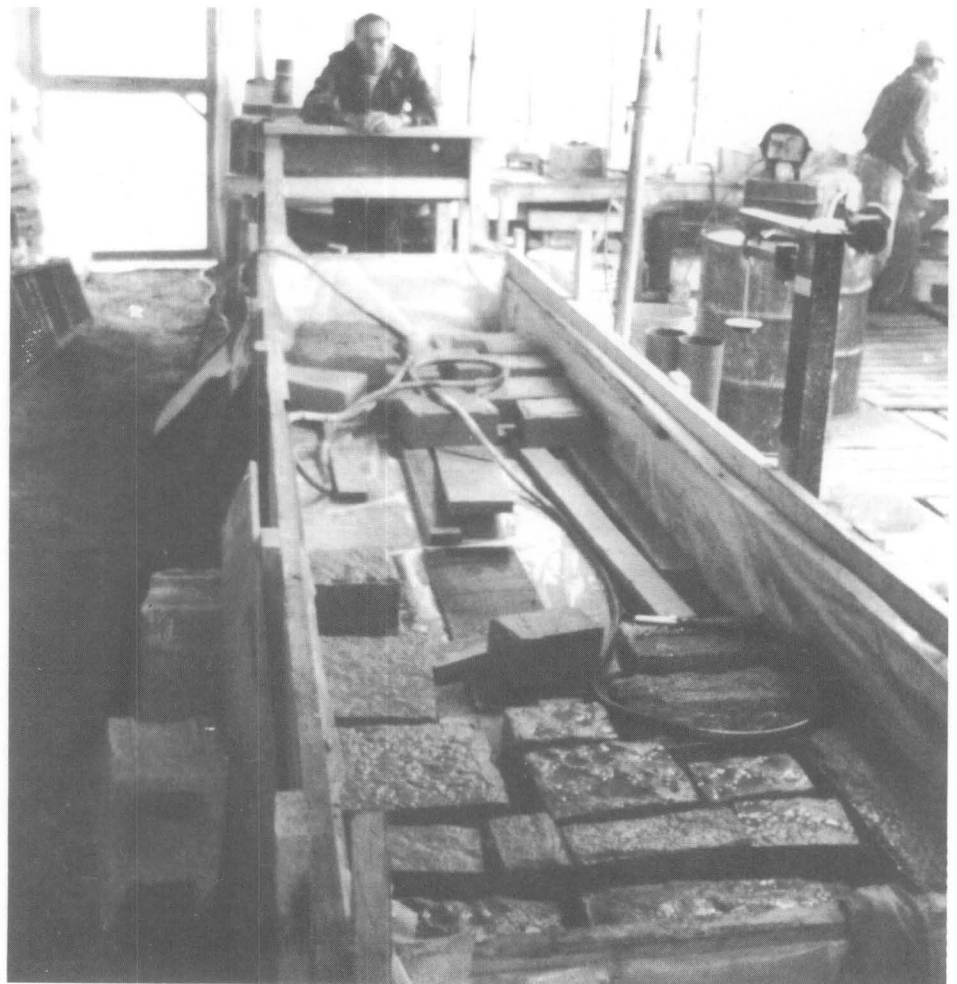
Figure 8. After soaking for 6 hours to remove soluble salts in a polyethylene-lined wood water tank, the pre-cast units were allowed to dry for another 6 hours. This process was repeated 3 times for each pre-cast unit. Photo: James Smith

The final step in the manufacturing process was essential to the successful outcome of the product. In this step, the stones were submerged in a water tank for a period of six hours, then removed and dried for six hours (see figure 8). The drying process forced soluble salts inherent in the concrete mix to the surface of the stone. An application of a weak solution of muriatic acid with a thorough water rinse was used to wash away the leaching salts. This procedure of soaking and drying was repeated three times for every stone. After completing this process, each stone was transferred to the base-ment for storage on wooden skids.

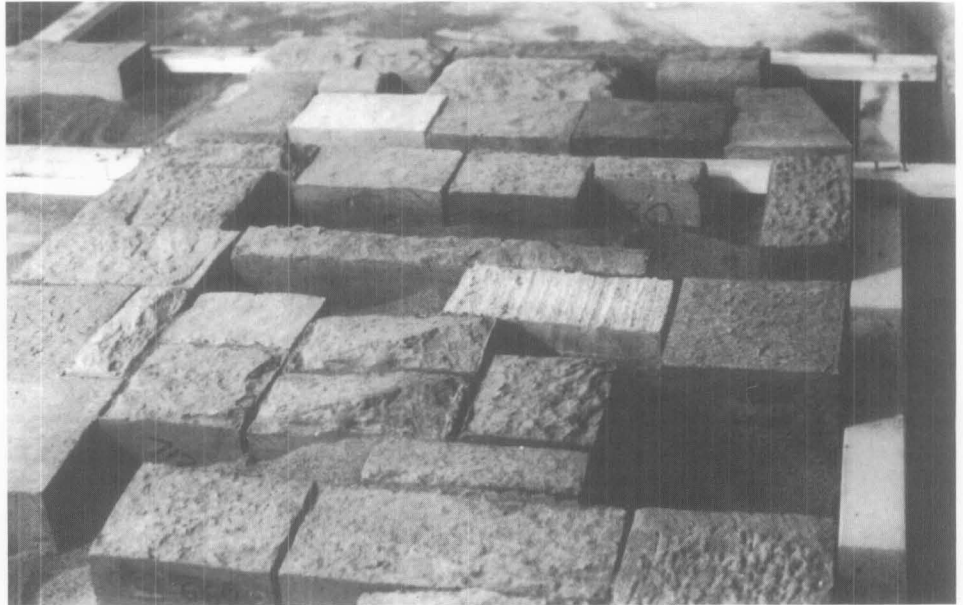
Figure 9. Using the measured drawings as a guide, the pre-cast units were assembled in the staging area on top of 4 inches of sand prior to their installation on the facade. Photo: Robert Powers

“staging area” in the basement. Using the measured drawings and numbering system prepared earlier, the blocks of cast stone were assembled on the basement floor on top of 4” of sand. Assembling them in the staging area allowed for a final inspection of the blocks and also allowed the master mason to arrange the new stones during a “dry run” prior to the actual installation on the building, thereby minimizing problems once the work on the building began (see figure 9).

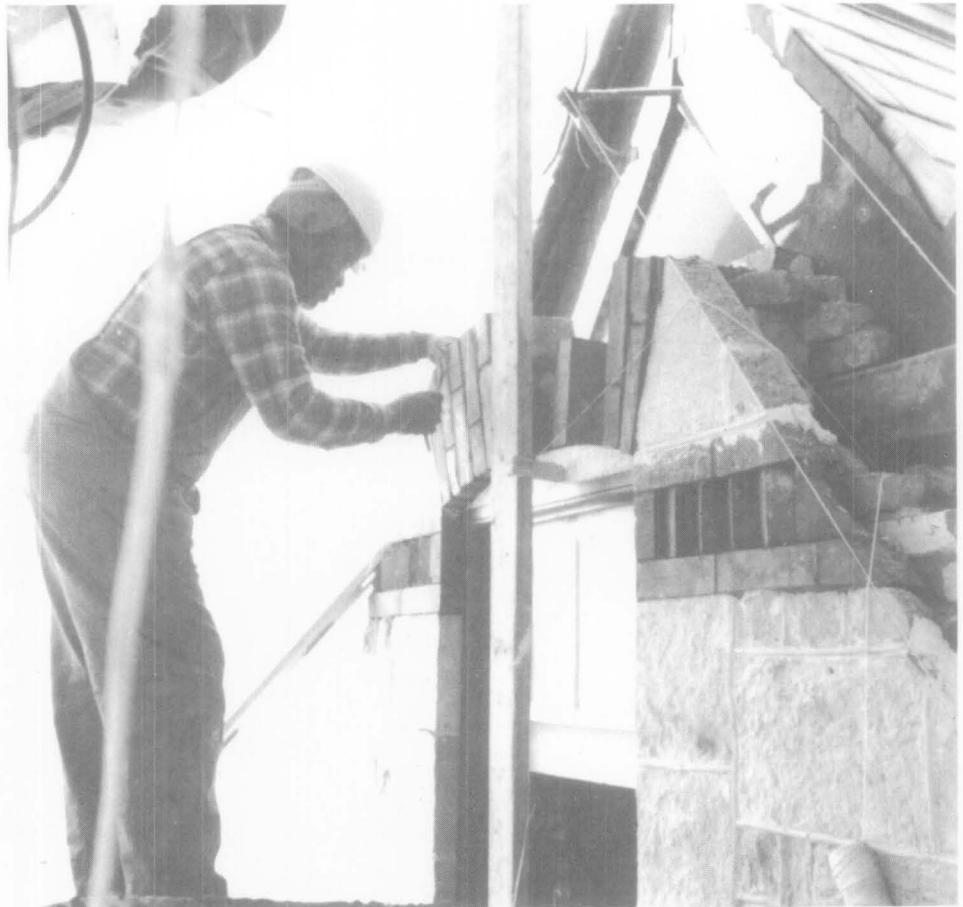
Figure 10. The new pre-cast units were hoisted up the scaffolding on wide belt slings with an electric winch, and installed in place using a portland cement-based mortar appropriate for cast-concrete. The original bricks were relaid with a more traditional lime-based, dark-colored mortar. Photo: James Smith

With the front elevation fully scaffolded, sections of the serpentine stone and ornamental brick were removed. Because the brick trim was in excellent overall condition and was to be reused in the new facade, it was carefully removed with hand tools, inventoried, and stored for reinstallation. With the serpentine and face brick removed, necessary repairs were made to the structural brick, and stainless steel anchors for the new pre-cast veneer were installed. The new cast stones were hoisted up the scaffolding on wide belt slings with an electric winch and installed in place (see figure 10).

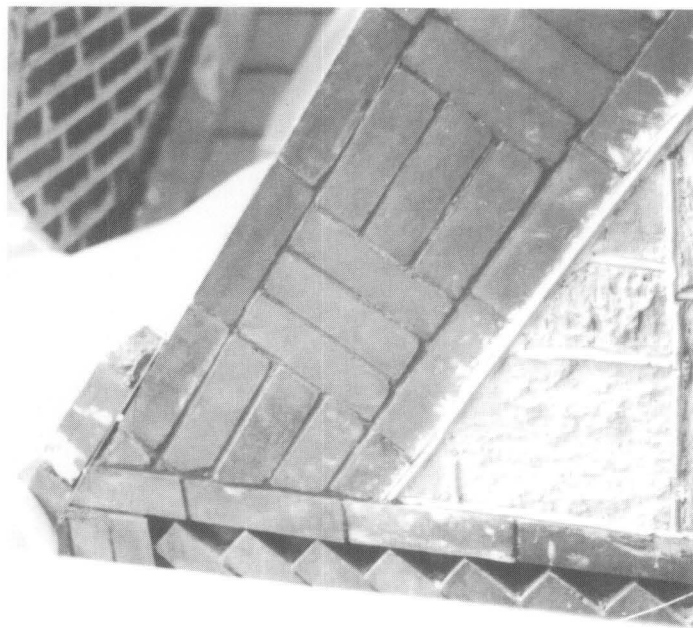
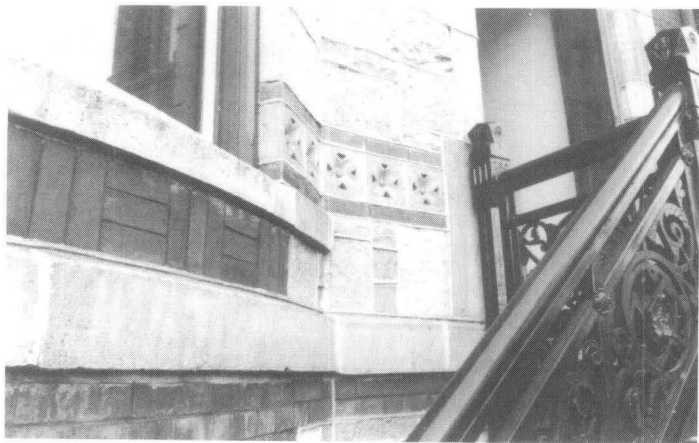
Figure 11. Close-up views of the newly installed pre-cast concrete units and the reinstated original brick. Photo: James Smith

The original bricks were individually cleaned with bristle brushes and water before being reset into the new facade. The new brick mortar was based on an analysis of the original, dark-colored brick mortar and matched it in composition, color, texture, joint width and profile. (see figure 11).

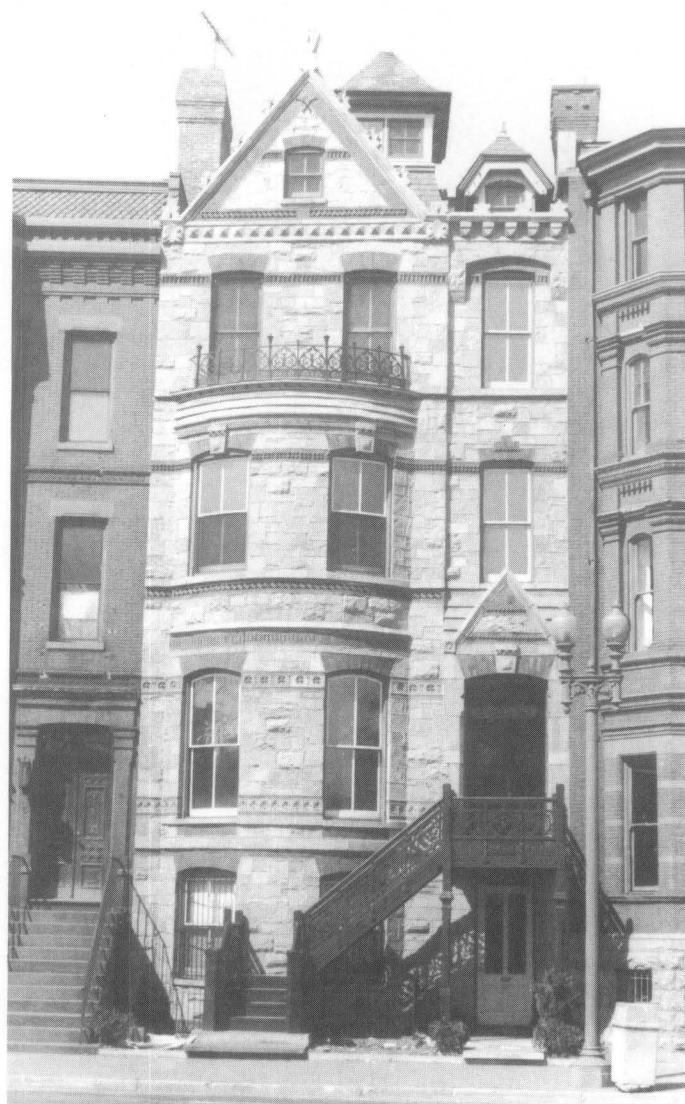
project was considered a success by all the participants; the stated goal of removing the crumbling serpentine veneer and replacing it with a new material that returned the facade to its original appearance was met. The building has a renewed presence with its pre-cast concrete units molded to match the form of the original stone, and exhibits a crispness of detail, texture and color that had been absent for many years (see figure 12).

Some of the trim pieces, in particular the floral blocks as well as units in the belt coursing and window sills, do have noticeable surface imperfections when

viewed up close, such as indentations caused by air bubbles and in a few instances the aggregate is exposed, indicating a poor concrete mix. Ideally, each of these units should have been rejected during the inspection stage. However, the small number of such pieces does not detract from the overall appearance of the rebuilt facade.

Figure 12. The house after rehabilitation. Photo: Anne Grimmer
