EAST BAY MUNICIPAL UTILITY DISTRICT

Asbestos Cement Pipe Study

Phase 1 Asbestos Cement Pipe Corrosion Study

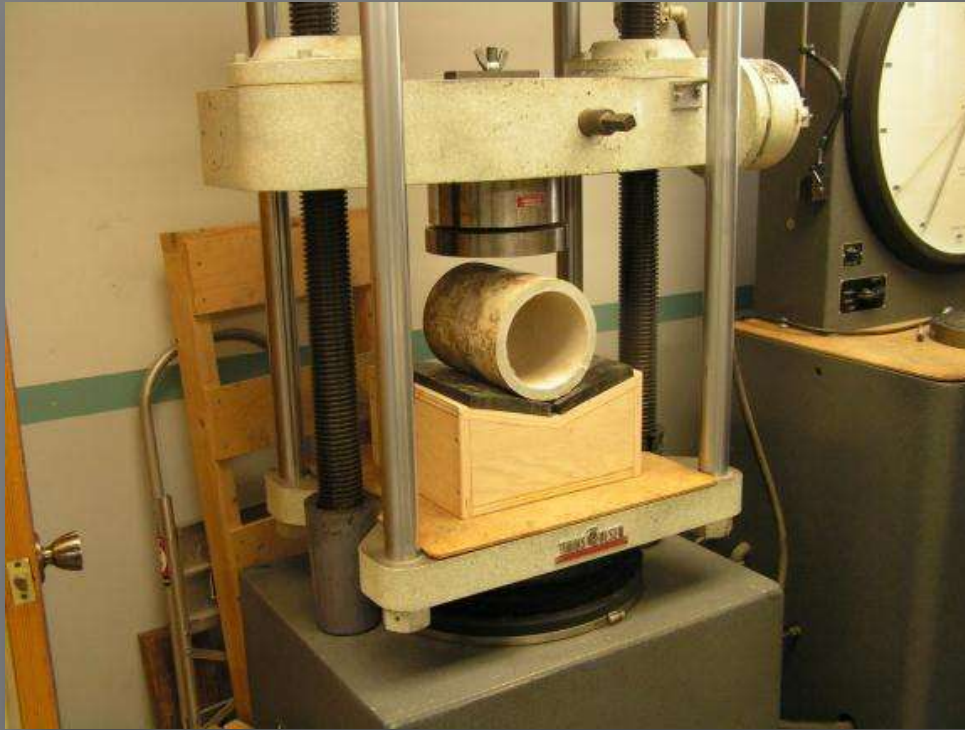
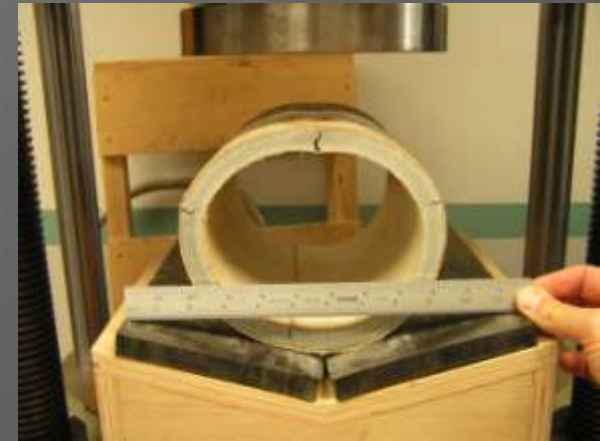
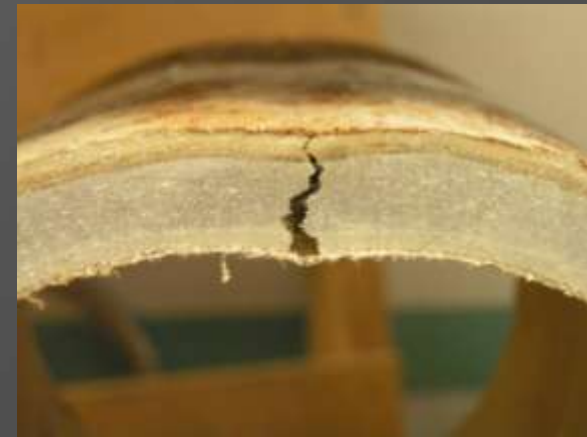
Crush Strength Test

Crush strength tests conducted on the pipe samples indicated that all of the samples met the requirements of as-manufactured (new) pipe for Class 150 pipe
