**CLASS 150 ASBESTOS CEMENT (AC)  
WATERMAIN PIPE  
CONDITION EVALUATION  
DEEP BAY WATER DISTRICT**

The Deep Bay Waterworks District  
5031 Mountainview Road  
RR1, Site 150, C 4  
Bowser, British Columbia  
V0R 1G0

Levelton Consultants Ltd.  
# 150 - 12791 Clarke Place  
Richmond, B.C.  
V6V 2H9

11 December 2008

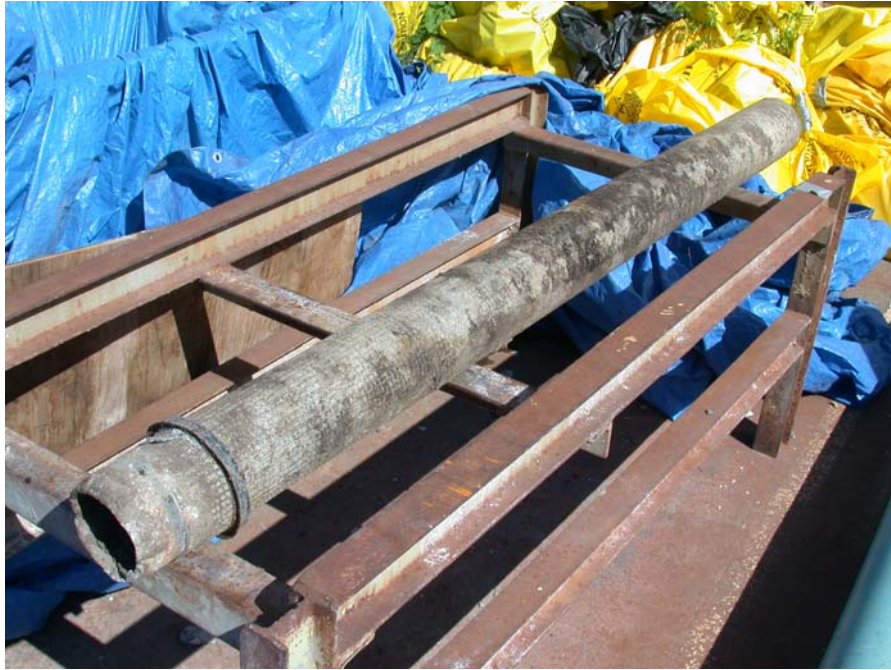
**Figure 1:** View of AC pipe Sample X-87 (Lot 10, Shoreline Drive) in the as-received condition.

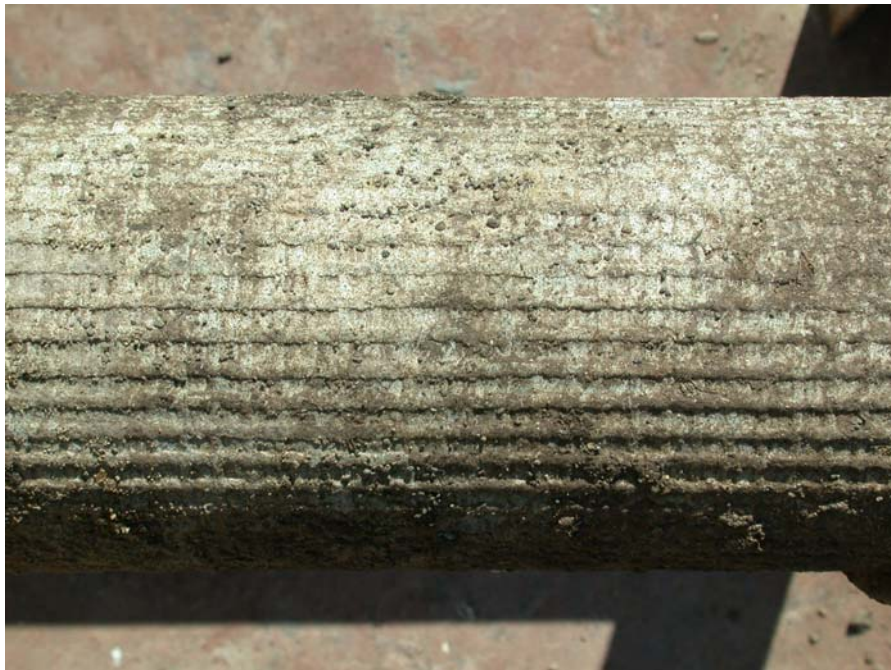
**Figure 2:** Close-up view of AC pipe Sample X-87 (Lot 10, Shoreline Drive) in the as-received condition, showing adhered dirt and sand and the heavy waffle pattern on the sample external diameter surface.

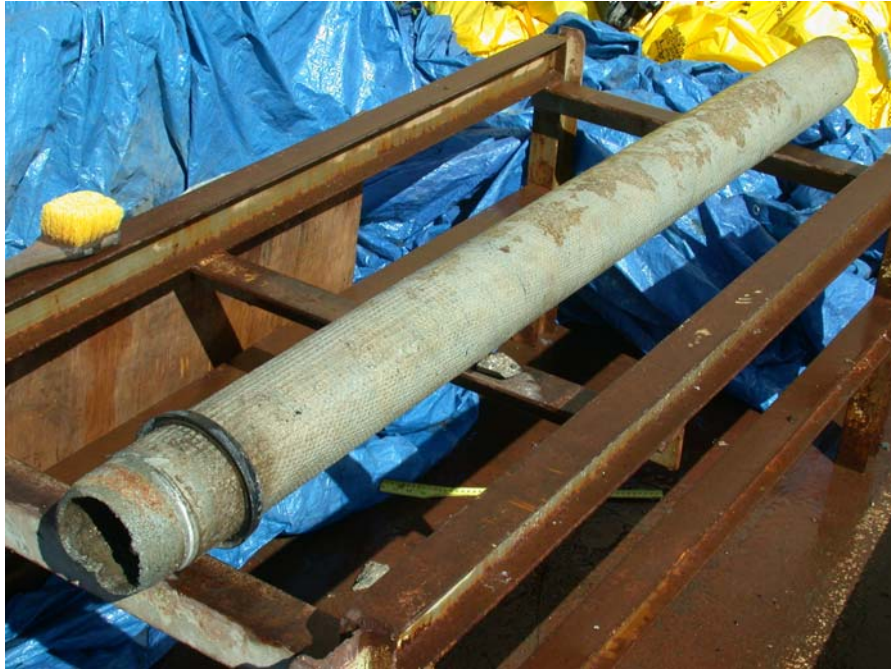
**Figure 3:** View of AC pipe Sample X-87 (Lot 10, Shoreline Drive) after cleaning showing areas of brown staining on the external diameter surface.

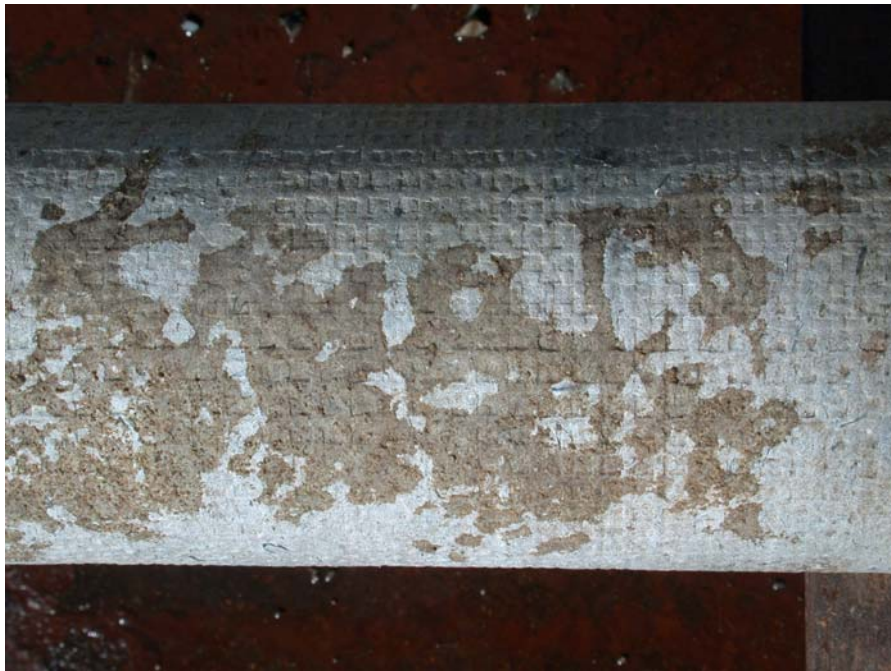
**Figure 4:** Close-up view of the external diameter surface of AC pipe Sample X-87 after cleaning showing the waffle pattern and an area of brown staining.

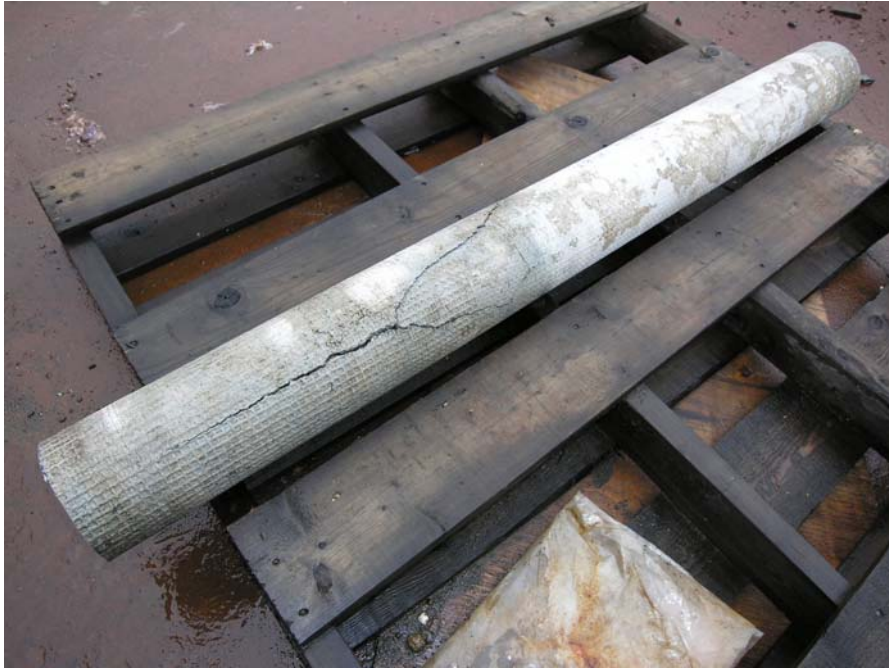
AC pipe Sample X-87 (Lot 10, Shoreline Drive) failed at an internal gauge pressure of 735 psig, which met the as-manufactured hydrostatic strength requirement for Class 150 AC pipe (600 psig). The failure exhibited a longitudinal fracture with one forked end. The non-forked fracture end terminated in the coupling used to seal the pipe end (Figures 5 and 6).

**Figure 5:** View of the hydrostatic strength fracture of Sample X-87 (Lot 10, Shoreline Drive) showing the longitudinal fracture (middle left) and forked end (middle), typical of hydrostatic pressure fractures observed in previous studies completed by Levelton.

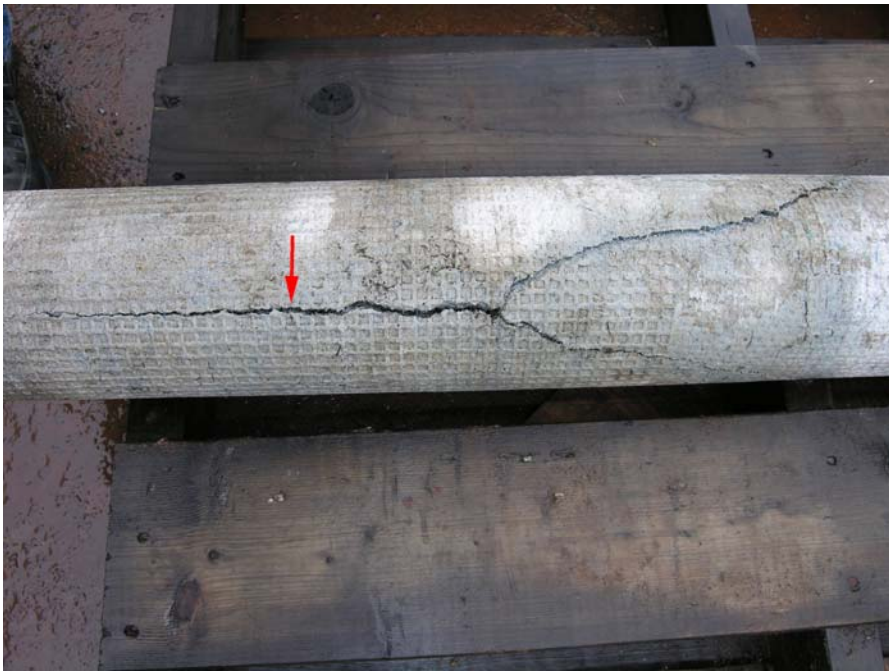
**Figure 6:** Additional view of the hydrostatic fracture of Sample X-87. The fracture would likely have originated in the longitudinal portion of the fracture shown (indicated by the arrow), which is where the hydrostatic ring section was removed from for further testing.

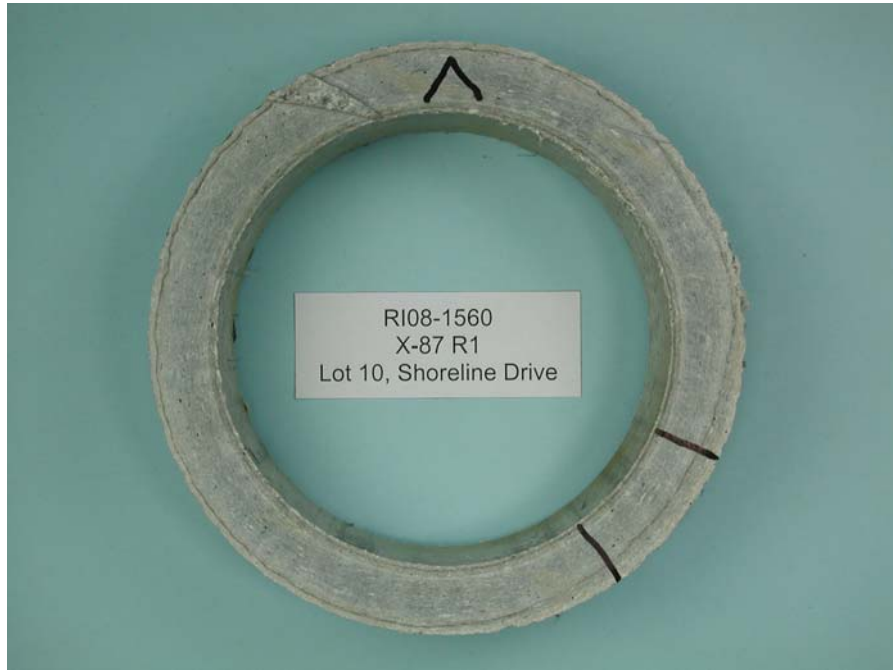
**Figure 7:** View of end ring section (X-87 R1) from AC pipe Sample X-87 (Lot 10, Shoreline Drive) with markings showing the area to be cut out for further analysis.

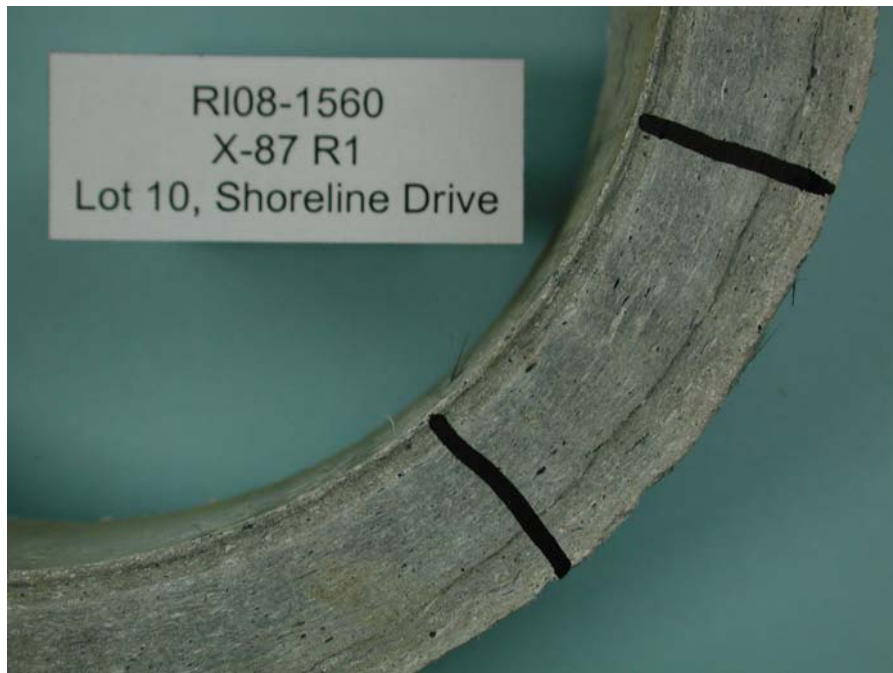
**Figure 8:** Close-up view of Figure 7 (end ring Section X-87 R1) showing the area marked for removal and further laboratory analysis.

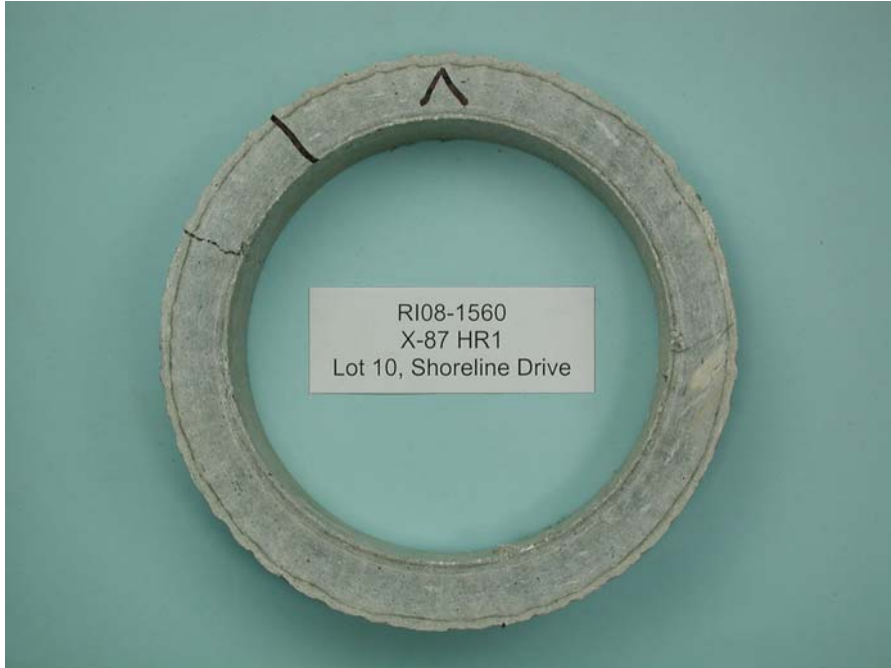
**Figure 9:** View of hydrostatic ring section (X-87 HR1) from AC pipe Sample X-87 (Lot 10, Shoreline Drive) with markings showing the area to be cut out for further analysis.

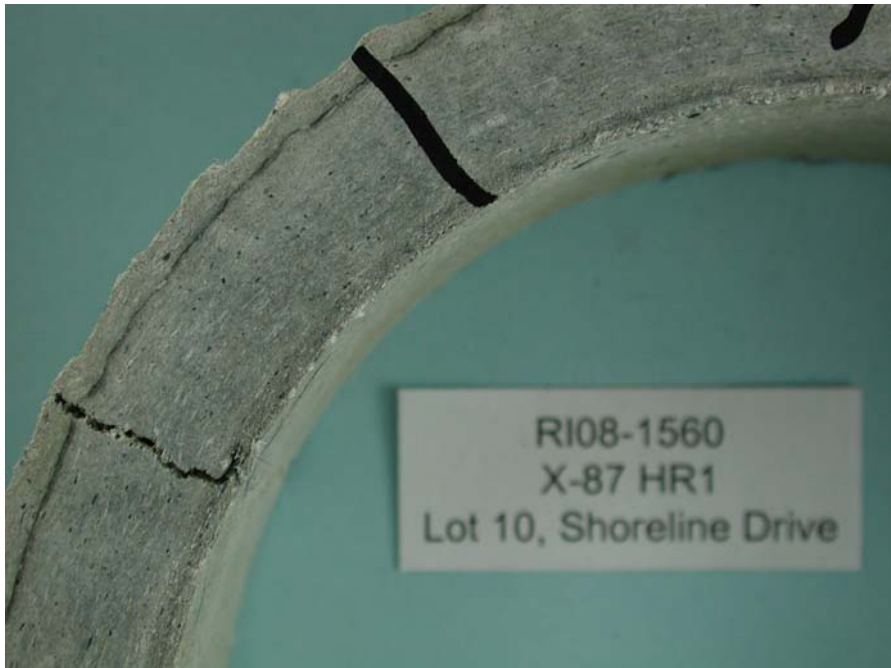
**Figure 10:** Close-up view of Figure 9 (hydrostatic ring section X-87 HR1) showing the area marked for removal and further laboratory analysis (hydrostatic fracture shown at the left).

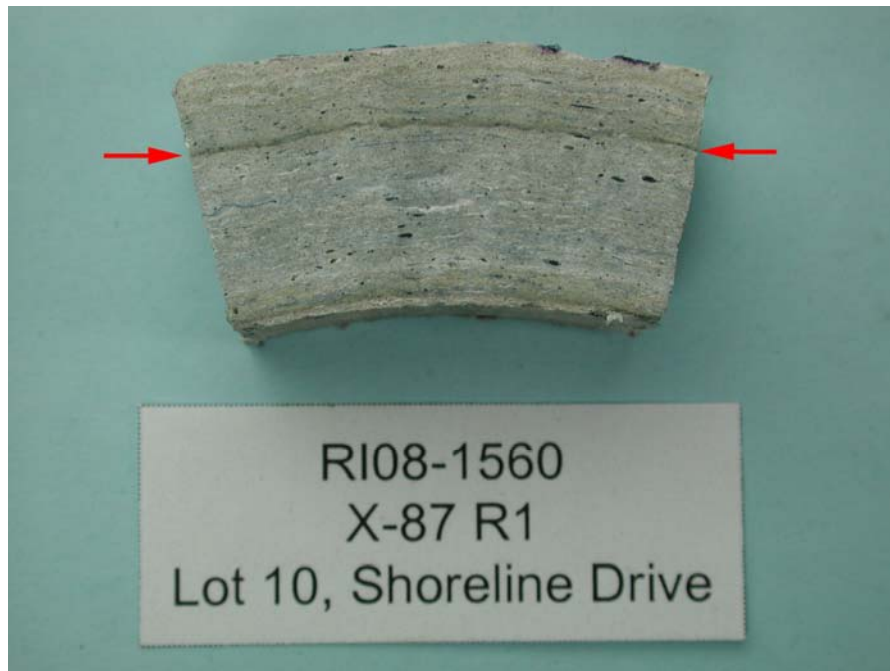
- The end (X-87 R1) and hydrostatic (X-87 HR1) ring sections taken from the AC pipe Sample X-87 (Lot 10, Shoreline Drive) showed apparent cement mortar leaching on both inside and outside diameter surfaces. Leached pipe wall appeared separated from sound pipe wall material by a distinct leaching front (Figures 11 and 12).

**Figure 11:** View of Sub-sample X-87 R1 shown in Figure 8 after removal and polishing. On the external diameter surface, leached and sound pipe wall material appeared separated by a distinct leaching front (dark line between arrows).

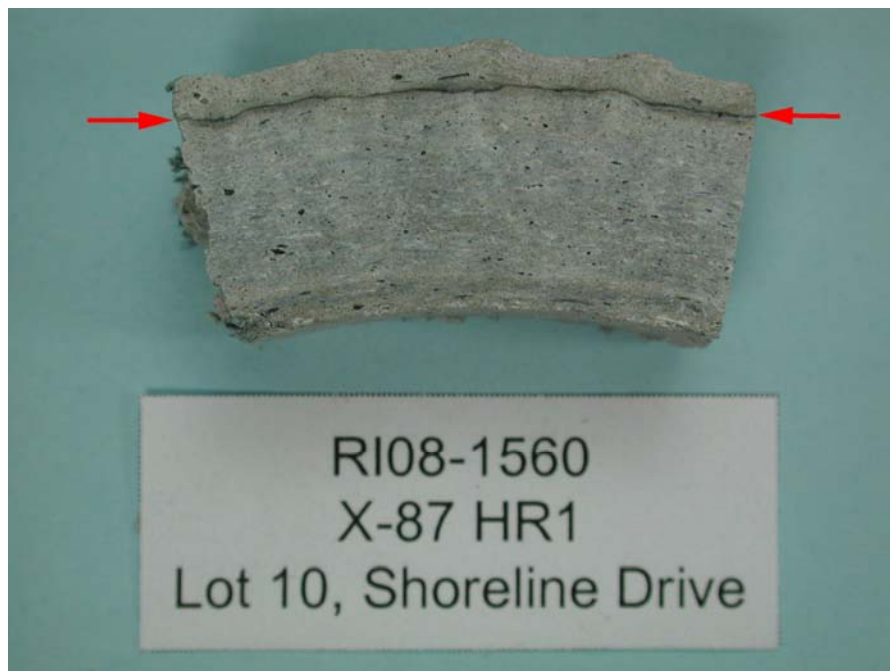
**Figure 12:** View of Sub-sample X-87 HR1 shown in Figure 10 after removal and polishing (hydrostatic fracture shown at left). On the external diameter surface, leached and sound pipe wall material appeared separated by a distinct leaching front (dark line between arrows).

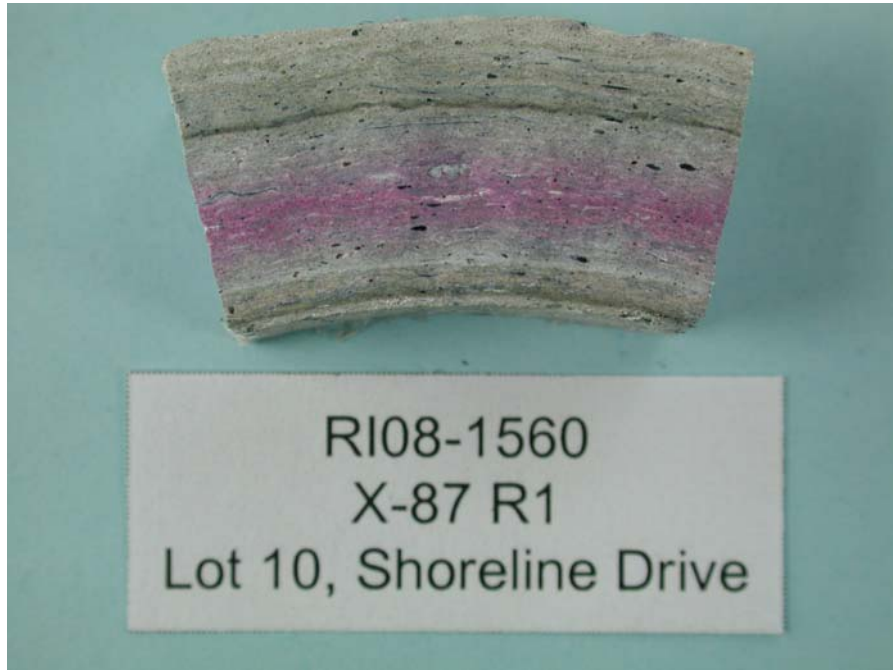
- The sub-samples taken from both the end and hydrostatic ring sections of AC pipe Sample X-87 (Lot 10, Shoreline Drive) appeared to demonstrate cement mortar leaching on both internal and external diameter surfaces.

**Figure 13:** View of Sub-sample X-87 R1 shown in Figure 11 after polishing and phenolphthalein indicator "staining". The pink colouration, caused by the phenolphthalein "staining", indicates a band of unleached (sound) pipe wall.

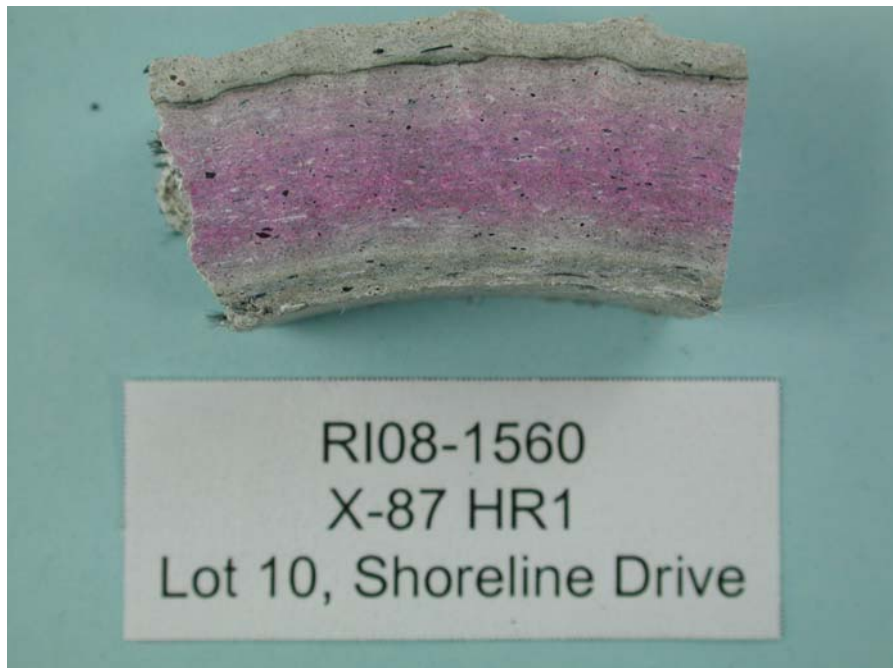
**Figure 14:** View of Sub-sample X-87 HR1 shown in Figure 12 after polishing and phenolphthalein indicator "staining" (hydrostatic fracture shown at left). The pink colouration indicates a band of unleached (sound) pipe wall.

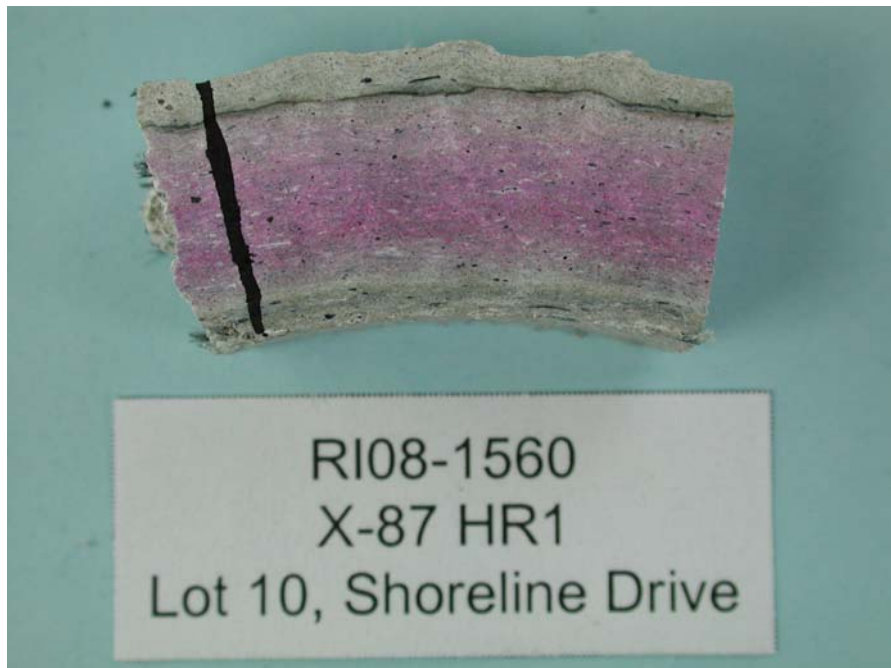
**Figure 16:** View of Sub-sample X-87 HR1 shown in Figure 14 after polishing, phenolphthalein indicator “staining”, drying and marking for SED/EDS analysis (hydrostatic fracture at left).

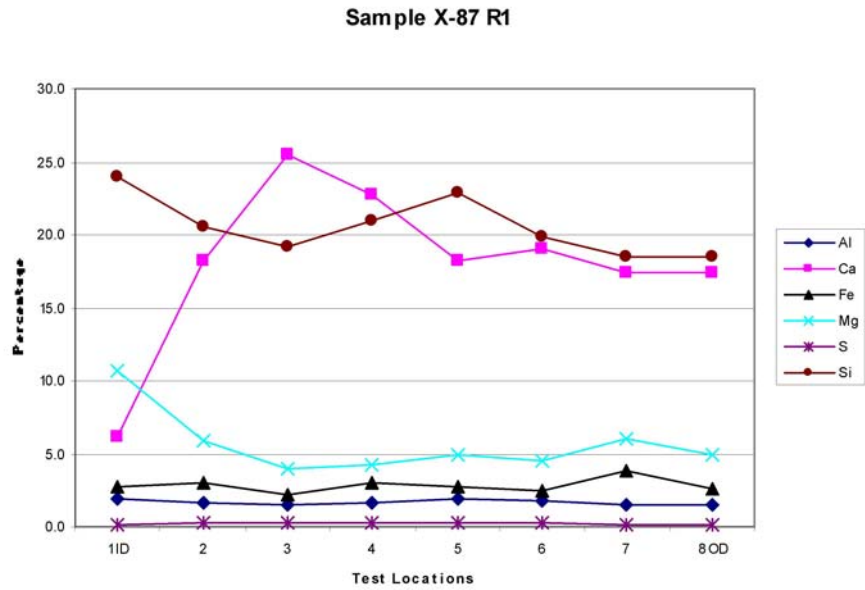
- Nominal calcium concentrations in the two sub-samples considered in this report (X-87 R1 and X-87 HR1) were lower than typically observed (observation: approximately 18-22%; typical: approximately 25%).
- End ring AC pipe Sub-sample X-87 R1 and hydrostatic ring Sub-sample X-87 HR1 showed cement mortar leaching primarily on their internal diameter surfaces.
- The two sub-samples considered in this report showed nominal silicon contents of approximately 20%, which is typical of AC pipe samples observed in past studies completed by Levelton.
- No iron pickup was observed on either of the sub-samples examined in this report. External diameter surface iron pickup did not appear to be a factor in the degradation of the pipe sample considered in this report.

**Figure 17:** SEM/EDS chemical analysis of end ring Sub-sample X-87 R1 taken from AC pipe Sample X-87 (Lot 10, Shoreline Drive).

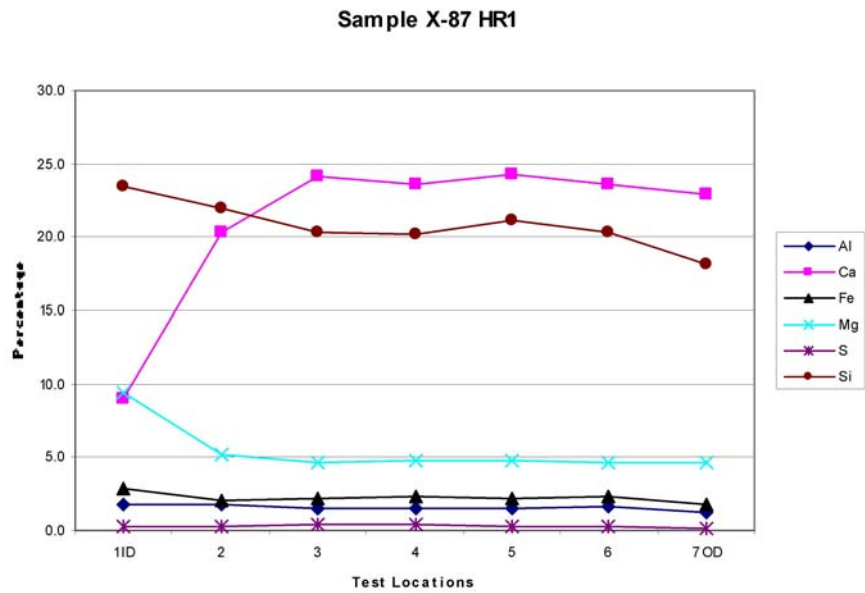
**Figure 18:** SEM/EDS chemical analysis of hydrostatic Sub-sample X-87 HR1 taken from AC pipe Sample X-87 (Lot 10, Shoreline Drive).
