# Understanding the Nature and Characteristics of Dark-Black Stains on Rooftops in Uyo Metropolis-Nigeria

Ihom A.P.<sup>1</sup>, Uko D.K.<sup>1</sup>, Markson I.E.<sup>1</sup>, Eleghasim O.C.<sup>1</sup>

<sup>1</sup> – Department of Mechanical Engineering, University of Uyo, Uyo, PMB, Uyo, Nigeria

**ABSTRACT.** Understanding the Nature and Characteristics of Dark-Black Stains on Roof-Tops in Uyo Metropolis-Nigeria; a study aimed at knowing the nature and characteristics of dark black stains on rooftops in Uyo metropolis has been undertaken. The study which covered key areas of the town, involved taking samples from rooftops, these samples were sent out for tests using Energy Dispersive X-Ray Fluorescence (ED-XRF), Optical Emission Spectrometer (OES), X-Ray Diffractometer (XRD) and Scanning Electron Microscope (SEM). The tests were carried out on the dark black stains which were scrapped from the rooftops. Tests were also carried out on the sheets, which were directly cut from the roofs. The work was able to establish that the dark black stains on the roofs can be cleaned using soft brush and water. The results of the work equally provided the nature and characteristics of the da

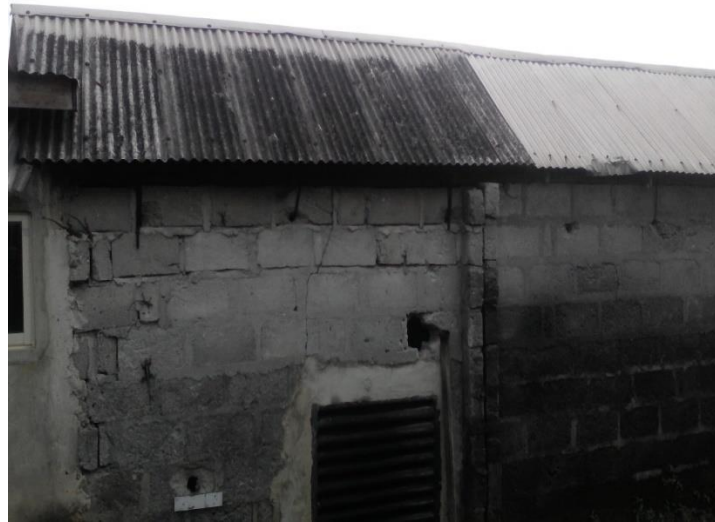
*Fig. 1. Building in Uyo Metropolis: The Roof is Completely Covered with Dark-Black Deposit.*

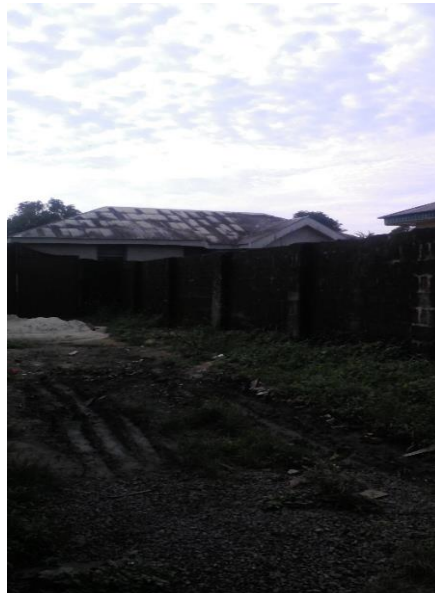
*Fig. 2. Building Roof Completely Covered with Dark-Black Coating/Deposit.*

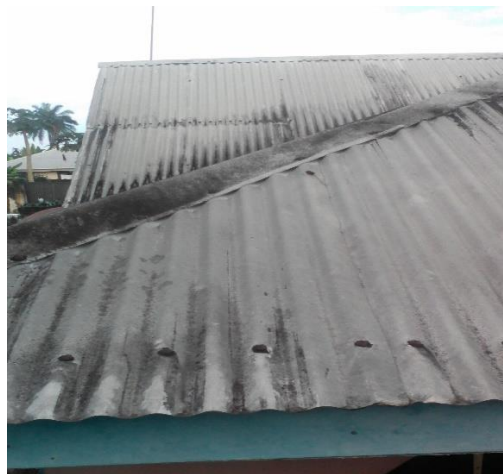
*Fig. 3. Building Roof Completely Covered with Dark-Black Deposit.*

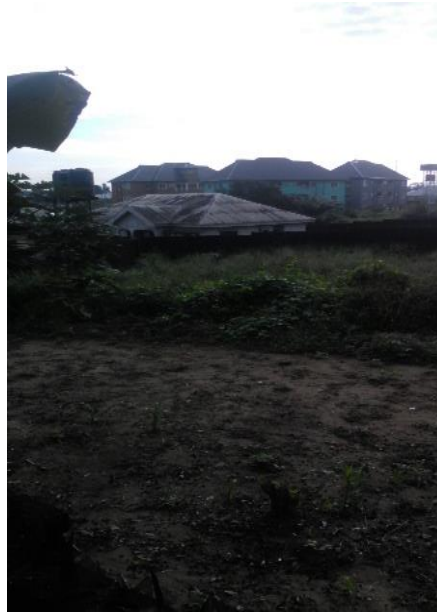
*Fig. 4. The Roof Top of the Building in the Front is covered with Dark-Black Deposit, the Storey Buildings Behind are Roofed with Dark-colour Roofing Sheets to Conceal the Effect of the Dark-Black Deposit.*

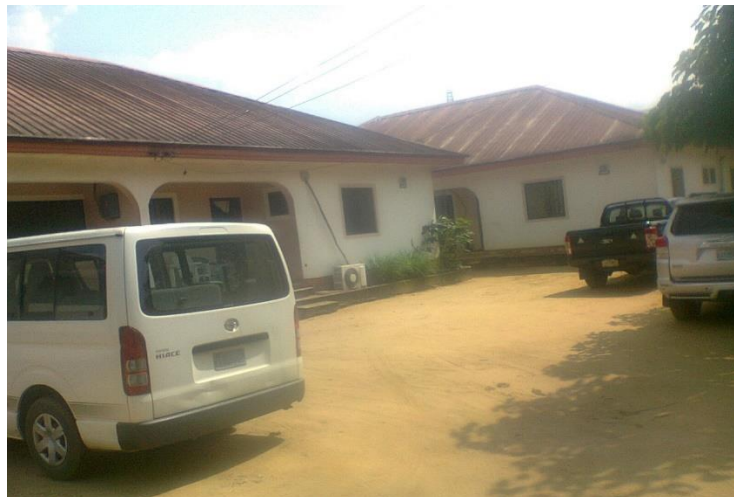
*Fig. 5. Dark-Black Deposit on Colour Roofs in a Housing Estate in Uyo Town.*

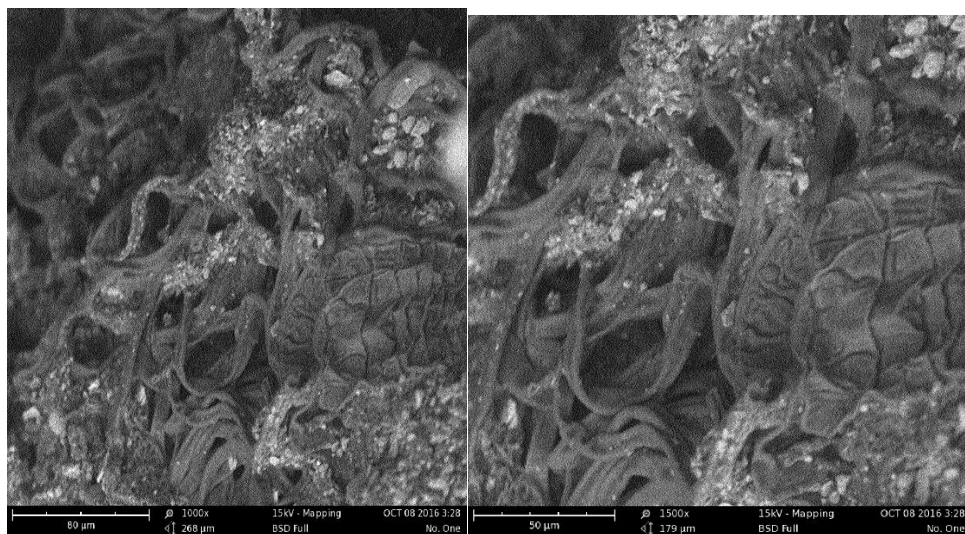
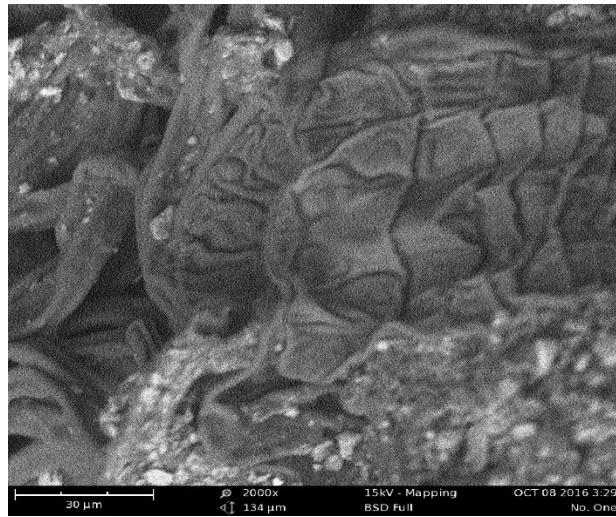
Fig. 11. Scanning Electron Microscope (SEM) Micrographs of the Scrapped Coatings on the Rooftops of Buildings at different magnifications (1000X, 1500X, 2000X).

The micrograph on the Fig. 11 shows that the dark-black material is not a uniform material; small white particles are there, amorphous-like structure like that of the polymer material can be seen and crystal-like structure similar to that seen in some carbon forms can be seen.

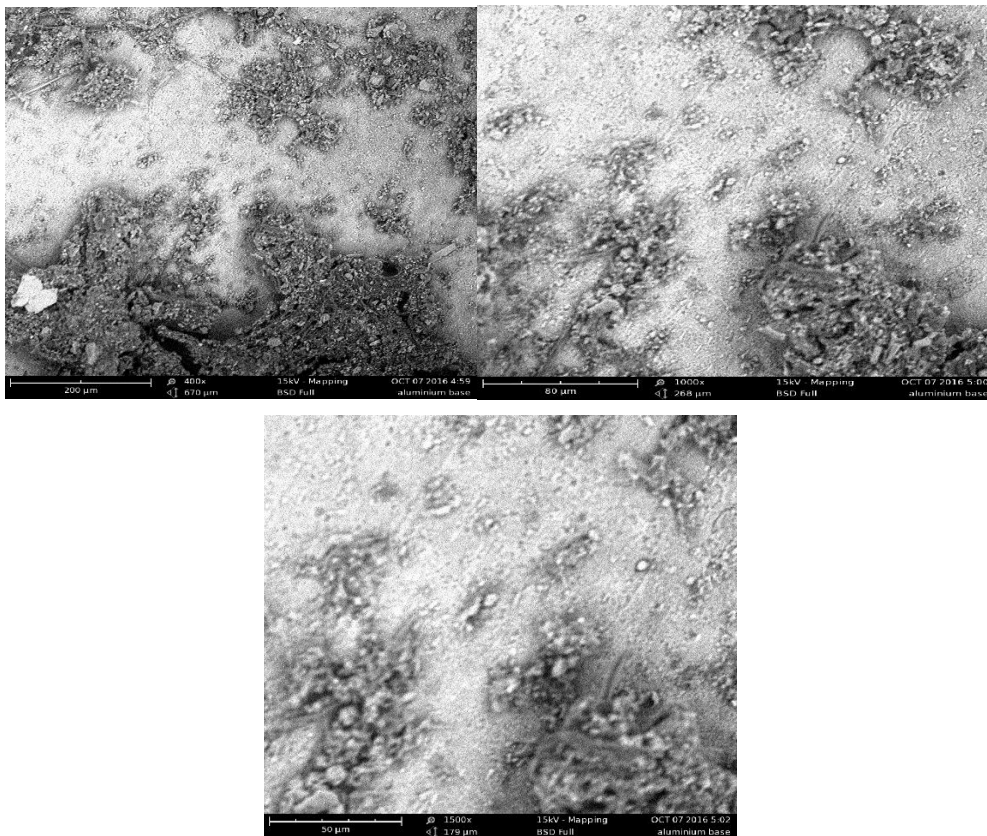
Fig. 12. Scanning Electron Microscope (SEM) Micrographs of dark-black Deposit on Aluminium-base roofing sheet at different Magnifications (400X, 1000X, 1500X). The light shining areas are where the deposit of the material is low and the dark areas are where the deposit has covered the aluminium sheet completely.

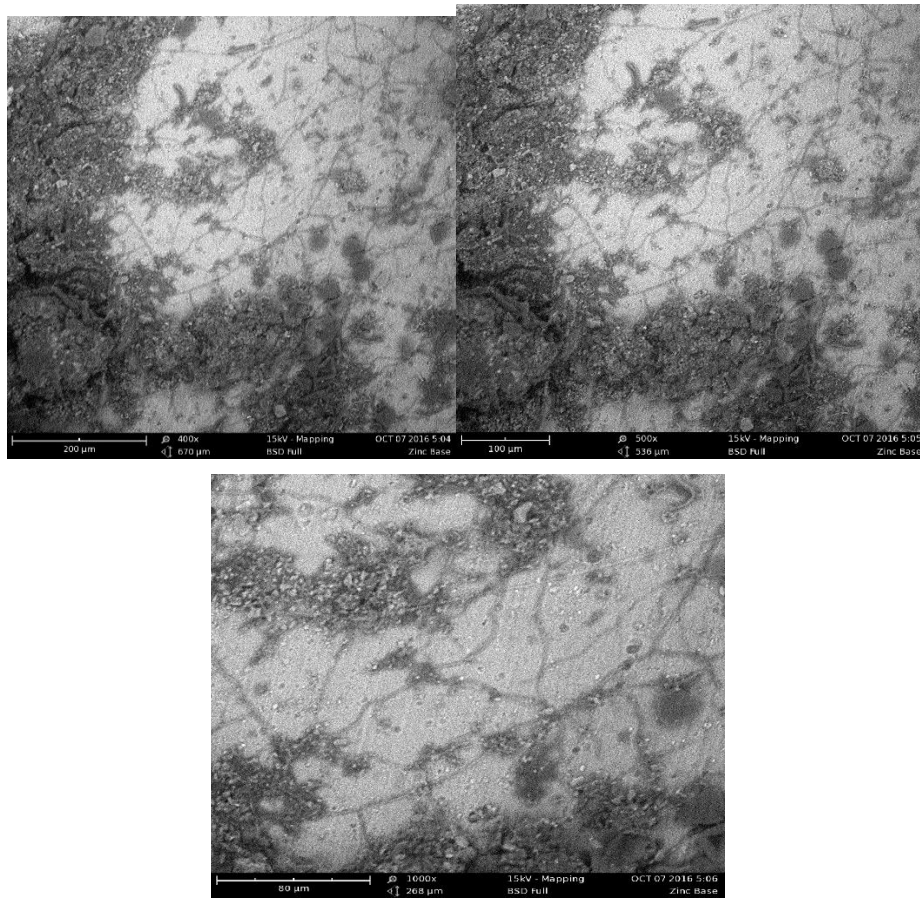
Fig. 13. Scanning Electron Microscope (SEM) Micrographs of dark-black Deposit on Zinc-Coated base roofing sheet at different Magnifications (400X, 500X, 1000X). The light areas have low deposit of the material; the substrate is still shining and the dark areas have large deposit of the material; the substrate is covered.
