# Blue-Green Algae and its Effect on Fiber-cement Roofing Within a Microclimate

## An Investigation of Biodeterioration of Fiber-Cement Roofing by Cyanobacteria and its Implications for the Roofing Industry in Hawaii

By Colin Murphy, RRC, FRGI

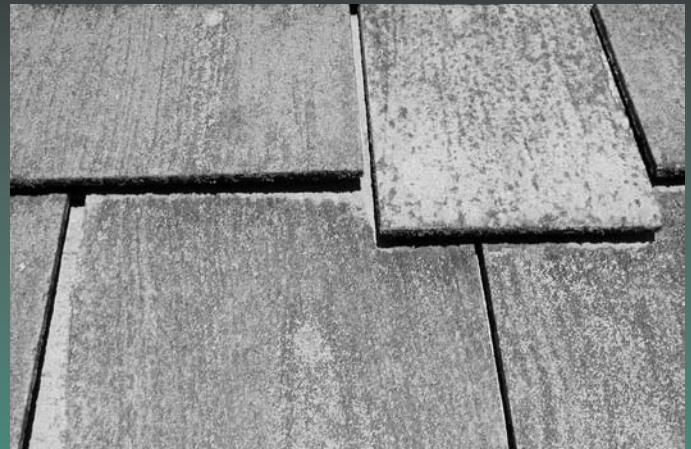
Inspections of fiber-cement roofing assemblies installed throughout Oahu revealed very extensive areas of blackish "algae" growth at all roofs. Only areas under cover (i.e., below overhangs and trees) were void of surface growth.

Photo 1 – Typical blackish algae growth observed throughout the project complex .

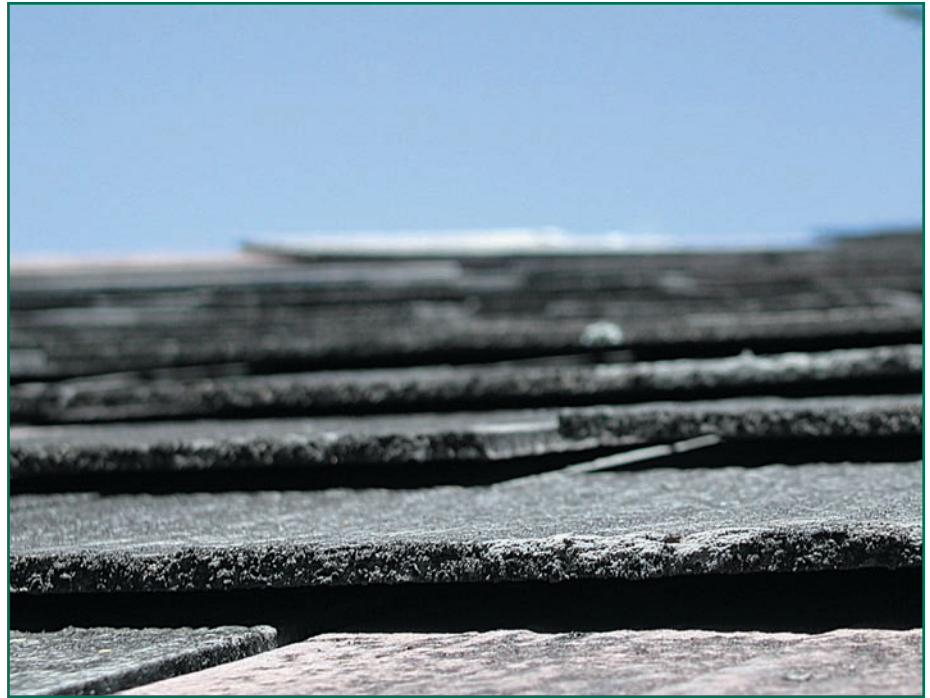
*Photo 3 – Crumbling deterioration at leading edge*

including cracking, crumbling and "leafing" at the leading edge, and delamination of the fiber-cement layers.

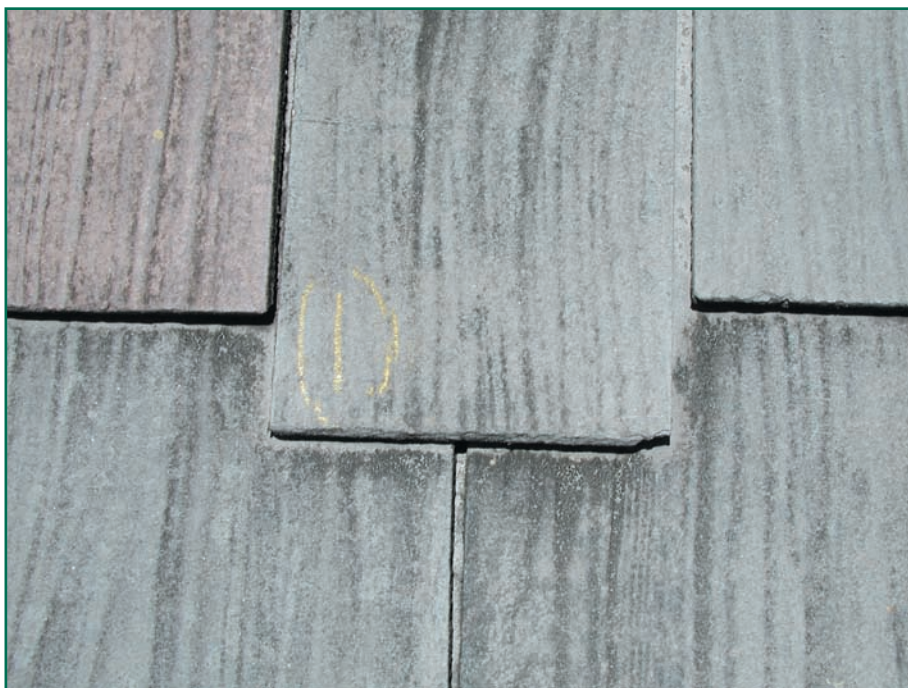
*Photo 2 – Typical blackish algae growth observed throughout the project complex*

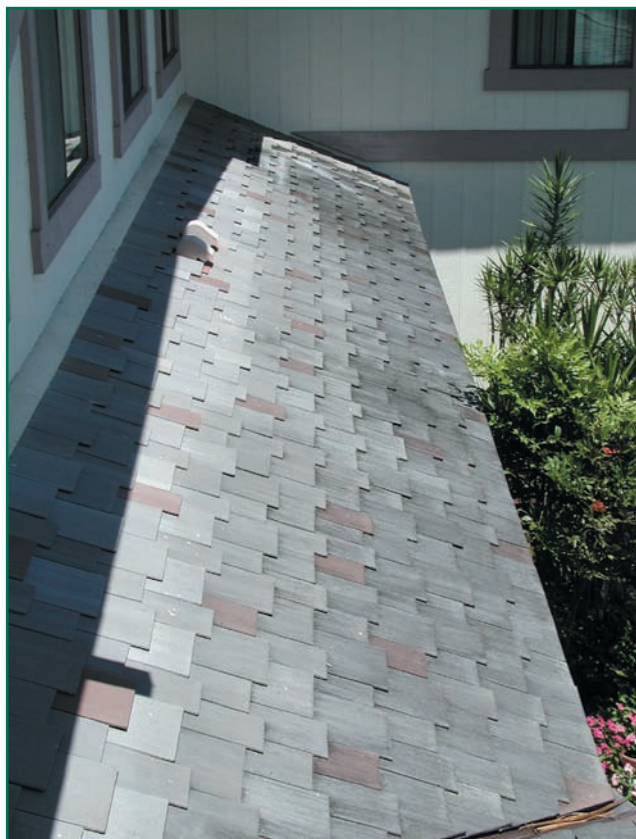
Photo 4 – Blackish algae growth begins below eave-protected, shaded area

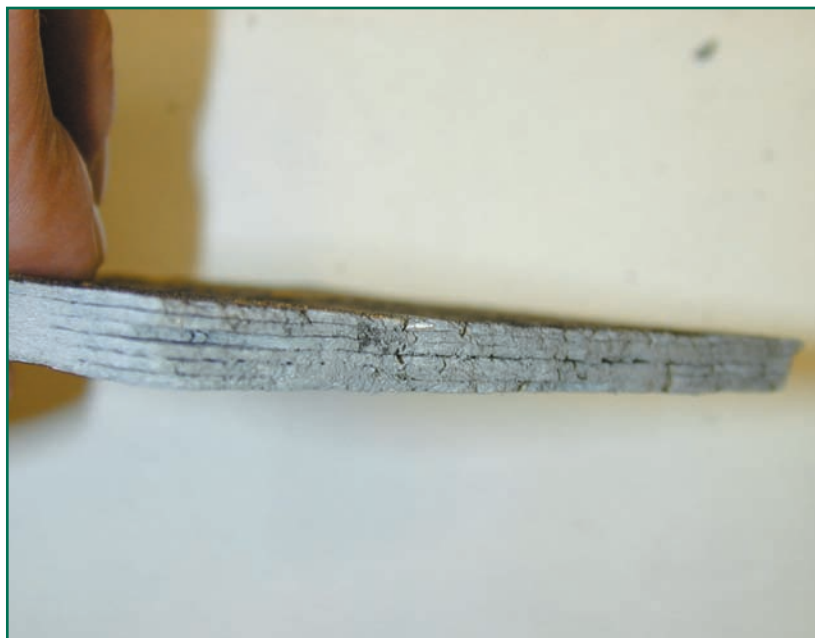
Photo 5 – Cohesive failure of the laminates

Cohesive failure (delamination) of the fiber-cement layers was observed on some samples. In several cases, the extent of the structural deterioration precluded testing of physical properties.

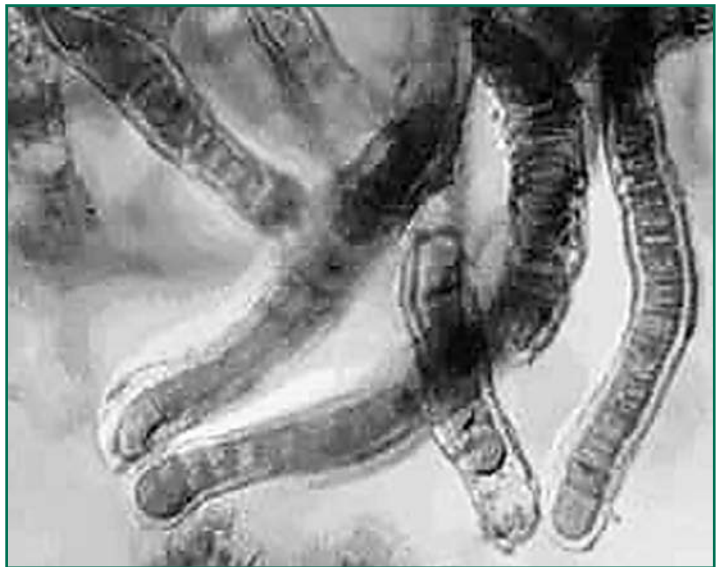
Photo 6 – Microscopic view of *Scytonema Endolithicum* – mucilaginous sheaths cover the growing filaments (<http://www.botany.hawaii.edu/faculty/webb/BOT314/Cyanobacteria/Cyanobacteria.htm>)

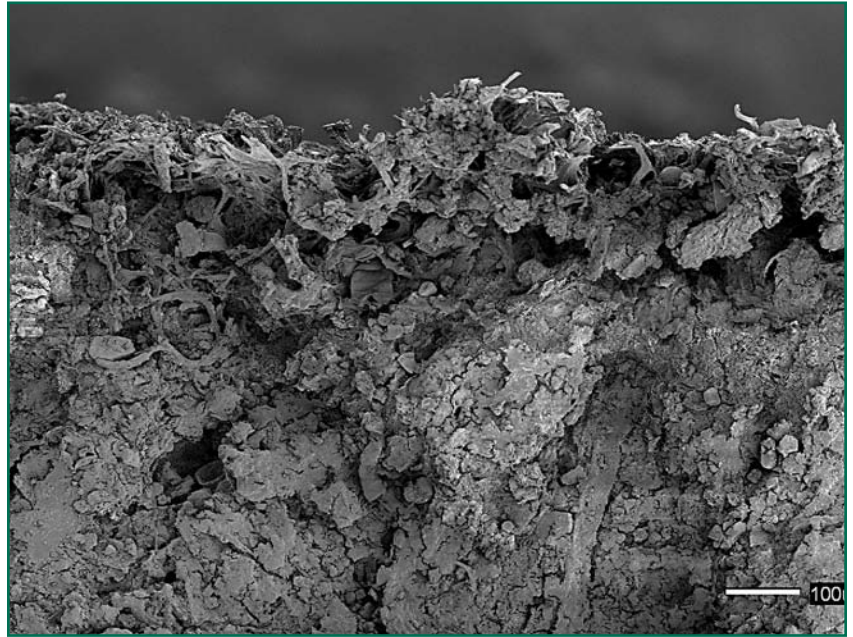
SEM (scanning electron microscope) images produced by Lab-Cor<sup>23</sup> dramatically depict the effects of the expansion of these mucilaginous sheaths into the fiber-cement elements. *Photos 7, 8, and 9* provide comparisons of a 150x cross-section of the surface of a fiber-cement sample (from below an eave) without algal growth and 100x and 1000x cross-sections of the biodegraded surface of a sample colonized by *Scytonema*.

*Photo 8 – SEM Image (original mag = x100) of cross-section of surface of fiber-cement sample taken from area colonized by Scytonema*

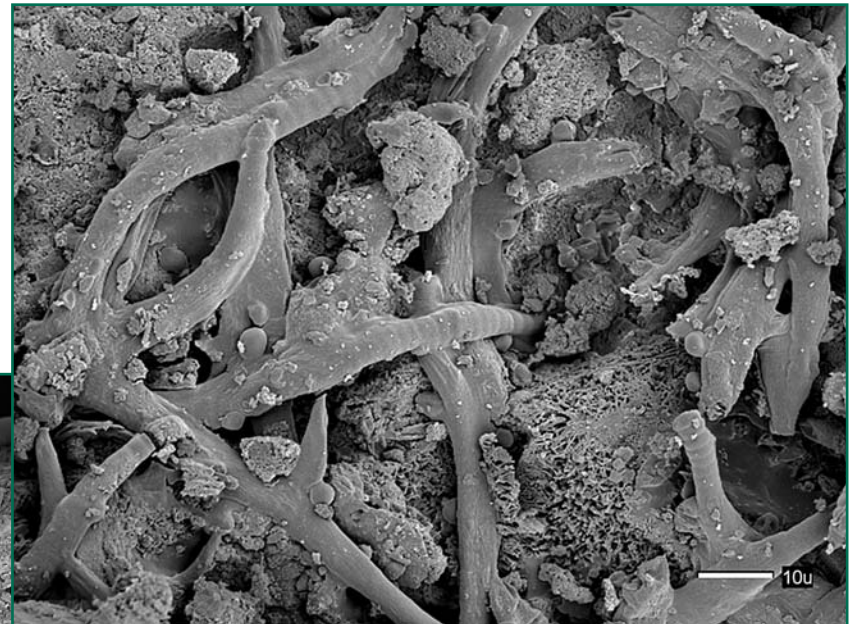
*Photo 9 – SEM image (original mag = x1000) of cross-section of surface of fiber-cement shake. Grains have "... become disassociated from the product matrix and become entangled with and adhered to the gelatinous sheaths of the filaments of the growing Scytonema sp."*

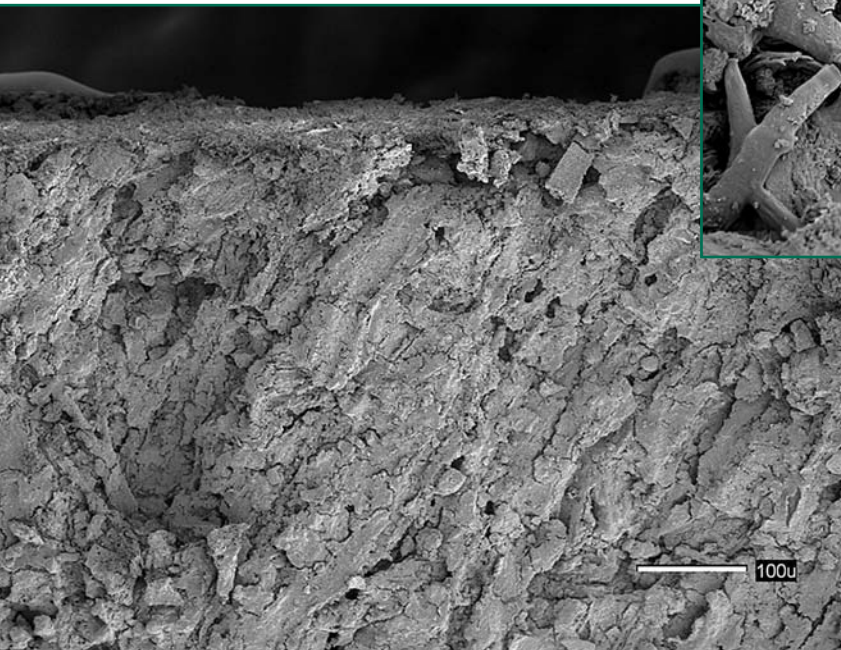
*Photo 7 – SEM image (original mag = x150) of cross-section of surface of fiber-cement sample taken from under eave where no algal or bacterial colonization had occurred*
