HAIL DAMAGE TO TILE ROOFING

Timothy P. Marshall*, Richard F. Herzog, Scott J. Morrison, and Steven R. Smith
Haag Engineering Co.
Dallas, Texas

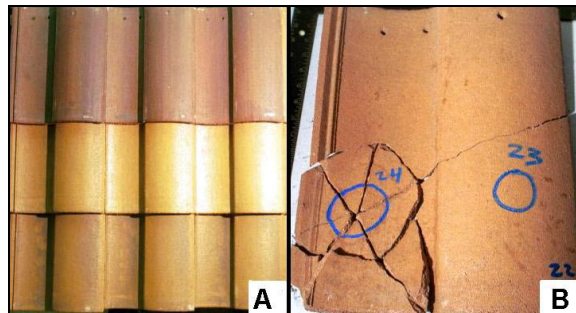
Figure 3. Concrete tile testing: a) sample test panel, and b) tile breakage after ice ball impact.

Damage to the concrete tile was defined as a fracture in the material. Typically, multiple irregular fractures emanated from the impact point. Fractures that occurred above the headlap were functional damage as the water shedding ability of the tile had been compromised. Table 2 shows a summary of our ice ball impact tests for one of the concrete tile products.

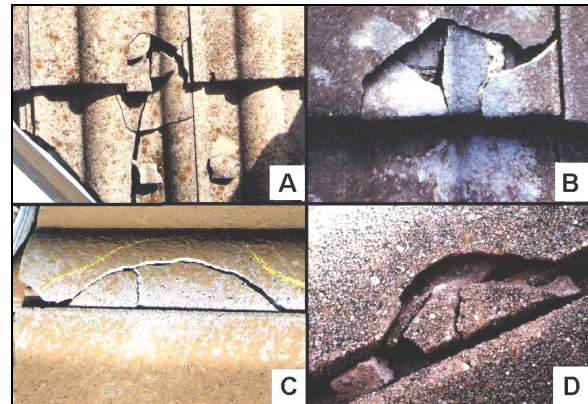
In summary, none of the concrete tiles tested were fractured by 1 in. (2.5 cm) diameter ice balls, even in their most sensitive locations. Four of the 13 tiles were fractured at their corners with ice balls as small as 1.25 in. (3.2 cm) in diameter. Six of the 13 tiles remained unbroken when impacted with 1.50 in. (3.8 cm) diameter ice balls. Ice balls of 2.5 in. (6.4 cm) in diameter broke all tiles. These test results correlated well with our observations of concrete tile roofs after actual hailstorms (Figure 4).

Figure 4. Hail damage to concrete tiles: a) shattered tiles from a single impact, b) shattered tile edge associated with a hail-caused spatter mark, c) large half-moon shaped fracture along the tile overlap, and d) small half-moon shaped fracture along the tile overlap.

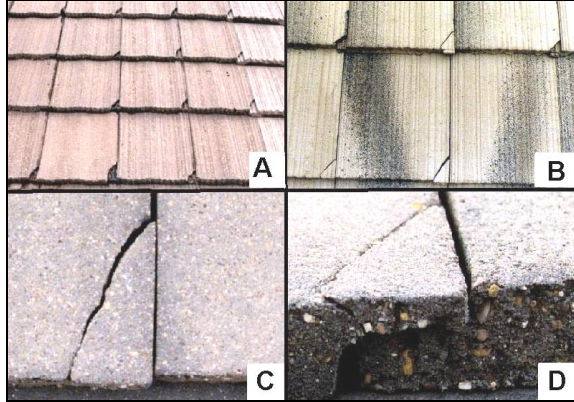
The authors have discovered that curved corner fractures are inherent in many concrete tile roofs. These cracks emanate from the lower right corners of the tiles and have a variety of causes (Figure 5). We

have found right corner fractures with all types of interlocking tile profiles. Occasionally, inspectors mistakenly identify this phenomenon as hail damage. Close examination usually reveals algae or dirt in the fractures thereby indicating old damage. Sometimes, tile corners are reattached with caulking or cement.

Figure 5. Curved right corner fractures in concrete tiles that were not the result of hailstone impact.

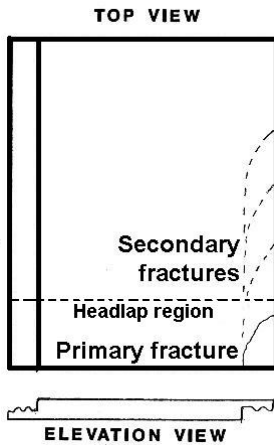
One cause of right corner fractures is shunting the tiles together so that they butt tight with no room for expansion. Tiles need room to expand with increasing temperature and moisture. One can expect a 50 ft. (15 m) length of tiles to expand roughly .2 in (.5 cm) due to a change of 50 F (10 C). Without providing room to accommodate expansion, tiles press against each other. The resulting strains can fracture the thinner overlap region on the tile, especially at the lower right (when looking upslope) corners. Thus, tiles with interlocking side joints should be installed with maximum "play" in order to accommodate for lateral movement. We also have found that persons walking on the tiles can also cause right corner fractures. In most instances, the fractured corners remain below the headlap regions and do not result in water infiltration. However, less common secondary fractures have been discovered in the tile overlaps extending above the headlap regions (Figure 6).

Figure 6. Primary and secondary right corner fractures in flat concrete tile.

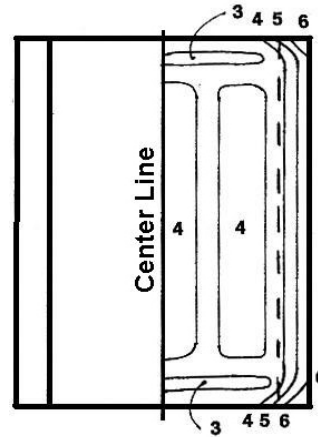
There are two additional factors in the design of concrete tiles that can promote right corner fractures. One factor is a shrinkage crack that forms as the tile dries unevenly. Tiles with interlocking side joints do not have a uniform thickness in cross section. Thus, as these tiles dry, the thin, outer edges of the tiles dry first and the thicker portions dry last. In particular, the interlocking side joints cure first since this area has the greatest surface area-to-volume ratio. In contrast, the thicker portion of the tile, containing head and nose lugs, dries last since this area has the smallest surface area-to-volume ratio. The relative time differences in drying/curing can create internal stresses that lead to shrinkage cracks (Figure 7). The authors have found small shrinkage cracks in new tiles. The cracks became more obvious when tiles were misted with water and the water-filled cracks dried slowly.

Figure 7. Surface area-to-volume ratios shown in right half of a flat tile. In general, the higher the area-to-volume ratio, the quicker the tile dries. In this case, the overlap dries first, especially at the corners.

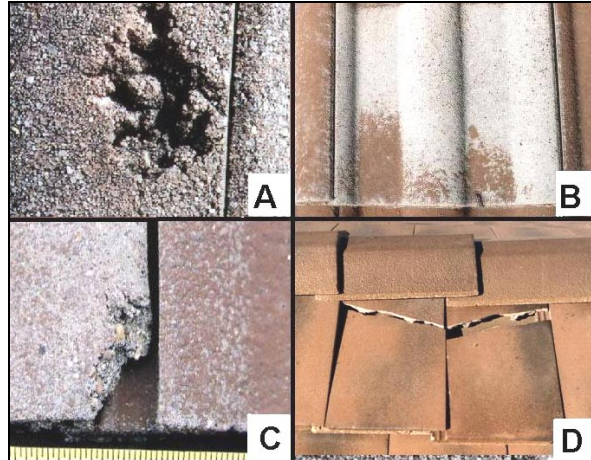
There are a number of additional tile deficiencies caused during the manufacturing process or installation (Figure 9). Some concrete voids have rounded forms that can be mistaken for hail damage. Persons walking improperly on the tiles can break the tiles across their widths. When walking on a tile roof, it is best to step along the lower portion of the tile, where underlying lugs provide firm support. In contrast, the center of the tile has little underlying support and is easier to break under foot.

Figure 9. Concrete tile defects not caused by hail: a) concrete void, b) lack of slurry coat, c) missing tile corner, and d) broken tiles from foot traffic.

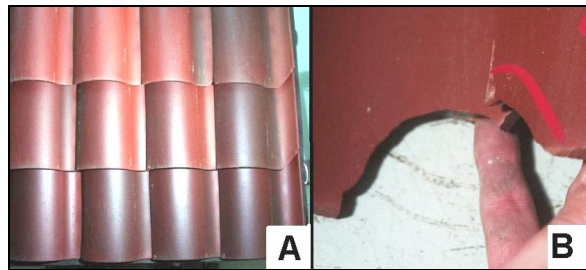
A test panel with Spanish clay tiles was constructed and impacted with various size ice balls using the IBL-7. The tiles were hung on nails on a wooden roof deck (Figure 10). Tiles were impacted perpendicularly in the field and in the lower right corners using ice balls of 1.25 and 1.5 in. (3.2 and 3.8 cm) in diameter. Damage to the tiles involved breaking or shattering of the product. Multiple fractures occurred in the tiles and fractures were irregular, emanating from the impact point.

Figure 10. Clay tile testing: a) test panel, and b) shattered nose or bottom edge of tile after impact.

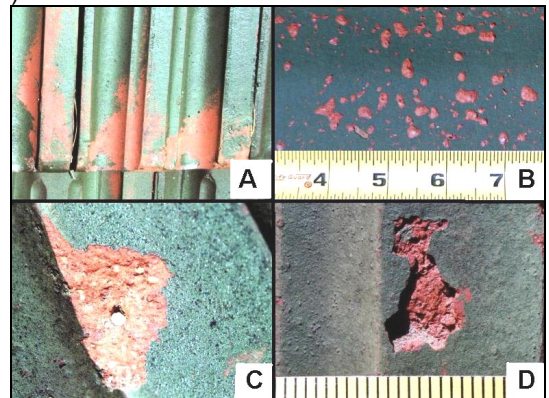
Clay tiles are prone to pitting or spalling due to freeze-thaw effects especially if they are deteriorated. Small voids and material inclusions absorb moisture and expand during freezing conditions. Some of these spots can take on rounded forms and be misidentified as hail-caused damage. Occasionally, rough areas on tile surfaces form when they are manufactured (Figure 11).

Figure 11. Clay tile deficiencies not caused by hail: a) lack of glazing, b) pitting, c) spalling, and d) void in the tile when made.

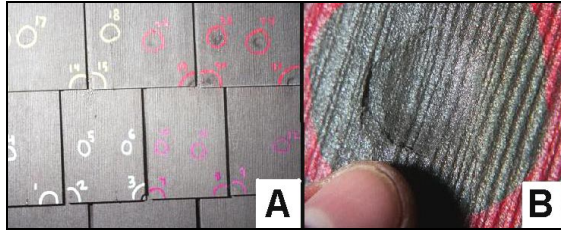
underlayment. Tiles were impacted perpendicularly in the field and in the lower corners using ice balls of .75, 1, and 1.25 in. (1.9, 2.5, and 3.2 cm) in diameter. Damage to wood fiber-cement tile involved an indentation with fracturing of the tile layers.

Figure 12. Wood fiber-cement testing: a) test panel, and b) indentation produced by 1.5 in. (4.5 cm) ice ball.

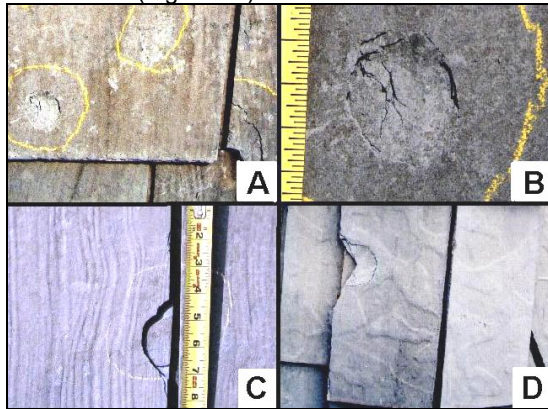
We found that wood fiber-cement tiles were softer than their concrete and clay counterparts and readily dented. There also were brittle-type fractures with half moon-shaped fractures along the tile edges. These observations correlated well with our field inspections of such roofs (Figure 13).

Figure 13. Hail damage to wood fiber-cement tiles: a) indentations, b) closer view of indentation, c) half moon-shaped fracture at edge, and d) broken ridge tile.

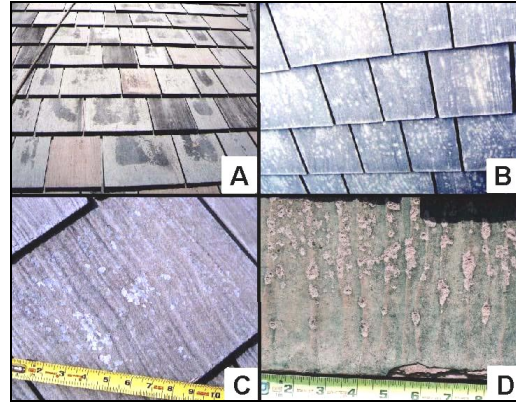
The authors have determined that a number of wood-fiber cement tile products have deteriorated rapidly with exposure to moisture and freeze/thaw effects. These thin tile products can peel, erode, and delaminate in as little as six years of normal weather exposure. Some aspects of tile deterioration take on rounded forms that can be misidentified as hail-caused damage (Figure 14). Murphy (2002) discusses the deterioration effects of blue-green algae on fiber-cement tiles.

Figure 14. Deterioration effects on wood fiber-cement tiles, not caused by hail: a) dark blotches, b) white blotches, c) surface peeling, and d) pitting/erosion as well as edge delamination.

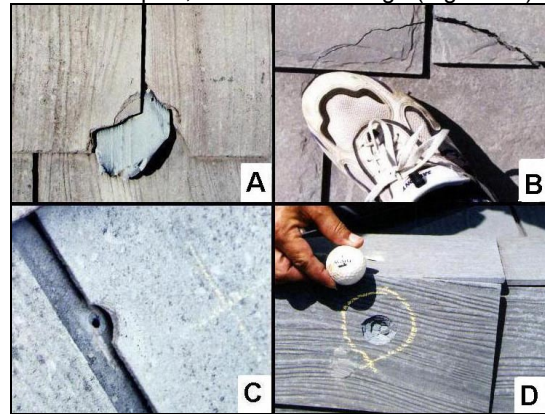
Wood fiber-cement tiles frequently are installed on steep roof slopes that are not walkable. Installers attach toe-boards to the roof in order to install the roofing tiles and removed them after the tiles are installed. Since the tiles are relatively soft or brittle, they are relatively easy to damage. We have identified various mechanical damages to wood fiber-cement tile roofs caused when the roof was installed. Such problems include broken corners, gouges, nail holes, overdriven staples, and footfall damage (Figure 15).

Figure 15. Mechanical damage to wood fiber-cement tiles: a) broken corners and metal toe-board bracket, b) foot broken tiles, c) chipped tile edge and nail hole, and d) golf ball impacts.

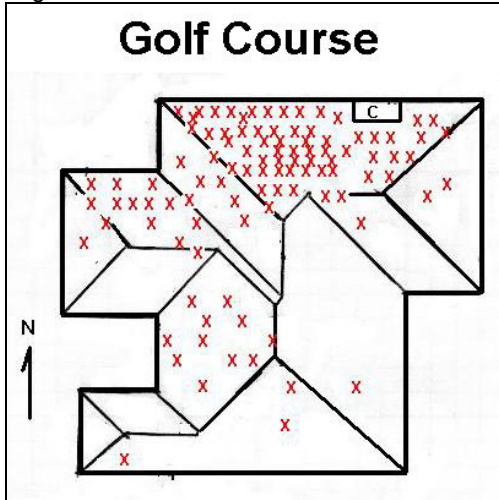
We also have found a number of cases where the tiles were indented by errant golf balls from a nearby golf course. Such damage was not randomly distributed on the roof but concentrated on the roof slope nearest the golf course (Figure 16). The indentations all were similar in size and shape, and a golf ball could fit well inside the indentations. Hail falls in various sizes and shapes and would not cause such damage.

Figure 16. Case where errant golf balls damaged the roof tiles as noted by Xs.

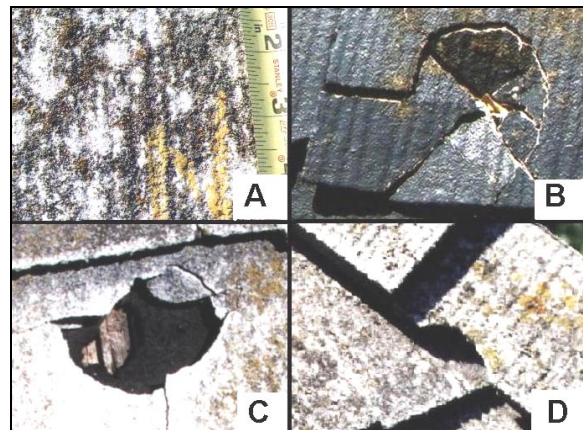
Asbestos-cement roofing tiles had the greatest hail resistance among cementitious products tested in spite of its small thickness. This conclusion has also been confirmed in our field inspections of asbestos-cement tile roofs (Figure 17).

Figure 17. Hail impacts to asbestos-cement products: a) hail-caused spatter marks resulted in no damage, b) indentation with fractures, c) puncture, and d) chipped edge on ridge tile.

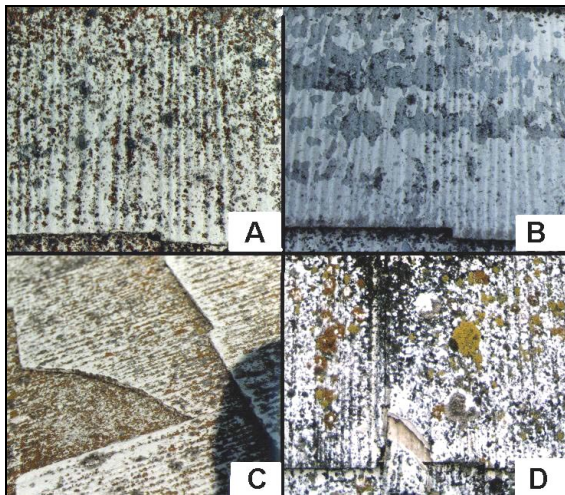
As mentioned previously, asbestos-cement tiles are quite resistant to the effects of weathering. However, the surface of the product provides a base for growing algae, fungus, and lichens. Also, as the tile wears, it may exhibit erosion of its surface layer as well as edge delamination. These effects can be erroneously attributed to hail damage. The tile also is susceptible to foot traffic damage, especially at tile corners or in areas where the tile is elevated and has less underlying support. Recent fractures can be distinguished from older fractures by the extent of discoloration on the exposed fracture surfaces. Tiles broken recently exhibit fresh, unweathered surfaces whereas tiles broken quite some time ago usually are discolored with algae, fungus, lichens, or dirt (Figure 18).

Figure 18. Non-hail caused anomalies on asbestos-cement tiles: a) algae, b) erosion of coated tile, c) old broken tile, and d) new broken tile corner from foot traffic.
