HAIL DAMAGE TO ASPHALT ROOF SHINGLES

Timothy P. Marshall*, Richard F. Herzog, and Scott J. Morrison
Haag Engineering Co.
Dallas, Texas

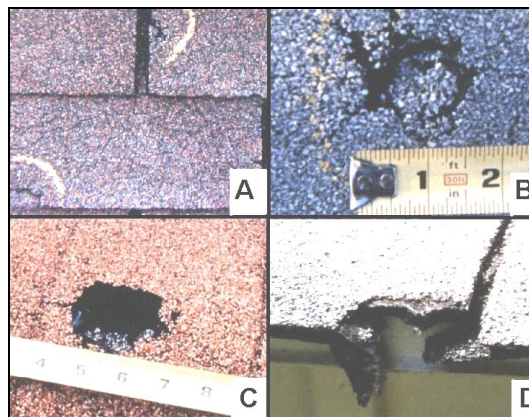
Morrison (1999) defined damage to roofing as a diminution of water-shedding capability or a reduction in the expected long-term life of the roofing material. Marshall and Herzog (1999) more specifically defined functional hail-caused damage to asphalt shingles as punctures, tears, or fractures (bruises) in the shingle mats (Figure 1). Shingle bruises are an indentation with fracture in the mat that feels soft like that of an apple bruise. The bruise is usually obvious as granules are also dislodged from the impact area exposing the asphaltic mat.

Figure 1: Hail damage to asphalt shingles: a) broken edges, b) bruise, c) puncture, d) torn edge.

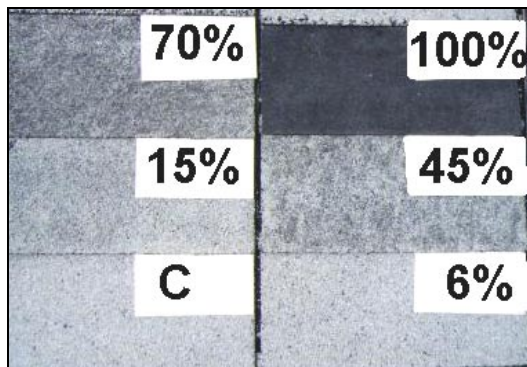
In order to determine how many granules, if any, must be removed in order to affect the service life or water shedding ability of the shingle, the authors' firm conducted a granule loss study on asphalt shingles. Varying quantities of granules were removed with a wire brush from new, three-tab, glass-fiber mat shingles. The shingles then were exposed naturally to the weather in Dallas, Texas for a period of ten years. The quantities of granules removed were none (control), and approximately 6, 15, 45, and 70 percent of the total granules on the shingles. Another shingle was installed upside down such that the asphaltic mat was exposed to the weather. The shingles were installed conventionally over a plywood deck on a 4:12 pitch that faced south. The shingles were examined at intervals throughout the ten year period as well as at the conclusion of the study (Figures 2 and 3).

Figure 2. Test panel at the beginning of the study showing percentage of granules removed. "C" is the control.

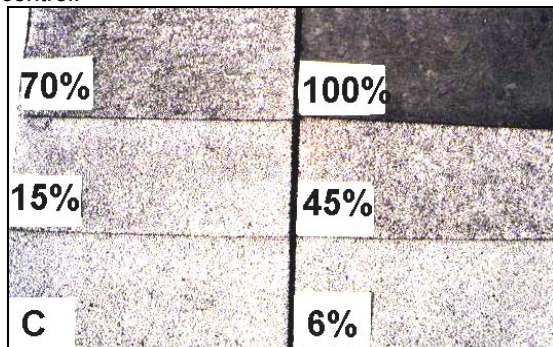
Figure 3. Same view as Figure 2 only at the conclusion of the ten-year study.

In one year, the exposed asphalt had oxidized grey but there was no visible evidence of surface cracks or erosion. After five years, areas of exposed asphalt had oxidized but this did not affect the function of the shingles to shed water. Surface erosion was visible on the shingle without granules, and some of the glass fibers had become exposed. After ten years, no significant change was noted in the shingles except for the shingle without granules. More glass fibers were exposed on this shingle due to erosion; but, the shingle continued to shed water (Figure 4).

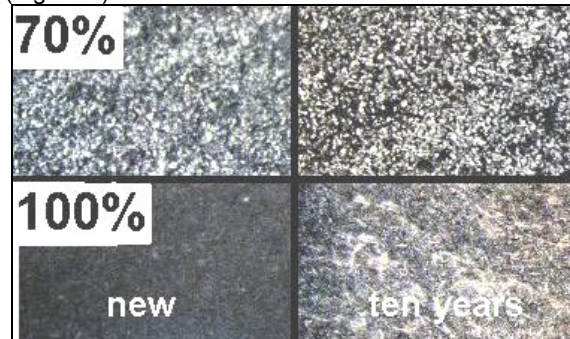
Figure 4. Close up views of new shingle and ten-year weathering with both 70 percent of the granules removed and no granules, respectively.

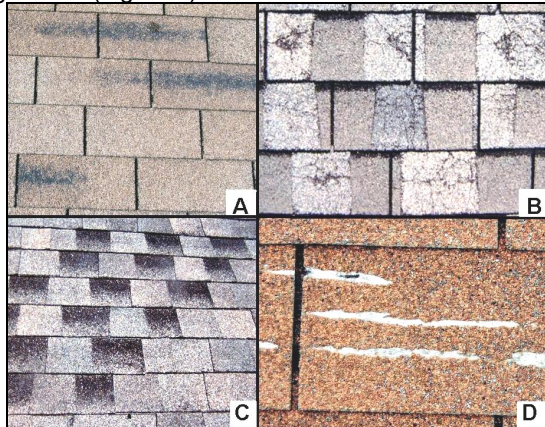
Asphalt shingles are manufactured in a high speed, fully automated process. Occasionally, certain defects involve insufficient granule or asphalt coverage, or the use of poor quality asphalt. Shingle manufacturers should "cull" or remove such defects before the shingles are shipped. However, the level of quality control of shingle products varies. Thus, it is not unusual to find shingle defects on a roof that involves bands or spots of missing asphalt and/or granules (Figure 5).

Figure 5. Various shingle manufacturing defects: a) lack of granule adhesion on a three-tab, b) blotchy appliques, c) asphalt exposed in lower laminate, and d) lines of missing asphalt and granules.

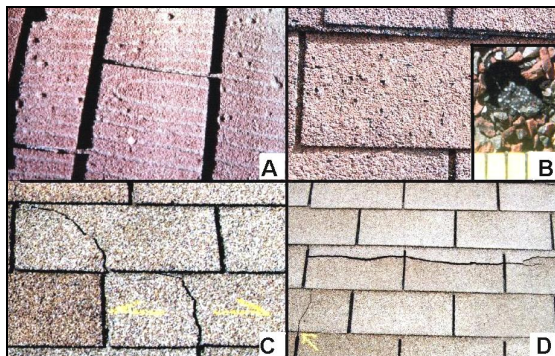
Figure 6. Various shingle anomalies not caused by hail: a) closed blisters, b) open blisters including close-up view in the inset photograph, c) diagonal splitting, and d) horizontal splitting.

Shingle blisters occur from a combination of poor quality asphalt combined with heat. They appear as small bubbles in the shingle surfaces where a portion of the granule surface is raised. Eventually, the shingle bubbles rupture exposing steep-sided voids in the shingle surfaces that frequently extends down to the shingle mat. Shingle blisters are usually 1/4 in. (.6 cm) in diameter or less and are not caused by hailstone impact.

Diagonal and horizontal splitting of asphalt shingles involves a combination of asphalt shrinkage, deck movement, and low tensile strength in the mat. Ribble et al. (1993) further explain such problems with asphalt shingles.

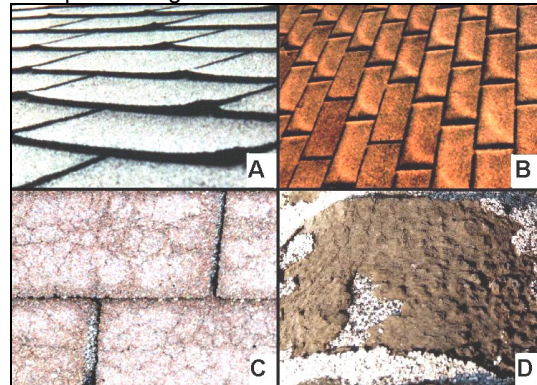
Figure 7. Various shingle anomalies not caused by hail: a) cupping, b) clawing, c) crazing, and d) flaking.

Cupping and clawing results from asphalt shrinkage on the top and bottom surfaces of the shingles, respectively. The corners and edges of the shingles are prone to curling or cupping as the mat shrinks. Crazing of the shingle surfaces also results from asphalt shrinkage. Eventually, chunks of granules flake away from the mat leaving the asphalt-coated mat exposed to the weather.

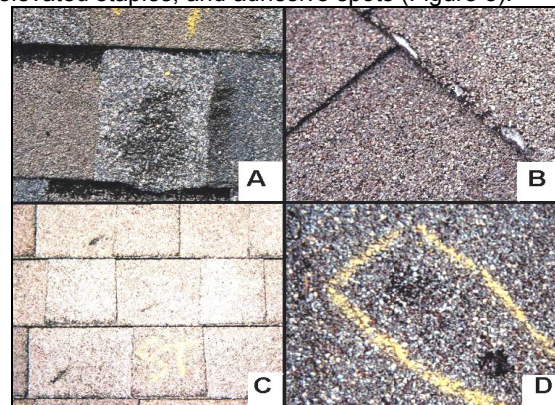
Figure 8. Shingle installation deficiencies: a) marring, b) edge scuffing, c) elevated fasteners, and d) adhesive spots.

Shingle marring occurs when people walk across the roof on a day when the shingles are hot, soft, and pliable. The asphalt in the shingle surface softens to the point where it is pushed aside along with the granules and typically forms a ridge on the outside edge of the mark. Persons walking on the roof can also remove granules along the bottom edges of the shingles.

Elevated fasteners can occur during the installation of the shingles and can protrude through or buckle the overlying shingles. The fasteners are either not driven flush to the shingle or are driven into joints between the roof decking. Elevated fasteners are not caused by hail striking the roof.

Adhesive can drip off the shingles onto the other shingles leaving a round, dark spot that can be mistaken by some as hail damage. If the adhesive from one shingle contacts another shingle and bonds to it, a portion of the shingle surface can be removed when the shingles are separated leaving a rounded area of missing granules that can also be mistaken by some as hail damage.

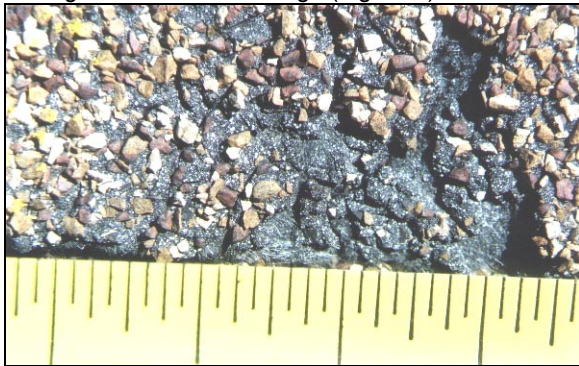
Shingles are particularly susceptible to hail damage if they have little or no underlying support, especially along ridges, rakes, eaves, and valleys. Shingle edges also are vulnerable to being chipped or broken. Therefore, the entire roof must be examined. Recently exposed asphalt appears black or unweathered, whereas asphalt exposed for several months oxidizes forming a surface film that is a grey color. This color difference is one way to tell new hail damage from old hail damage (Figure 9).

Figure 9. An example of 9-year-old hail damage to a glass-fiber mat asphalt shingle.

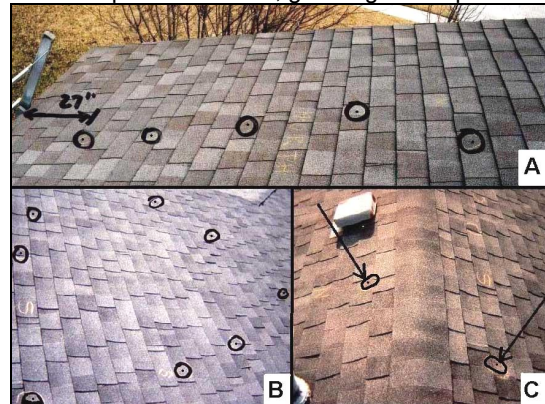
On occasion, some people have utilized various tools or other objects in an attempt to simulate hail damage on a roof. Popular items have included: 1) ball peen hammers, 2) claw hammers, 3) coins, and 4) screwdrivers. The authors have recognized a number of factors that distinguish intentional damage from hail damage. For example, intentional damage is not randomly distributed on the roof but usually occurs in groups or lines concentrated in upper portions of the roof, away from roof edges. Impact angles of the tool or object are nearly perpendicular to the affected roof slope, therefore indicating multiple impact directions (Figure 10). In contrast, hail would leave a random distribution of damage on the roof. The windward slope typically sustains the most concentrated and direct hail impacts whereas the leeward slopes have fewer, glancing hail impacts.

Figure 10. Intentional roof damage examples: a) line of impact marks, b) circular arrangement of impact marks, and c) impact marks perpendicular to each affected slope with no marks on the ridge.

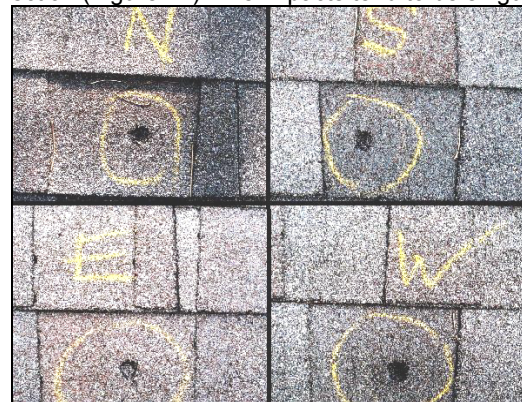
Intentional damage is concentrated frequently in the interior or center portions of the shingles, away from shingle edges, as it is human nature to hit the center of an object. Such centered impacts usually are found on each affected slope, regardless of slope direction (Figure 11). The impacts tend to be singular,

Figure 11. Attempts to simulate hail damage with a ball peen hammer.

occurring once per shingle. In contrast, hail does not prefer the centers of the shingles nor strike shingles once consistently.

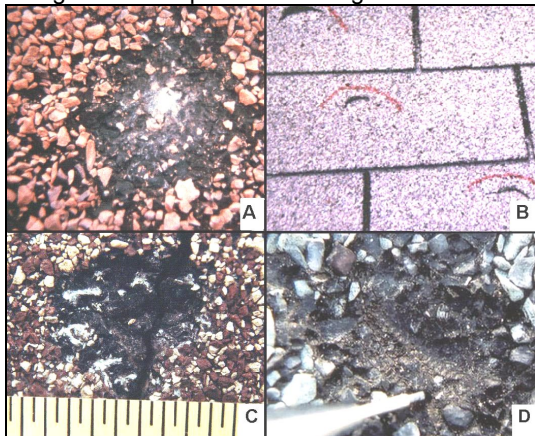
In our inspections of suspicious roof damage, we utilize a series of magnification rings to closely photograph the impact marks. Typically, shingles struck by metal objects will have broken or shattered the ceramic coating on the granules. This will leave a "powder" residue containing shattered ceramic material within the impact mark. Any side-to-side or "rounding out" motions will tend to leave swirl marks within the powder residue and/or leave smudges in the exposed asphalt surface (Figure 12).

When claw hammers are utilized, the metal peen frequently does not strike the roof slopes exactly perpendicular but tends to tilt forward slightly leaving a characteristic curving fracture in the shingles that opens towards the direction of impact. The concave fracture in the shingle resembles a "frowny" face when looking upslope. Granules closest to the concave side of the fracture are frequently compressed uniformly into the shingle mat.

Sometimes coins are utilized to leave small divots in the shingle surface. Quarter coins have small ridges around their perimeters that can leave a series of ridges in the asphalt under magnification.

Figure 12. Close-up views of mechanically caused impacts to shingles using: a) a ball-peen hammer, b) claw hammer, c) screwdriver, and d) quarter coin.

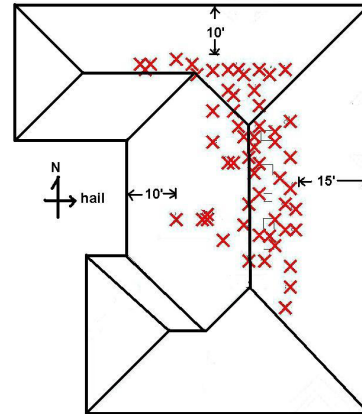
After a general examination of the building surroundings is performed, a roof plan diagram is drawn and shingle marks are plotted. Any pattern or grouping of shingle marks quickly becomes apparent in the diagram (Figure 13). The diagram will indicate those roof slopes or ridges that are notably without shingle marks as well as any grouping of marks. Usually, large areas of the affected roof slopes are without shingle marks as are other, perhaps smaller, roof slopes that face the same direction. Shingle marks closest to the roof edge are measured.

Figure 13. Roof plan diagram showing the distribution of mechanically-caused impact marks in an alleged hail damage claim.
