Robustness of large-span timber roof structures – Two examples

Jørgen Munch-Andersen^a, Philipp Dietsch^{b,*}

This paper discusses the robustness of large-span timber roof structures, based on findings from failures of two roof structures. One is the Siemens arena in Ballerup, Denmark and the other the Bad Reichenhall ice-arena in Germany. The structures are described as well as the flaws that are believed to have caused the failures. The two cases serve as examples of different design strategies for large-span timber roof structures and the consequences of such strategies for robustness. It is demonstrated that robustness is not a straightforward concept because the best strategy depends on the cause of the failure – which is obviously not known during planning and design.

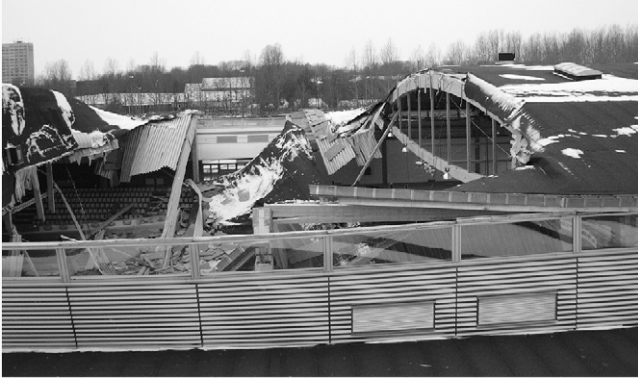
Two of the trusses collapsed without warning at a time with almost no wind and only a few millimetres of snow. The partial collapse happened just a few months after the inauguration of the arena. No people were present in the arena during the collapse.

Fig. 1. The Siemens arena roof structure after the collapse of two trusses. An intact truss can be seen on the right.

During design, it was decided that the 12 m long purlins between the trusses should only be moderately fastened to the trusses, such that a failure of one truss should not initiate progressive collapse. Each truss then becomes a key element. This strategy proved to work fairly well as “only” 2 of the 12 trusses collapsed. Considering that all trusses had a much lower strength than required it might be fair to conclude that the extent of the collapse was *not* disproportionate to the cause.

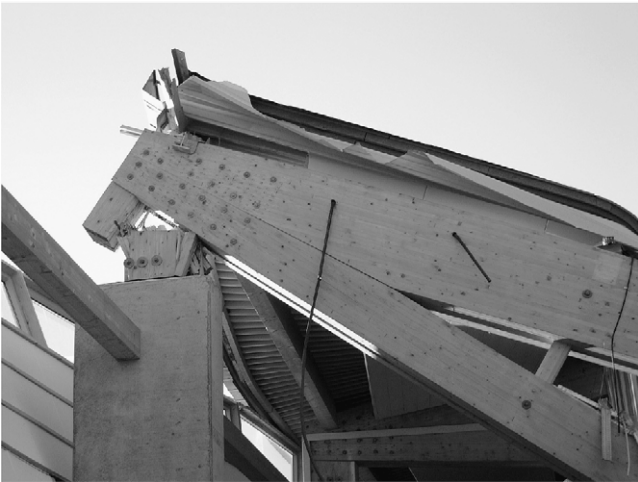
- The design strength used for the timber part was almost 50% too high.
- The reduced height of the cross-section near the ends of the arches, see Fig. 2, was not considered.
- The reduction of the timber cross-section due to steel plates, bolts and dowels, see Fig. 3, was not considered.

Fig. 2. Corner connection with concealed steel plates, connecting the timber parts through bolts (visible) and dowels (not visible).

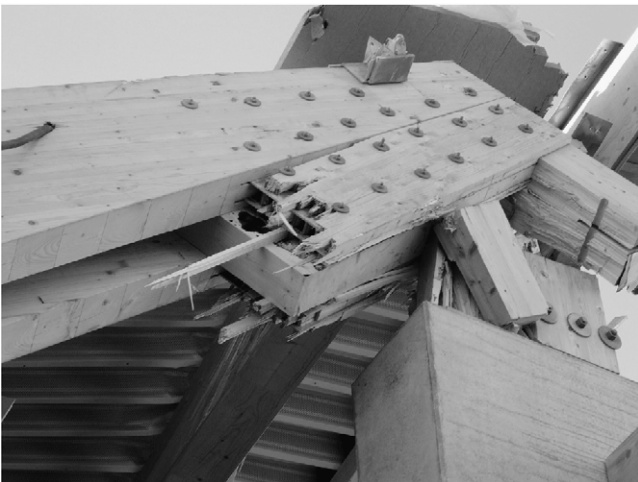
An investigation, see [1], showed that the cause of the failure could be localised to one critical cross-section in the tension arch near the support, where the load bearing capacity was found to be between 25% and 30% of the required capacity, see Fig. 3. By mistake, this cross-section was not considered at all in the design. Three critical design errors were identified:

The expected short term load-carrying capacity at the critical cross-section happened to be only slightly larger than the loads from the self-weight of the structure. Because the strength of timber is reduced over time when it is loaded (the k_{mod} -effect), it is likely that the collapse took place when the strength was reduced to the stresses caused by the self-weight. According to Eurocode 5 [2] and confirmed by Hoffmeyer and Sørensen [3], the reduction factor for medium duration loads (1 week to 6 months) is $k_{mod} = 0.8$. Such a reduction is enough to explain how the collapse could take place at a time with no special external load.

Fig. 3. Rupture at the critical cross-section in the corner connection. Note the dowels and steel plates.

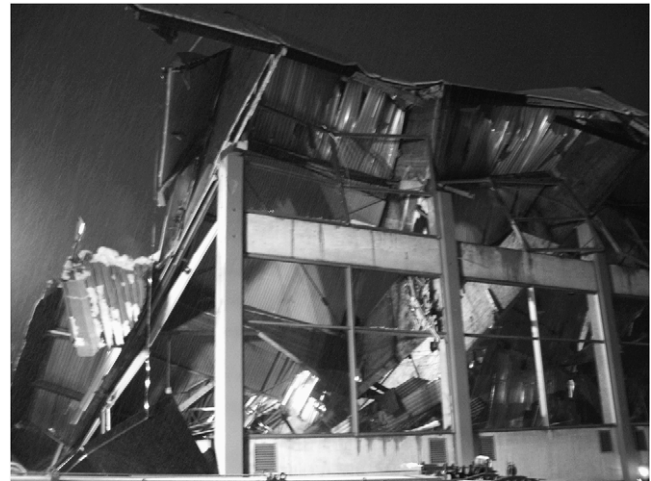
Fig. 5. Partial view of the collapsed roof structure.

On January 2nd 2006, the entire roof collapsed – without warning – during a period of significant snowfall, see Fig. 5. However, the snow load was not above the characteristic snow load used in the design.

The investigation showed that the first failure occurred in one of the three main girders on the east side. Due to the stiff cross-bracing, the loads were shifted from the girder that failed to the neighbouring girders. Because these girders suffered from the same mistakes and degradation processes as the first failing girder, they could not sustain the additional load. Consequently, this developed into a progressive collapse which took place within seconds.

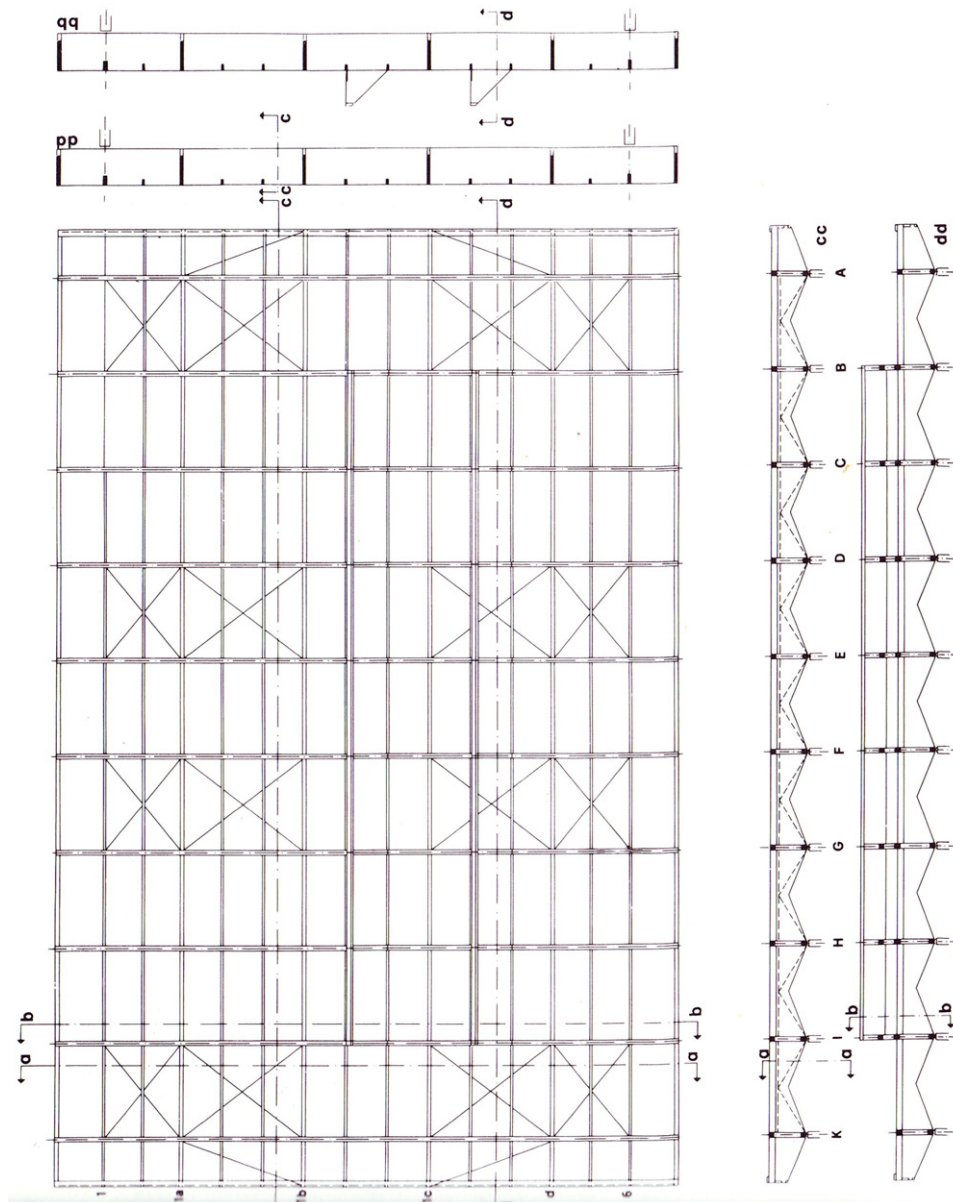
The secondary system was fixed to the sides of the girders and acted both as purlins and as lateral bracing (*K*-bracing) for the main box-girders, see Fig. 6. This enabled the roof structure to redistribute loads between the girders.

Fig. 6. Layout of the roof of the ice-arena and side view of the girders (from [5]).

The ability to redistribute loads, often called redundancy, is generally regarded as favourable for the robustness of a structure because a random local failure will not cause total collapse. This also means that the box-girders are not key elements in the usual meaning of the term. But since the secondary structure was not only strong but also very stiff, a weak girder would transfer its loads to the adjacent girders without any warning from large deformations. This means that e.g. some general finger joints could have lost their strength long ago.

- A strong but softer secondary system could give warning about redistribution of load taking place due to increasing deformations. Since the secondary structure also had to fulfil the purpose of bracing against lateral-torsional buckling of the main girders, it needed to be stiff. If both requirements should have been fulfilled, a different bracing system would have been needed.
- A statically determinate secondary system with connections, which would allow for one girder to collapse, without increasing the load on the adjacent girders.

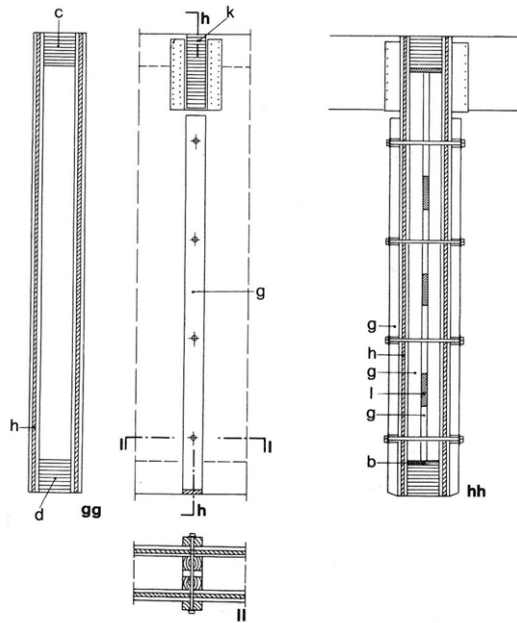
The review of the structural calculations revealed two important errors. For the assessment of the load-bearing capacity of the box-girder, the bending strength of the glulam was applied, rather than the tensile and compressive strength of the lower and upper girders. In addition, the weakening of the cross-sections due to the general finger joints between the girder parts as well as the web-boards was not taken into account in the structural calculations. Comparative calculations, based on the technical rules

Fig. 7. Cross-section of the box-girders in the ice-arena (from [5]).

the general finger joints in the lower girder and the bonding between the girders and the web-boards. It was found that in some cases, there was no adhesive effect to a depth of 50–80 mm in the lower girders. In combination with the errors in the structural calculations, this represents the most significant cause for the collapse of the Bad Reichenhall ice-arena.
