REDUCING THE FIRE HAZARD

IN ALUMINUM-WIRED HOMES

Jesse Aronstein, PH.D., P.E.

Latest update: November 25, 2011

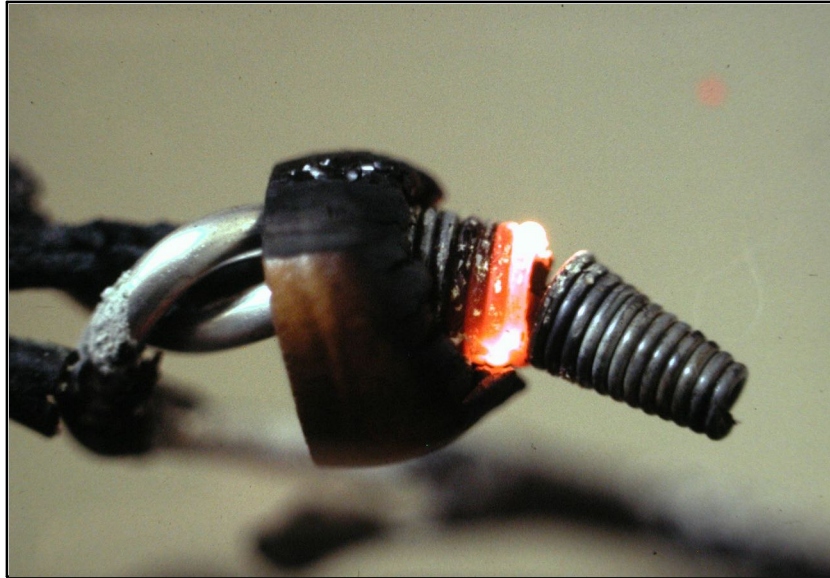
FIGURE 1 - ALUMINUM WIRE SPLICES MADE WITH TWIST-ON CONNECTORS CAN BE DANGEROUS. The use of most types of twist-on connectors with aluminum wire can lead to hazardous results. This twist-on pigtail connection (two #10 aluminum wires with one #12 copper wire, in a 20-amp circuit), made with a twist-on connector that was UL listed for use with aluminum wire at the time, remains electrically functional in the circuit, but it becomes extremely hot whenever a significant amount of current flows. The heat has deteriorated the insulation on both the connector and the wires. In this photo, a portion of the connector's spring is red hot, at current well below the circuit rating.

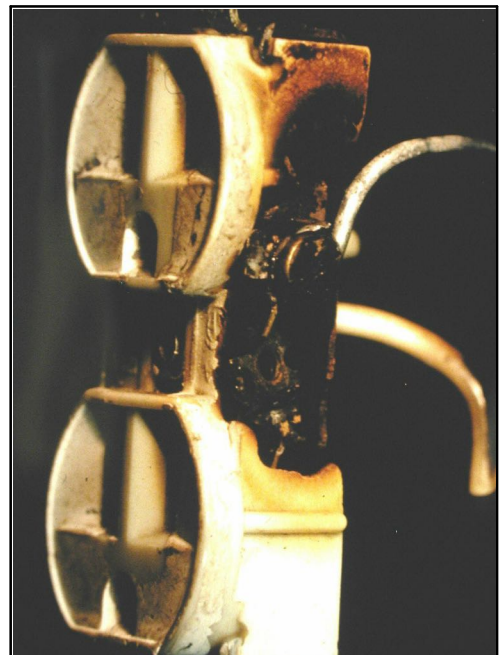
FIGURE 2 - EXAMPLE: OVERHEATING OF ALUMINUM-WIRED TERMINALS ON A RECEPTACLE. Enough heat was generated by current flowing through the aluminum wire connections to cause charring of the receptacle body and disintegration of the insulation that was on the wire. Note that the face of the receptacle, as the homeowner or an inspector would have seen it, with the cover plate on, would look normal.

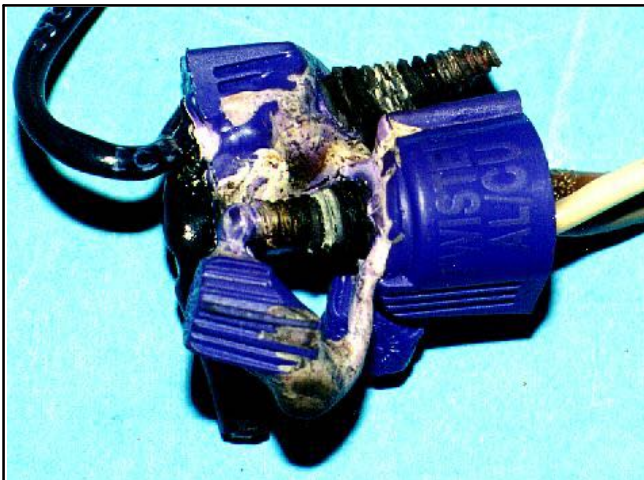
FIGURE 5 - FIELD FAILURES OF ALUMINUM TO COPPER SPLICES MADE WITH IDEAL #65 CONNECTORS [12]

A. These two failed splices are adhered together by the melted plastic insulating shells.

3. IDEAL #65: came on the market in the mid 1990's. Within three years of its introduction, the first report of field failure surfaced. [12] There have been additional failures reported since then.

Additionally, field burnouts have now been reported with the Ideal #65 connectors in their rated applications. With CPSC skeptical (and requesting that UL withdraw its listing), the manufacturer initially agreeing that the connector is not for the pigtail retrofit application, independent tests clearly demonstrating poor performance, and field failures reported, the use of the Ideal #65 "Twister" connector for the pigtail application is definitely not recommended. If the COPALUM repair is not available, use the AlumiConn connector (See Section 1C).

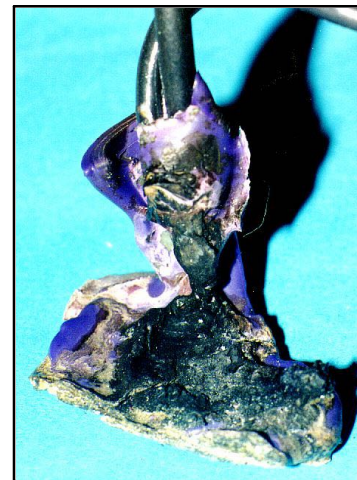
B. Severe failure, plastic shell melted and charred. The charring indicates that it had probably ignited.
