**U.S. CONSUMER PRODUCT SAFETY COMMISSION
DIRECTORATE FOR ENGINEERING SCIENCES**

**EVALUATION OF
ELECTRIC LIGHTING PRODUCTS**

December 2007

Anna Luo
Electrical Engineer
Division of Electrical Engineering
Directorate for Engineering Sciences

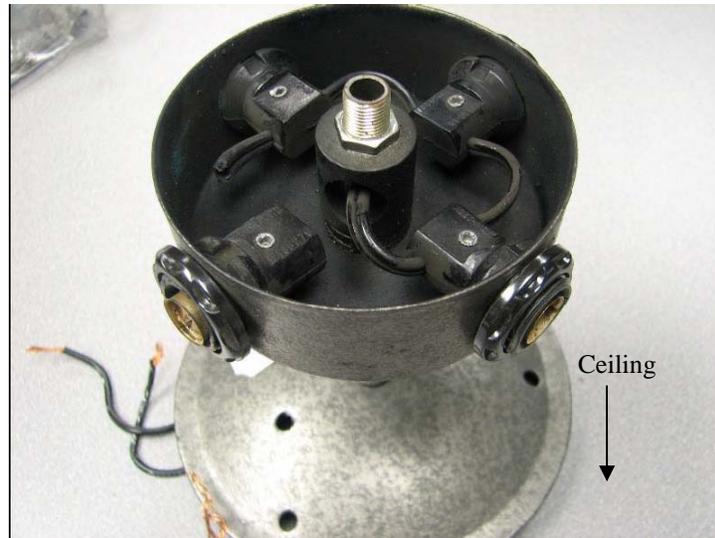
Figure 5. Lampholders in Incident Sample

The incident sample had one burned-out 25W bulb and two severely damaged 60W bulbs. The only remnants of the two 60W bulbs were two brass-colored screw shells that still remained in the two light sockets. The lighting fixture was rated for four 60W bulbs; the four lampholders were UL Recognized Components rated at 75W. The glass lens/cover and manufacturer's labels were missing. Figure 5 shows a view of the fixture base that encloses the wiring. Soot deposits were found on all surfaces inside the fixture base.

Examination of the incident lighting fixture showed thermal damage from overheated electrical connections within the lighting fixture base. There was evidence of a localized flame in one lampholder or socket (No. 4). The likely causes of the incident may have been from insufficient cooling from the radiant heat generated by the four light bulbs (total 240W), a poor wire-piercing connection, a short within the lampholder, or a combination of these.

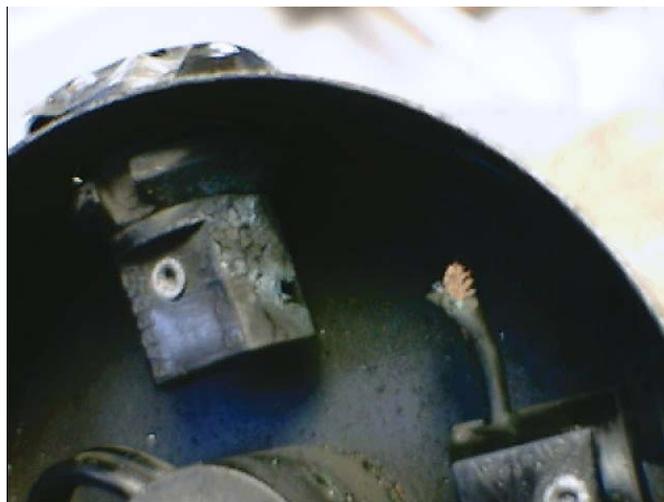
Figure 6. Damaged Fourth Socket of Incident Sample

The fourth socket was damaged from overheating; it appeared that a portion of the wiring to that socket was consumed in a local fire, as shown in Figure 6.

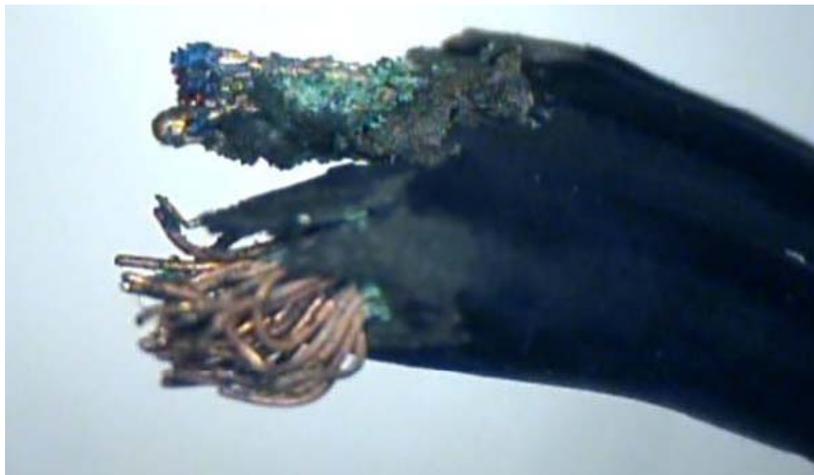
Figure 7. Close-up of Wiring to the Fourth Socket

A close-up view of the wiring leading to the fourth socket showed a ball of re-solidified copper on the “hot” conductor (a small amount of insulation was trimmed away for examination), as shown in Figure 7. In addition, the condition of the exposed wiring inside the fixture base showed signs of thermal damage. The wiring to the damaged fourth socket was brittle; the exposed wiring that connected the other three sockets was quite stiff and not pliable. However, the rest of the wiring, including the portion that was inside a rod leading to the ceiling disk, retained its pliability and did not show any signs of thermal damage.

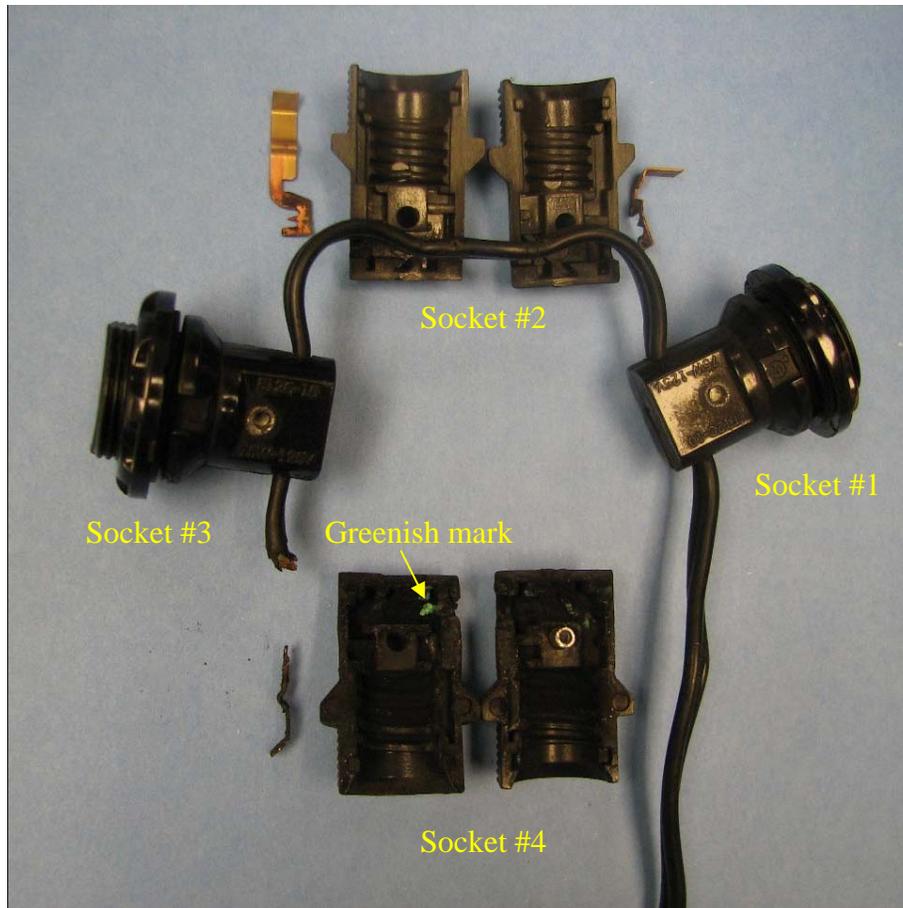
Figure 8. Four Sockets Removed from Fixture with Socket Nos. 2 and 4 Disassembled

Figure 8 shows the interior conditions of sockets No. 2 and No. 4. As shown, both insulation-piercing terminals of socket No. 2 were still intact and undamaged. Socket No. 4 had only part of its vertical insulation-piercing terminal (neutral contact); the lower portion that had a sharp triangular tip for piercing the insulation was missing and perhaps consumed by the localized overheating. The horizontal insulation-piercing terminal (hot contact) was completely consumed and only a greenish mark was left where the electrical wire entered the socket. The remains of this socket were charred and brittle.

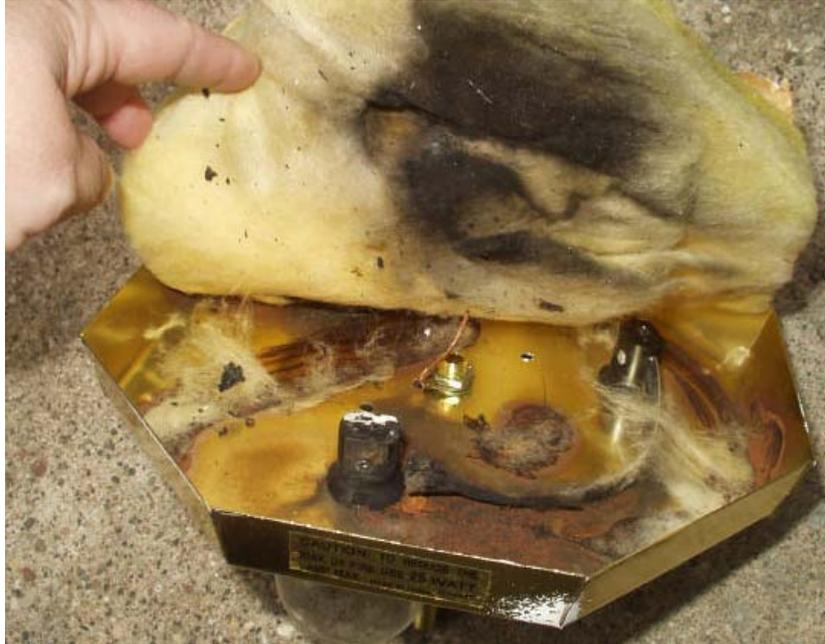
Figure 9. Incident Sample “Old Design”

Figure 9 shows the thermal damage on the incident “old design” sample. Soot deposits were seen on the fiberglass insulation. The parallel-conductor power supply cord, which had a temperature rating of 125°C, was separated from the last socket. Copper balls were observed on each conductor at the last socket terminal; the socket was brittle. The thermal damage appeared to be the result of localized arcing.

It appears that overlamping of the incident sample may have contributed to the failure. The bulbs installed in the lampholders were 25W, 40W, and 60W; the bulbs should have been 25W maximum. The markings on the lampholders were not consistent with the markings on the socket or the fixture, which could be misinterpreted by a user.

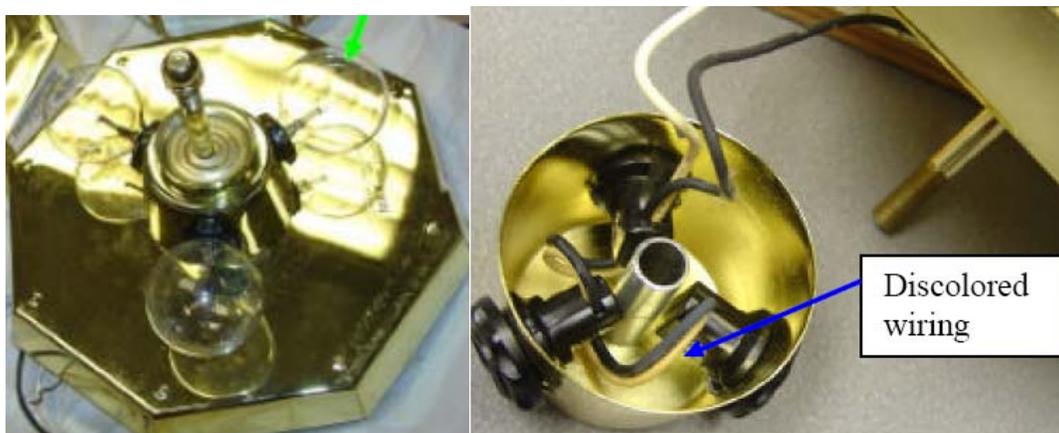
Figure 10. The Exemplar “New Design”

The new design fixture had three sockets mounted horizontally into an extension at the center of the fixture, as shown in Figure 10. The wiring in this fixture had a temperature rating of 150°C. This fixture contained two burned-out 60W bulbs (broken filaments and/or detached glass bulb) and one operational 25W bulb. The sockets of the fixture appeared normal, but the white insulation of the wiring was discolored.

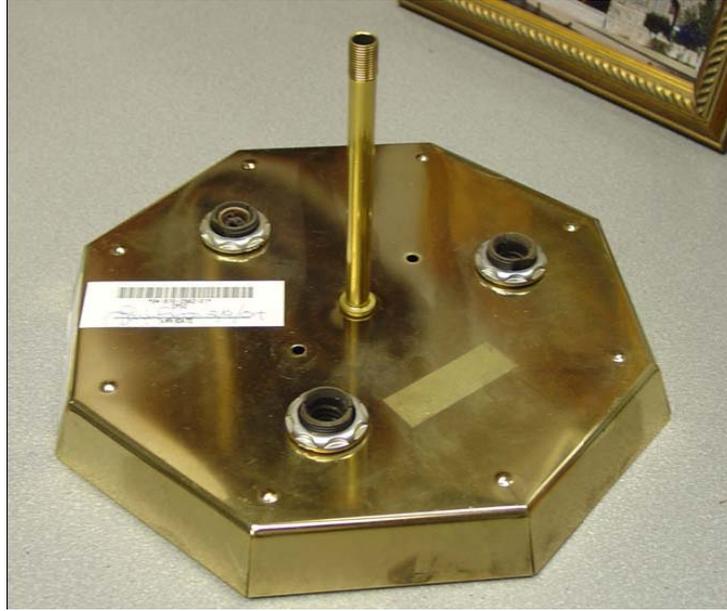
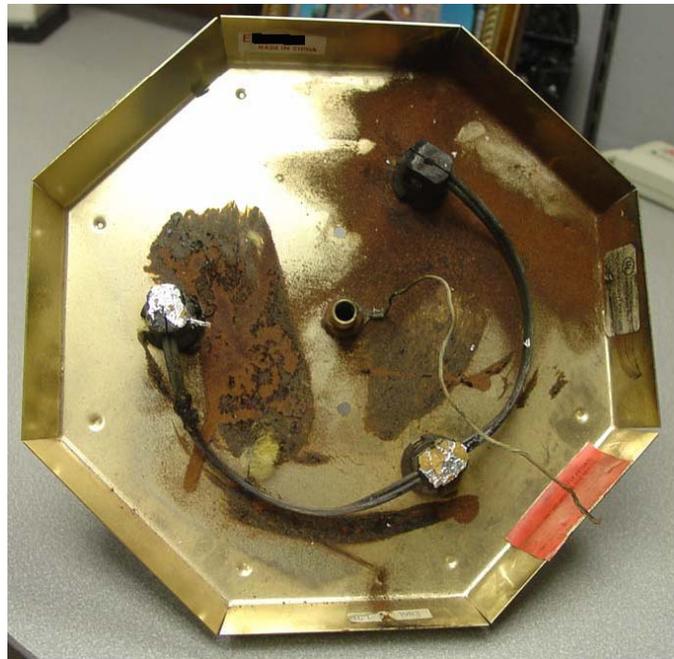
Figures 11 and 12 show the lighting fixture as received. The glass cover was not included in the sample. One socket contained the base of a bulb. The housing/plate was slightly rusty in two areas but was otherwise intact. On the exposed surface of the plate, there was a warning label to use only 25-watt bulbs or lower; the label was faded and nearly illegible. The bare ground conductor was firmly attached to the plate on the top (ceiling side) of the fixture.

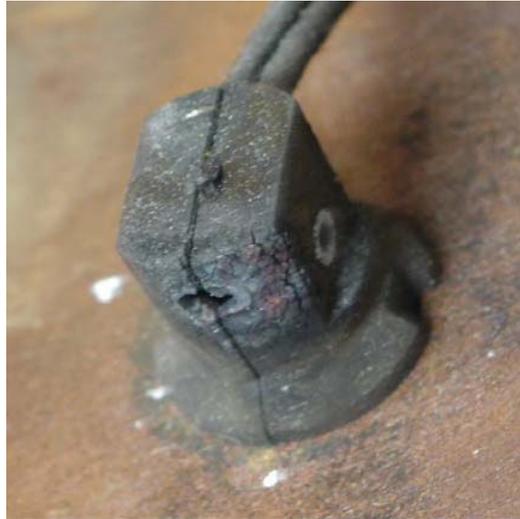
Figure 13. Overheated Socket

The plastic sockets were overheated and cracked. The interior of one socket (physically, the first one attached to the electrical wiring as it entered the fixture from the house wiring) was blackened and sooty inside. When this socket was split open, it was found that one of the insulation-piercing terminals had burned away. The other terminal was burned and corroded.

Most likely, the initial assembly of the socket/insulation piercing terminals to the wiring resulted in a poor electrical connection. Over a period of use, the poor connection resulted in overheating of the connection and socket. The three bulbs likely exacerbated the problem by providing additional heat, which would be trapped between the metal disk

and the fiberglass. The wiring insulation degraded, and the copper conductors became corroded and embrittled.

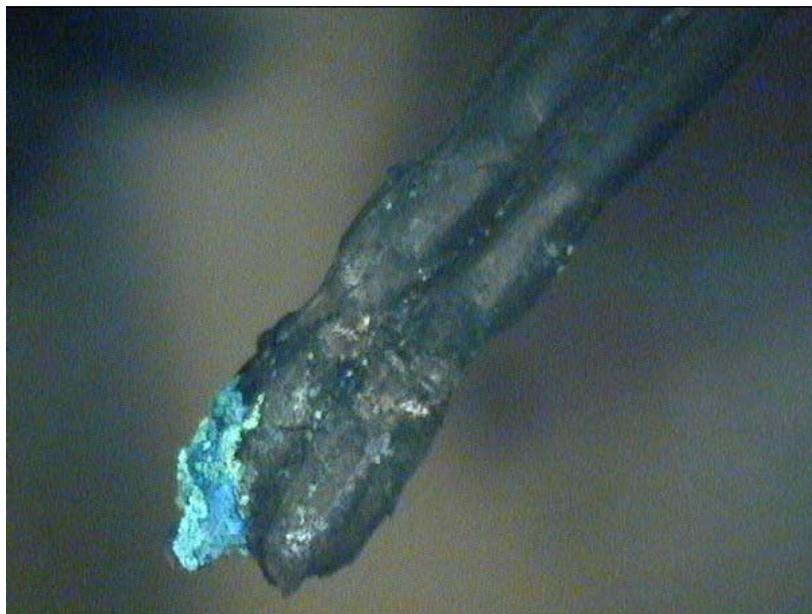
Figure 14. Electrical Wiring in Socket

The foil insulation (the side that is positioned against the plate) was covered with soot in the area next to the socket. Inside the burnt socket, the input power wiring was burned and melted and had green/blue corrosion on the copper wire strands. Figure 13 shows a close-up picture of the socket. Figure 14 shows a picture of the wiring after its removal from the socket. The wires showed no sign of arcing or beading.
