U.S. CONSUMER PRODUCT SAFETY COMMISSION
WASHINGTON, D.C. 20207

Re: FOIA Request S-712020: Information concerning Lennox Pulse Furnaces

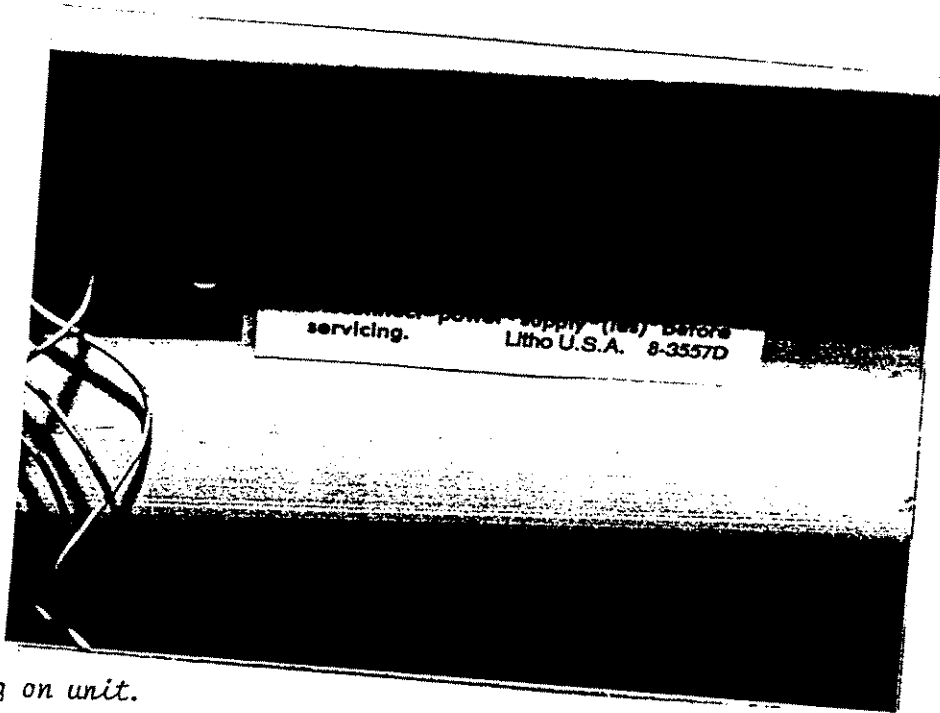
17. Warning on unit.

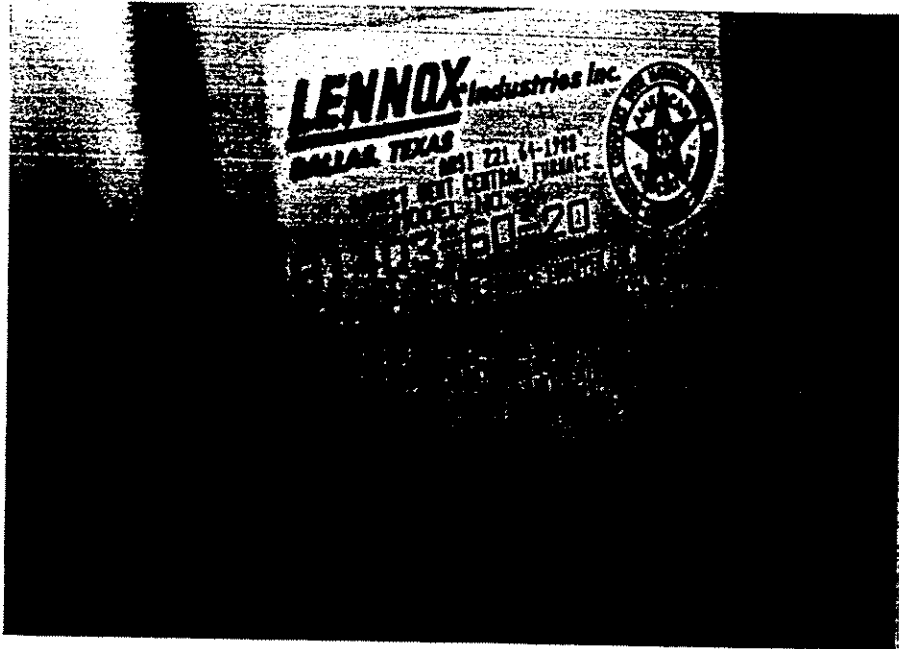
20 & 21 AGA Certification on furnace.
