# Oregon Caves

## Historic Structures Report

#### Interior Assessment and Recommendations

##### Fiberboard Wall and Ceiling Finishes

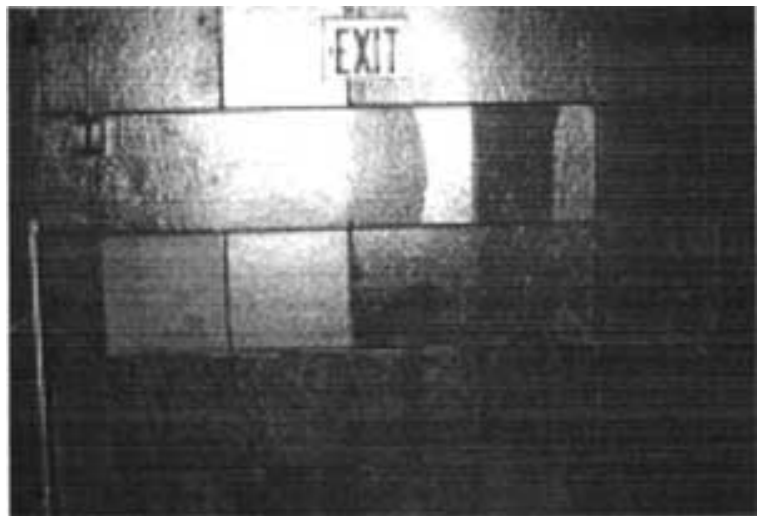
Typical interior hallway. Note the mismatched replacements.

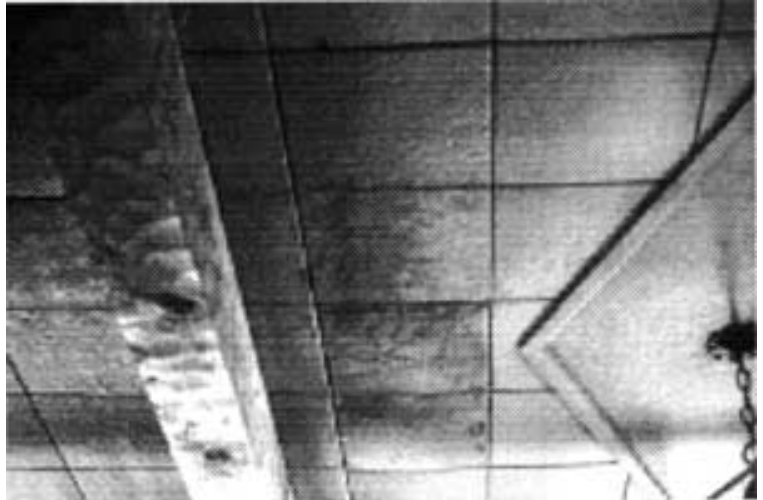
Water damage at the lobby ceiling.

The panels also show signs of water damage, especially in areas under bathrooms on the floors above. When a leak develops, often the only way the concessionaire becomes aware is from water damage to the Nu-Wood panels. This damage is permanent and irreversible, unless the panel is painted over once it has dried. The areas under the window sills, particularly on the 6th floor on the west side of the building also show signs of water damage. A recent article in the APT Bulletin (Vol. 28 #2-3) notes that "the best conservation technique is careful maintenance...finishes must be maintained, and problems must be addressed immediately. Once the boards are warped or deeply stained, the likelihood of successful repair seems remote." (Page 67)

- The use of paint to hide water damage has been employed in some areas of the building. Unattractive portions of the building may be painted to hide this staining. Natural divisions should be maintained between painted and unpainted wall surfaces. For example, where the walls have already been painted, one entire wall plane is painted up to a corner or projecting element. This strategy has been employed in the dining room and many of the guest rooms. This strategy would conserve the historic fabric, but not the historic appearance (which has been significantly altered by the application of the glaze). A matte finish paint should be used if the fiberboard surfaces are painted, in keeping with the historic character of the fiberboard.

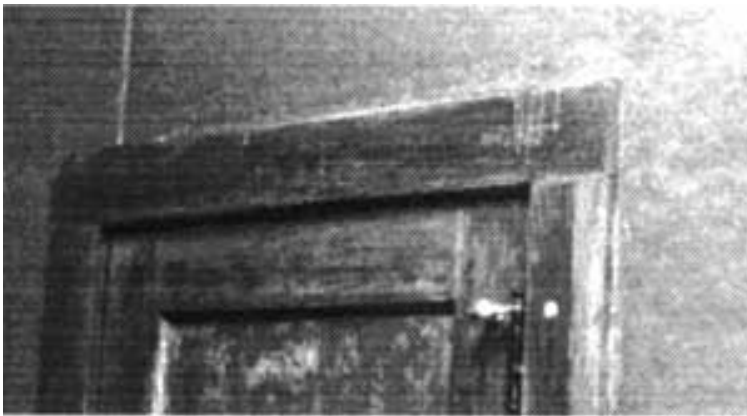
Glaze slopped onto door trim.

applied exactly is uncertain, but it was applied with either a brush or roller. Careless application has resulted in the glaze slopping over onto interior trim, especially at the heads of doors and windows.

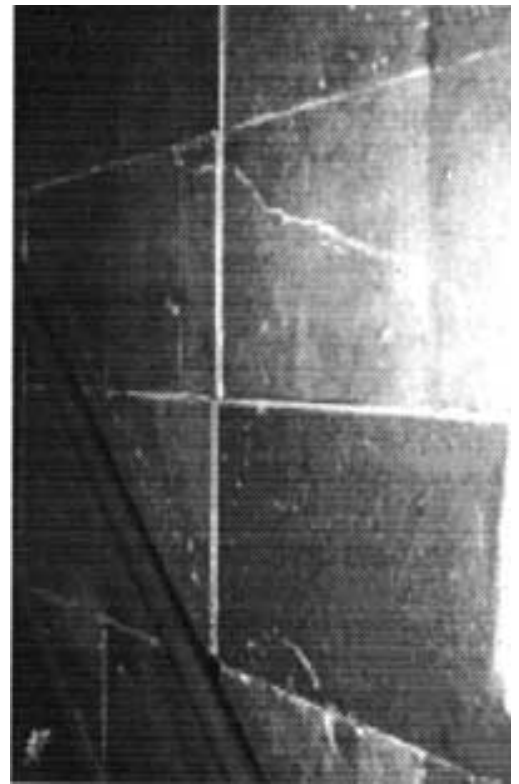
In addition to the problems with the fire retardant glaze, the fiberboard panels have suffered impact and abrasion damage. In the guest rooms, the impact damage can often be attributed to door knobs, as many of the stops are missing. In hallways and utility or linen closets, the damage is typically caused by housekeeping carts, rollaway beds, and other typical hotel equipment. Some of these areas have been patched with a replacement piece of Nu-Wood, either surrounded by small pieces of wood trim or left with the joints exposed. Many others, especially impact damage from door knobs, have been patched with wood putty. To make repairs in the public areas of the building, the concessionaire has removed panels from areas only open to employees, such as the office behind the front desk. The walk in freezer in the kitchen was placed in an opening historically used as an access to the coffee shop, and panels from the ceiling above the freezer have all been taken and placed in locations throughout the building to repair damage.

Abrasion damage at the stair.

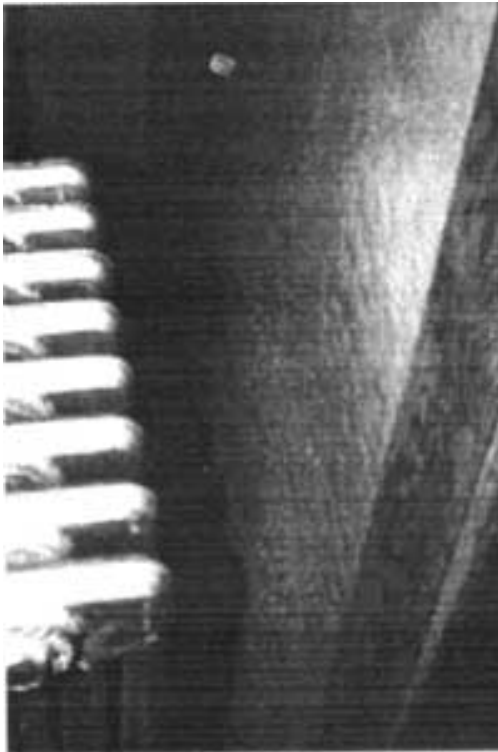
The thickness of the glaze and method of application has resulted in an uneven and bumpy appearance in many parts of the building. This is especially apparent in the guest rooms, which have only one central light fixture. The thick glaze has also developed a network of cracks in certain areas, similar to the crazing found in terra cotta glazes. Behind the radiators and above the electric baseboard heaters, the glaze has clouded over, most likely due to excessive heat.

Glaze damage behind radiator.

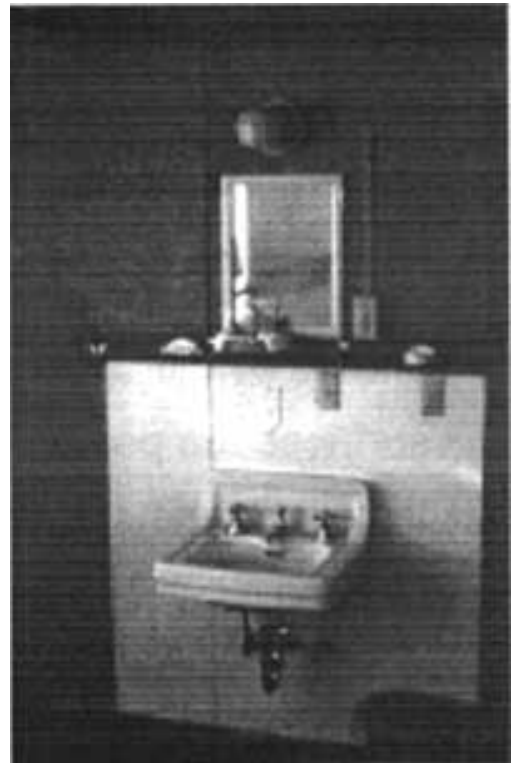
A few areas of the fiberboard have been painted to cover earlier damage with a color closely resembling the color of the glaze coating. Many of the sink surrounds, especially on the sixth floor, that still employ Nu-Wood have been painted white to avoid water damage. Room 214 is also painted entirely white due to a concession manager's cats that wreaked havoc on the historic wall surfaces.

Painted sink surround, 6th floor.
