Tests of Materials and
Systems for Flood
Proofing Structures

August 1988

Prepared by
Structures Laboratory
US Army Engineer Waterways Experiment Station
for
Corps of Engineers
National Flood Proofing Committee

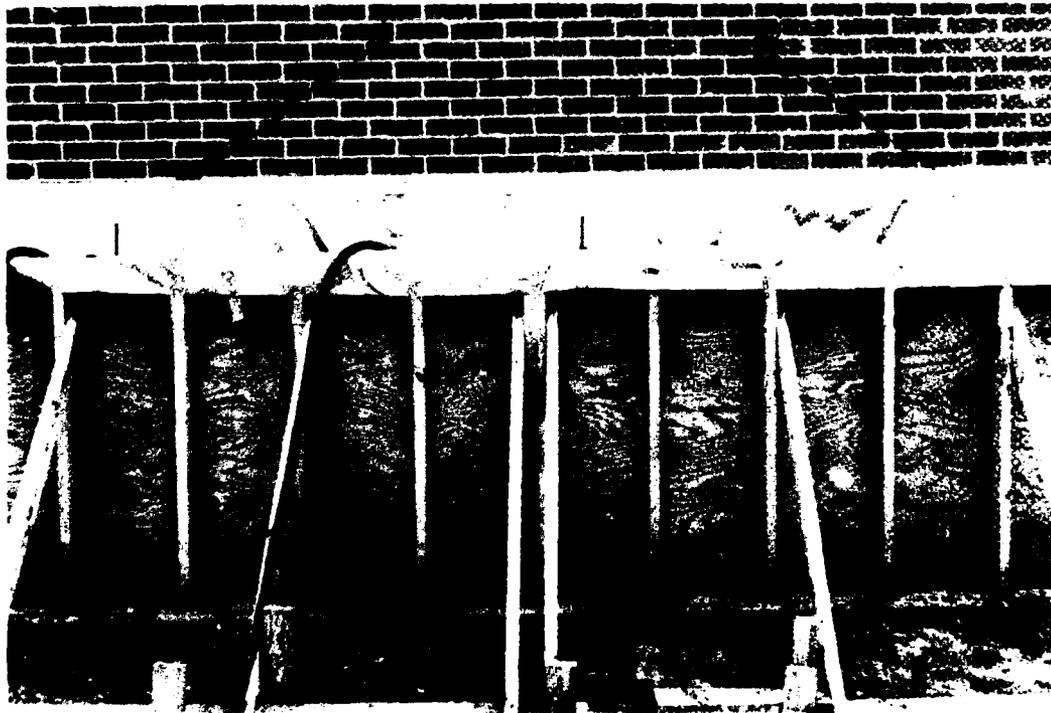
A severe loss of integrity began at 2 ft of water with complete loss occurring at 2.4 ft (Figure 8). The failure at 2.4 ft of water is presented in Figures 10 and 11.

Figure 10. Wall 1. Failure pattern of wall

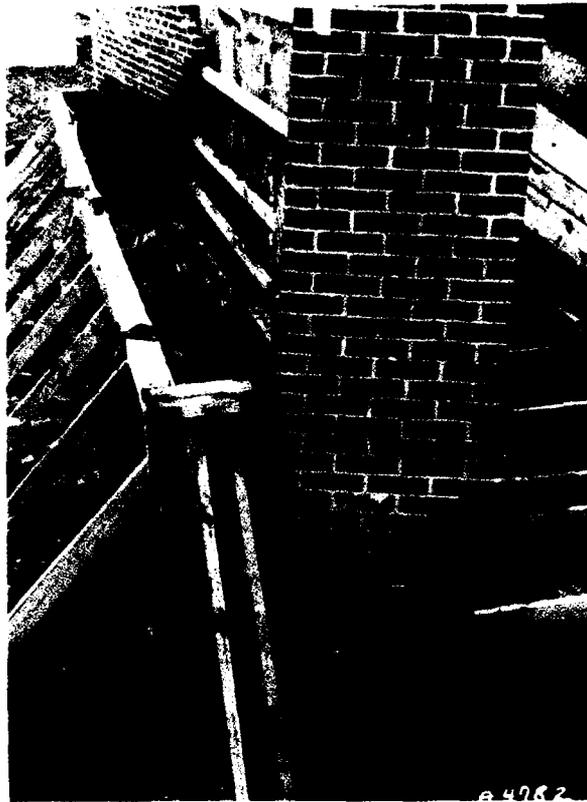
Figure 11. Wall 1. Wall failure

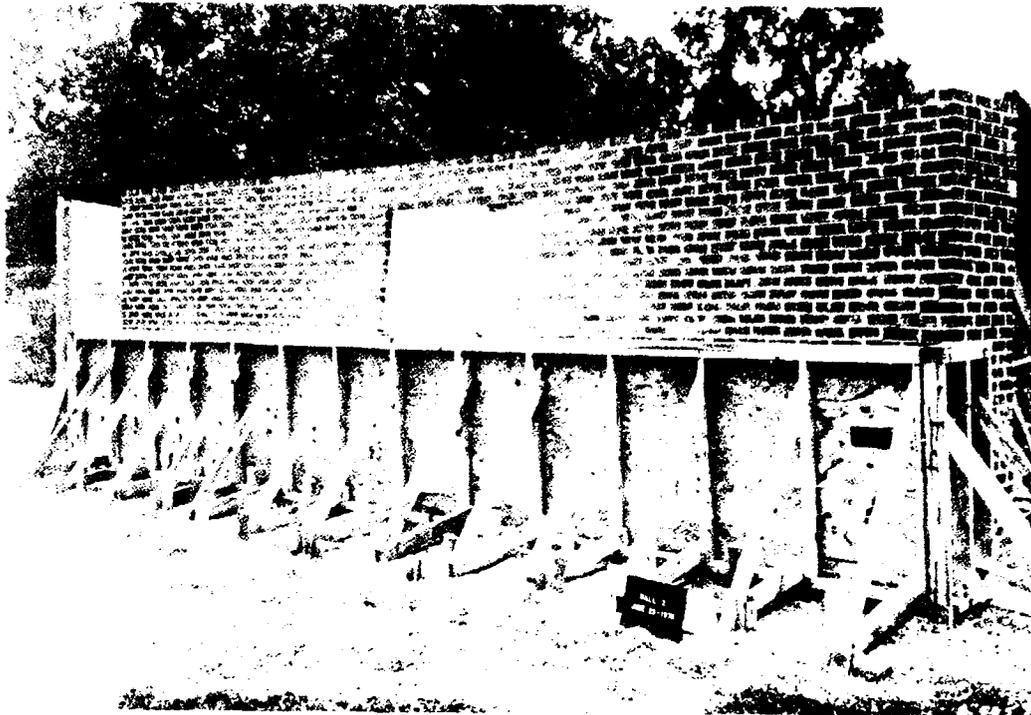
The wall deflected forward for low water loads because cord lengthening in the vicinity of the loading caused the upper part of the wall to cup forward. In an actual home, the finishing materials on the inside of the studs will give support to the wall and allow it to experience a deeper water loading than indicated by these tests. Computer solutions could be used to determine the effect of such restraints. The significant point is that the deflections recorded for Wall 2 at a given water depth should be an upper bound of deflections experienced in an actual brick-veneer house under the same loading. The failure of Wall 2 is shown in Figures 13 and 14.

Figure 13. Wall 2. Wall failure, front view

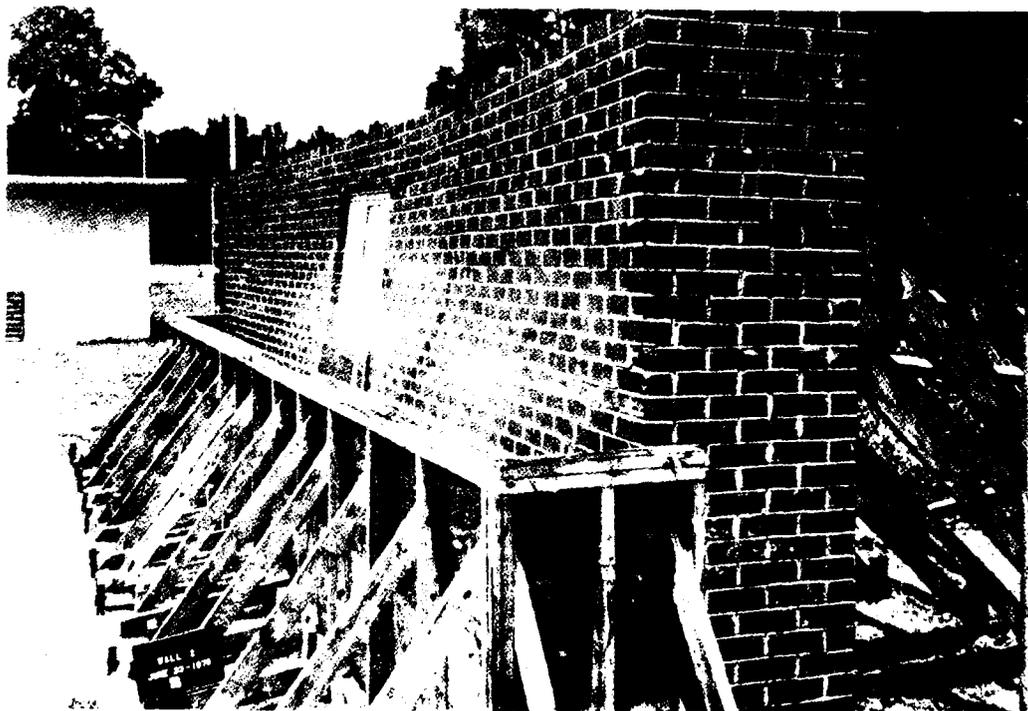
Figure 14. Wall 2. Wall failure, side view

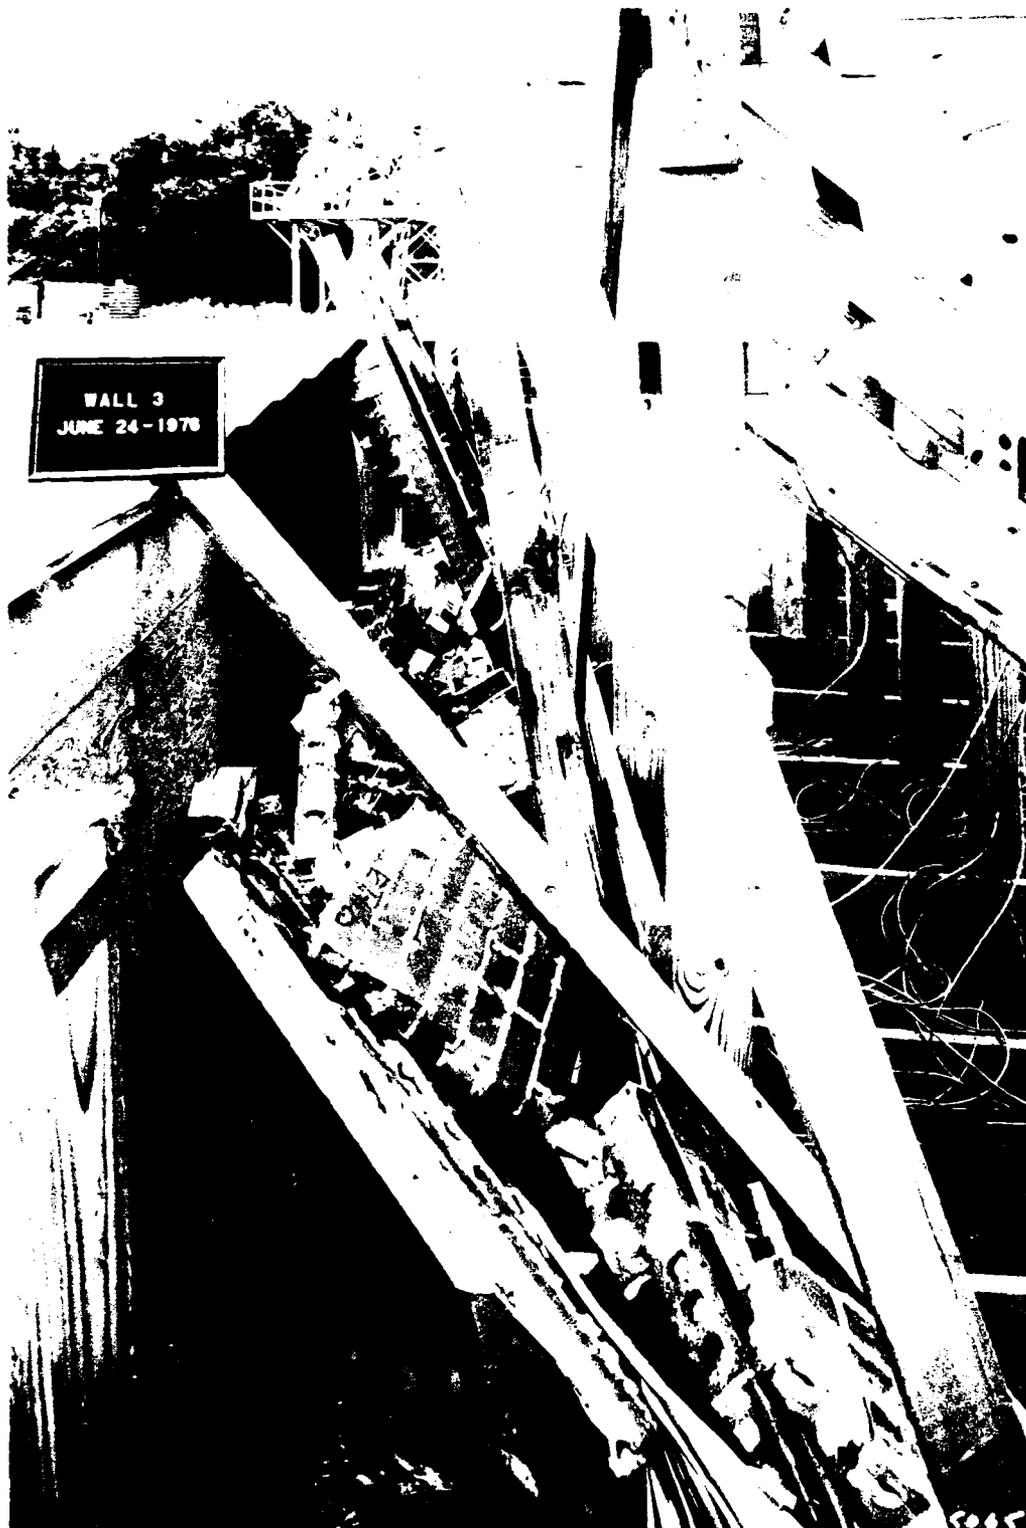
Total collapse of the brick-veneer wall occurred at a depth of 57 in. and at a total applied force of 18,300 lb. This failure was sudden and resulted from the failure of the supporting studs. The remains of the brick-veneer wall after failure are presented in Figures 16 and 17.

Figure 17. Wall 3. Wall failure, side view

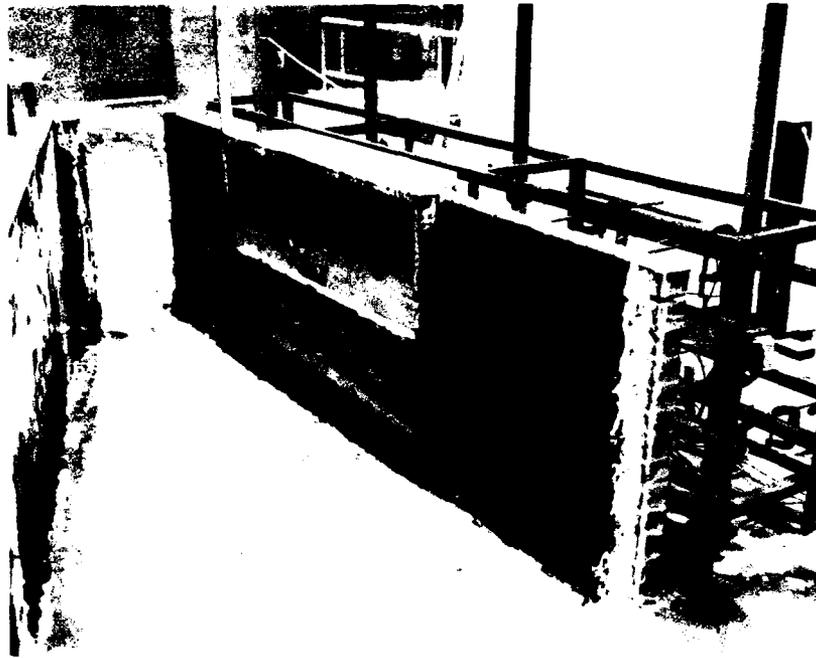
3	Same as Tests 1 and 2.	Coated with asphalt cement. Figure 37 shows the wall after the test.	The wall continued to leak in a couple of places. After the bulkhead was removed, no flaws could be observed in the asphalt cement coating in areas where the wall leaked. This implies that great care must be exercised, even if asphalt cement is put on the wall, or water will penetrate the house. The wall leaked so badly that the closure was not tested for water.

Figure 37. Brick walls coated with asphalt cement

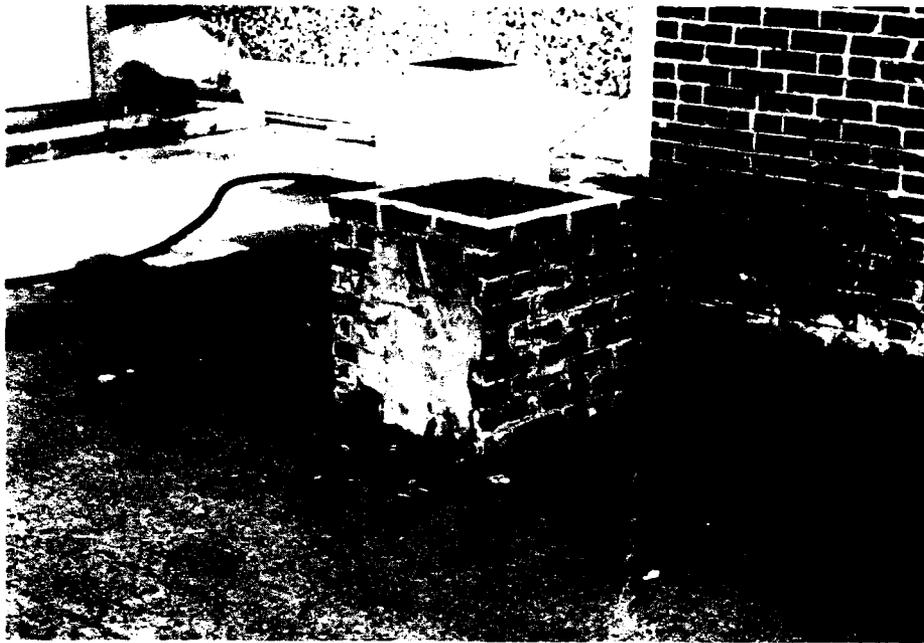
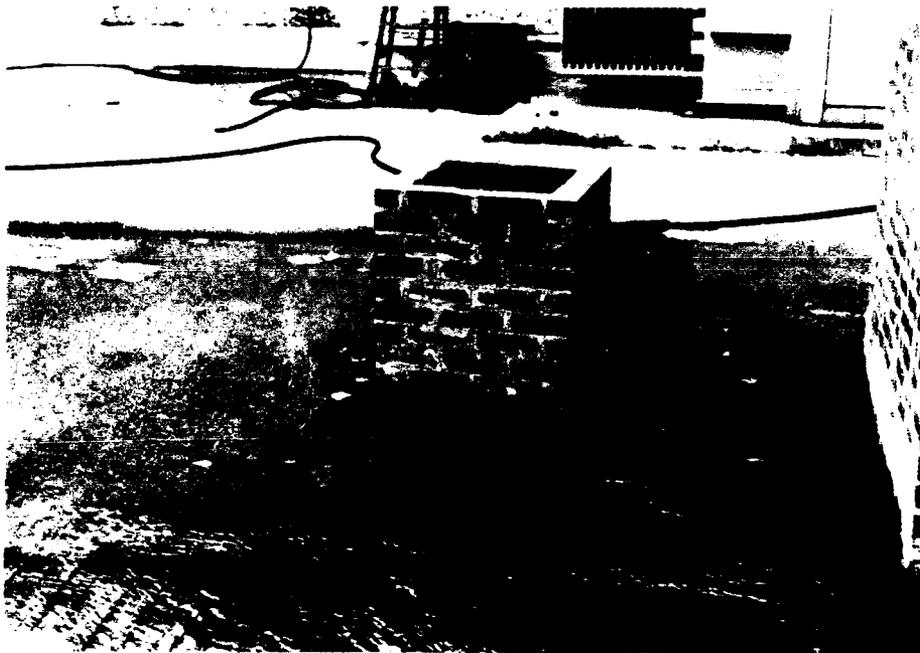
Figure 46. Failure of coating 4

a. Front view

b. Side view

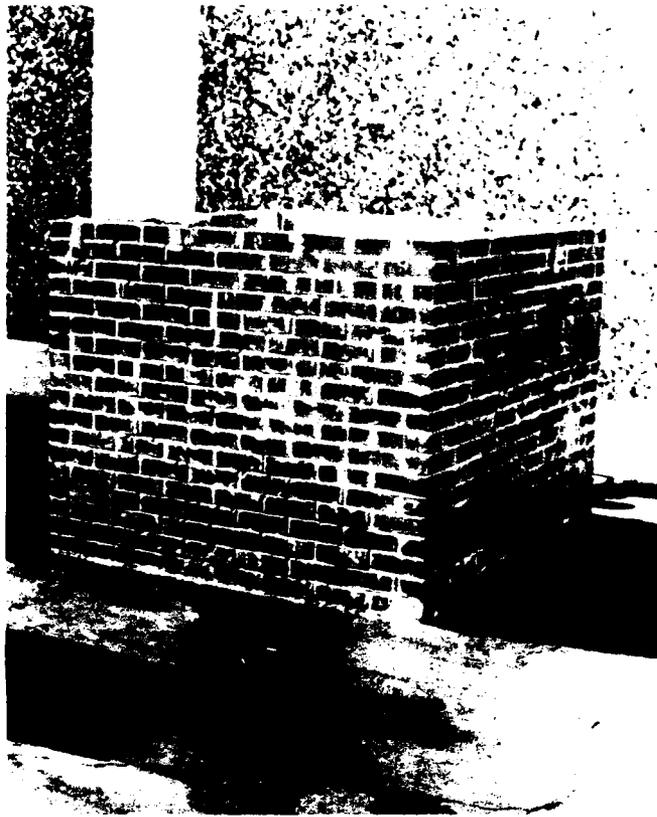
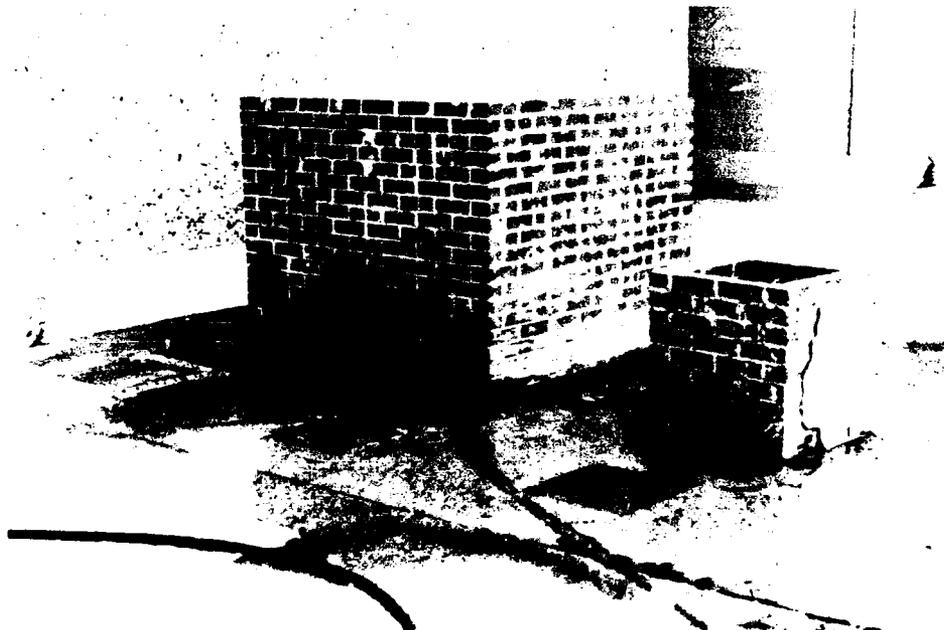
Figure 52. Dye in water leaking from large brick cube

a. Front view

b. Side view

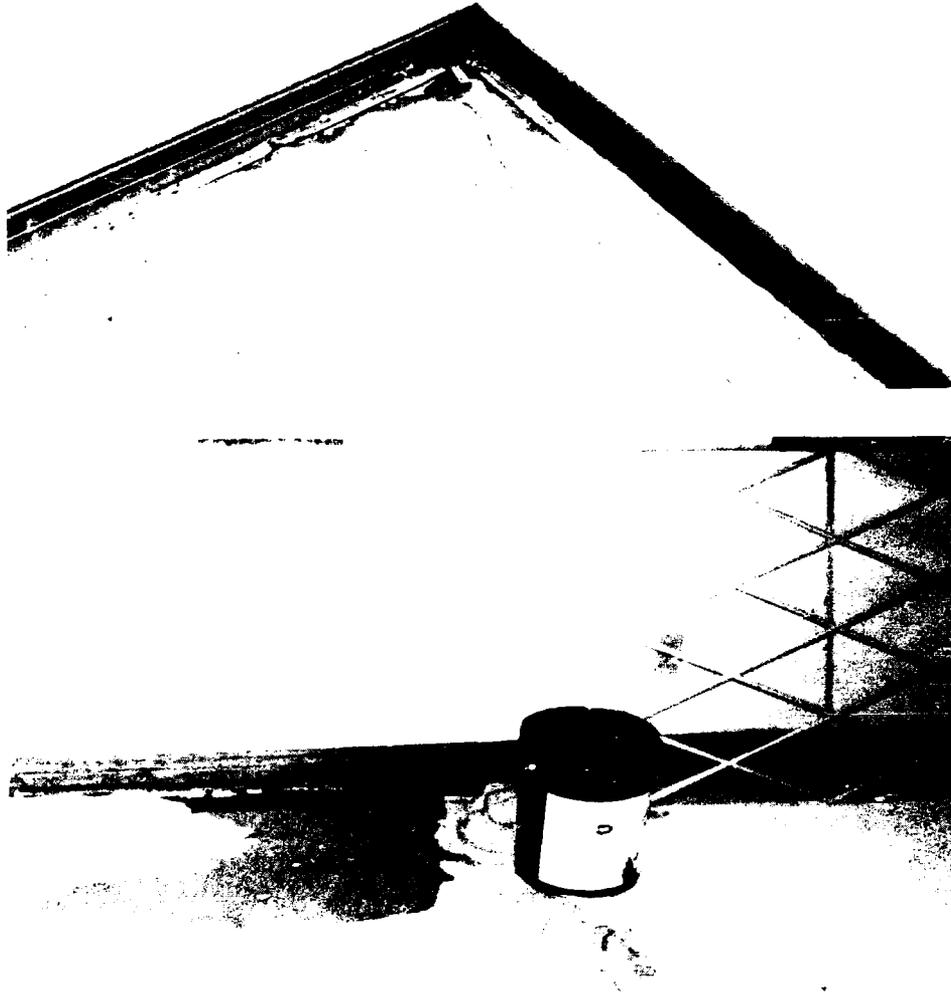
Figure 74. Seepage along baseboard due to leak in lap of fabric
