# Performance of Glass/Cladding of High-Rise Buildings in Hurricane Katrina

Ahsan Kareem and Rachel Bashor

NatHaz Modeling Laboratory  
University of Notre Dame  
Notre Dame, IN 46656

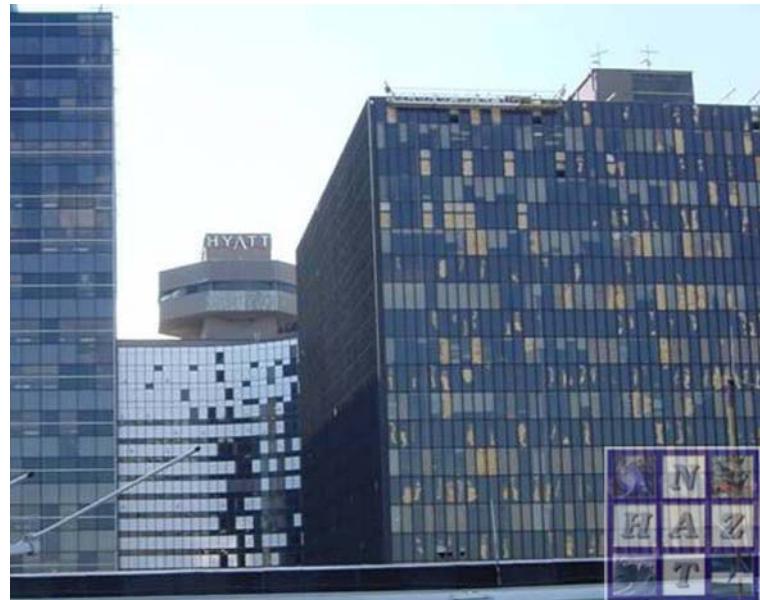
**Figure 2** Damage to Hyatt Regency Hotel and Amoco Building as seen from the roof of City Hall

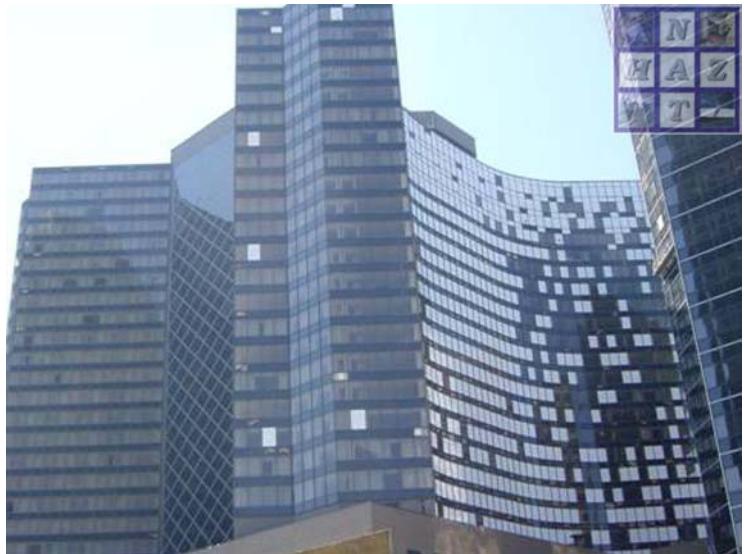
The Hyatt Regency Hotel, located near the Superdome, suffered significant glass and cladding damage, especially on the north face of the hotel (See Figure 3). Nearly every window on the north face of the hotel was broken as it experienced not only high winds during the storm, but also wind with debris accelerating through the canyon formed by the upwind buildings. Some of the falling glass during its downwards trajectory damaged glass at lower levels, initiating a domino effect causing more damage to windows below. Along with the glass damage, the building roof was also significantly damaged. Large portions of the roofing material were torn up and missing. There was evidence of abrasions on certain faces of the various roof structures, including the round center tower, and evidence of façade elements ripped off at several corners. The debris found on the property included gravel, fasteners, and large pieces of glass likely from upwind buildings. In addition, the inside of the hotel was heavily damaged with walls torn down and room contents scattered everywhere (See Figure 4).

**Figure 3** East and north faces of Hyatt Regency Hotel.

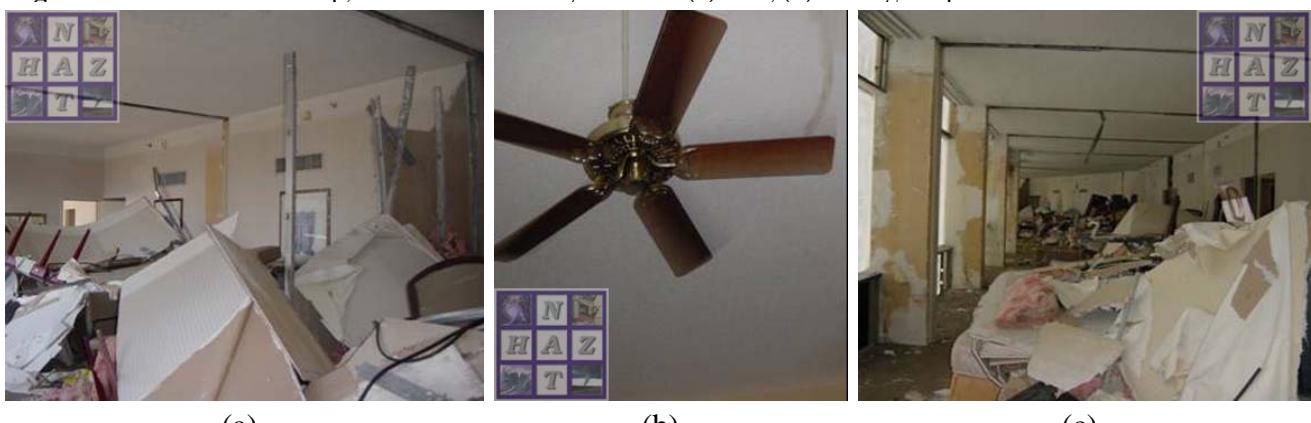
**Figure 4** Inside view of the top, north floor of the Hyatt Hotel: (a) East, (b) Ceiling fan pushed

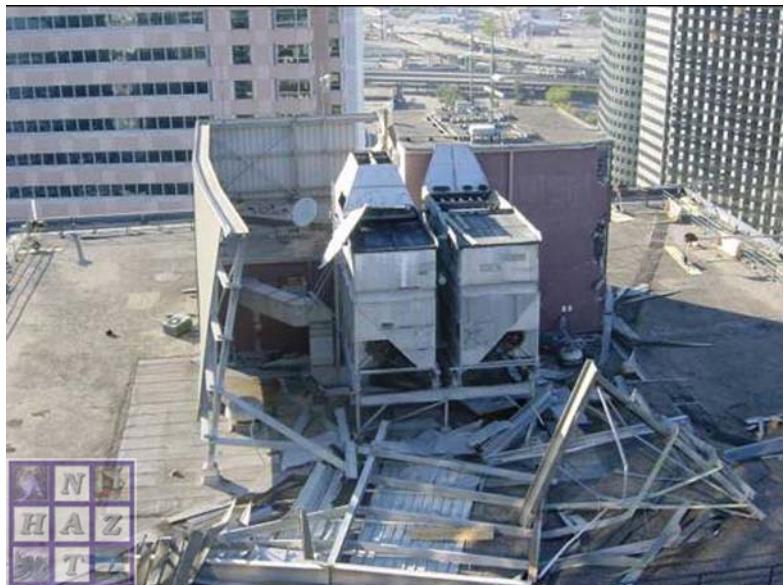
The Amoco Building sustained a large amount of glass and cladding damage as well as damage to the rooftop penthouse (See Figures 2 and 5). A large percentage of the windows were broken and boarded up with plywood. Of the windows that were not covered, many of them showed pitting where a missile had impacted the window. The roof of the Amoco Building originally had a layer of loose pea gravel several inches thick that covered the built-up roof surface completely.

The wind blew off much of the gravel, piling some up along the south parapet and exposing sections of tar. The penthouse structures on the roof suffered considerable damage, as their large beams had been blown off supports and their connections torn out of the cinder block wall. The four columns that supported the penthouse had all been pushed away from the supports - one was missing from the rooftop. It appeared that the bolts that held the steel columns to the concrete bases had been sheared off. Most of the penthouse cladding had been blown off; some large components were found on an adjoining low-rise building south of the Amoco Building.

**Figure 5** Rooftop penthouse on Amoco Building was nearly destroyed

Another cause of damage can be contributed to poor connections and lack of redundancy. This applies mostly to roof top structures. Nearly all of the damaged penthouses had missing siding at the corners associated with high levels of suction. For example, the round tower on the roof of the Hyatt was missing siding on the corners of the north face. Also, miscellaneous fasteners were found on the roof of the Hyatt among the debris. Another example of inadequate connections and bracings was the penthouse on the Amoco Building.

Commonly, in extreme wind events, an overall lack of wind resistant provisions is responsible for most structural damage, including glass and cladding, rather than simply the severity of the storm. This conclusion was previously noted during Hurricane Celia in Corpus Christi, Texas, Hurricane Alicia in Houston, Texas, Hurricane Andrew in South Florida, and Typhoon York in Hong Kong. Cladding damage as experienced during Hurricane Katrina is not only costly but also threatens lives, exposes building interiors to costly damage, and puts buildings out of service for extended periods of time thus seriously impacting the community's day-to-day infrastructure and economy. As long as the availability of wind-borne debris exists in urban areas, it will continue to threaten the integrity of fragile building envelopes even in storms that experience winds under design level. Current levels of cladding damage and associated losses are unacceptable. In order to alleviate this situation, effort must be made to limit the roof top gravel, secure appurtenances and appendages, and ensure the integrity of penthouses and railings.

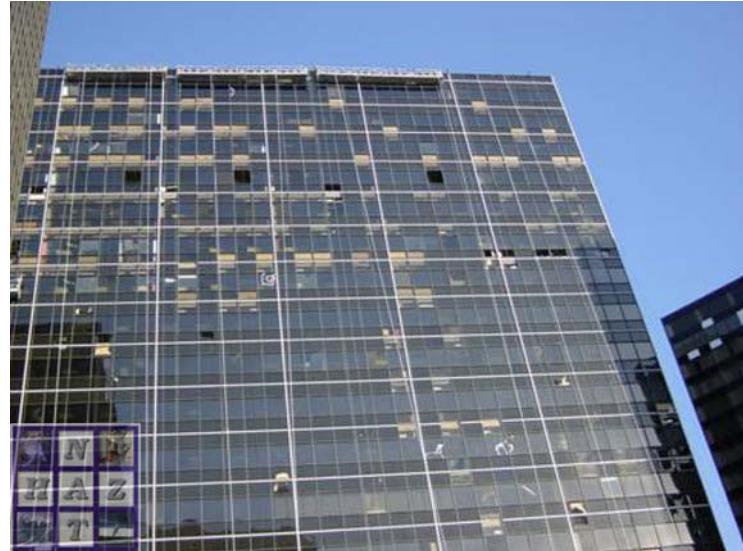
The building known as 1250 Poydras also suffered damage to the glass and cladding, especially on the north face (See Figure 6). The old gravel roof of this building had been replaced two years ago; however, the roofing membrane had bubbled up in the northeast corner. Additionally, a roof drain had been pulled up. The penthouse was in good condition with exception of the loss of one large door. Overall the roof of 1250 Poydras performed satisfactorily. However, some debris from different sources was found.

**Figure 6** West face of 1250 Poydras.

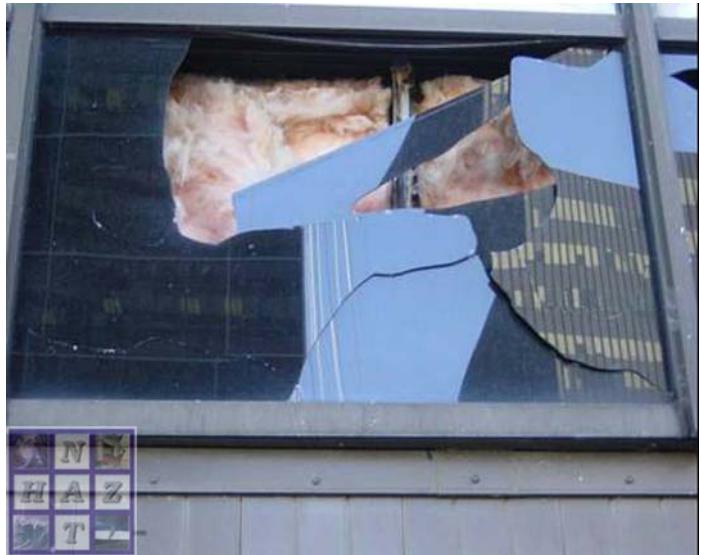
The gathered evidence suggests that the majority of the damage was likely caused by wind-borne debris. The wind-borne debris included pea gravel, rooftop appurtenances, siding, and penthouse structures which became airborne and caused significant damage to the glass and cladding of the surrounding buildings. The finding of gravel, glass shards, pitted glass and other debris on or inside buildings supports this scenario. The breakage patterns to the spandrel glass supports the missile impact theory due to the appearance of impact-induced pitting with cracks that spread from the impact point (See Figure 7 and 8). Given the orientation of the buildings in relation to the damaged areas and the availability of wind-borne debris from upwind buildings, it is

conjectured that the main debris source was the gravel roofs and appurtenances of upwind buildings.

**Figure 7** Broken window on north face of Hyatt Regency Hotel, likely caused by missile impact.

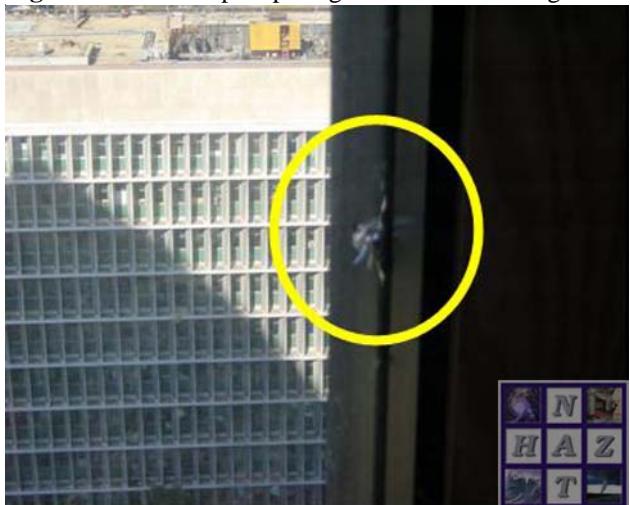
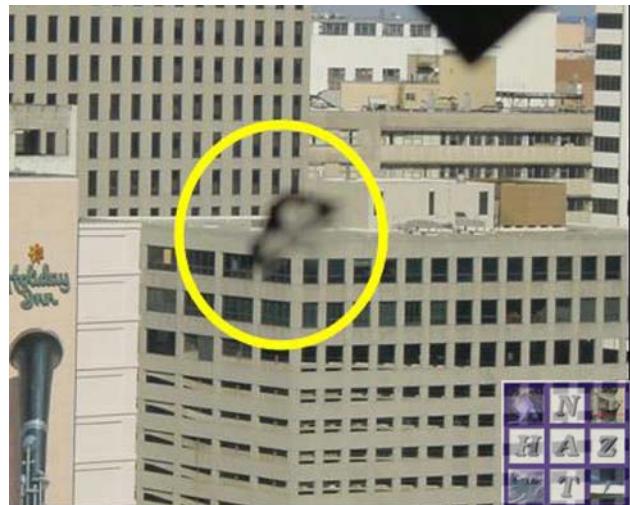
**Figure 8** Missile impact pitting on Amoco Building.
