**"OLE JIM"
GALLAUDET COLLEGE
Washington, D.C.**

Tech Notes

**EXTERIOR
WOODWORK**

**Proper Painting
And Surface Preparation**

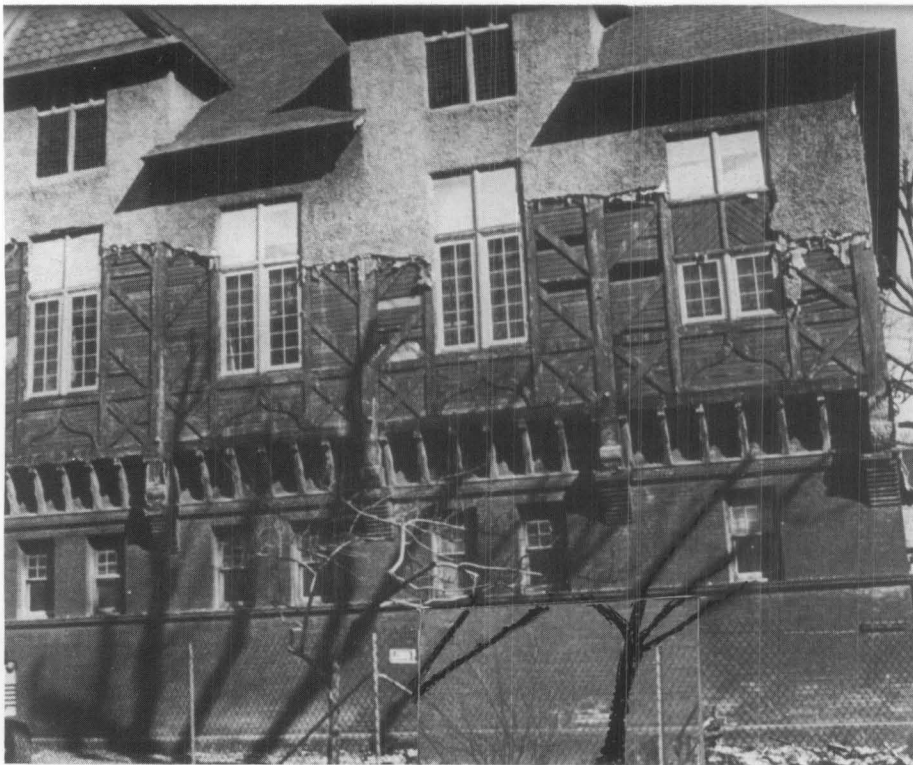
As early as 1910, the second floor wall surfaces were covered with stucco in an attempt to reduce water damage. The most dramatic aspect of the 1980 rehabilitation was the removal of the applied stucco and restoration of the painted half-timbered wooden exterior, much of it still intact (see figure 1). Old paint was removed down to bare wood and a new primer and two topcoats were applied. However, the newly applied paint on the wooden surfaces started failing within a year. By 1984, with the paint blistering and peeling, the college realized that the entire exterior wooden surface once again needed major work.

Figure 1. The stucco, applied circa 1910, is shown here being removed as part of the 1980 restoration. The wooden siding and "half-timbering" was largely intact underneath. Photo: Courtesy of Gallaudet College

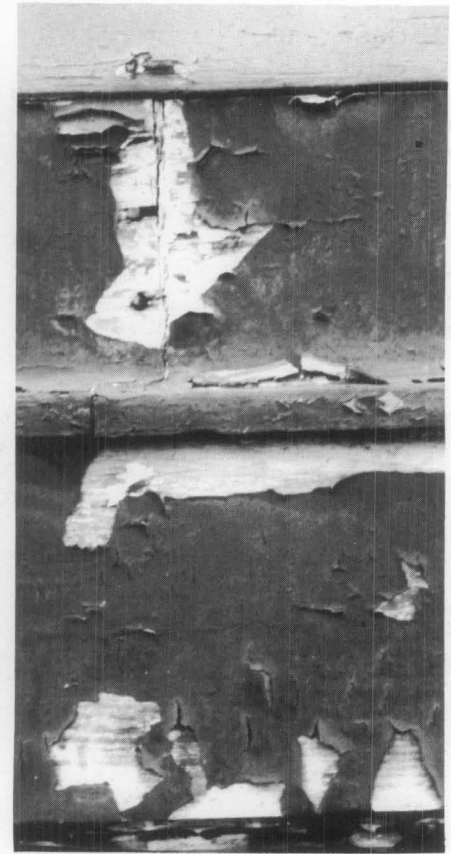
Figure 2. Paint applied in 1980 started to peel within a year, and by 1984 extensive failure had occurred. Photo: Sharon Park, AIA

Paint peeling off the wooden surface indicated that the prime coat had not adequately bonded to the wood (see figure 2). A close inspection using a "cherry picker" revealed three areas of serious deterioration. First it was apparent that moisture was getting behind the "half-timbering" where it covered the tongue and groove siding, and was rotting the wood. Secondly, the joint where the recessed tongue and groove siding abutted the heavy timber posts and lintels was equally difficult to keep sealed once the paint had failed. And finally, extensive dry rot had occurred at the intersection of the structural column and sill plate (see figure 3). The extensive paint failure, together with the deteriorated wood, indicated a serious moisture problem.

The only way to solve the problem was to remove all the paint, properly prepare the wood surface, and repaint.

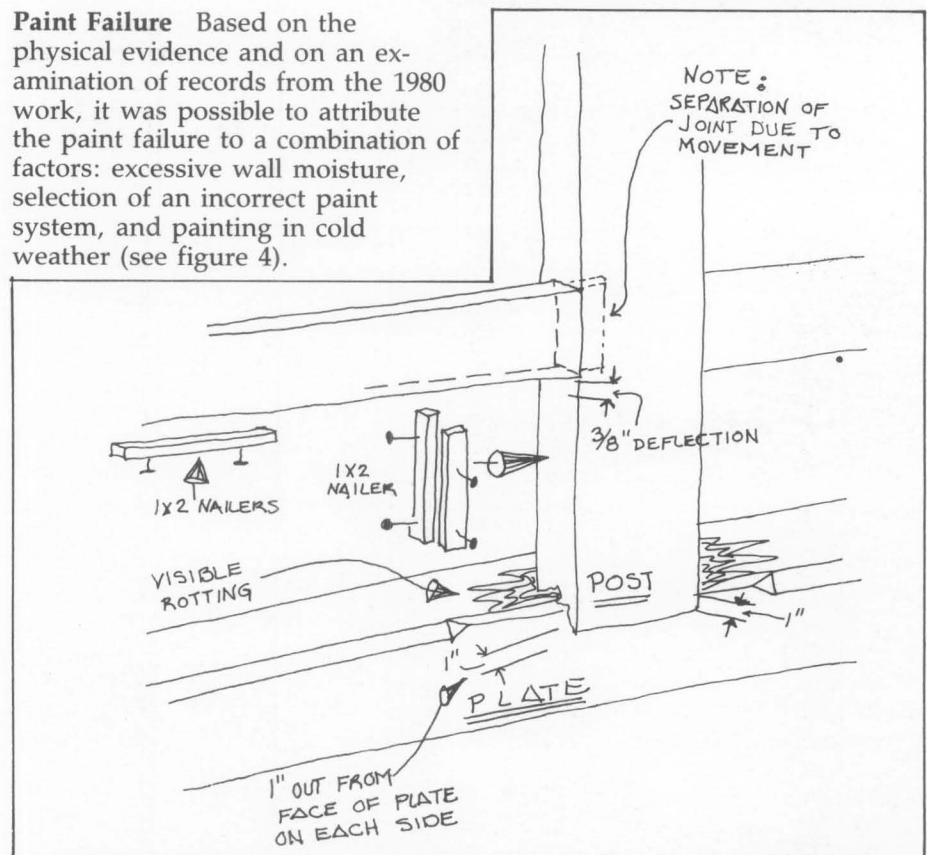
Figure 3. Areas of wood deterioration included the horizontal sill plate at the structural post connection as shown in this sketch made on site in 1985. Drawing: Dell Corporation.

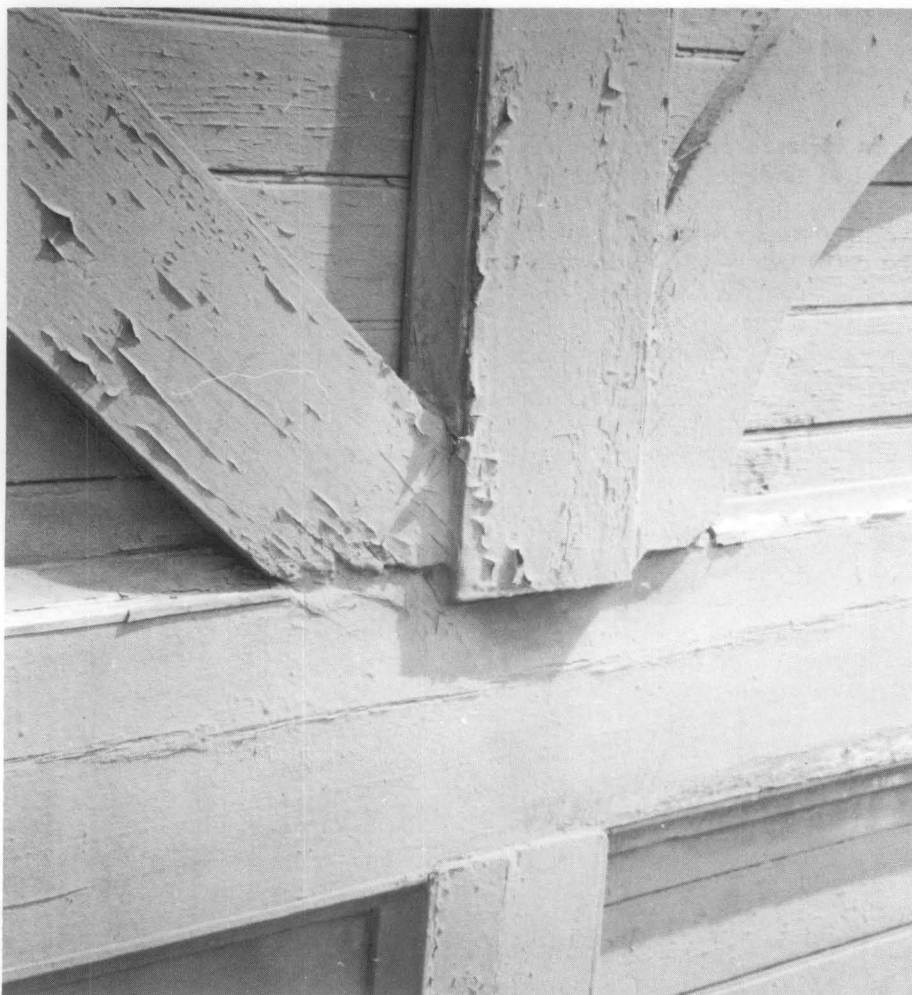
Paint Failure Based on the physical evidence and on an examination of records from the 1980 work, it was possible to attribute the paint failure to a combination of factors: excessive wall moisture, selection of an incorrect paint system, and painting in cold weather (see figure 4).

During the 1980 restoration, a steam pipe had burst, saturating a large section of the exterior wooden wall in the gymnasium. Readings taken after the accident showed a moisture level in the wood as high as 43%. Apparently, the walls were not adequately dried out before batt insulation was installed and the wall surfaces painted, thereby contributing to the paint failure.

The paint selected for the 1980 exterior work was a fire-retardant marine grade epoxy (pigmented polyamide epoxy). The paint had been chosen partly because it contained fire-retardant agents and was therefore consistent with the college's fire safety concerns. Local codes required a fire-retardant coating on the interior wooden surfaces, and the local fire officials had recommended its application on the exterior as well. In addition, the paint was selected because it was supposed to help waterproof the exterior and seal the many troublesome wood joints.

This impervious paint only compounded the problem. Residual moisture trapped in the walls from the broken steam line could not easily escape once the epoxy paint was applied. Furthermore, the paint turned out to be hygroscopic, or moisture absorbing, because of the salts used in the fire-retardant formulation. Once exposed to moisture, the paint swelled and, due to poor surface bonding, blistered off. Records also showed that the painting occurred during weather below 40°F, creating the possibility that the paint had frozen before drying or, at a minimum, that the prime coat had not properly bonded to the wood. As a result of all these factors, there was widespread paint failure, exposing bare wood to further water damage and ultra-violet degradation.

Figure 4. Flaking paint was the result of painting moisture-laden wood, using an inappropriate paint system, and undertaking the work during cold weather. Photo: Baird Smith, AIA

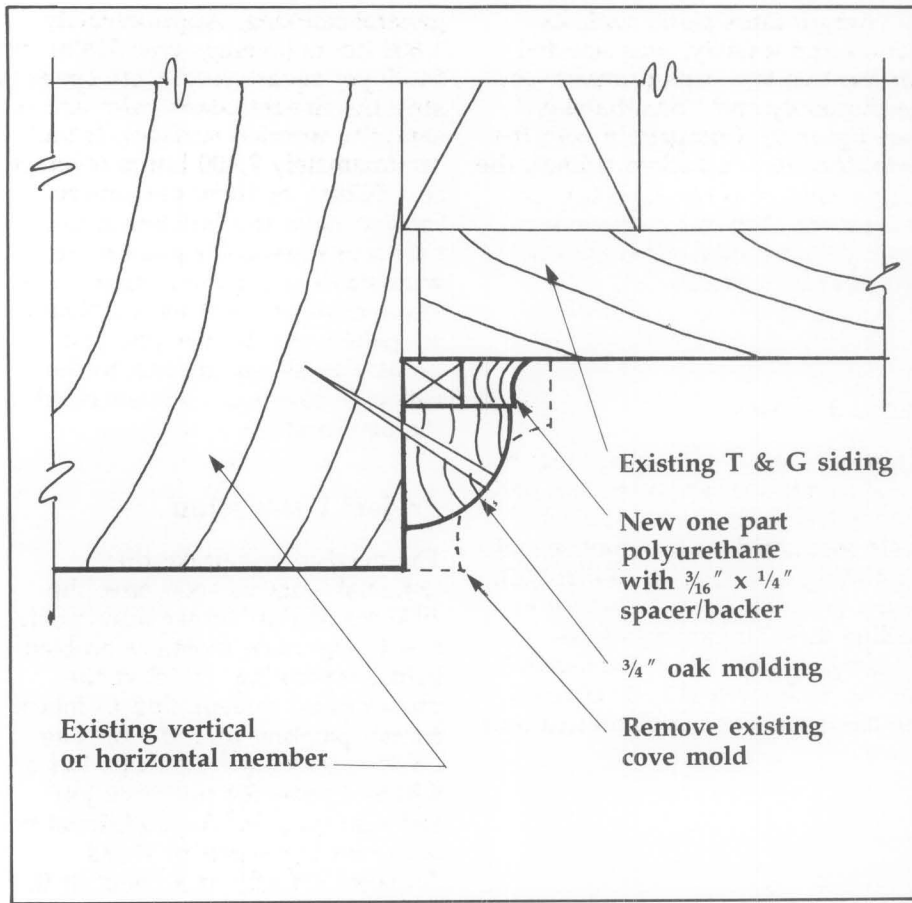
Figure 7. A molding detail was developed to seal the vertical and horizontal reveals. The additional backing strip for the molding provided a channel for a caulking or sealant bead. Drawing: Geier Brown Renfrow, Architects

In the 1980 restoration, a cove molding had been added where the recessed panels abutted the structural posts and beams. The joints, however, were not caulked and water penetrated behind the molding once the paint began to fail. The architect for the remedial work developed a new detail using a combination of a 3/4" quarter-round piece of oak with a 1/4" x 3/16" pine backing (see figure 7). The new wood was back-primed and edge-grain primed prior to installation. The reason for the backing piece was to create a channel to receive a 1/4" bead of caulking/sealant. Without this channel, there was no guarantee that the sealant would hold firm. This detail should allow for an effective seal at the joint—a chronic source of water penetration over the years (see figure 8).

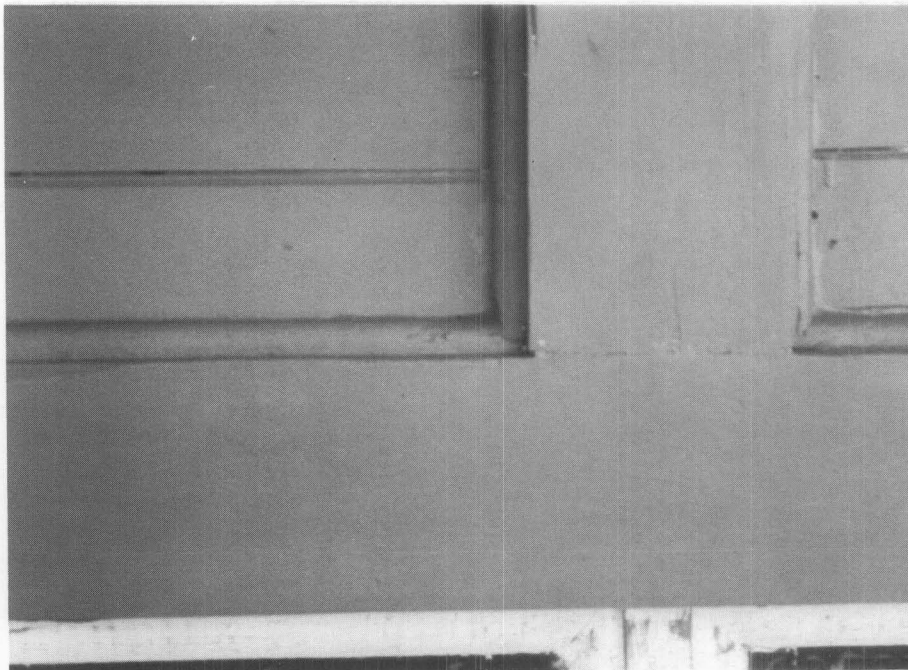
Figure 8. The molding strips blended with the horizontal and vertical boards and in combination with caulking should effectively keep moisture from penetrating behind the recessed paneling. Photos: Sharon Park, AIA

The sealant selected for caulking was a long-lasting pre-mixed one-part polyurethane. This is a high-quality sealant applied with a caulking gun and is recommended for use on exterior wood. Areas caulked included open seams where horizontal and vertical boards intersected, joints around window openings, and along the new oak molding strips. The sealant takes paint very well after curing and should last at least as long as the paint.

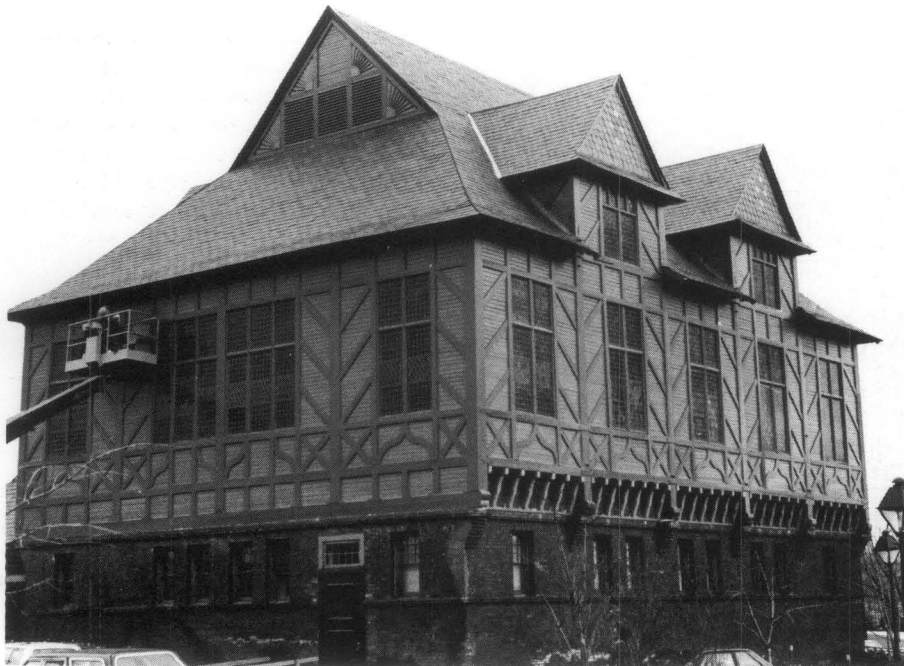
Figure 10. The college will inspect the building on a regular basis to ensure that any problems are immediately corrected. Photo: Charles Fisher

For "Ole Jim," a 7-year life is expected from the new paint job before repainting will be necessary. Under normal conditions, 7 years is the commonly recognized life span for paint applied to bare wood which has been properly prepared. Future repainting should be much easier and cheaper due to the addition of trim pieces and thorough caulking to eliminate pockets where water collected. The owner is committed to regular inspection of the building and the correction of any problems as soon as they are apparent (see figure 10).
