## MASONRY NUMBER 3

### Water Soak Cleaning of Limestone

### THE WIDENER BUILDING Philadelphia, Pennsylvania

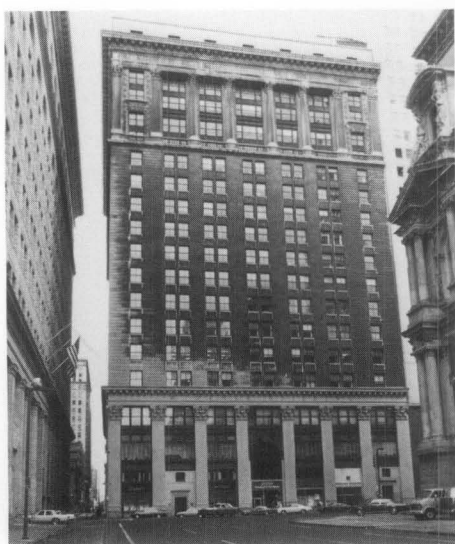
Figure 1. In 1989, just prior to the onset of the rehabilitation project, the Widener Building was showing the effects of 75 years of exposure to an urban environment. Note the lighter color of the left side of the building regularly washed by rain. Photo: John Milner Associates.

to seventy-five years of exposure to an urban/industrial environment and had never been cleaned, the masonry surfaces were heavily coated with typical deposits of air-borne particulates of soot, fly ash, tar and clay matter as well as localized areas of organic matter. These deposits in conjunction with sulfur oxides accelerate the decay process of the calcareous stones such as limestone by forming non-stable, highly soluble and chemically-reactive crusts that increase the stone's surface area and ultimately leave the stone more vulnerable to damage from continuing deposition attack.

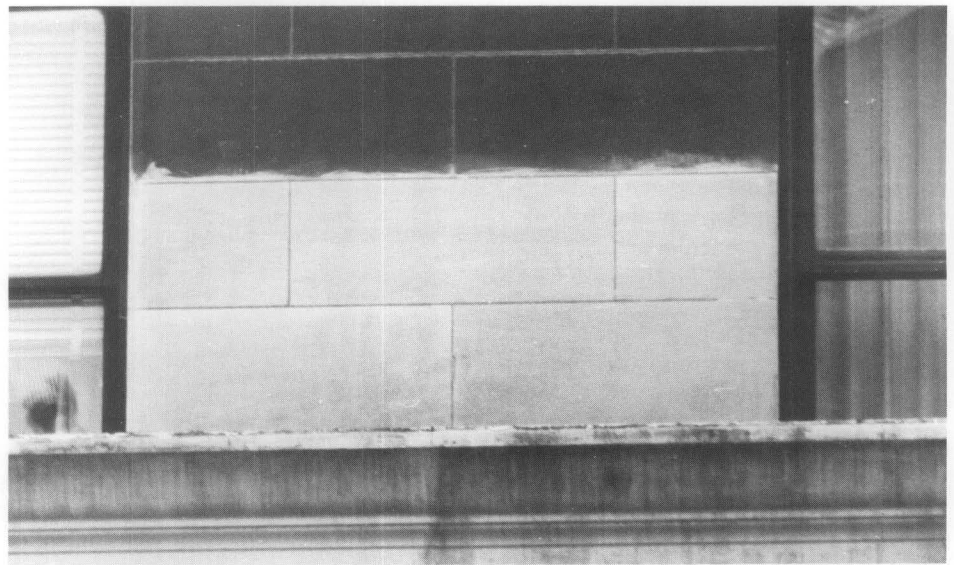
For this test, the limestone was soaked for 4 hours with low-pressure water from an oscillating sprinkler in order to dissolve and loosen the pollutant crust. After the 4-hour soak, the loosened crust and remaining particulate matter were rinsed off the stone surface by a pressure washer with a 45 degree fan tip nozzle at 400 pounds per square inch (psi) using approximately 5 gallons of water per minute (gpm) (see figure 2a).

Figure 2. The three test panels were carried out on the right side of the 4th floor of the South Penn Square elevation directly above the cornice that tops the 3-story storefront columns. (a) The completed panel on which the water soak method was tested; (b) the second completed panel after testing with the two-part alkaline chemical cleaner; and (c) the third completed panel after testing with the one-part alkaline chemical cleaner. Photos: John Milner Associates.

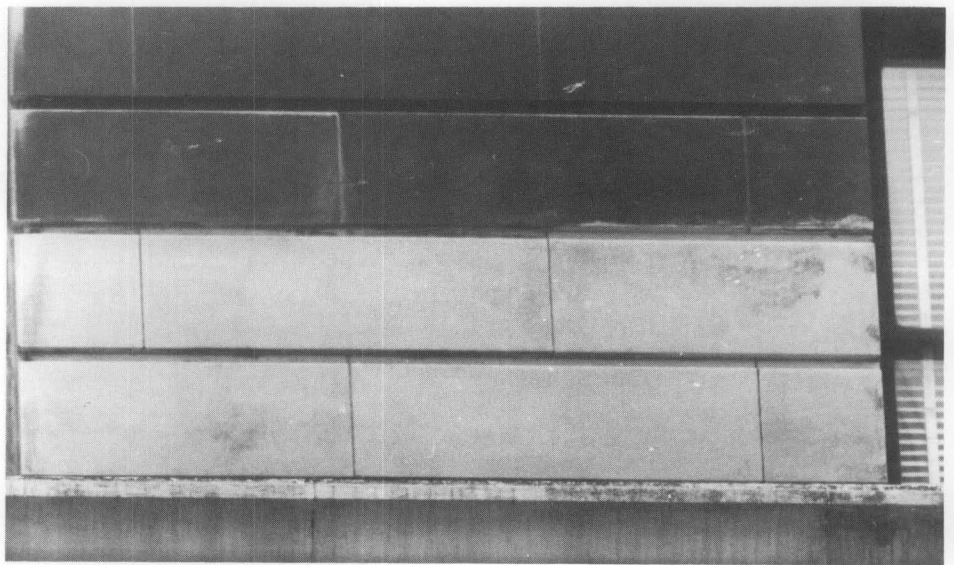
(b)

allowed to remain on the surface of the test patch for approximately 30 minutes. The treated area was then thoroughly rinsed at a pressure of approximately 400 psi at 5 gpm using a 30 degree nozzle. Immediately after rinsing, the acidic neutralizer was applied (diluted 1:1 with water), to the wet stone with a deep nap roller. The neutralizer was left on the surface for 3 minutes, and then the stone was fully rinsed with water (see figure 2b).

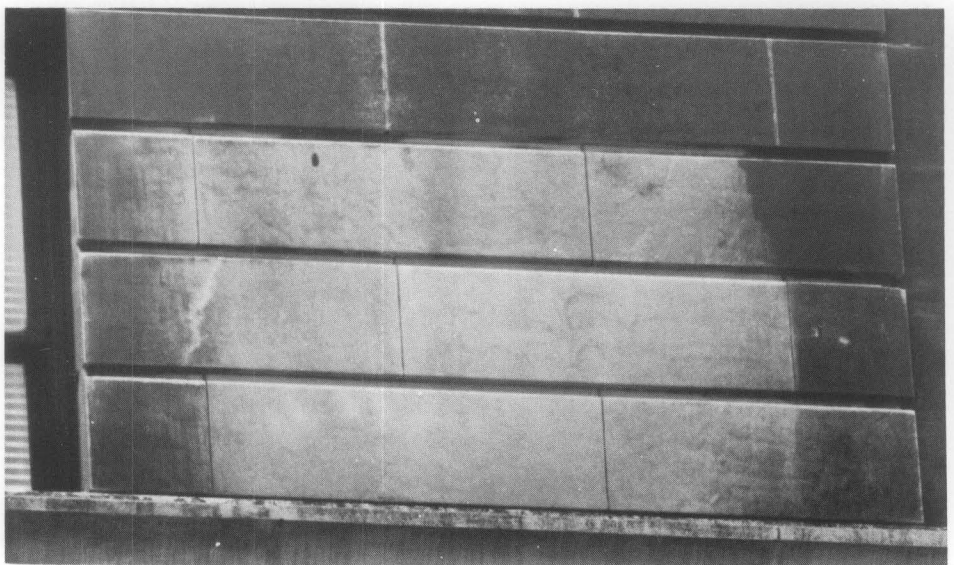
(c)

The second type of chemical cleaning tested was also an alkaline-based cleaner, and it too is intended to be used on limestone. It consists of a fluoro-chemical surfactant containing carbonate emulsifiers (pH of 10). It was applied full strength to the dry surface of the stone with a deep nap roller, allowed to remain on the surface for approximately 5 minutes and then rinsed with a pressure washer delivering water at 600 psi at 5 gpm (see figure 2c).

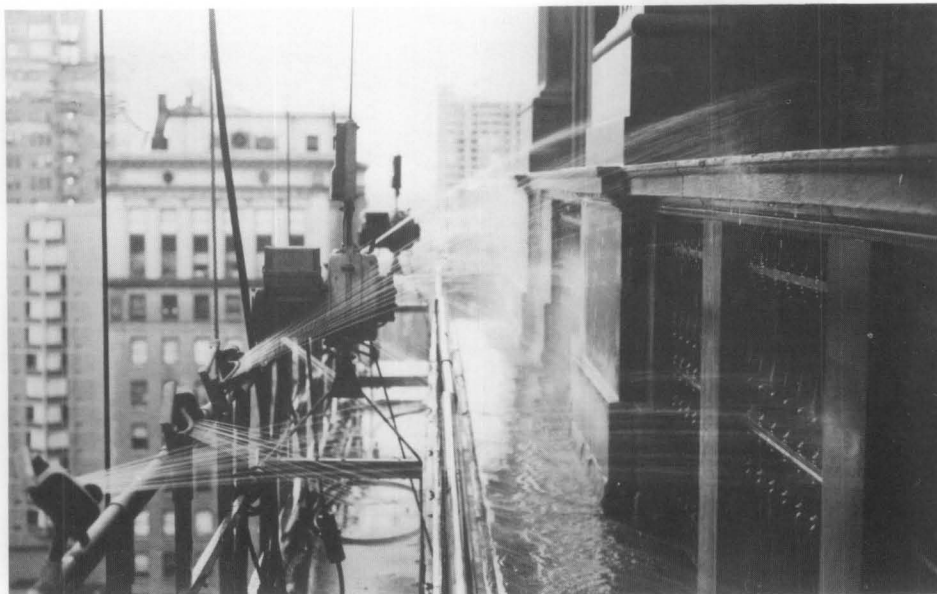
Figure 3. Close-up view of the oscillating sprinklers spaced 3 feet apart and connected to 1/4" PVC piping attached to the rear bar of each scaffold. Photo: P & R Masonry Restoration, Inc.

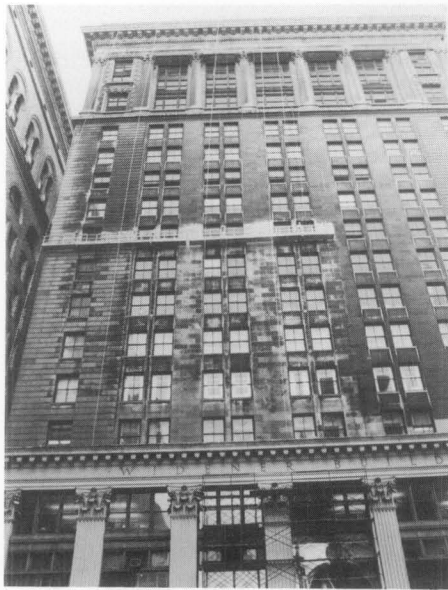
Figure 4. South Penn Square elevation after the completion of two drops from the 9th-4th floors of water soaking only, and prior to beginning the rinse process. Photo: P & R Masonry Restoration, Inc.

soaking had been completed on both drops (a "drop" is the amount of vertical wall surface that can be covered by one scaffold moving vertically up or down a building), the crew began the rinsing process this time moving down the elevation, starting from the 9th floor and proceeding to the 4th (*see figure 4*).

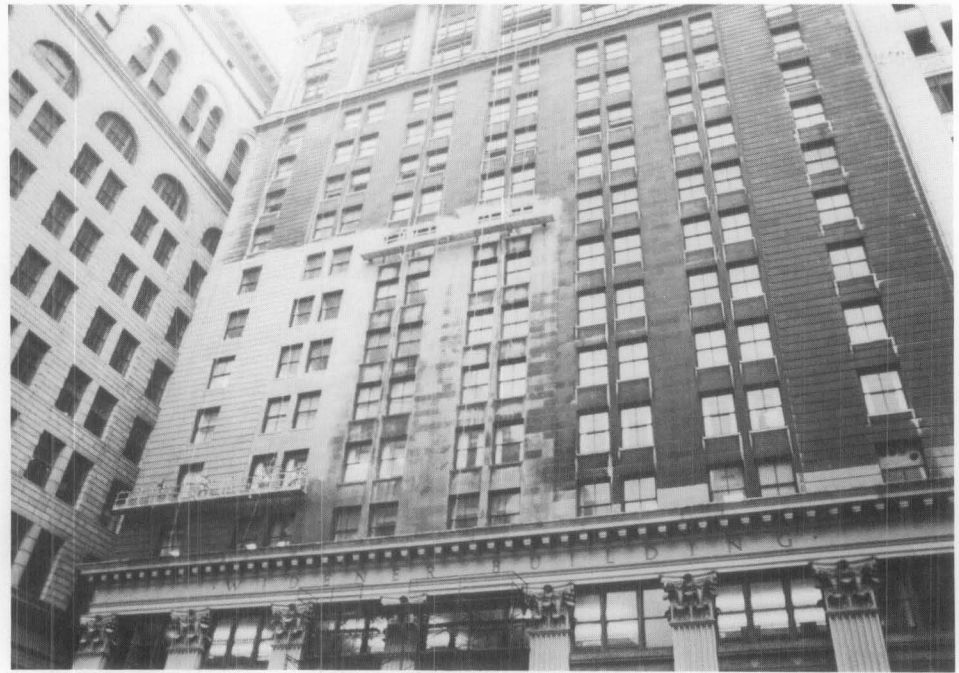
For the rinsing process, two pressure washers were placed atop the building with pressure hoses extending to the scaffolds. Each machine generated a pressure of 400 psi and 5 gpm. Throughout the cleaning, one worker per scaffold used a short-handled spray wand with a 30 degree nozzle to rinse away loose material and clean out the pores of the stone. The nozzle was kept a minimum of two feet away from the masonry surface at all times (*see figure 5*).

Figure 5. The drop on the left side of the building has been water-soaked and rinsed, while the drop on the right has been soaked only. Note the amount of soil that still remains on the right side before rinsing. Photo: P & R Masonry Restoration, Inc.

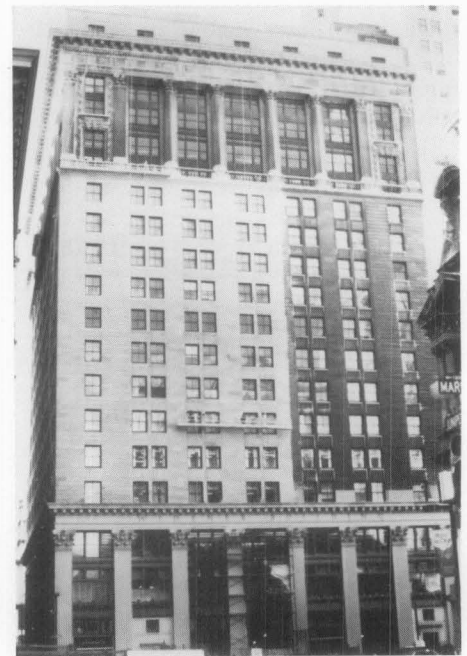
After cleaning (soaking and rinsing) the 4th through the 9th floors, both scaffolds were moved up to the 10th floor where the soaking process was begun again and was continued up through the 13th floor (*see figure 6*). This section was then rinsed, and the soaking process recommenced at the 14th floor and proceeded to the cornice at the top of the building.

Figure 6. The contrast between the cleaned and the uncleaned portions of the facade after completion of both the water soak and the washdown rinse of these two drops from the 14th-4th floors is dramatic. Photo: Robert M. Powers.

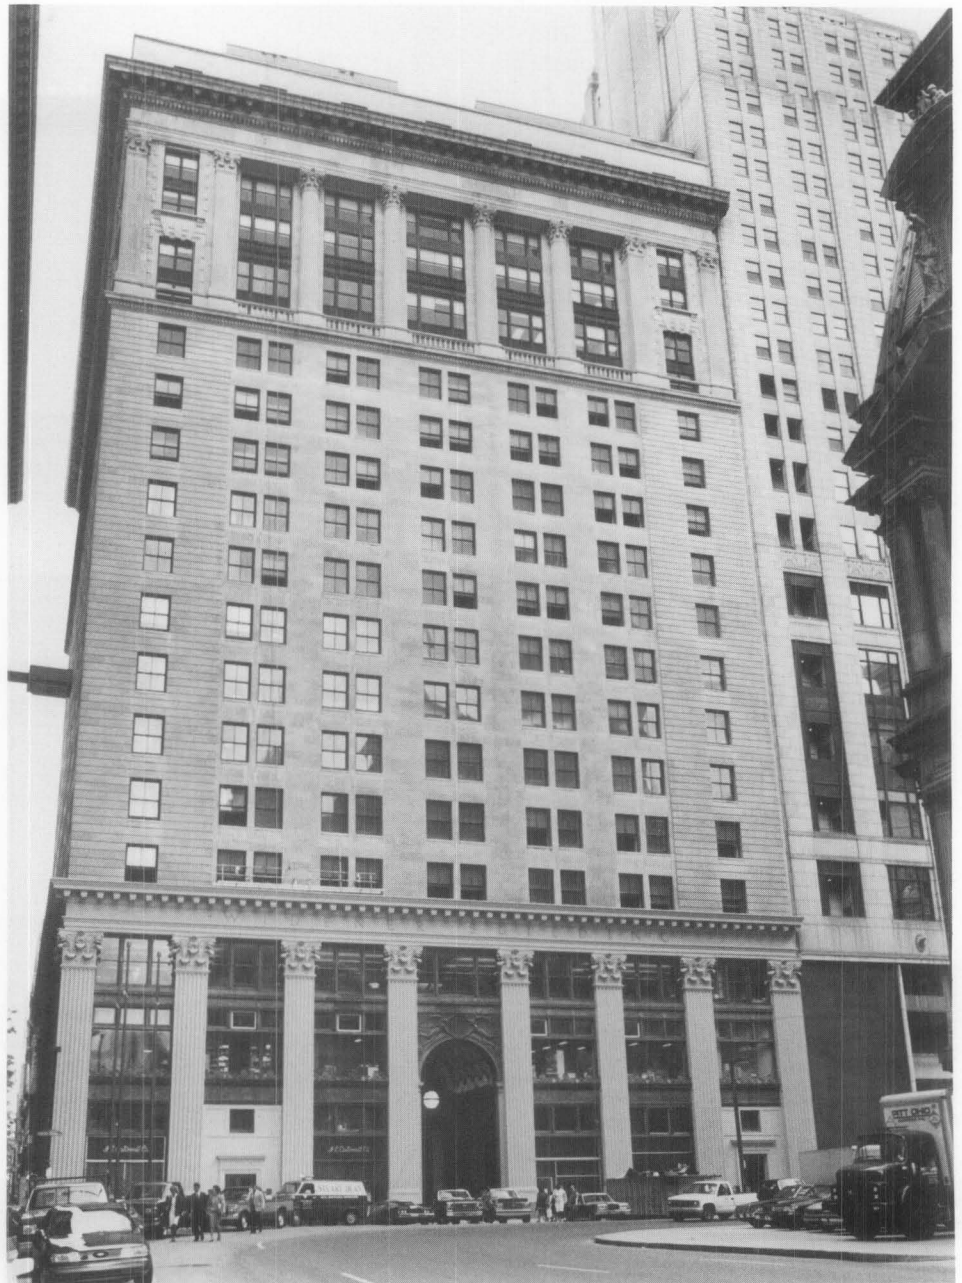
Water soaking is a cost-effective cleaning process for both large and small limestone buildings. The results of the cleaning of the Widener Building are startling, especially when compared to the appearance of the stone prior to the start of the project (*see figure 7*). Although the cleaning team was on the job site for a longer

Figure 7. The South Penn Square elevation after its successful cleaning using the water soak method. Photo: Faherty/Kelter Associates, Inc.
