# Furnace and Water Heater Venting Field Demonstration

**May 2019**

Prepared by  
OAK RIDGE NATIONAL LABORATORY  
Oak Ridge, TN 37831-6283  
managed by  
UT-BATTELLE, LLC  
for the  
US DEPARTMENT OF ENERGY  
under contract DE-AC05-00OR22725

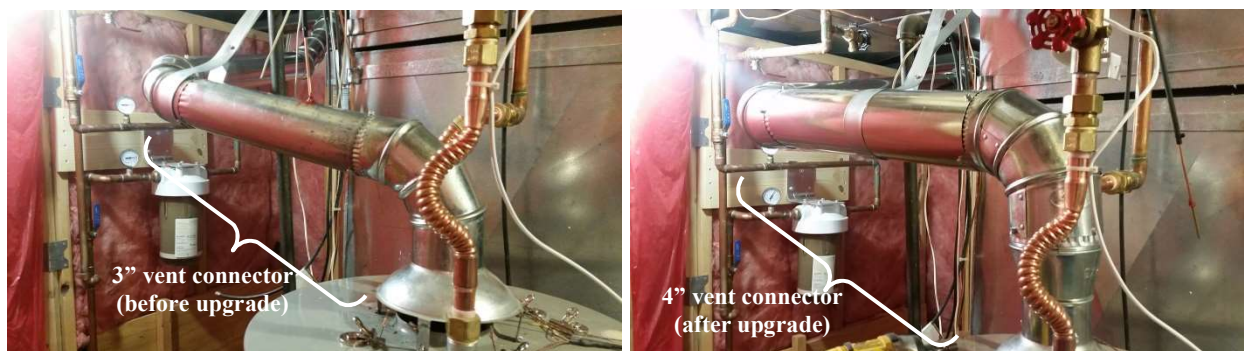
The combination of a reduced venting area due to the inner liner in the vertical chimney and the long vertical rise put this installation near the limit of acceptable performance in the NFPA 54 vent tables and is likely why it is experiencing frequent spillage events following the installation of the FasNSeal 80/90 venting system. Significant spillage was seen after the initial installation of the FasNSeal system. For this reason, the interconnecting vent between the water heater and the vertical vent pipe was increased from a 3 in. to a 4 in. diameter, as shown in Figure 5.13, approximately one month after the FasNSeal system was installed. This improved the drafting based on spillage tests performed with a smoke stick. The continuous data monitoring still showed frequent spillage events, but of much shorter durations.

Figure 5.13. Three inch vent connector (left) upgraded to a 4 inch vent connector (right) in House CO1.

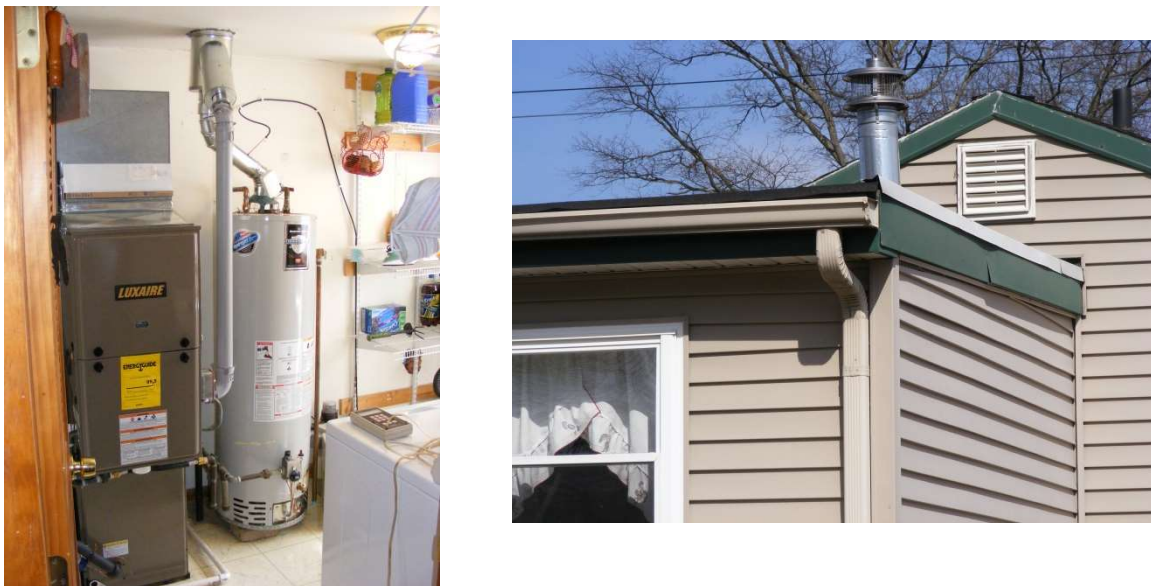
The short length of the flue run in this house may explain these anomalies. The length of the venting system in this house was the shortest of the 16 houses used in the field demonstration. As shown in Figure 5.14, the venting from the water heater to the vertical vent pipe was short and direct, and the vent rose just a few feet through essentially a flat roof. Examination of the NFPA 54 vent tables shows that the maximum allowable capacity for a naturally vented water heater decreases as the height of the flue decreases. For example, for a 3 in. vent diameter, a 6 ft height, and a 2 ft lateral run, the maximum capacity is 36,000 Btu/h. The 34,000 Btu/h water heater that is installed should be well below the maximum capacity allowed for the 6 in. B Vent installed before retrofit, so this does not necessarily explain the frequent spillage observed before the installation of the FasNSeal venting system. However, following the retrofit, the water heater capacity may be closer to the acceptable limit with the 4 in. effective diameter of the annular space (2 in. inner liner installed in a 6 in. B Vent according to the DuraVent installation instructions).

Figure 5.14. Short flue run found in House PA1.

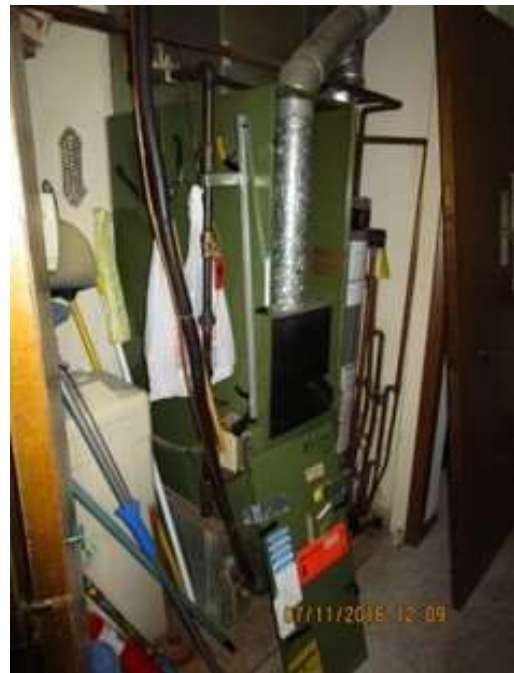
Figure 5.15. House MN2 furnace closet.

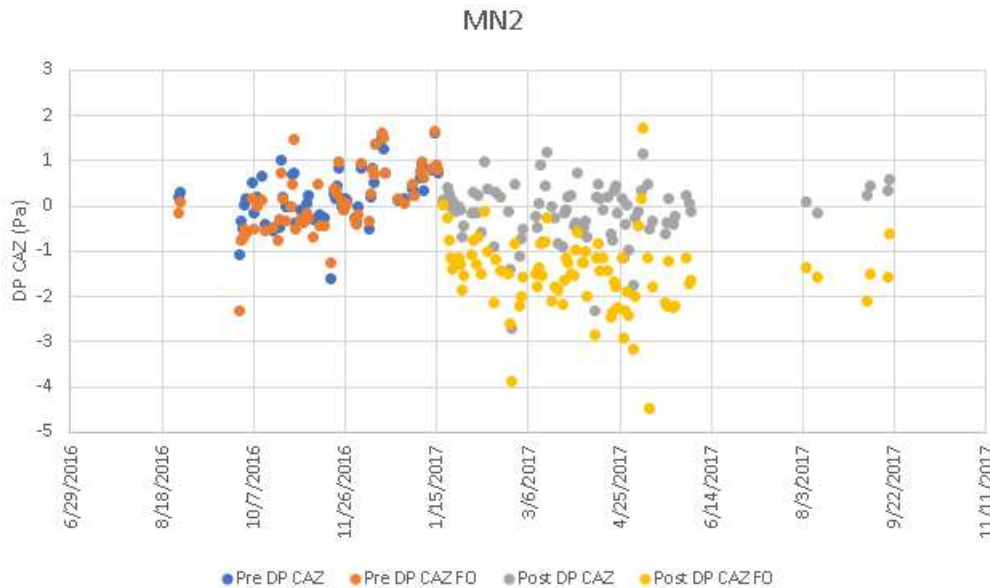
Figure 5.16 shows the daily average pressure difference between the CAZ and the outdoors (blue for the pre-retrofit period and gray for the post-retrofit period) and the daily average pressure difference between the CAZ and the outdoors only when the furnace, and therefore the supply air blower, was running (orange for the pre-retrofit period and yellow for the post-retrofit period). The average daily pressure difference between the CAZ and the outdoors was about the same before and after retrofit, but the pressure difference when the supply air blower was running was noticeably different following retrofit. The CAZ became more depressurized relative to the outdoors in the post-retrofit period when the supply air blower was running compared with the average daily pressure in the CAZ; this behavior did not occur in the pre-retrofit period.

**Figure 5.16. Daily average pressure differences between the CAZ and the outdoors in House MN2. (FO means furnace on)**

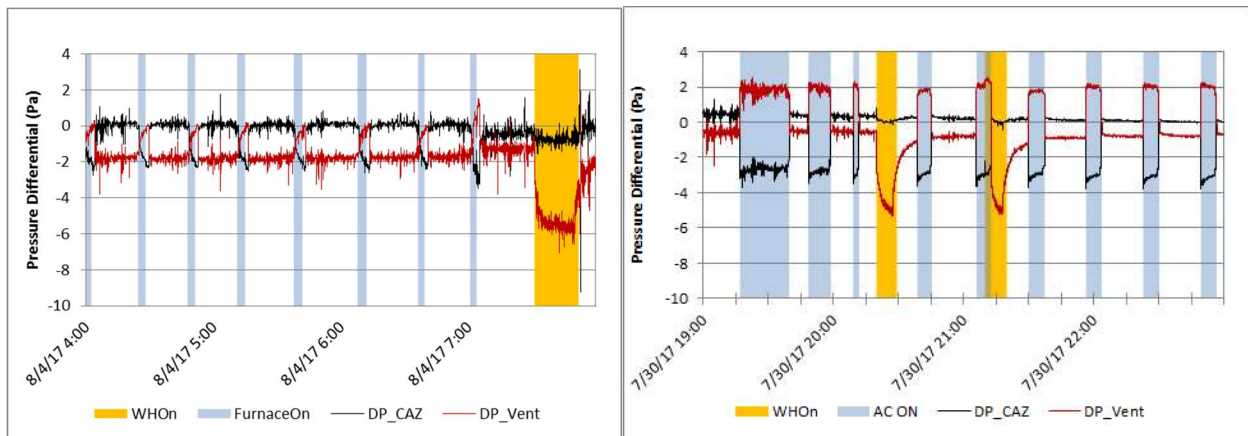
The operational impact of the supply air blower on the CAZ pressure and the venting system is shown more directly in Figure 5.17. At the same time that the condensing furnace turns on (as shown by the blue bars in the plot on the left in Figure 5.17), the pressure difference between the CAZ and the outdoors (the black line labeled DP\_CAZ) decreases noticeably and the pressure difference between the vent and the CAZ (the red line labeled DP\_Vent) increases, which indicates a downflow of air. A similar decrease in the CAZ pressure and an increase in the vent pressure can be seen in the plot on the right in Figure 5.17 when the air-conditioner turns on (as shown by the blue bars).

**Figure 5.17. Post-retrofit CAZ and vent pressures during supply air blower operation during furnace operation (left) and air-conditioner operation (right) in House MN2.**

air-conditioner ran. Therefore, in Figure 5.10 for MN2, spillage across all post-retrofit outdoor temperatures was observed.

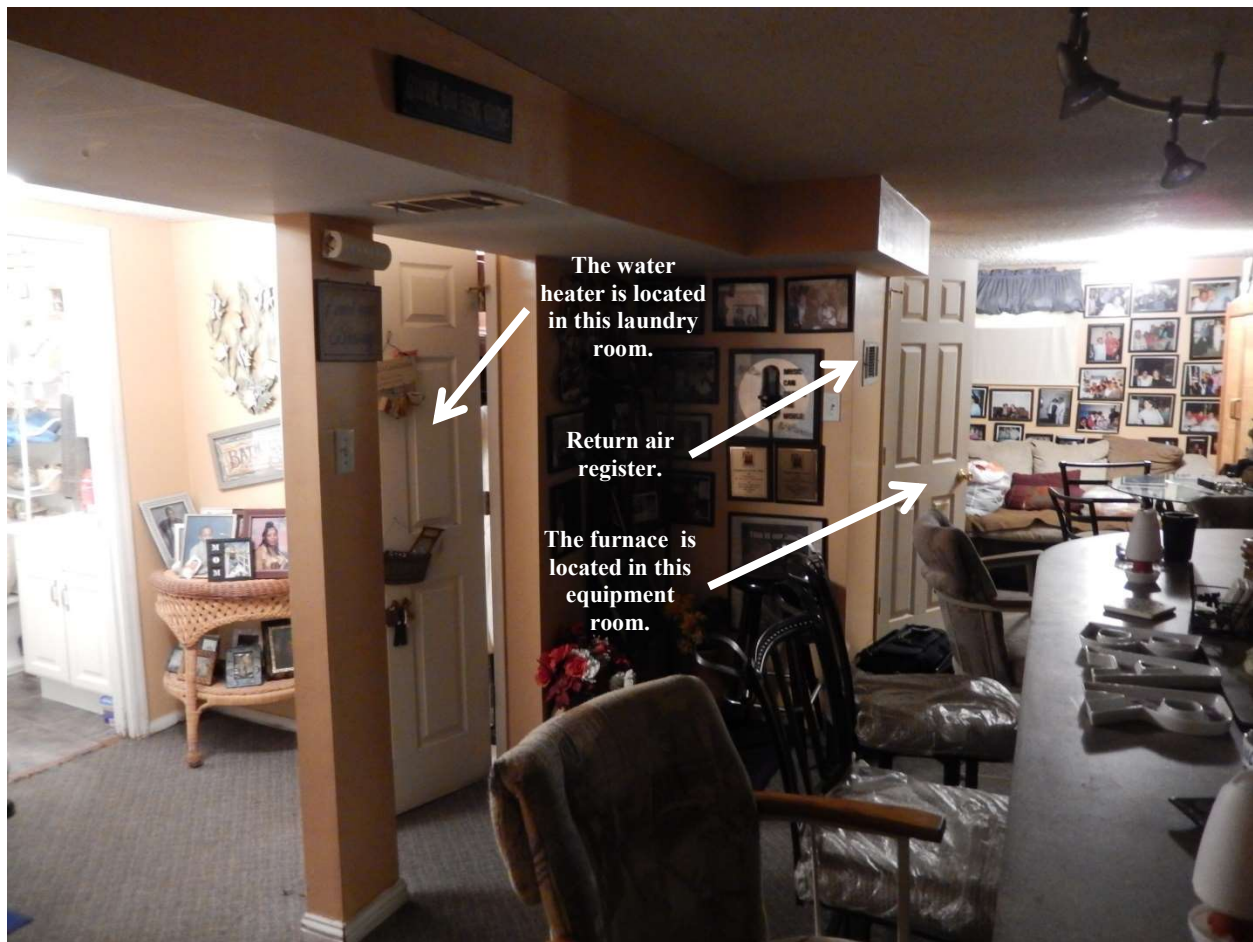
The water heater and furnace are installed in separate but adjacent equipment rooms located in the conditioned basement of House MO3. As shown in Figure 5.18, the white paneled door on the right opens into the furnace room, while the paneled door on the left opens into a large storage/laundry room where the water heater is installed.

**Figure 5.18. Basement equipment rooms in House MO3.**

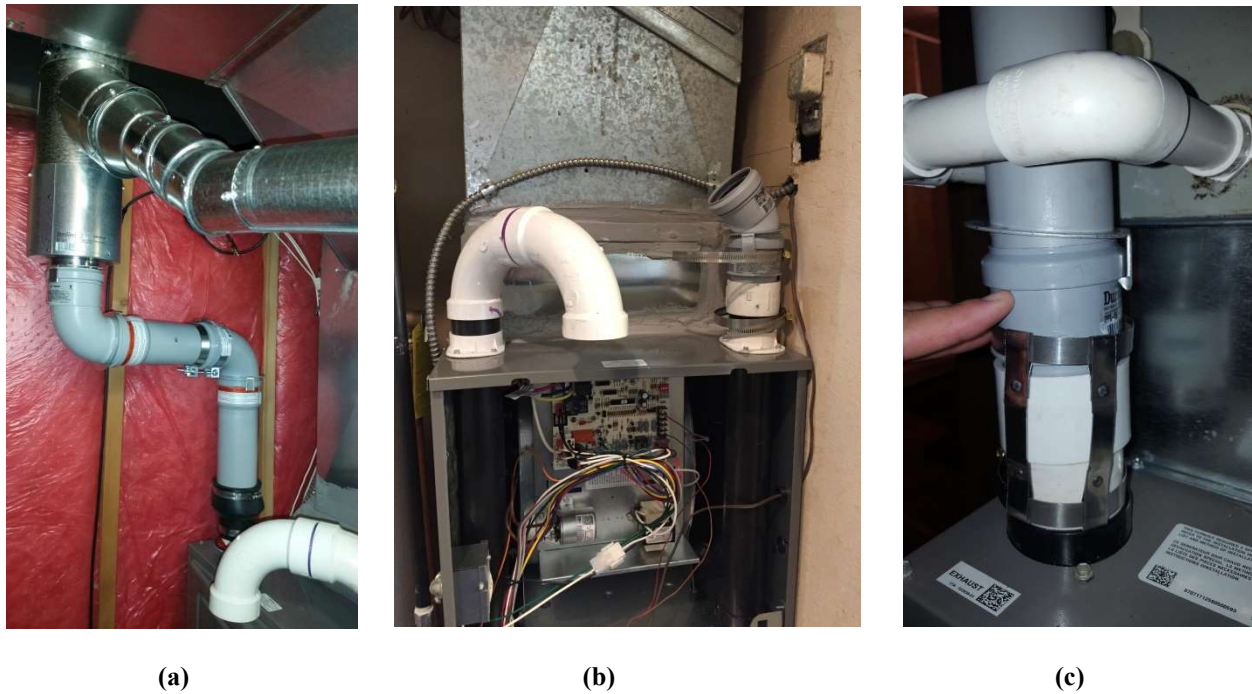
An important issue that arose at every agency was the connection of the PolyPro to the condensing furnace. The DuraVent literature available at the time two agencies ordered material for the March 2016 installations did not identify the availability and use of a “PolyPro Appliance Adapter for PVC Coupler.” At one agency, the proper connector was provided by a DuraVent representative present at the first installation and used in three houses, while in the other house the PolyPro was run directly to the furnace blower inside the furnace cabinet. At the other agency, a rubber reducer was used to make the connection at three houses (see Figure 6.1a) and an alternative method was used at a fourth house (see Figure 6.1b). The remaining two agencies also had issues even though the adaptors were ordered based on updated DuraVent literature. One agency prematurely converted from PolyPro to PVC before reaching the condensing furnace because of their unfamiliarity with PolyPro. The other agency encountered an issue with the length of the adaptor and the clamp provided to secure the assembly. This agency used a small length of PVC to complete the installation (Figure 6.1c).

**Figure 6.1. Alternative methods of connecting the PolyPro to the furnace.**

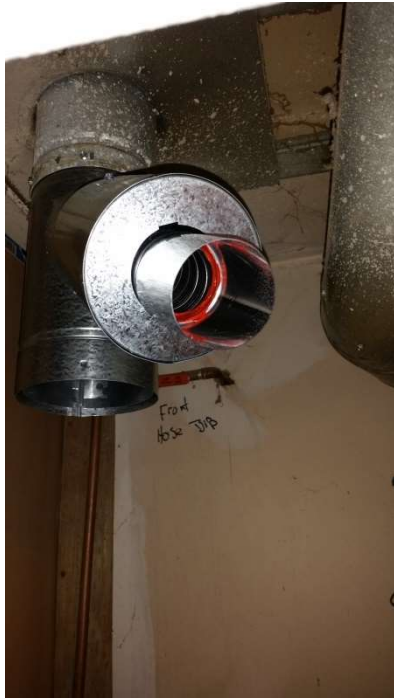
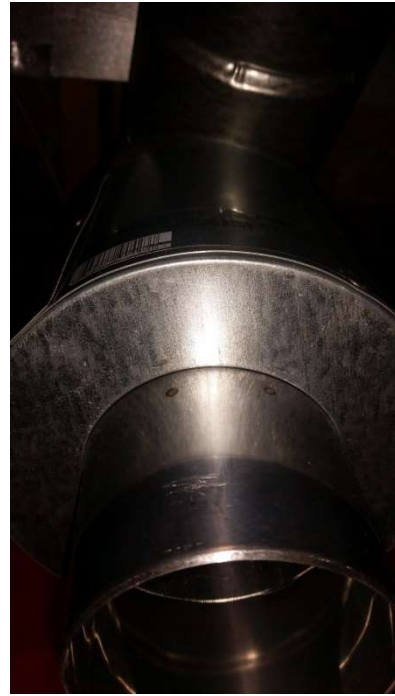
**Figure 6.3. Loose fit in the 2 in. fire stop compared with the 3 in. fire stop.**
