COMPARISON OF STRENGTH PROPERTIES AND FAILURE CHARACTERISTICS BETWEEN FIRE-RETARDANT-TREATED AND UNTREATED ROOF FRAMING LUMBER AFTER LONG-TERM EXPOSURE: A SOUTH CAROLINA CASE STUDY

DEREK A. HODGIN*
ANDY W.C. LEE*

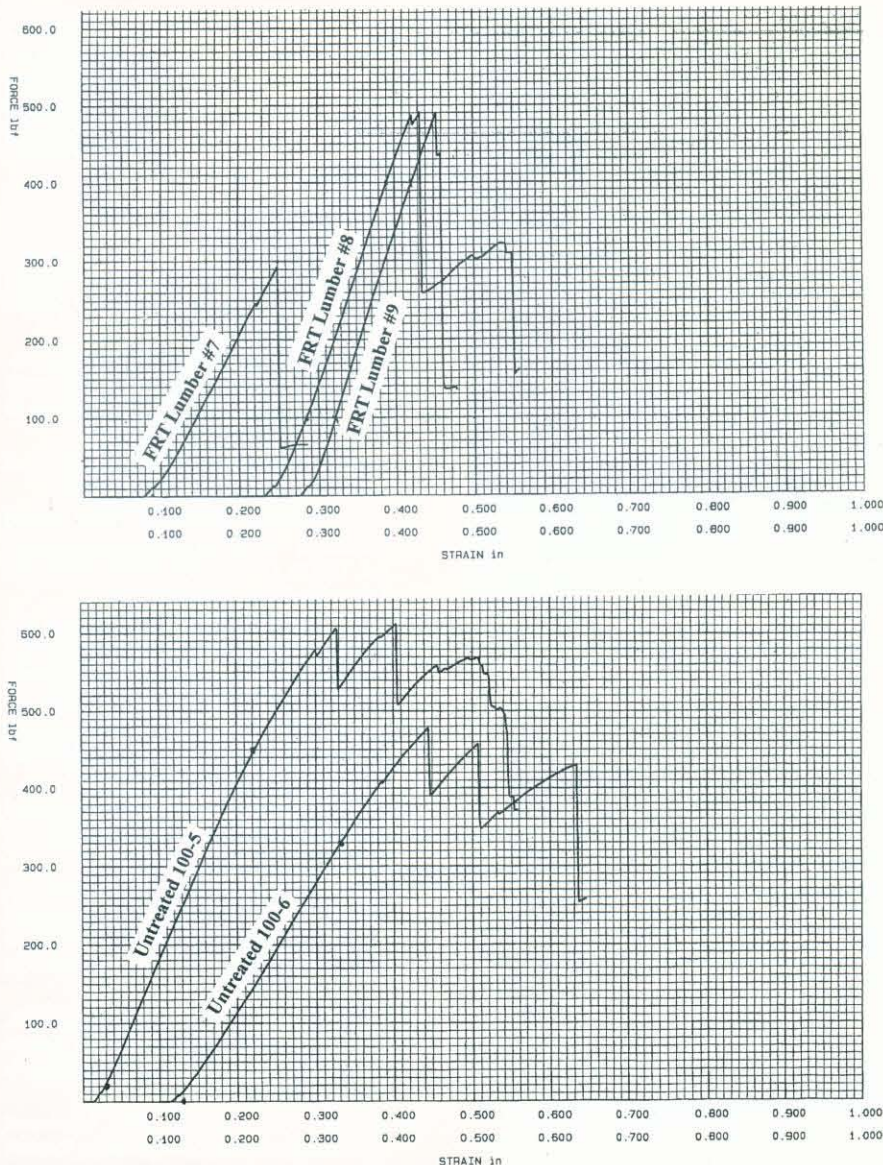
The plots (stress vs. strain) of the test data for the treated wood samples just described typically showed an abrupt mode of failure (**Fig. 1**). These plots included a relatively linear and proportional stress/strain relationship early in the test. However, when failure occurred, the load-carrying capacity of the treated specimens dropped suddenly. The abrupt failure of the treated specimens is depicted by a sharp truncation on the final stage of the test plot. This portion of the test plot typically includes a nearly vertical drop indicating the rapid loss of the specimen's load-carry-

ing capacity. This sharp truncation reduces the area below the stress/strain curve, which is directly related to toughness. The brash and sudden failure contributes to the reduced toughness of the treated specimens (**Fig. 2**).

Figure 1. — Recording plots of static bending tests of FRT wood samples (top) and untreated wood samples (bottom).

The plots (stress vs. strain) of the untreated wood samples just described typically showed a less abrupt mode of failure (**Fig. 1**). Specifically, failure occurred more gradually with the load-car-

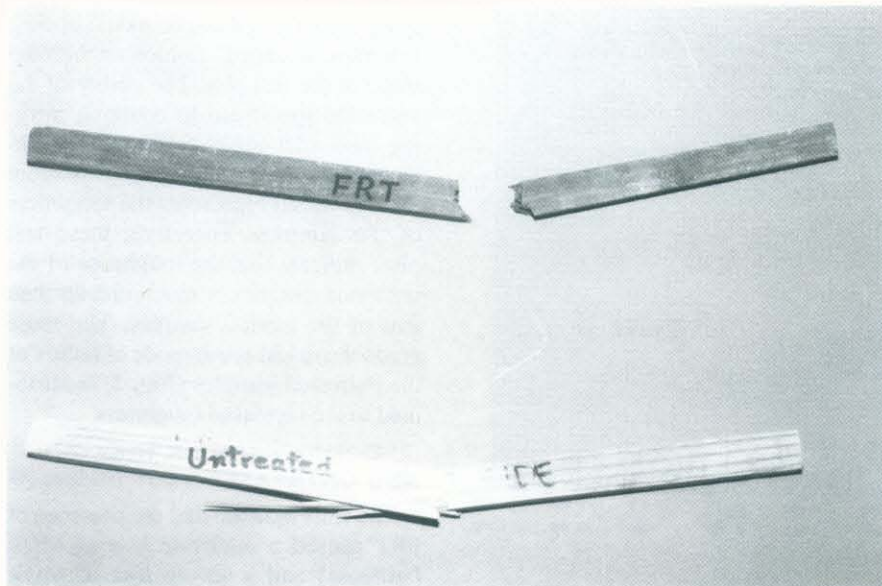
rying capacity of the specimen dropping in a more "stepped" fashion on the final stage of the test plot. The ability of the untreated specimens to continue carrying load after initial failure greatly increased the area below the stress/strain curves, which represents the toughness of the samples. Therefore, these test plots indicate that the toughness of the untreated samples is much greater than that of the treated samples. The more gradual and less brash mode of failure of the untreated samples (**Fig. 2**) is attributed to the increased toughness.

The brittle condition of the treated wood samples is associated with a significant reduction of toughness. The loss of toughness in the treated wood resulted in a sudden and brash failure. In contrast, the untreated wood samples were able to continue carrying load after initial failure. The mode of failure for the untreated samples was more gradual and resilient in nature.

Figure 2. — Failure modes of static bending tests of FRT wood sample (top) and untreated wood sample (bottom).
