# Tech Notes

### LAMAR BARN Yellowstone National Park Wyoming

### Log Crown Repair and Selective Replacement Using Epoxy and Fiberglass Reinforcing Rebars

PTN-28

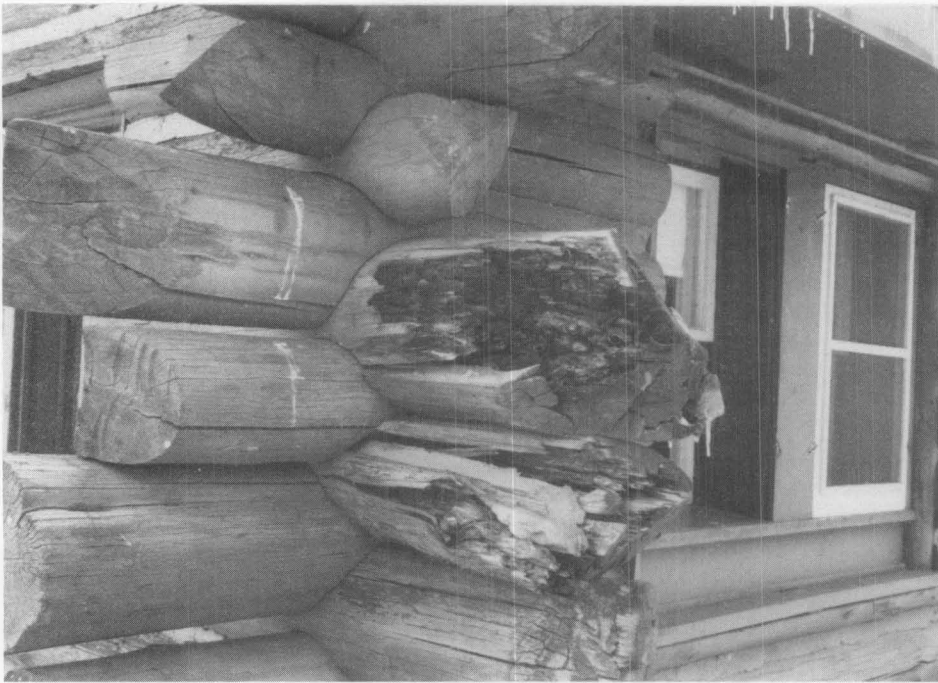
portions of the logs directly exposed to the weather were deteriorated. The culprit in every case was moisture. It was easy to predict where to find the greatest pockets of decay. Log crowns extending beyond the drip edge of the roof were in the worst condition. Sill logs, particularly on the north side of the building, were also badly deteriorated. The amount and depth of decay in both instances followed a pattern: the further out from the roof they extended, the greater the deterioration (see figure 1).

After about sixty years, decay had taken its toll. More than half of the extending crowns were so rotten that it was possible to pull large chunks of the heartwood out of the exposed ends. In some cases, the log crowns were almost totally gone. In others, the shells of the crowns had given way and the soft mulch-like interior had fallen out. In the most severe cases, the decay had penetrated beyond the notch where the logs intersected and had traveled into the log as much as ten to twelve inches. This impacted both the visual and the structural integrity of the walls and their appearance.

Figure 1. Typical deterioration of log crowns is seen at the Institute Building, adjacent to the Lamar Barn. This is the condition of many of the log crowns at the Lamar Barn prior to the repair and replacement work. Logs are notched at the corners. Photo: Harrison Goodall.

Option #3 involved cutting off the deteriorated log crowns at the area of greatest decay (the intersecting notches), and splicing on replacement crowns of the same size, configuration, and texture. This approach had several advantages:

The treatment selected for the log crowns was to splice replacement sections onto sound portions of the wall logs. Additionally, one totally deteriorated sill log required replacement, a few wall logs needed facing, and some decay in checks or horizontal cracks required consolidation with a flexible epoxy. The rafters and purlins, previously cut back, were left untouched.

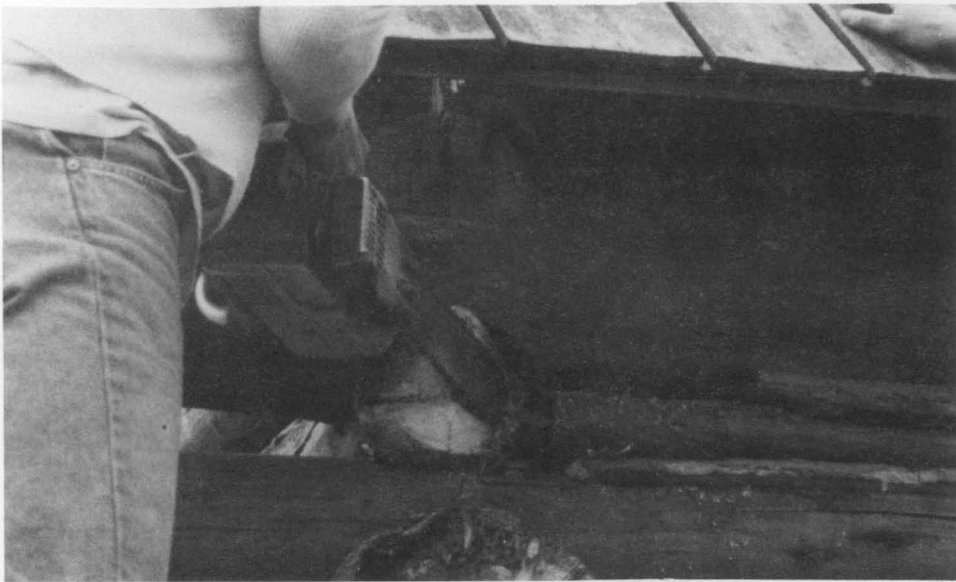
Figure 2. Small chainsaws were used to cut off deteriorated log crowns. The darker portions of wood at the log ends are the soft punky deteriorated fibers. Photo: Harrison Goodall.

Each of the deteriorated log crowns was carefully photographed and documented. Diameter, length from the wall and surface configuration of the cut end of the log were recorded. Then the crowns were cut off, at an angle towards the notch (see figure 2). Next, the original logs were drilled back to the center line of the intersecting walls, using a plumber's bit (see figure 3). This gave a flat surface to begin the new crowns. The recessing with a flat surface to the center line of the wall was more difficult than first anticipated because the barn builder had anchored each log with four galvanized square spikes 8" x 3/8". These spikes had to be chiseled and sawn back to a flat surface so the new crowns could be properly anchored.

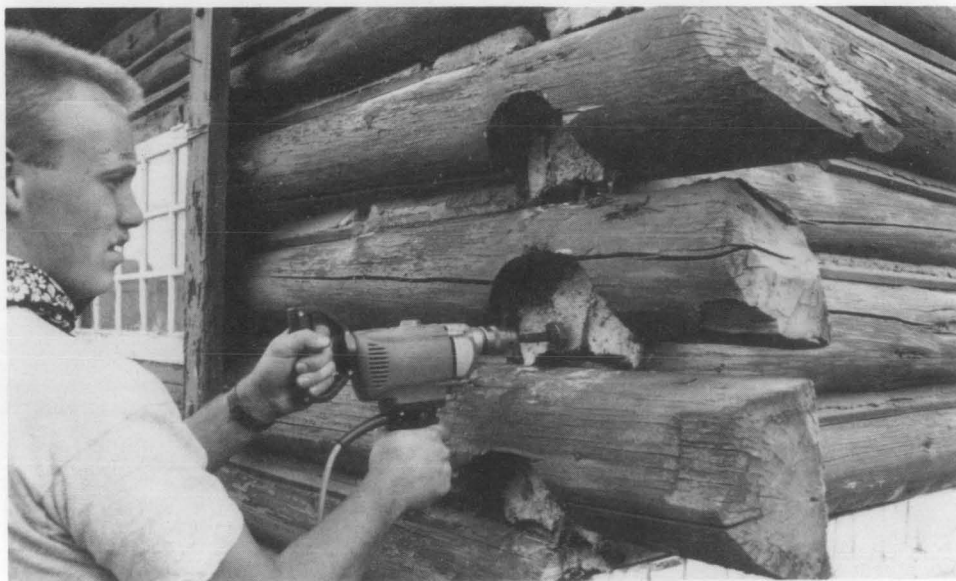
Figure 3. A plumber's bit was used to recess the crown back to the center line to create a flat surface for attaching the replacement crowns. Photo: Harrison Goodall.

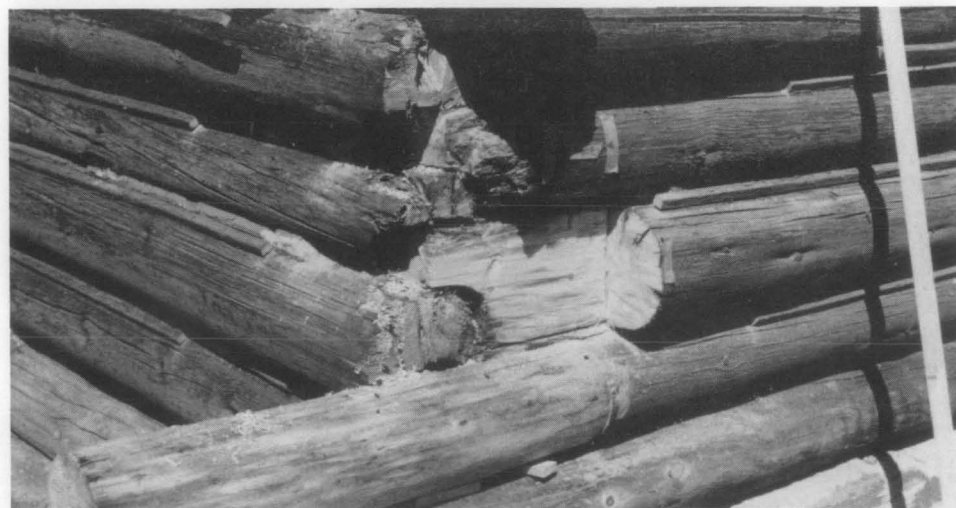
Figure 4. In a few cases, the deterioration had penetrated beyond the center line of the log corners and portions of the wall face were removed. Photo: Harrison Goodall.

In a few cases, deterioration penetrated beyond the center line of the wall, and more material had to be cut back to reach sound wood. A rotary rasp, not unlike a king-size dental drill, was used to remove remaining decay at the center line. The sound wood surface was treated with an epoxy consolidant to encapsulate remaining soft absorbent wood, thereby retarding future decay. Where the decay had traveled into the log walls, sufficient wood was removed and the surface flattened to permit new faces to be attached to the logs (see figure 4). These new faces were notched to match the log surfaces removed.

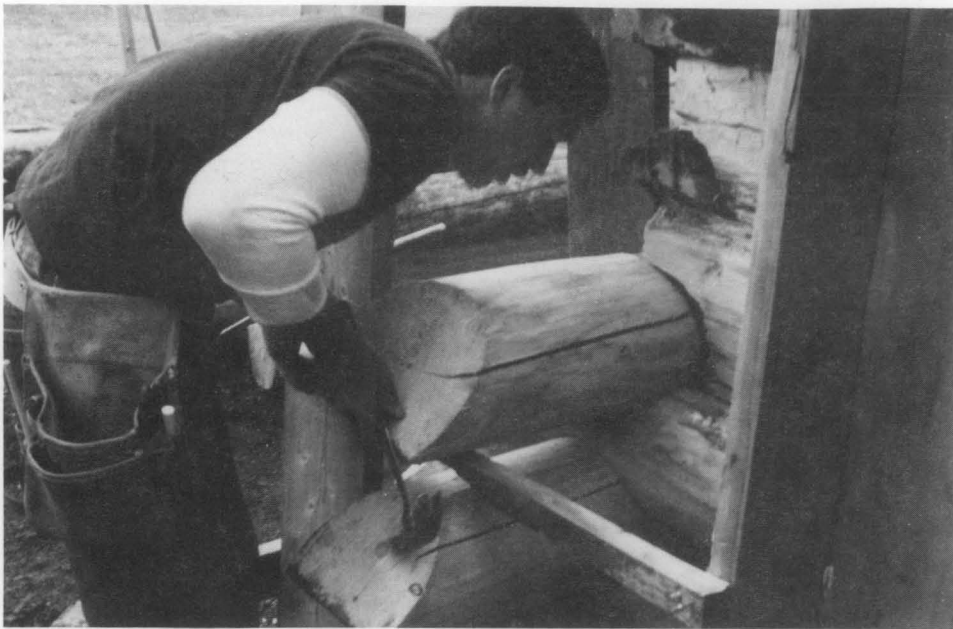
**Figure 5.** A framework or cribbing held the replacement crowns as they were fabricated. All the crowns had to be temporarily put in place to ensure a proper fit. Once stacked up, they were numbered to make sure they would be properly aligned at the time of anchorage.  
Photo: Harrison Goodall.

The photographs of the deteriorated crowns were used to reconstruct the replacements. Each replacement log crown was cut and fitted until it matched the notch of the original. A wood framing not unlike cribbing was constructed at each corner to hold the replacement log crowns as they were marked, cut, and fitted in place from the bottom level up (see figure 5). As much as possible, checks in the wood were placed in a downward position to prevent water from collecting in the wood. As the crowns were extensions of the logs and not supported by the ground, it was necessary to provide temporary support until the replacement crowns were epoxied in place. The log crowns were not anchored until all had been stacked in place with all notching complete. They were then marked to ensure proper alignment when anchored.

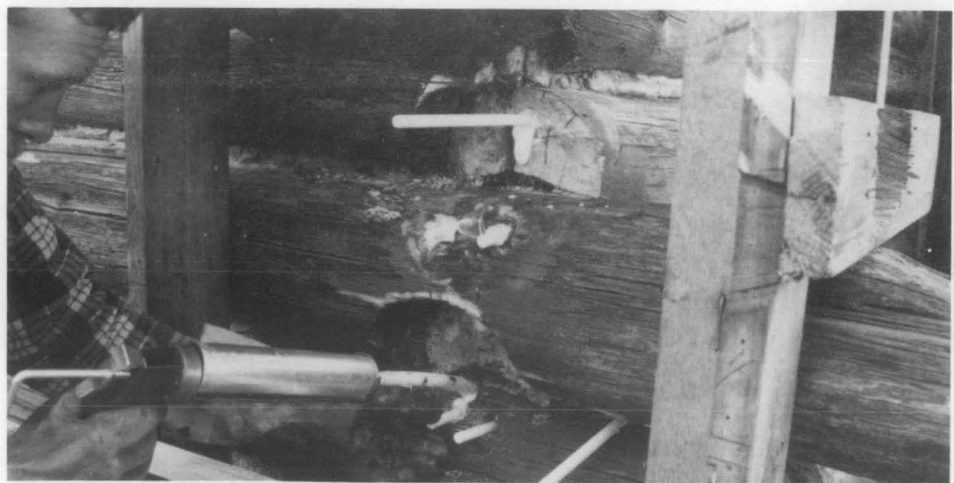
**Figure 6.** A flexible tube was stapled onto a caulking gun in order to fill the 12"-12 1/2" deep holes that had been drilled into the sound end of the historic log. The individual hole was filled two-thirds with epoxy adhesive and a 1/2" diameter fiberglass reinforcing rebar was then inserted.  
Photo: Harrison Goodall.

The holes (7/8" diameter) for the 1/2" reinforcing fiberglass rebars were drilled into the original logs. Corresponding holes were drilled into the crowns. An 8" piece of flexible tubing was stapled onto the nozzle of a caulking tube in order to reach to the back of the long drilled hole. The caulking gun was filled with a high-strength structural two-part epoxy in a paste-like consistency, which was then injected into the original log. The cavity was filled two-thirds. The paste-like consistency of the epoxy kept it from draining out of the drilled hole. The precut rebar was then inserted using a twisting motion (see figure 6). The replacement crown was also filled two-thirds with epoxy, then aligned, inserted and left to cure (see figure 7).

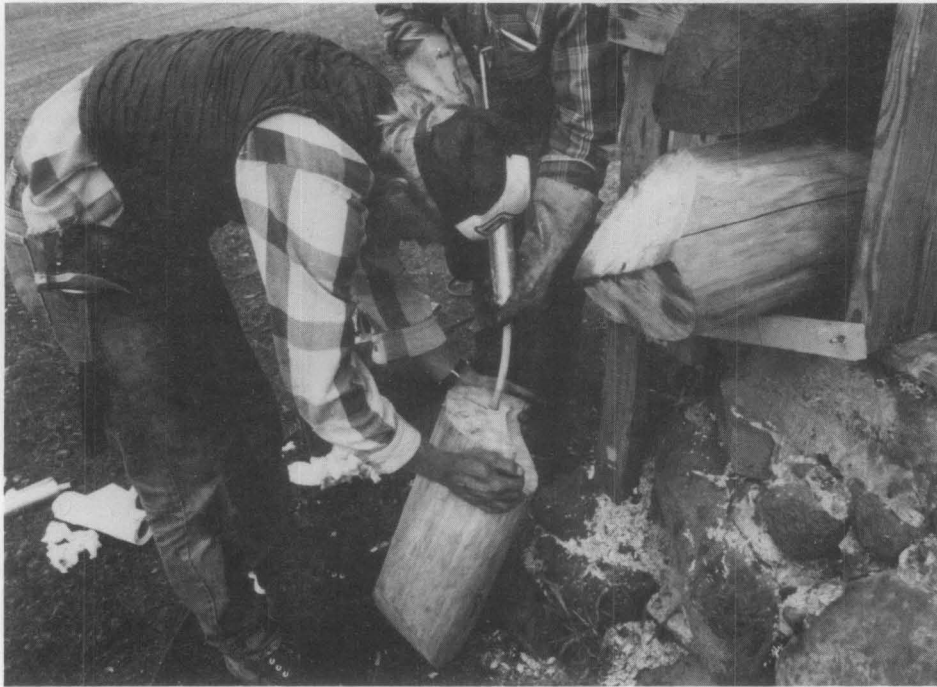
Figure 7. A 12 1/2" long hole was drilled into the new crowns. This hole was filled in the same manner as were the old logs. The crown was then immediately lifted into position and supported by the cribbing framework for several days until the epoxy cured. Photo: Harrison Goodall.

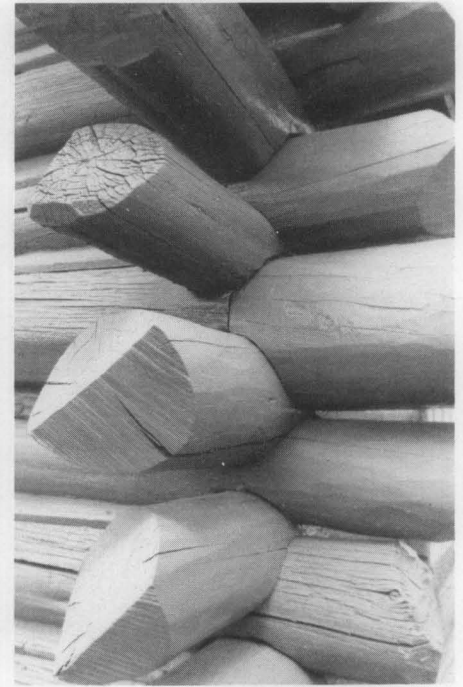
Figure 8. The joints between the historic logs and the new crowns are visible, but not disconcerting. The unsealed joint will help keep future decay isolated to the log crown. Photo: Rodd Wheaton.

While there is a tendency to caulk the cracks in wood, it has been found that in many instances it is best to leave small checks open to let wood breathe naturally (see figure 8). For this reason the joints between the log crowns and the original log walls were also left open and not sealed. The new crown ends are expected to last between 10 and 30 years. The upper crowns directly under the roof runoff are likely to deteriorate first. These can be replaced as required. As with any completed preservation project, the better the routine maintenance the longer the work will last and the more cost-effective it will be in the long run (see figure 9).

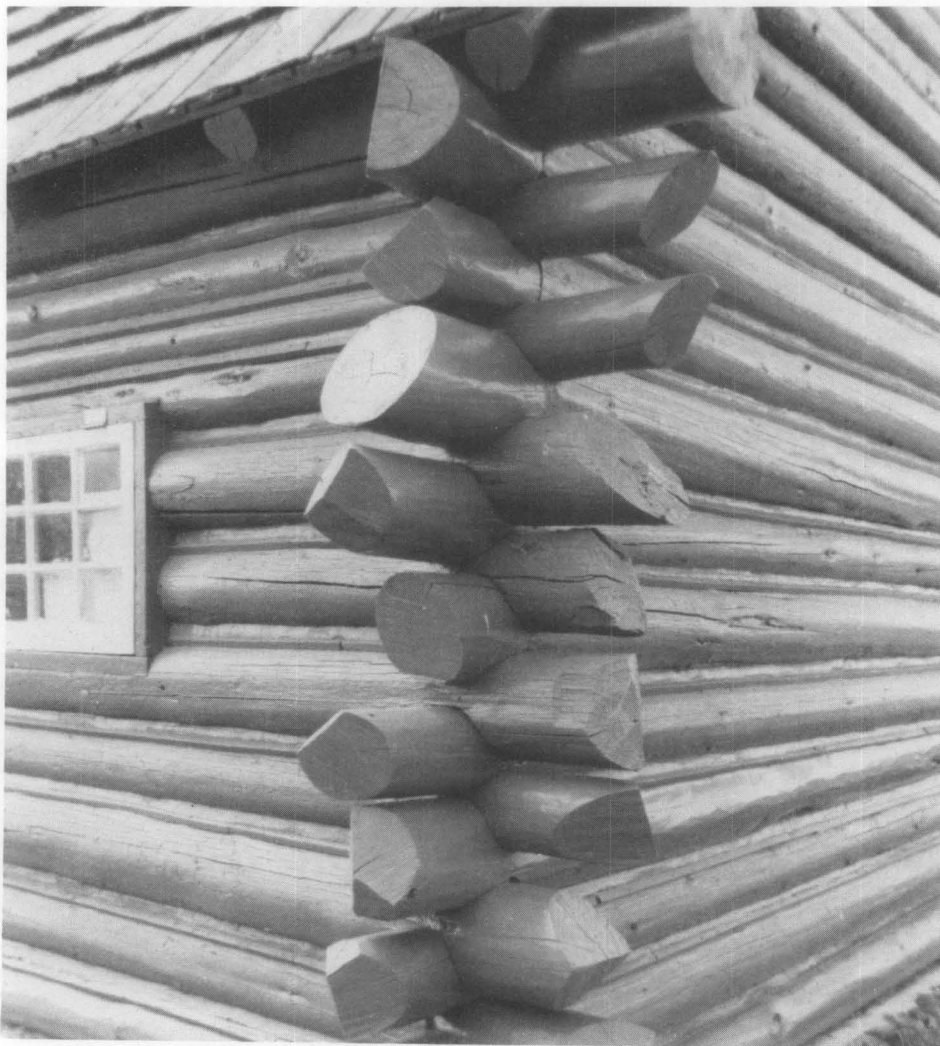
Figure 9. A repaired corner of the Lamar Barn. It is expected that the log crowns will need replacing in 10-30 years. Photo: Rodd Wheaton.

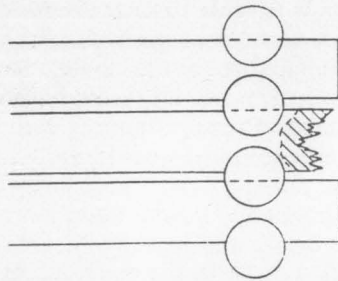
Deteriorated log crown.
