REDUCING THE FIRE HAZARD

IN ALUMINUM-WIRED HOMES

Jesse Aronstein, PH.D., P.E.

Latest update January 27, 2004

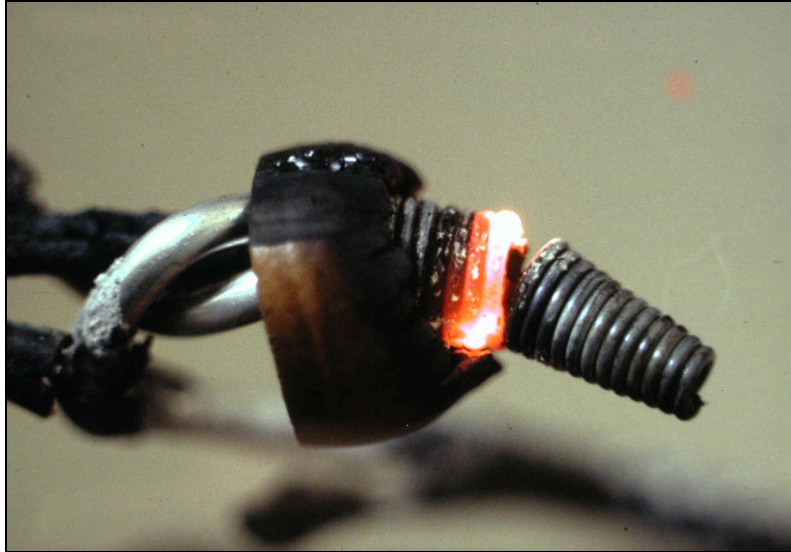
FIGURE 1 - ALUMINUM WIRE SPLICES MADE WITH TWIST-ON CONNECTORS CAN BE DANGEROUS. The use of most types of twist-on connectors with aluminum wire can lead to hazardous results. This twist-on pigtail connection (two #10 aluminum wires with one #12 copper wire, in a 20-amp circuit), made with a twist-on connector that was UL listed for use with aluminum wire at the time, remains electrically functional in the circuit, but it becomes extremely hot whenever a significant amount of current flows. The heat has deteriorated the insulation on both the connector and the wires. In this photo, a portion of the connector's spring is red hot, at current well below the circuit rating.

The most certain corrective action for all cases would be to rewire the home with copper wire. This is expensive and impractical in most cases. A practical approximation to rewiring can be achieved by a method known as "pigtailling", using a specially-selected connector and installation method to splice a short length of solid copper wire to each aluminum wire end. The copper wire "pigtail" is then connected to the circuit breaker, light fixture, receptacle, dishwasher, or other termination. This method is only effective if the connections between the aluminum wires and the copper pigtails are extremely reliable. Pigtailling with some types of connectors, even though they might be presently listed by UL or certified by CSA for the application, can lead to increasing the hazard.[5][6] (See Figure 1.)

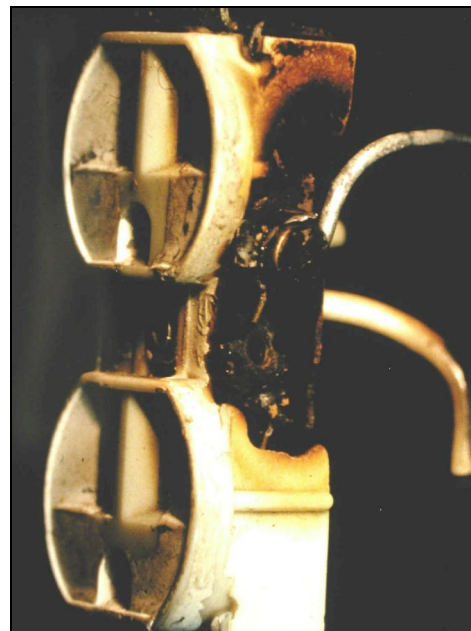
FIGURE 2 - EXAMPLE OF OVERHEATING OF ALUMINUM-WIRED TERMINALS ON A RECEPTACLE. Enough heat was generated by current flowing through the aluminum wire connections to cause charring of the receptacle body and disintegration of the insulation that was on the wire. Note that the face of the receptacle, as the homeowner or an inspector would have seen it, with the cover plate on, would look normal.

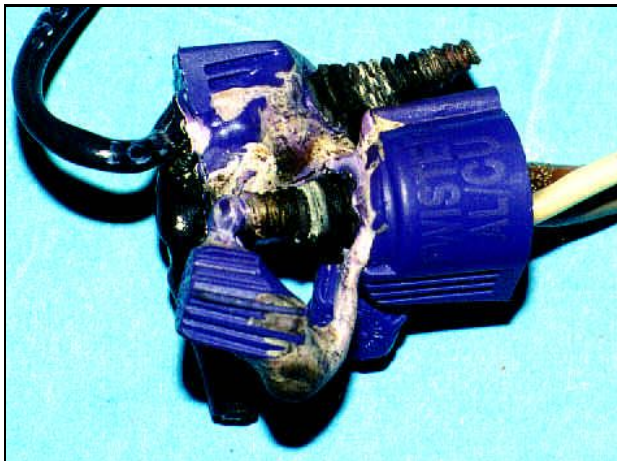
A. THESE TWO FAILED SPLICES ARE ADHERED TOGETHER BY THE MELTED PLASTIC SHELLS

FIGURE 4 - FIELD FAILURES OF ALUMINUM TO COPPER SPLICES MADE WITH IDEAL #65 CONNECTORS [12]

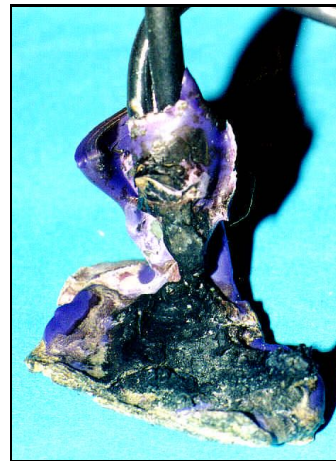
B. SEVERE FAILURE, PLASTIC SHELL MELTED AND CHARRED. THE CHARRING INDICATES THAT IT HAD PROBABLY IGNITED.
