REPORT ON EXCAVATION SURVEYS ON INTERLOCKING BLOCK PAVEMENTS WITH GEOTEXTILE

Ando, Y., Noda, E. and Yaginuma, H.

Yutaka Ando, Sumitomo Osaka Cement Co., Ltd. Etsuro Noda, Nippon Road Co., Ltd.
Hiroshi Yaginuma, ILB Co., Ltd.

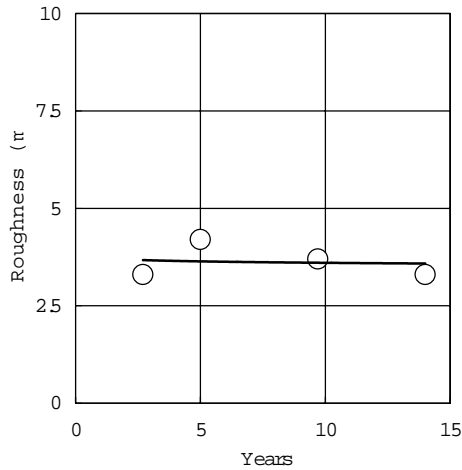
Figure 2. Relationship between Number of Service Years and Degree of Roughness.

Figure 2 shows the relationship between the number of service years and degree of roughness. A longer period in service does not necessarily mean a higher degree of roughness, which remained at around 3 mm to 4 mm. One of the reasons why the roughness remained intact would have been that the geotextile helped maintain regularity. Figure 3 shows the relationship between the number of service years and rutting depth. The ruts tend to become deeper with increasing years in service, but the deepening rate is small, and the ruts remain at favorable values of around 5 to 10 mm even after 15 years in service. Figure 4 shows the relationship between the number of service years and block breakage rate, as compared with the existing data on pavements without geotextile. The rate of block breakage is a half or less of that of pavements without geotextile, which proves the beneficial effect of installing geotextile in interlocking block pavements.

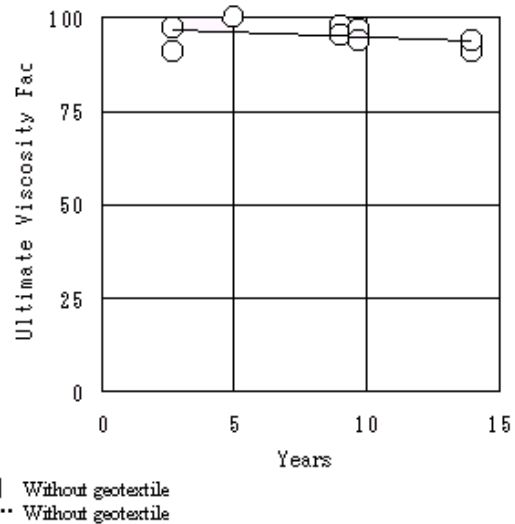
Figure 5. Secular Changes in Ultimate Viscosity Factor.

Figure 5 shows the relationship between the number of service years and ultimate viscosity factor of geotextile. This factor, which provides an indication of deterioration in a polymeric material, showed a favorable value of 90% or more even after 14 years in service. In view of the above, there is little risk of deterioration of geotextile durability after 15 or so years in service.
