## **THE HEXAGON (Ephraim Shay House) Harbor Springs, Michigan**

### **NUMBER 3**

## **In-Kind Replacement of Historic Stamped Metal Exterior Siding**

**Rebecca A. Shiffer**  
Mid-Atlantic Regional Office  
National Park Service

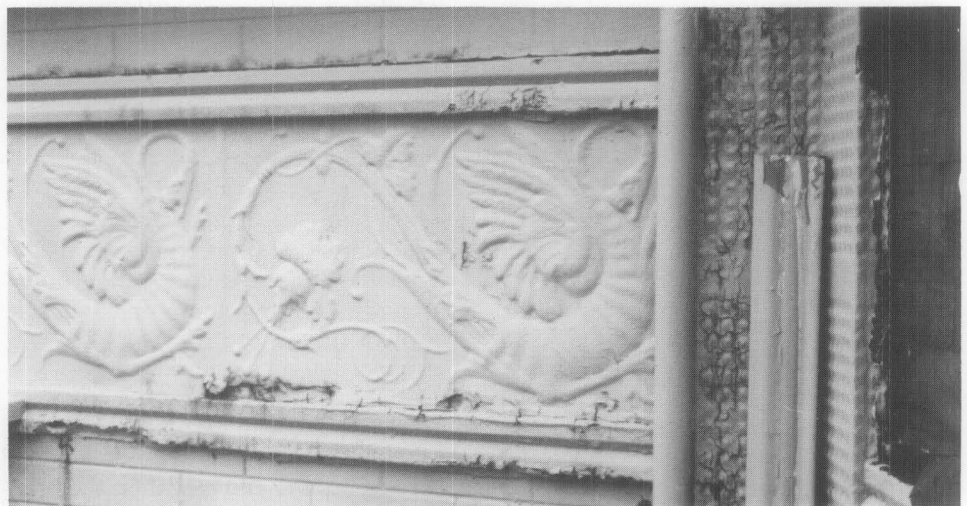
The house had been poorly maintained for several decades and, more recently, had been unoccupied. The asphalt shingle roof that replaced the original standing seam metal roof leaked badly, allowing water to penetrate into the wall cavities behind the stamped metal siding. Due to neglected repairs and cleaning, the original drainspout system failed to divert rainwater away from the house (*see figure 3*). In some places, rainwater

3. Stamped metal siding simulating brickwork covered most of the exterior of the house. Pebbled corner pieces and several ornamental bands added decorative details. Deteriorated drainspout and original plank wall sheathing are at right. Photo: Richard Hiler.

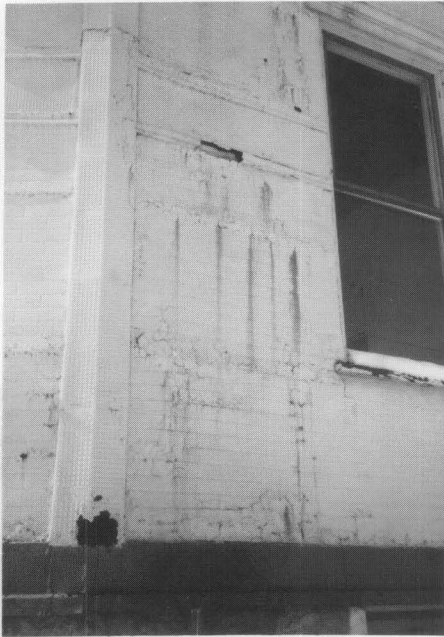
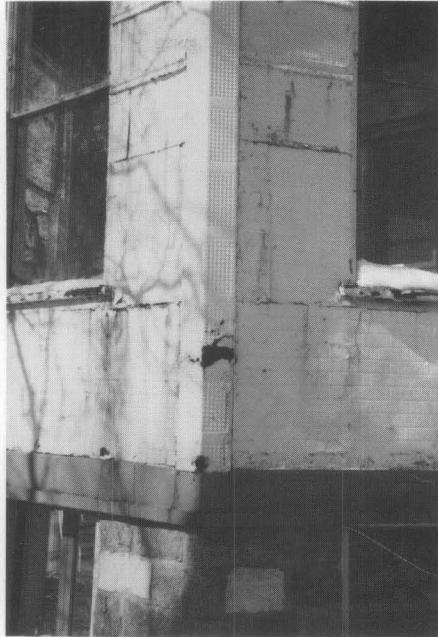
Although the original galvanized (zinc-coated) steel and zinc siding had been back-primed, long-term water infiltration caused the siding to corrode from the inside toward the face. The location of the building at Little Traverse Bay also contributed to the slow deterioration of the siding. In extremely deteriorated areas, the metal had been reduced to an easily breakable, crusty mass. An assessment of the exterior revealed that nearly 90% of the stamped siding had moderately or severely deteriorated to the point that replacement was required (see figure 4). Since only a small percentage of the siding was salvageable and all needed to be removed to facilitate other project work, the decision was made to replace all of the metal siding.

4. Rust stains indicate where corrosion, caused by water infiltration, are breaking through the metal from the rear. Rust and separation are also evident at seams between sheets of stamped metal. Inspection determined that nearly 90% of the stamped metal siding had to be replaced. Photo: Richard Hiler.

Five exterior sheet metal patterns required replacement: the brick pattern that covered more than half of the exterior, two ornamental band patterns, the wall corner pattern, and the molding that separated the ornamental bands from the brick pattern (see figure 5).

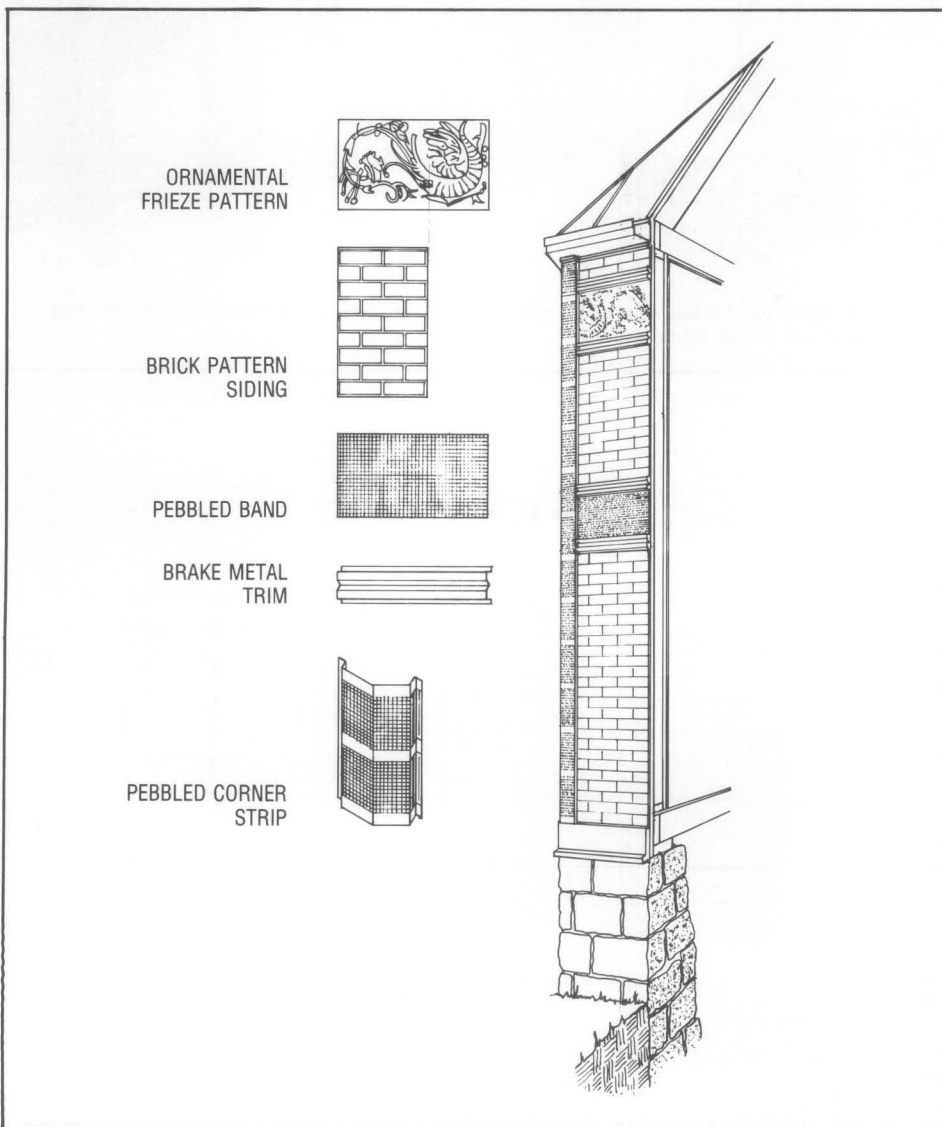
5. Five different sheet metal patterns were used to cover the exterior wall. Drawing: Timothy Buehner.

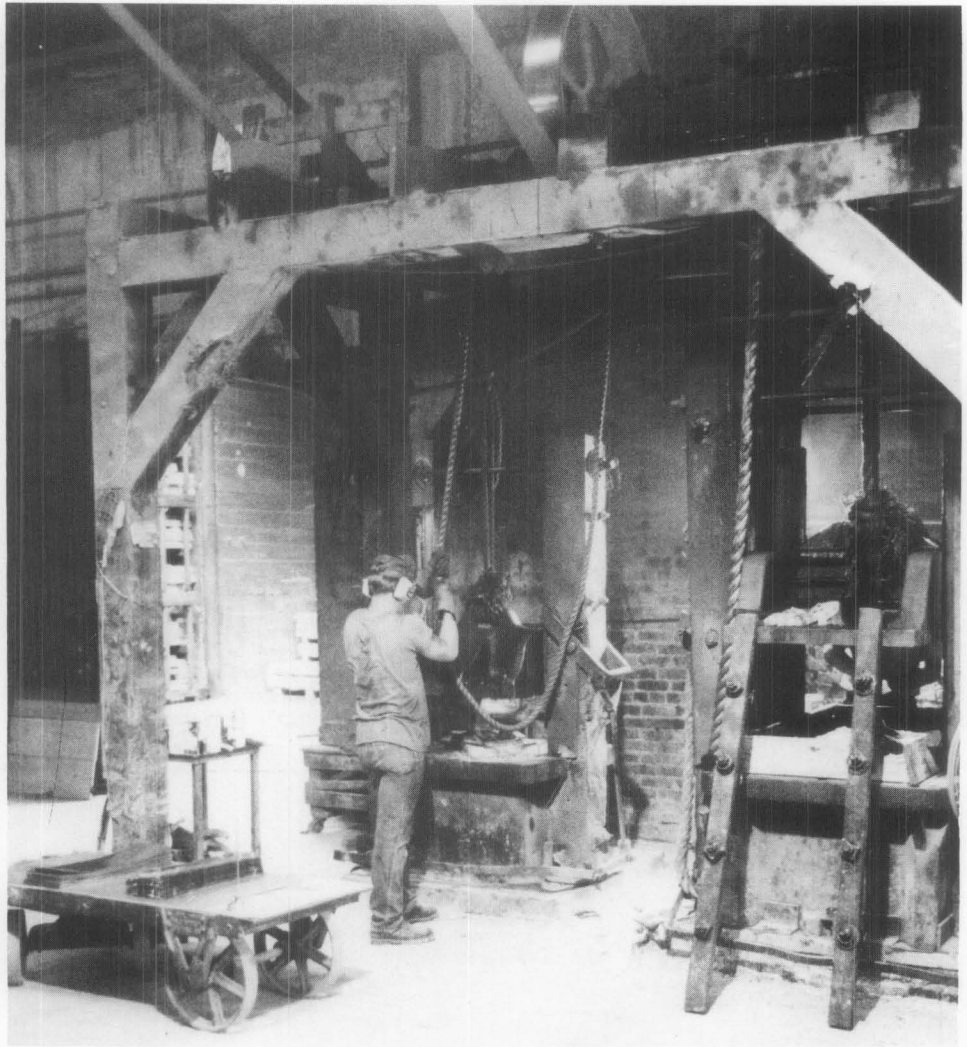
6. The stamped-metal siding was made the traditional way using gravity drop hammers and cast-iron dies. Photo: Lance Carlson.

the male half attached to a large, cast-iron hammer, known as a gravity drop hammer, hanging above the press bed. A sheet of metal was then placed over the die on the cast-iron bed, and a press operator released the hammer to drop onto the bed, stamping the design into the metal by the force of the meeting of the die-set (see figure 6).

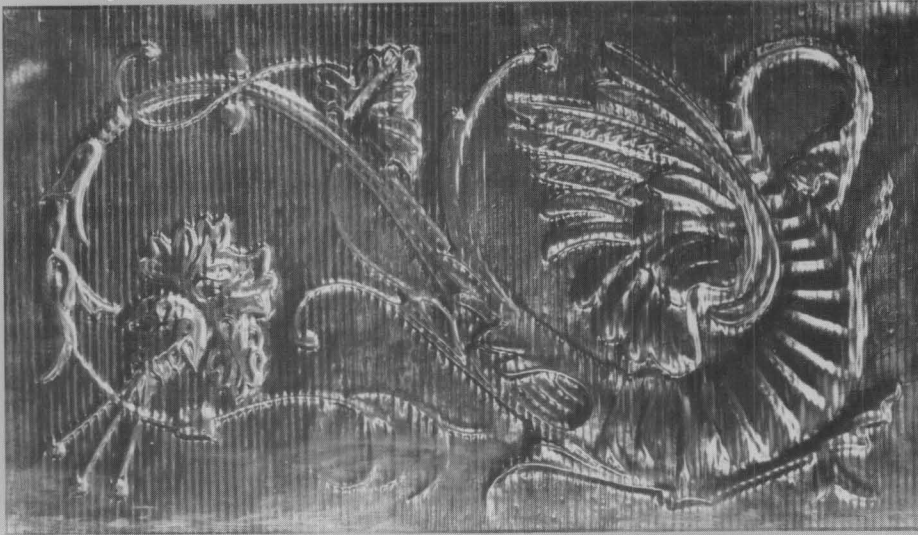
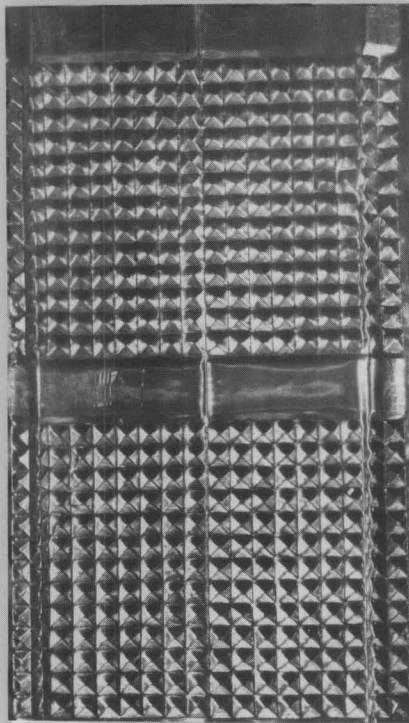
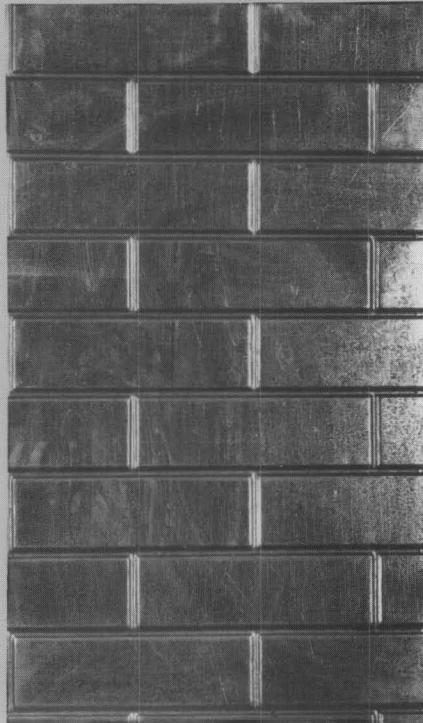
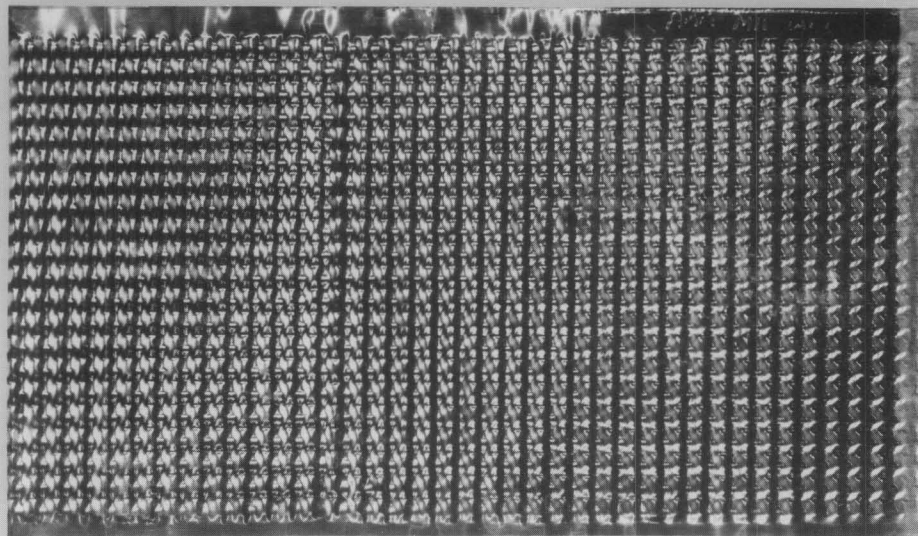
8. The four stamped patterns used at the Hexagon are shown (samples in photograph are smaller than the actual sheet size).

The ornamental frieze pattern, pebbled corner strip, and pebbled band were all stamped into pure sheet zinc. More malleable than galvanized steel, zinc is used when the relief of the design must be deep and sharp. The pieces of the pebbled band measured 13" by 48", and the pieces of the pebbled corner and the ornamental frieze measured 15" by 48" (see figure 8).

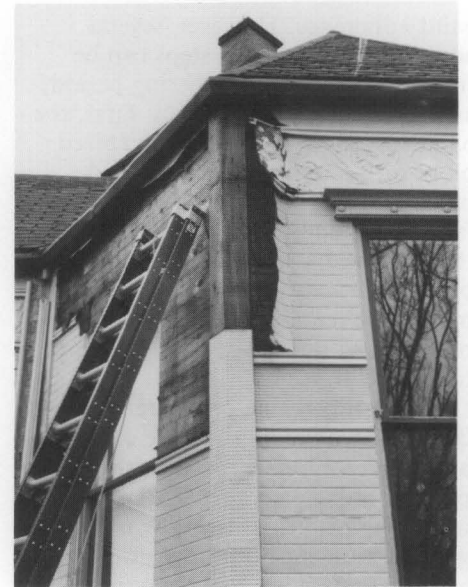
9. Original exterior siding was removed, revealing the exterior plank wall sheathing, which was also removed in order to install additional insulation and a vapor barrier. Photo: Mary Cay Bartush Jones.

After ordering the replacement metal siding, the contractor waited approximately three months for its arrival at the job site. During this time, a new metal roof was installed and the walls were prepared to receive the new siding. The total replacement of the siding provided an opportunity to add wall insulation for enhanced energy efficiency. Insulation was installed from the exterior to avoid damage to the stamped sheet metal covering the interior walls and to permit installation of a vapor barrier. This required removal of all the exterior plank sheathing, some of which was also deteriorated (see figure 9).

Removal of the plank sheathing also permitted repair and replacement of some deteriorated original framing, primarily on the south side of the house and at the lower portions of the walls. A vapor barrier was installed against the back of the interior plank sheathing. Sheets of 3-1/2" fiberglass

insulation were placed in front of the vapor barrier, and 3/4" plywood was installed as an exterior sheathing in place of the original planks.

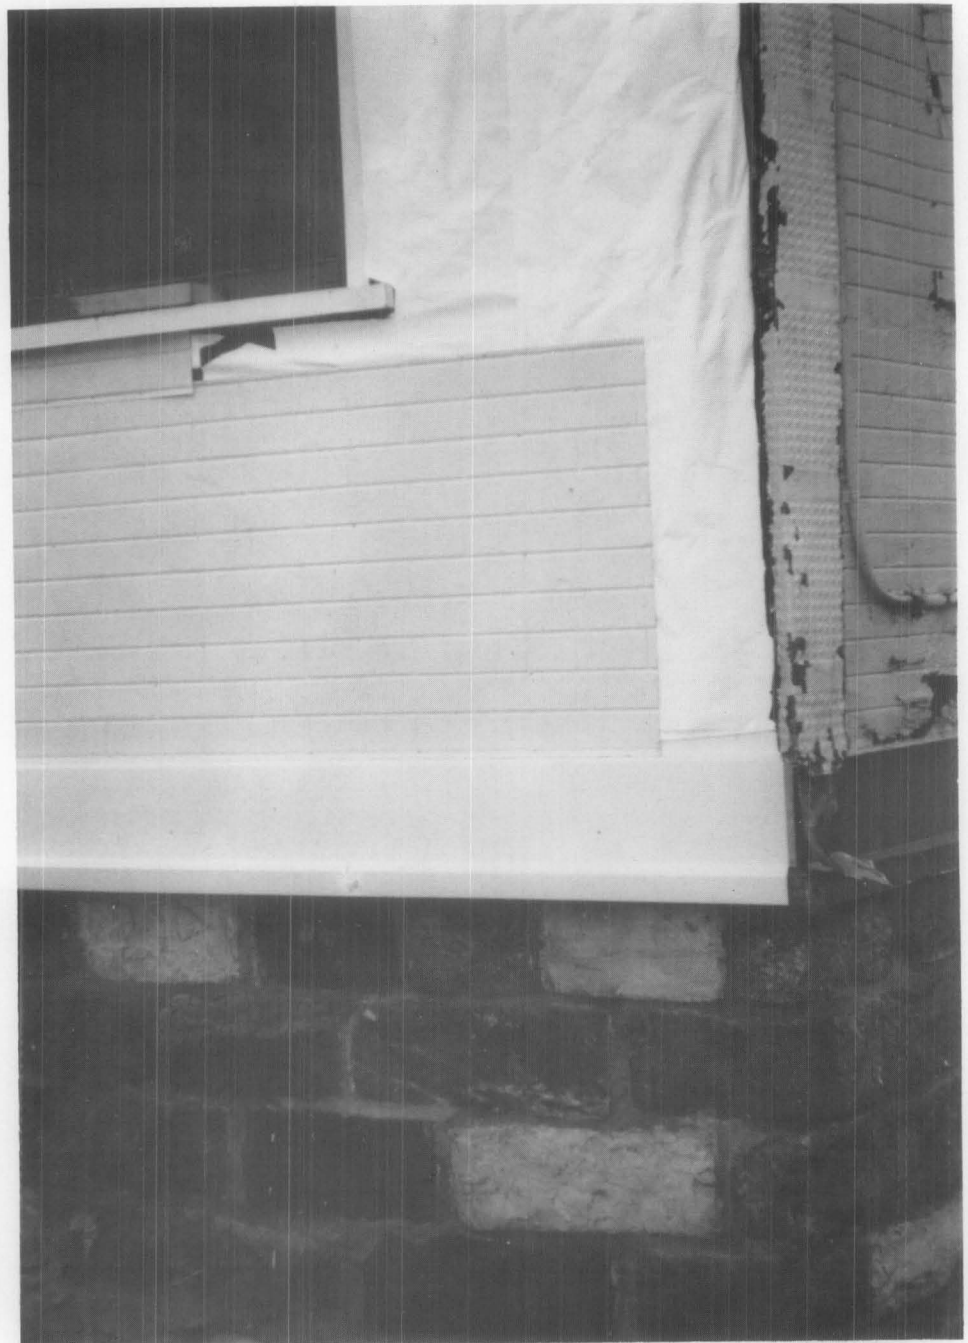
10. Installation of siding began at the base of each story of the building. Corner pieces were installed first, followed by the base flashing, and the stamped brick siding. Care was taken to match the patterns from one elevation to the next around the building. Photo: Mary Cay Bartush Jones.

On each story, installation began at the bottom and proceeded upward toward the roofline (see figure 10).

Each piece of siding lapped over the piece of siding below it and was face-nailed to the house's wood frame. The siding also lapped over the already installed corner pieces. Since the new sheets and bands of siding were identical in size to the originals, only minor trimming was required.

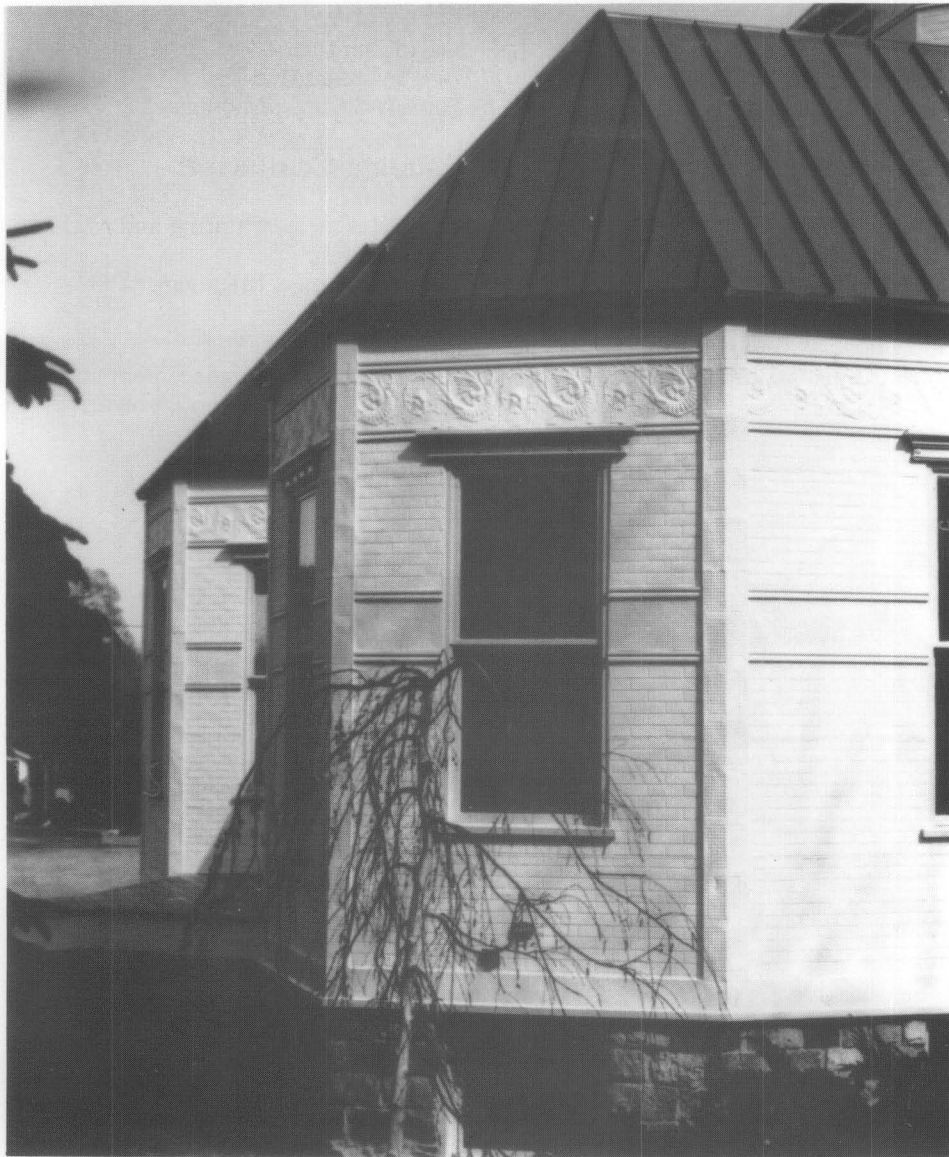
11. Finished appearance of several elevations. Siding has been face nailed to underlying materials and second coat of paint has been applied. Each piece of siding laps over the piece below it, and all overlap the corner pieces. Photo: Richard Neumann.

In the original construction of the Hexagon, the siding had been installed before the windows had been set into the walls. During this project, the window frames were retained in place, so the new siding was bent around and tucked back alongside them. A quarter-round molding was then installed and the edges sealed with a silicone-based caulk. The window hoods were reinstalled after the siding was in place (see figure 11).

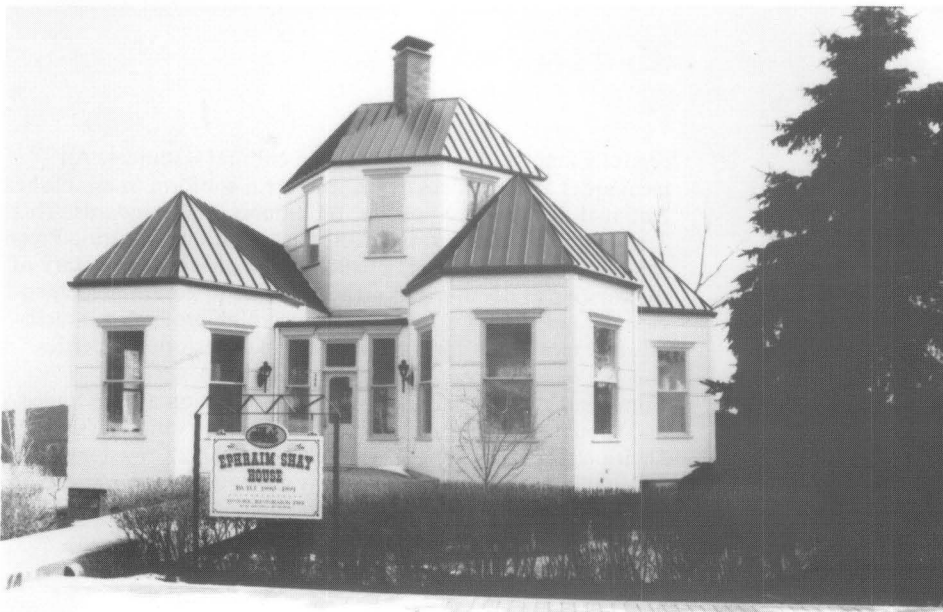
12. The replication of the stamped metal siding has restored the Hexagon to its historic appearance. A new metal panel roof system that duplicates the appearance of the original standing seam roof also contributes to the restoration. Photo: Richard Neumann.
