J. ARONSTEIN
CONSULTING ENGINEER
MECHANICAL AND MATERIALS ENGINEERING
BME, MSME, Ph.D., N.Y.S. P.E. LIC. NO. 39860
50 PASTURE LANE POUGHKEEPSIE, N.Y. 12603
(845) 462-6452 aronsteinj@verizon.net

HAZARDOUS FPE CIRCUIT BREAKERS **AND PANELS**

Information for Homeowners, Inspectors, and Electricians

(Updated December 2, 2011)

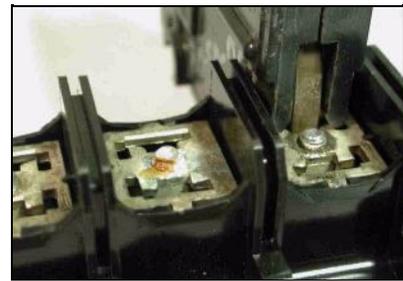
**C. Stab socket on a post,
attached with an 8-32 steel screw.**

Of the three types illustrated, the one shown in Figure 2-C is known to have a high probability of deteriorating and overheating of the stab socket structures when subjected to significant current flow. Each individual stab socket plate is connected to its bussbar via a post (spacer), and the assembly is held together by an 8-32 steel screw. FPE panels with this construction are prone to overheating failure. Eight of the panels of the present study that showed evidence of serious overheating were constructed this way. One example is shown in Figure 3.

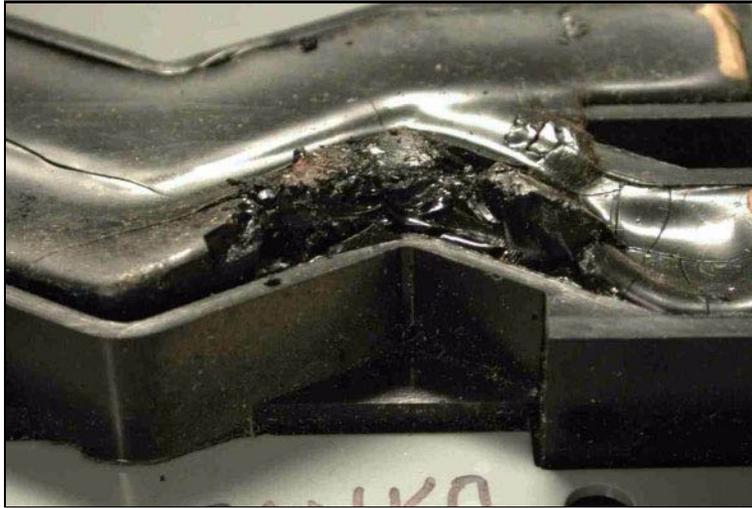
FIGURE 3 - OVERHEATING AT THE CONTACT BETWEEN THE BUSSBAR AND THE STAB SOCKET ASSEMBLY CAUSED THIS DAMAGE TO THE INSULATION.

(This view is of the backside of the panel. The damage cannot be seen unless the panel is taken out of the enclosure.)

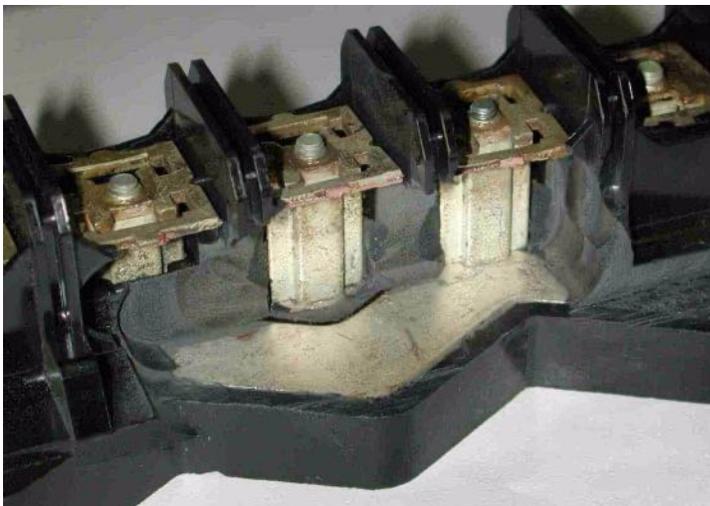
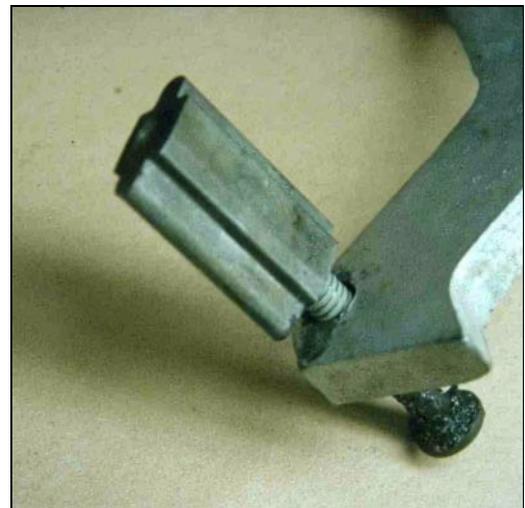
FIGURE 4 - CONDUCTING PATH FROM BUSSBAR TO STAB SOCKET

A more serious failure of this type has been documented.¹ In that instance, the failure had been severe enough to ignite a smoldering fire on the plastic insulating material. The fundamental weakness in this design is the use of a single, relatively flimsy 8-32 screw to hold a structure together that can feed up to four half-width breakers with a total "ampacity" (rated circuit capacity) up to about 160 Amps. Figure 4 shows how the stab socket plate and post are attached to the busbar.

Various material combinations were utilized by FPE in these assemblies. Some bussbars are copper, others are aluminum. Some posts are copper, others are aluminum. The worst case (most likely to fail) is where both the bussbar and the post are made of aluminum, and the best case (least likely to fail) is where both are made of copper. Inspectors (or homeowners, or electricians) have no way of knowing which materials are utilized in any particular FPE panel with this type of construction.

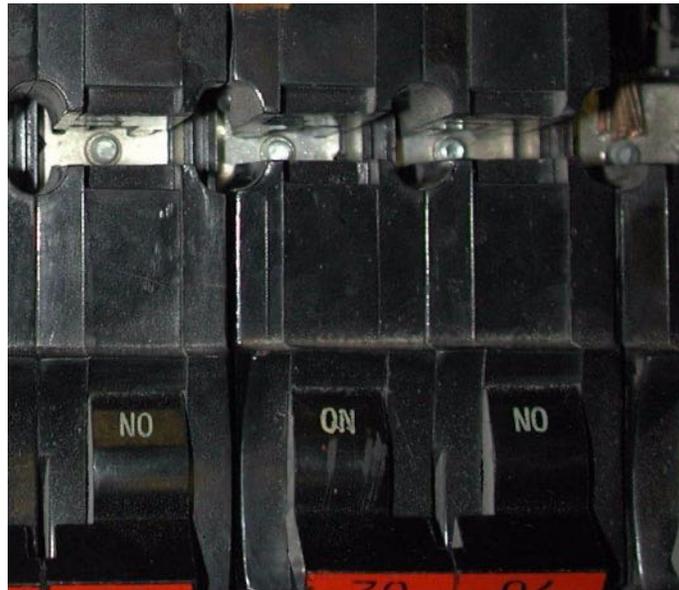
Inspectors can, however, determine if a particular FPE panel has this type of construction, and, to a limited extent, whether it has failing bussbar interconnections that have previously overheated. With the panel cover off, for this type of panel, the inspector can see the ends of the screws that attach the stab socket plates, as shown in Figure 5. (Note: If there are slotted screwheads visible, that is a different type of panel construction.) The stab socket plates and the visible ends of the screws should have a bright metallic look. Darkening, discoloration, or signs of corrosion most likely indicate past episodes of abnormal overheating.

FIGURE 5 - THE ENDS OF THE SCREWS HOLDING THE STAB SOCKET PLATES ARE VISIBLE BETWEEN THE TWO ROWS OF BREAKERS. THIS IDENTIFIES IT AS A PANEL OF THE TYPE SHOWN IN FIGURE 2-C

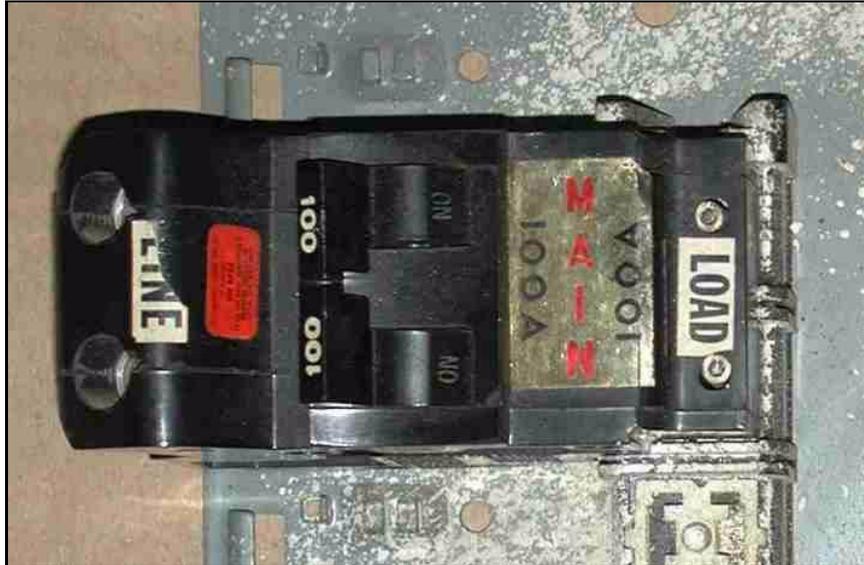
Some FPE Stab-Lok[®] panels have 100-amp main breakers that feed into the bussbars through the same plate and post system. In this design, the two main breaker output terminals do not have the stab type contact. Instead, each one is screwed down to a plate the same size as the stab socket plate, but which has a threaded hole in it instead of the stab openings. As with the plate and post assembly, the screws clamping the main breaker to the busbar assembly are size 8-32, which is absurdly small for a 100-amp main breaker connection, and this is another common point of overheating failure.

FIGURE 6 - FPE 100-AMP MAIN BREAKER CONNECTS TO THE BUSBARS THROUGH THE PLATE & POST CONFIGURATION, USING ONE SOCKET-HEAD 8-32 SCREW FOR EACH POLE TO ATTACH TO ITS CONTACT PLATE.

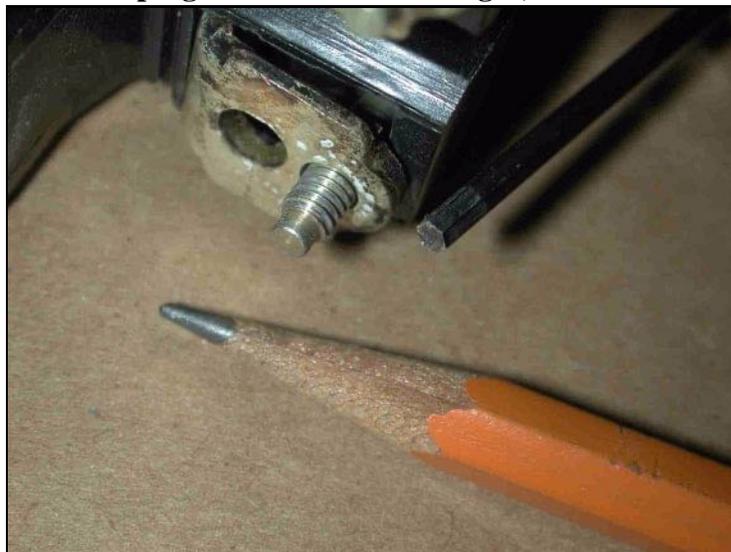
To put the diameter of the 8-32 screw in perspective, it is the same size as used on common receptacles for connecting #14 or #12 copper wire (for 15- and 20-amp circuits), with a diameter of only about 5/32". An FPE panel and main breaker of this type is shown in Figure 6. The main breaker's output terminal mounting screws and the tiny Allen-wrench that fits them are shown in Figure 7.

FIGURE 7 - ONE LOAD-SIDE CONTACT AND ITS 8-32 CLAMPING SCREW, ON THE FPE 100-AMP MAIN BREAKER OF FIG. 6. THE SCREW-HEAD TAKES A 3/32" ALLEN WRENCH, WHICH IS ONLY SLIGHTLY LARGER THAN THE LEAD OF THE PENCIL.

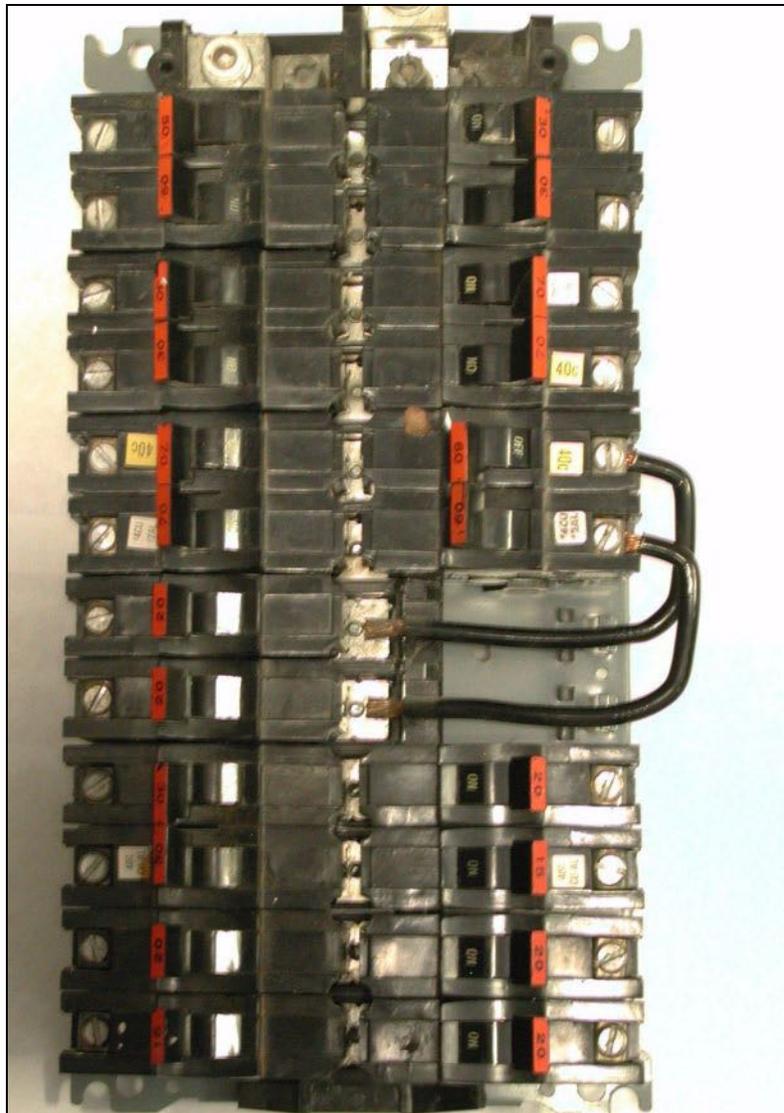
FIGURE 8 - FPE STAB-LOK® "RULE-OF-SIX" (SPLIT-BUS) PANEL WITH NO MAIN BREAKER. THE JUMPER CABLES ON THE RIGHT SIDE FEED THE LOWER SECTION.

There are many different design variations, but the essential element is that in these "rule of six" panels there is no main breaker, and, typically, the lower section of the panel is fed from jumpers coming from the output of one of up to six double-pole breakers in the upper section. The FPE Stab-Lok® double pole breakers have a relatively high probability of jamming when called on to trip, however, as previously demonstrated by the test results presented in Section 2. That means that the home with an FPE "rule-of-six" panel has an unacceptably high probability of having one or more circuits that are totally unprotected, in which the maximum current flow is only limited by what the transformer on the pole can deliver. That may be of the order of 1,000 Amps or more.

On first glance, the FPE Stab-Lok® panel previously shown in Figure 8 looks normal. In fact, however, it clearly demonstrates several of the hazardous failure modes discussed in the previous sections. It is one of those collected for the recent testing. It is from a home built in 1974, whose new owners had determined in 1999 that it should be replaced. Their decision to replace it was in part prompted by information available on the internet regarding FPE breaker problems.⁷ According to the homeowner, who sent it to me for examination and testing, *"We recently had it replaced and found the breaker to the dryer fried in just the way described. Our electrician was astonished. Two others we had bids from dismissed our concerns with contempt."*⁸

There are additional problems in this panel. Overheating damage occurred to the insulation on the backside of the panel. Further, in addition to the dryer breaker that failed (jammed) in the home, two other two-pole breakers from this same panel failed in the lab testing. All this in a panel that looked OK from the front!

Everything in the home was functioning. The dryer worked. Why wouldn't it, since the circuit breaker was jammed with its contacts closed? Keep in mind that this panel is one of the "rule-of-six" configuration. Before they replaced this panel, the homeowners unknowingly had a situation where, essentially, the clothes dryer was wired straight through to the power line transformer on the pole, with no functional circuit protection at all.

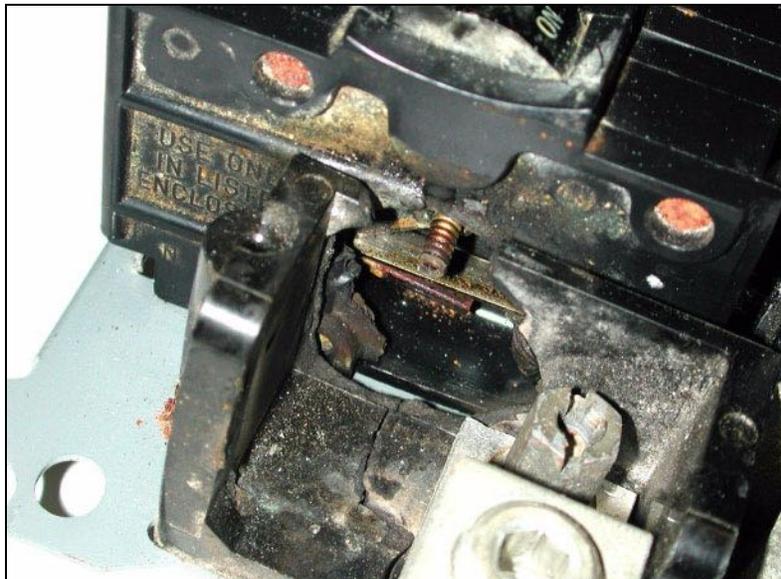
Viewing the panel from the front, some signs of overheating (as previously discussed) are evident. These are subtle compared to the view looking down at the top right (dryer) breaker, as in Figure 9.

The main service cable connector has been rotated out of the way for better visibility of the damage. The plastic insulator is burnt and cracked. The breaker's internal mechanism can be seen through the hole burned through its side. Figures 10 and 11 show the damage to the separate items.

FIGURE 9 - VIEW DOWN TOWARD UPPER RIGHT OF PANEL SHOWN IN FIG. 8. THE FPE STAB-LOK® TWO-POLE 30-AMP BREAKER FED THE CLOTHES DRYER.

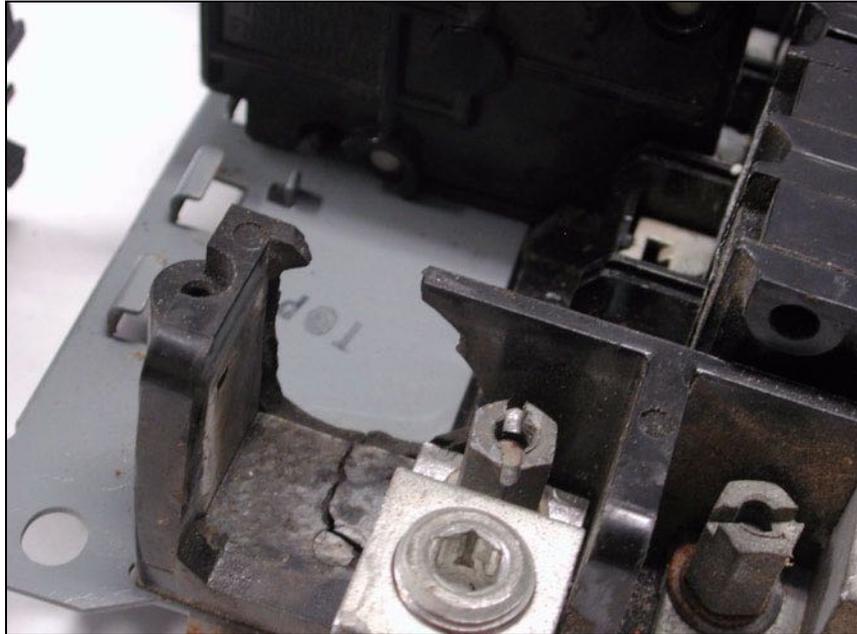
FIGURE 10 - THE DAMAGE TO THE INSULATING STRUCTURE OF THE PANEL (FIG. 8) IS MORE CLEARLY VISIBLE WITH THE BREAKER REMOVED.

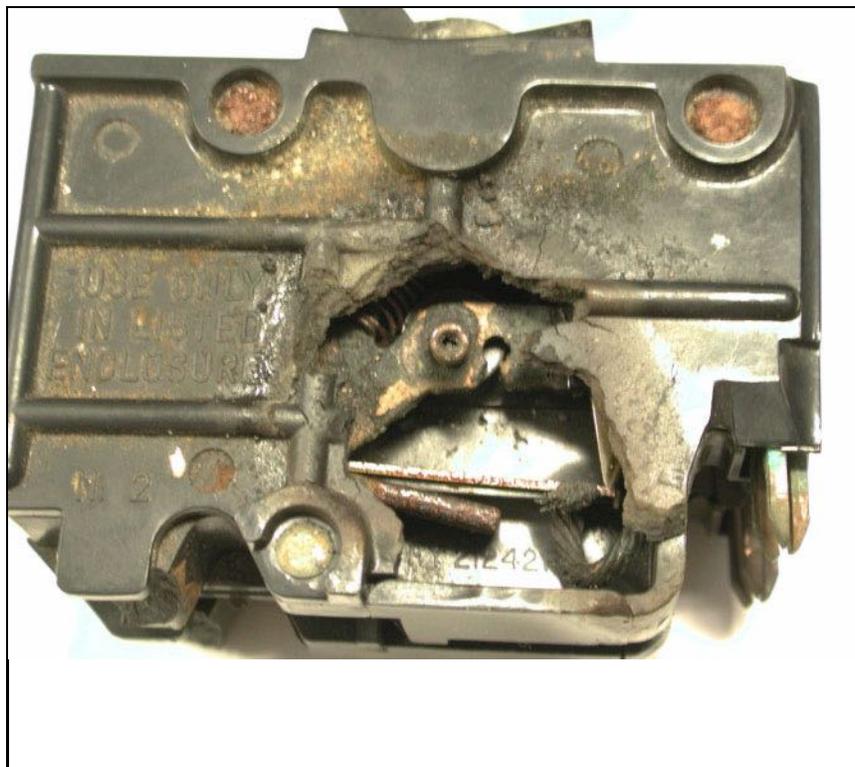
FIGURE 11 - THE FAILED FPE STAB-LOK® DRYER BREAKER (UPPER RIGHT, FIG. 8)

The damage to the breaker, from some previous high current event, is exactly as had been demonstrated in the tests done for CPSC.^{2,3,4} Those tests demonstrated that, when an FPE breaker jammed and the current exceeded about 300% of the breaker's rating, the side of the breaker disintegrated and/or ignited from the heat being generated within the breaker. This is due to resistive heating of the breaker's internal current-carrying components, mainly the bimetal element and the flexible copper braid that connects to it. This is not an arcing failure, although the damage to the insulating materials of the breaker and panel sets the stage for an arcing fault to occur.

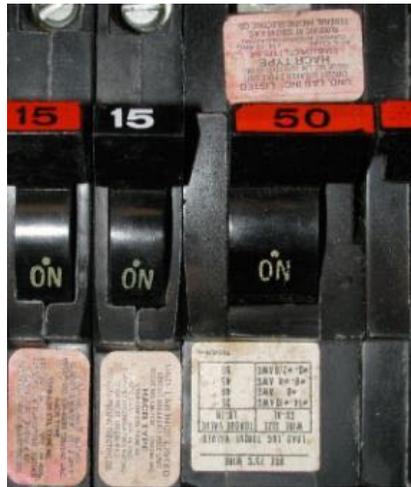
The question often arises as to whether there are any years or models of FPE Stab-Lok® circuit breakers that meet the standard performance requirements. The answer is that only FPE Stab-Lok® breakers with (authentic) pink UL listing labels *and* white dots on the handles are likely to perform as required by the UL standard. These breakers were manufactured after production restarted in about 1981, subsequent to the discovery and elimination of the company's fraudulent testing.¹⁴ The fraudulent testing practices existed prior to that -- from the time that the manufacturing operations were moved from Newark, NJ in the 1960s. The pink labels and white dots can be seen on the FPE Stab-Lok® breakers shown below in Figure 12. Inspectors are cautioned to check for both label color and white dot before concluding that the breakers were produced to UL requirements.

FIGURE 12 - FPE STAB-LOK[®] BREAKERS WITH WHITE DOT ON TOGGLE (ABOVE “ON”) AND PINK LABEL
