HAZARDOUS FPE CIRCUIT BREAKERS **AND PANELS**

Information for Homeowners, Inspectors, and Electricians

(Updated December 2, 2011)

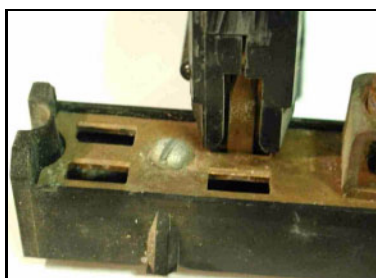
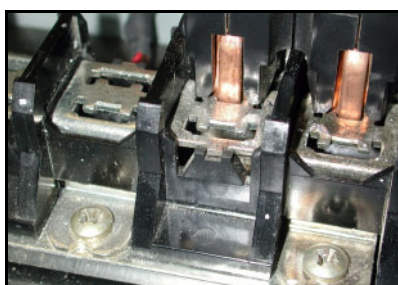
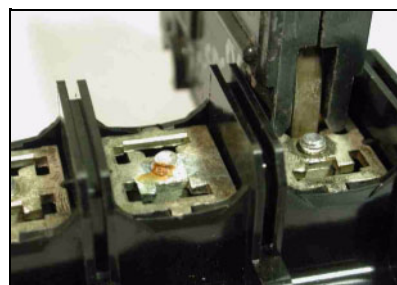
FIGURE 2 - THREE DIFFERENT FPE STAB-LOK® SOCKET DESIGNS

A. Copper buss bar with punched openings.

**B. "Z" clip, clamped to .
bussbar with 10-32 screw.**

**C. Stab socket on a post,
attached with an 8-32 steel screw.**

Of the three types illustrated, the one shown in Figure 2-C is known to have a high probability of deteriorating and overheating of the stab socket structures when subjected to significant current flow. Each individual stab socket plate is connected to its bussbar via a post (spacer), and the assembly is held together by an 8-32 steel screw. FPE panels with this construction are prone to overheating failure. Eight of the panels of the present study that showed evidence of serious overheating were constructed this way. One example is shown in Figure 3.

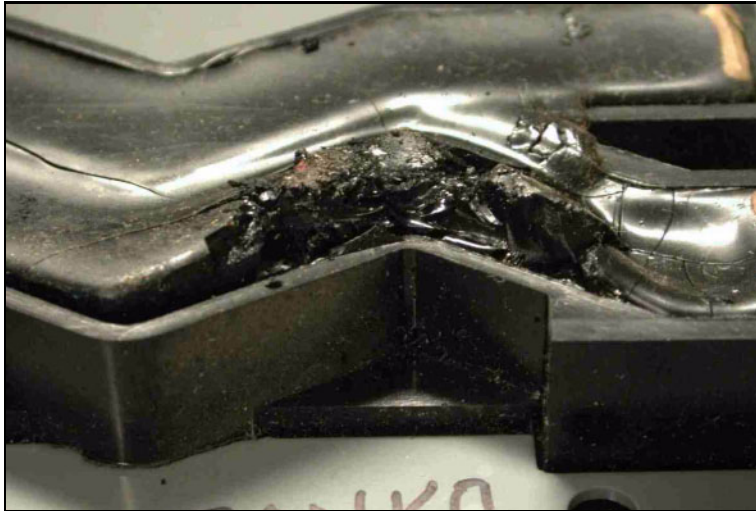
FIGURE 3 - OVERHEATING AT THE CONTACT BETWEEN THE BUSSBAR AND THE STAB SOCKET ASSEMBLY CAUSED THIS DAMAGE TO THE INSULATION.

(This view is of the backside of the panel. The damage cannot be seen unless the panel is taken out of the enclosure.)

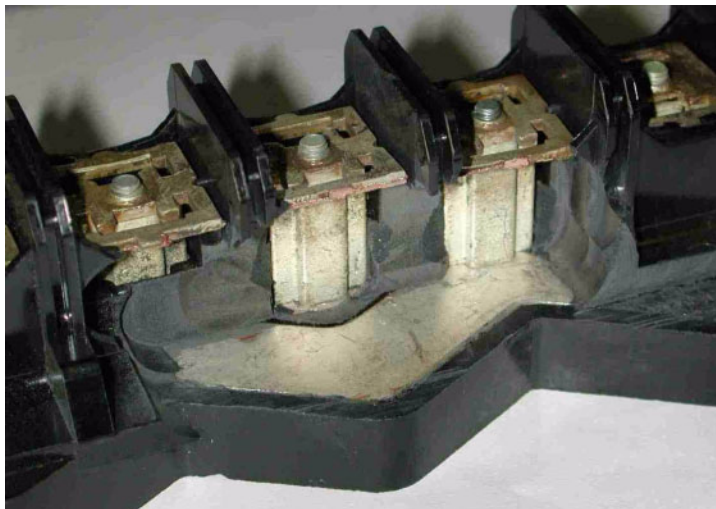
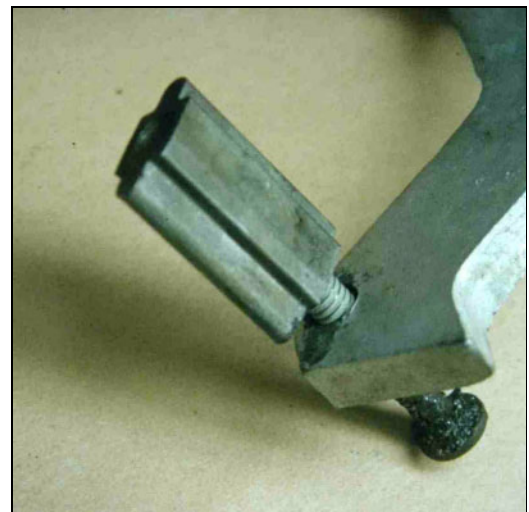
FIGURE 4 - CONDUCTING PATH FROM BUSSBAR TO STAB SOCKET

A. Cutaway - Bussbar, Post, and Stab Socket Plate.

B. Bussbar, Screw, and Post

Various material combinations were utilized by FPE in these assemblies. Some bussbars are copper, others are aluminum. Some posts are copper, others are aluminum. The worst case (most likely to fail) is where both the bussbar and the post are made of aluminum, and the best case (least likely to fail) is where both are made of copper. Inspectors (or homeowners, or electricians) have no way of knowing which materials are utilized in any particular FPE panel with this type of construction.

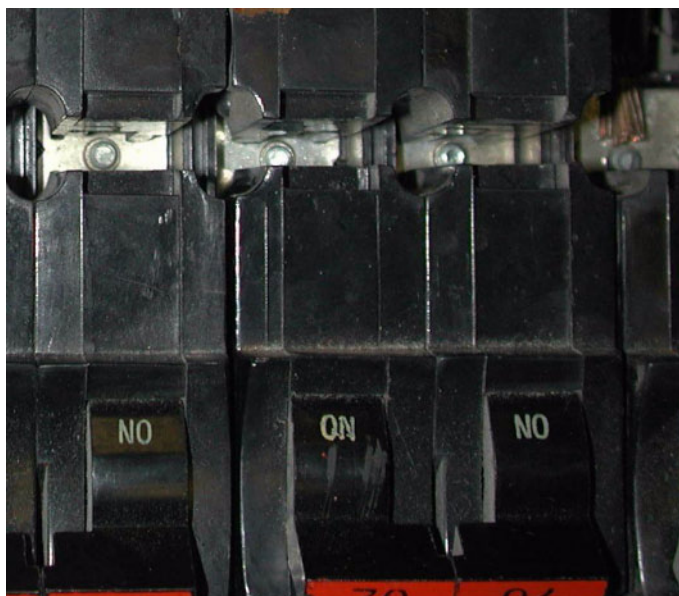
Inspectors can, however, determine if a particular FPE panel has this type of construction, and, to a limited extent, whether it has failing bussbar interconnections that have previously overheated. With the panel cover off, for this type of panel, the inspector can see the ends of the screws that attach the stab socket plates, as shown in Figure 5. (Note: If there are slotted screwheads visible, that is a different type of panel construction.) The stab socket plates and the visible ends of the screws should have a bright metallic look. Darkening, discoloration, or signs of corrosion most likely indicate past episodes of abnormal overheating.

FIGURE 5 - THE ENDS OF THE SCREWS HOLDING THE STAB SOCKET PLATES ARE VISIBLE BETWEEN THE TWO ROWS OF BREAKERS. THIS IDENTIFIES IT AS A PANEL OF THE TYPE SHOWN IN FIGURE 2-C

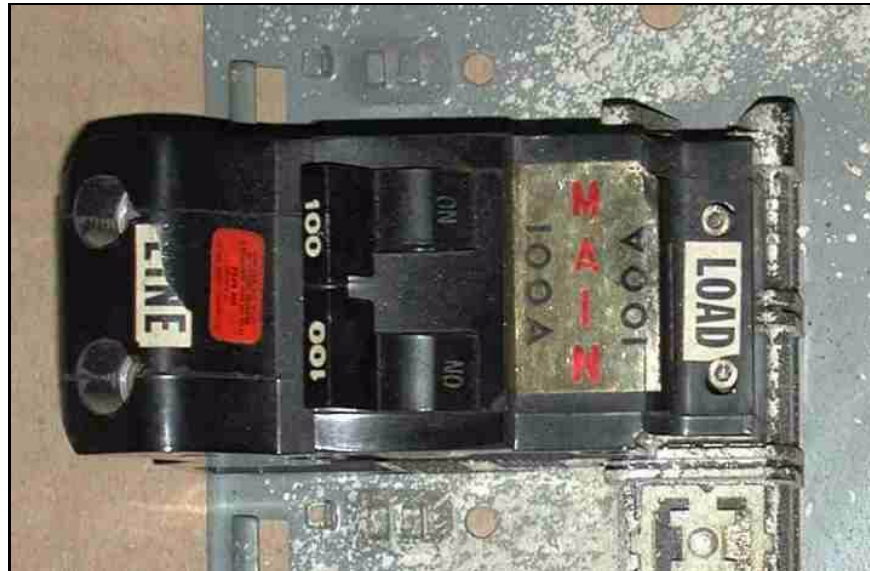
Some FPE Stab-Lok® panels have 100-amp main breakers that feed into the bussbars through the same plate and post system. In this design, the two main breaker output terminals do not have the stab type contact. Instead, each one is screwed down to a plate the same size as the stab socket plate, but which has a threaded hole in it instead of the stab openings. As with the plate and post assembly, the screws clamping the main breaker to the busbar assembly are size 8-32, which is absurdly small for a 100-amp main breaker connection, and this is another common point of overheating failure.

FIGURE 6 - FPE 100-AMP MAIN BREAKER CONNECTS TO THE BUSBARS THROUGH THE PLATE & POST CONFIGURATION, USING ONE SOCKET-HEAD 8-32 SCREW FOR EACH POLE TO ATTACH TO ITS CONTACT PLATE.

(The heads of the 8-32 clamping screws are seen at right, above and below the "LOAD" label.)

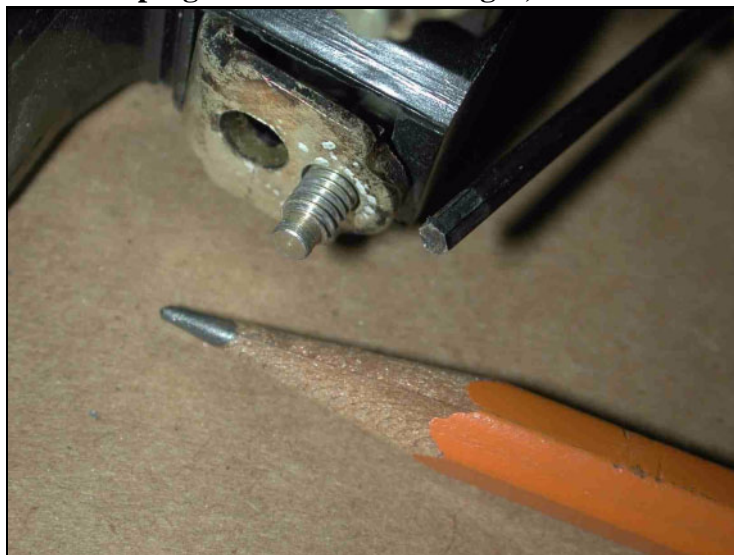
To put the diameter of the 8-32 screw in perspective, it is the same size as used on common receptacles for connecting #14 or #12 copper wire (for 15- and 20-amp circuits), with a diameter of only about 5/32". An FPE panel and main breaker of this type is shown in Figure 6. The main breaker's output terminal mounting screws and the tiny Allen-wrench that fits them are shown in Figure 7.

FIGURE 7 - ONE LOAD-SIDE CONTACT AND ITS 8-32 CLAMPING SCREW, ON THE FPE 100-AMP MAIN BREAKER OF FIG. 6. THE SCREW-HEAD TAKES A 3/32" ALLEN WRENCH, WHICH IS ONLY SLIGHTLY LARGER THAN THE LEAD OF THE PENCIL.

(The larger hole next to the clamping screw provides clearance for the end of the screw that protrudes from mating contact plate)

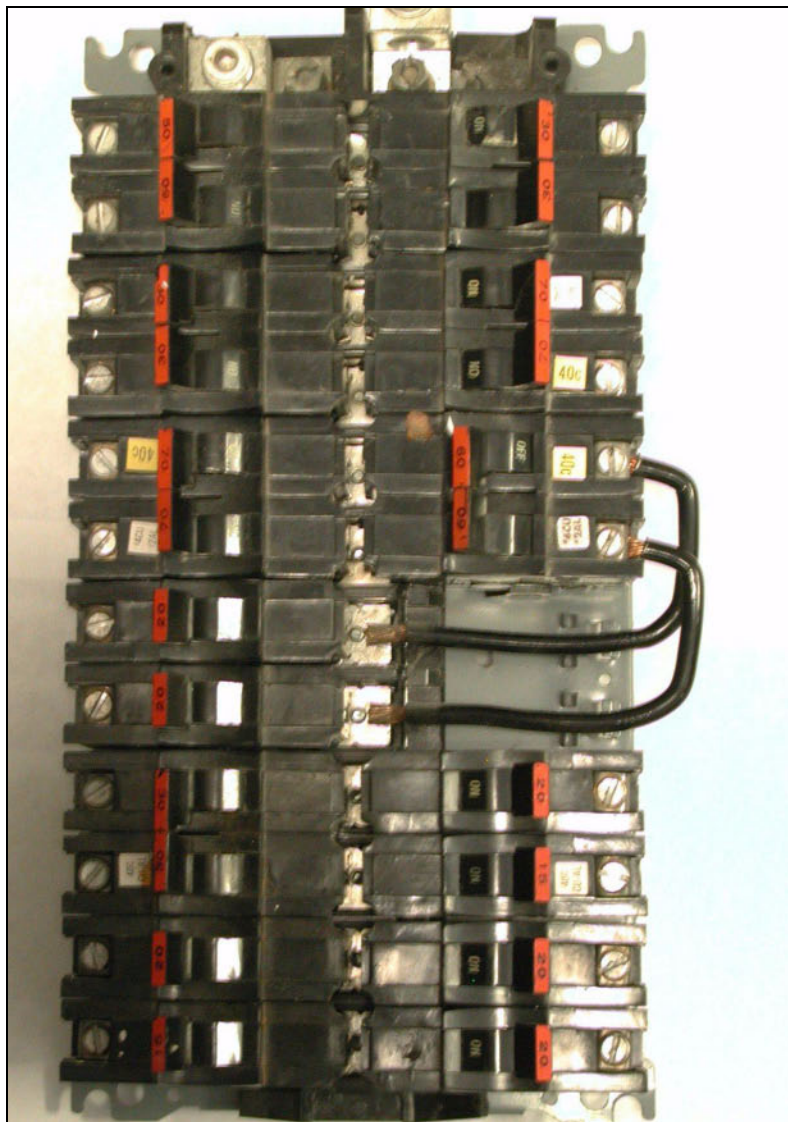
FIGURE 8 - FPE STAB-LOK® "RULE-OF-SIX" (SPLIT-BUS) PANEL WITH NO MAIN BREAKER. THE JUMPER CABLES ON THE RIGHT SIDE FEED THE LOWER SECTION.

There are many different design variations, but the essential element is that in these "rule of six" panels there is no main breaker, and, typically, the lower section of the panel is fed from jumpers coming from the output of one of up to six double-pole breakers in the upper section. The FPE Stab-Lok® double pole breakers have a relatively high probability of jamming when called on to trip, however, as previously demonstrated by the test results presented in Section 2. That means that the home with an FPE "rule-of-six" panel has an unacceptably high probability of having one or more circuits that are totally unprotected, in which the maximum current flow is only limited by what the transformer on the pole can deliver. That may be of the order of 1,000 Amps or more.

On first glance, the FPE Stab-Lok® panel previously shown in Figure 8 looks normal. In fact, however, it clearly demonstrates several of the hazardous failure modes discussed in the previous sections. It is one of those collected for the recent testing. It is from a home built in 1974, whose new owners had determined in 1999 that it should be replaced. Their decision to replace it was in part prompted by information available on the internet regarding FPE breaker problems.⁷ According to the homeowner, who sent it to me for examination and testing, *"We recently had it replaced and found the breaker to the dryer fried in just the way described. Our electrician was astonished. Two others we had bids from dismissed our concerns with contempt."*⁸

There are additional problems in this panel. Overheating damage occurred to the insulation on the backside of the panel. Further, in addition to the dryer breaker that failed (jammed) in the home, two other two-pole breakers from this same panel failed in the lab testing. All this in a panel that looked OK from the front!

Everything in the home was functioning. The dryer worked. Why wouldn't it, since the circuit breaker was jammed with its contacts closed? Keep in mind that this panel is one of the "rule-of-six" configuration. Before they replaced this panel, the homeowners unknowingly had a situation where, essentially, the clothes dryer was wired straight through to the power line transformer on the pole, with no functional circuit protection at all.

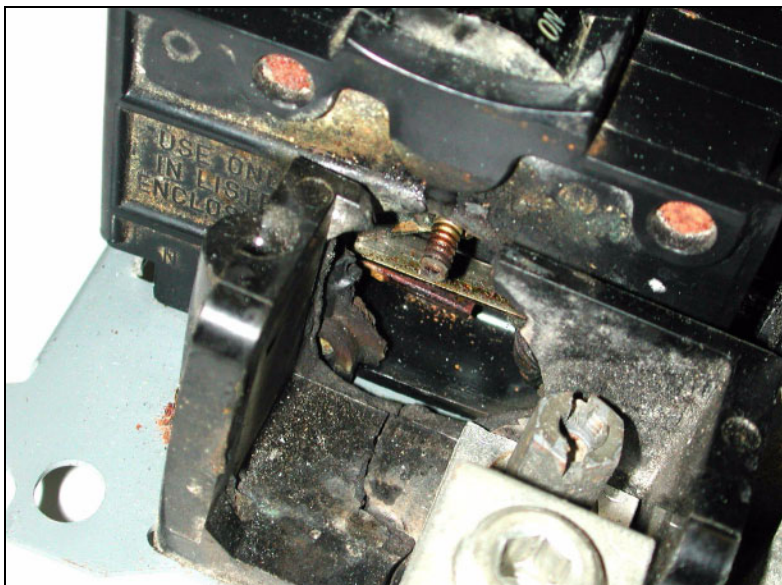
Viewing the panel from the front, some signs of overheating (as previously discussed) are evident. These are subtle compared to the view looking down at the top right (dryer) breaker, as in Figure 9.

The main service cable connector has been rotated out of the way for better visibility of the damage. The plastic insulator is burnt and cracked. The breaker's internal mechanism can be seen through the hole burned through its side. Figures 10 and 11 show the damage to the separate items.

FIGURE 9 - VIEW DOWN TOWARD UPPER RIGHT OF PANEL SHOWN IN FIG. 8. THE FPE STAB-LOK® TWO-POLE 30-AMP BREAKER FED THE CLOTHES DRYER.

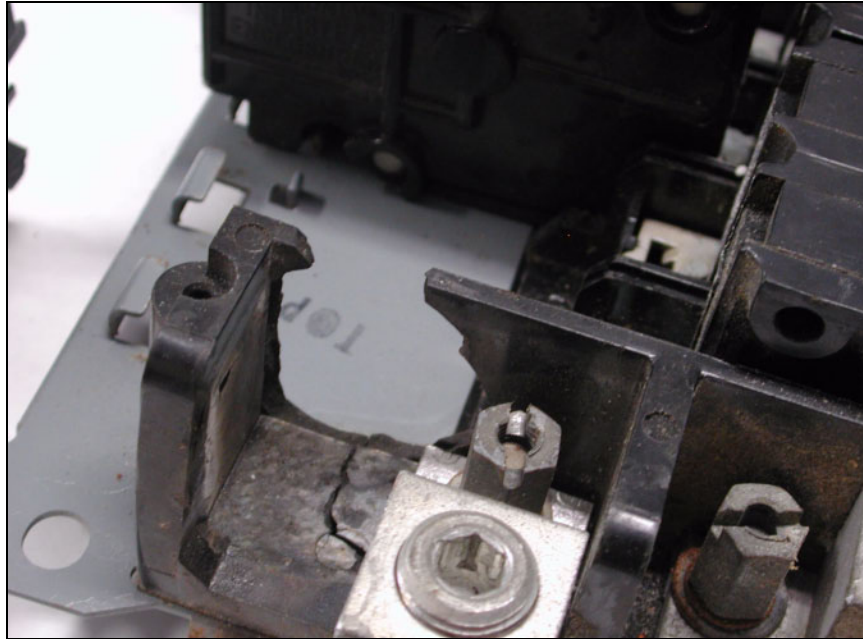
FIGURE 10 - THE DAMAGE TO THE INSULATING STRUCTURE OF THE PANEL (FIG. 8) IS MORE CLEARLY VISIBLE WITH THE BREAKER REMOVED.

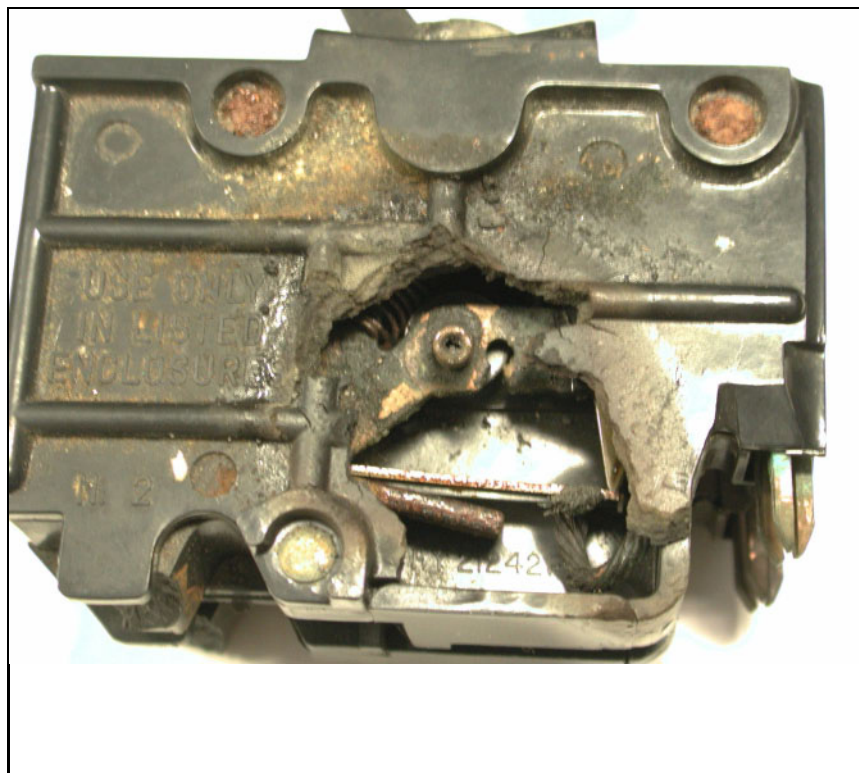
FIGURE 11 - THE FAILED FPE STAB-LOK® DRYER BREAKER (UPPER RIGHT, FIG. 8)

The damage to the breaker, from some previous high current event, is exactly as had been demonstrated in the tests done for CPSC.^{2,3,4} Those tests demonstrated that, when an FPE breaker jammed and the current exceeded about 300% of the breaker's rating, the side of the breaker disintegrated and/or ignited from the heat being generated within the breaker. This is due to resistive heating of the breaker's internal current-carrying components, mainly the bimetal element and the flexible copper braid that connects to it. This is not an arcing failure, although the damage to the insulating materials of the breaker and panel sets the stage for an arcing fault to occur.

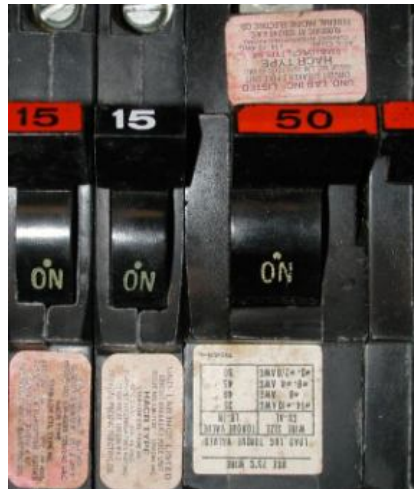
The question often arises as to whether there are any years or models of FPE Stab-Lok® circuit breakers that meet the standard performance requirements. The answer is that only FPE Stab-Lok® breakers with (authentic) pink UL listing labels ***and*** white dots on the handles are likely to perform as required by the UL standard. These breakers were manufactured after production restarted in about 1981, subsequent to the discovery and elimination of the company's fraudulent testing.¹⁴ The fraudulent testing practices existed prior to that -- from the time that the manufacturing operations were moved from Newark, NJ in the 1960s. The pink labels and white dots can be seen on the FPE Stab-Lok® breakers shown below in Figure 12. Inspectors are cautioned to check for both label color and white dot before concluding that the breakers were produced to UL requirements.

FIGURE 12 - FPE STAB-LOK® BREAKERS WITH WHITE DOT ON TOGGLE (ABOVE “ON”) AND PINK LABEL
