**J. ARONSTEIN**  
**CONSULTING ENGINEER**

**HAZARDOUS FPE CIRCUIT BREAKERS**  
**AND PANELS**

*Information for Homeowners, Inspectors, and Electricians*  
*(Updated November 10, 2017)*

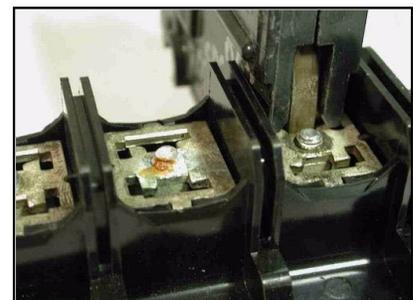
**C. Stab socket on a post, attached with an 8-32 steel screw.**

Of the three types illustrated above, the one shown in Figure 2-C is known to have a high probability of deteriorating and overheating of the stab socket structures when subjected to significant current flow. Each individual stab socket plate is connected to its bussbar via a post (spacer), and the assembly is held together by an 8-32 steel screw. FPE panels with this construction are prone to overheating failure. Eight of the panels of the present study that showed evidence of serious overheating were constructed this way. One example is shown in Figure 3.

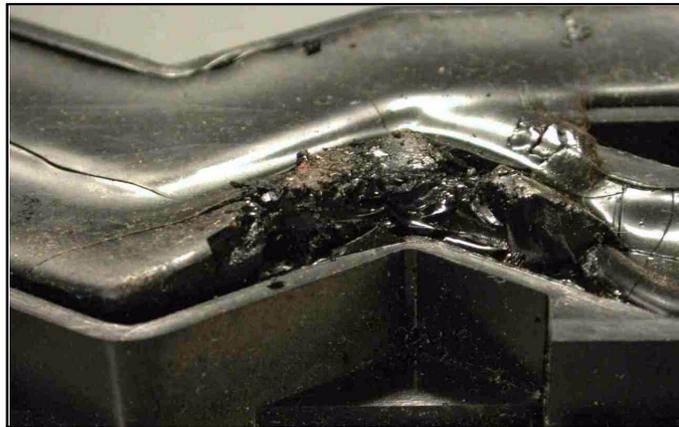
**FIGURE 3 - OVERHEATING AT THE CONTACT BETWEEN THE BUSSBAR AND THE STAB SOCKET ASSEMBLY CAUSED THIS DAMAGE TO THE INSULATION. (This view is of the backside of the panel. The damage cannot be seen unless the panel is taken out of the enclosure.)**

A more serious failure of this type has been documented.<sup>1</sup> In that instance, the failure had been severe enough to ignite a smoldering fire on the plastic insulating material. The fundamental weakness in this design is the use of a single, relatively flimsy 8-32 screw to hold a structure together that can feed up to four half-width breakers with a total "ampacity" (rated circuit capacity) up to about 160 Amps. Figure 4 shows how the stab socket plate and post are attached to the bussbar.

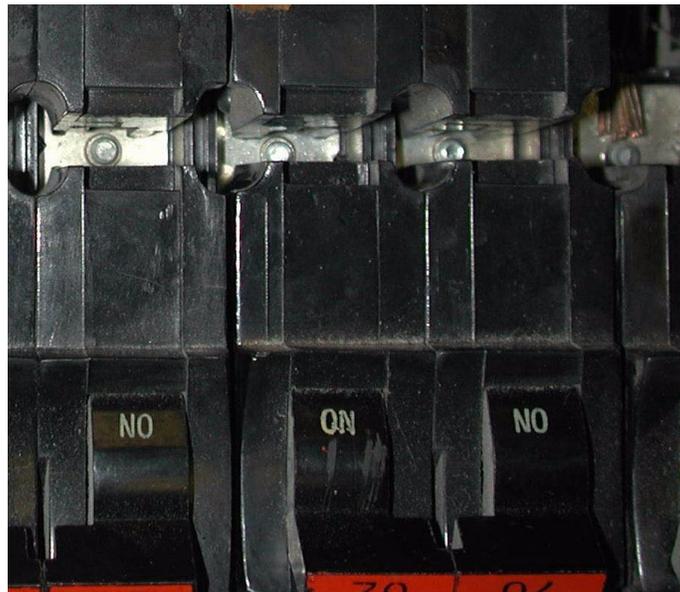
Inspectors can, however, determine if a particular FPE panel has this type of construction, and, to a limited extent, whether it has failing bussbar interconnections that have previously overheated. With the panel cover off, for this type of panel, the inspector can see the ends of the screws that attach the stab socket plates, as shown in Figure 5. (Note: If there are slotted screwheads visible, that is a different type of panel construction.) The stab socket plates and the visible ends of the screws should have a bright metallic look. Darkening, discoloration, or signs of corrosion most likely indicate past episodes of abnormal overheating.

**FIGURE 5 - THE ENDS OF THE SCREWS HOLDING THE STAB SOCKET PLATES ARE VISIBLE BETWEEN THE TWO ROWS OF BREAKERS. THIS IDENTIFIES IT AS A PANEL OF THE TYPE SHOWN IN FIGURE 2-C**

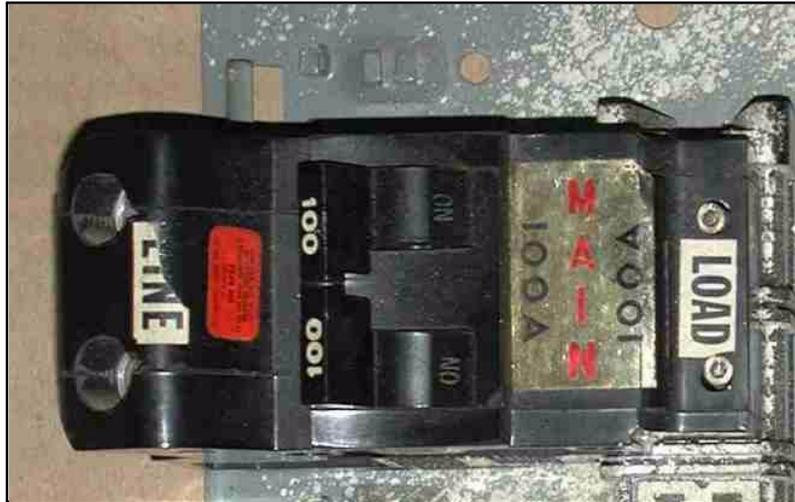
Ten FPE 90 and 100 Amp two-pole main breakers (such as shown in Figure 6) are included in the results presented in Table 2. Four of the ten failed to trip at 135% of rated current as required.

Some FPE Stab-Lok<sup>®</sup> panels have 100-amp main breakers that feed into the bussbars through the same plate and post system. In this design, the two main breaker output terminals do not have the stab type contact. Instead, each one is screwed down to a plate the same size as the stab socket plate, but which has a threaded hole in it instead of the stab openings. As with the plate and post assembly, the screws clamping the main breaker to the busbar assembly are size 8-32, which is absurdly small for a 100-amp main breaker connection, and this is another common point of overheating failure.

**FIGURE 6 - FPE 100-AMP MAIN BREAKER CONNECTS TO THE BUSBARS THROUGH THE PLATE & POST CONFIGURATION, USING ONE SOCKET-HEAD 8-32 SCREW FOR EACH POLE TO ATTACH TO ITS CONTACT PLATE.  
(The heads of the 8-32 clamping screws are seen at right, above and below the "LOAD" label.)**

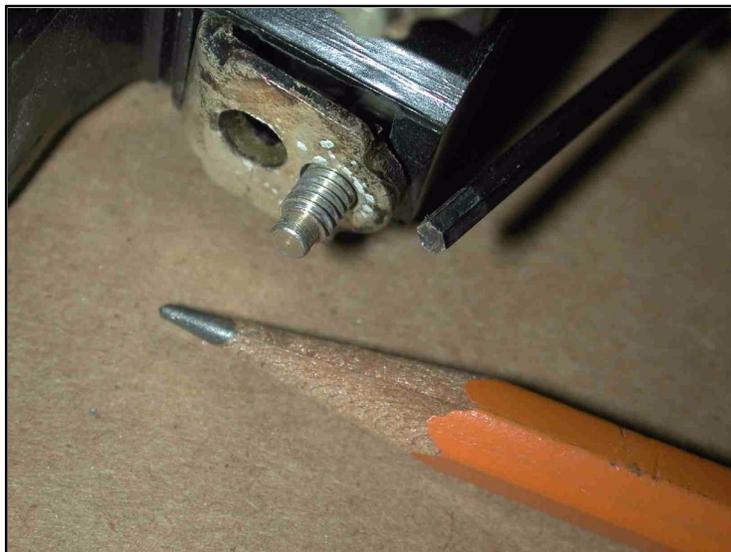
To put the diameter of the 8-32 screw in perspective, it is the same size as used on common receptacles for connecting #14 or #12 copper wire (for 15- and 20-amp circuits), with a diameter of only about 5/32". An FPE panel and main breaker of this type is shown in Figure 6. The main breaker's output terminal mounting screws and the tiny Allen-wrench that fits them are shown in Figure 7.

**FIGURE 7 - ONE LOAD-SIDE CONTACT AND ITS 8-32 CLAMPING SCREW, ON THE FPE 100-AMP MAIN BREAKER OF FIG. 6. THE SCREW-HEAD TAKES A 3/32" ALLEN WRENCH, WHICH IS ONLY SLIGHTLY LARGER THAN THE LEAD OF THE PENCIL.  
(The larger hole next to the clamping screw provides clearance for the end of the screw that protrudes from mating contact plate)**

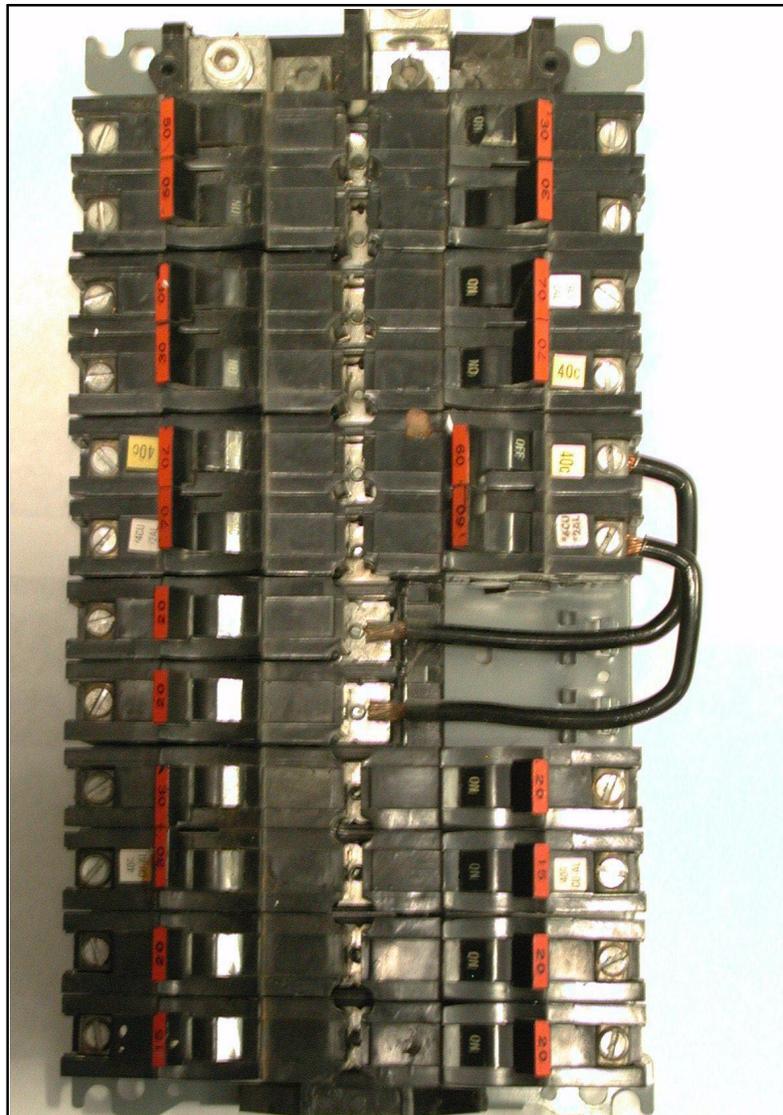
**FIGURE 8 - FPE STAB-LOK® "RULE-OF-SIX" (SPLIT-BUS) PANEL WITH NO MAIN BREAKER. THE JUMPER CABLES ON THE RIGHT SIDE FEED THE LOWER SECTION.**

On first glance, the FPE Stab-Lok® panel previously shown in Figure 8 looks normal. In fact, however, it clearly demonstrates several of the hazardous failure modes discussed in the previous sections. It is one of those collected for the recent testing. It is from a home built in 1974, whose new owners had determined in 1999 that it should be replaced. Their decision to replace it was in part prompted by information available on the internet regarding FPE breaker problems.<sup>7</sup> According to the homeowner, who sent it to me for examination and testing, *"We recently had it replaced and found the breaker to the dryer fried in just the way described. Our electrician was astonished. Two others we had bids from dismissed our concerns with contempt."*<sup>8</sup>

Viewing the panel in Fig. 8 from the front, some signs of overheating (as previously discussed) are evident. These are subtle compared to the view looking down at the top right (dryer) breaker, as in Figure 9. The main service cable connector has been rotated out of the way for better visibility of the damage. The plastic insulator is burnt and cracked. The breaker's internal mechanism can be seen through the hole burned through its side.

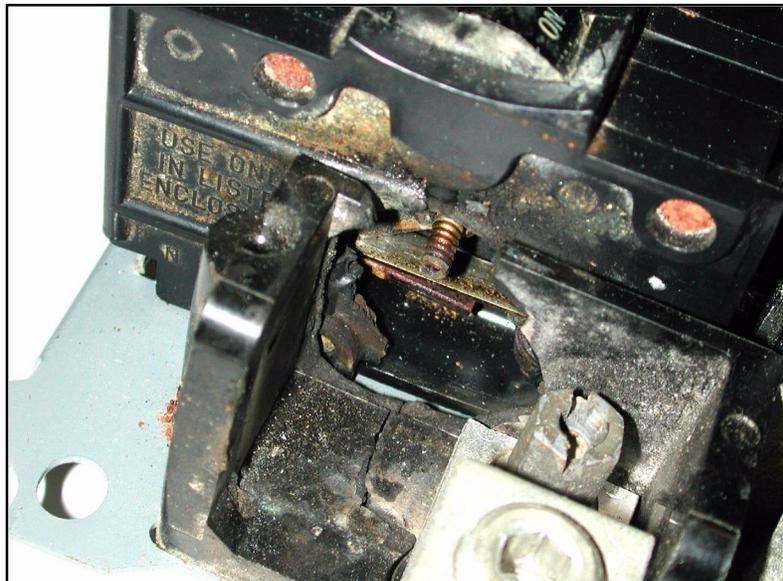
**FIGURE 9 - VIEW DOWN TOWARD UPPER RIGHT OF PANEL SHOWN IN FIG. 8. THIS FPE STAB-LOK® TWO-POLE 30-AMP BREAKER FED THE CLOTHES DRYER.**

The damage to the breaker, from some previous high current event, is exactly as had been demonstrated in the tests done for the CPSC.<sup>2,3,4</sup> Those tests demonstrated that, when an FPE breaker jammed and the current exceeded about 300% of the breaker's rating, the side of the breaker disintegrated and/or ignited from the heat being generated within the breaker. This is due to resistive heating of the breaker's internal current-carrying components, mainly the bimetal element and the flexible copper braid that connects to it. This is not an arcing failure, although the damage to the insulating materials of the breaker and panel sets the stage for an arcing fault to occur.

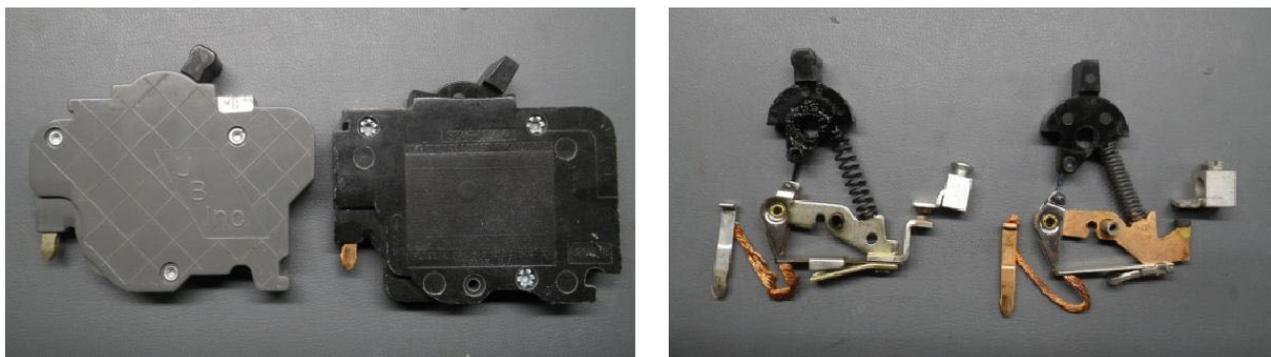
Replacing the FPE breakers with UBI-F breakers is definitely not recommended, as it is likely to result in an increased level of hazard. The UBI-F breakers, marketed by Connecticut Electric Products, are the only new breakers commonly marketed today in the U.S.A. as replacements for the FPE Stab-Lok<sup>®</sup> breakers. The UBI breaker housings look different, but internally the breakers are essentially the same design as the FPE breakers, as can be seen in Figure 10. The test results for UBI breakers are poor.

**FIGURE 10 - UBI-F BREAKER AND FPE BREAKER, OUTSIDE AND INSIDE**  
(UBI on left, FPE on right in both photos)
