## **J. ARONSTEIN**

## **HAZARDOUS FPE CIRCUIT BREAKERS AND PANELS**

*(Updated as of May 25, 2007)*

*Information for Inspectors and Homeowners*

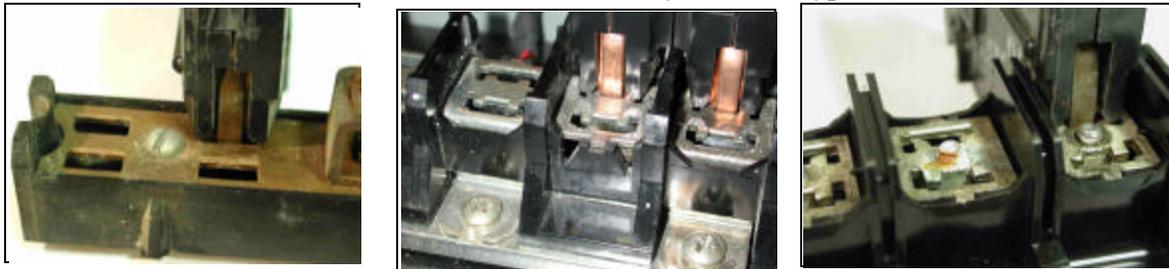
**FIGURE 2 - THREE DIFFERENT FPE STAB-LOK® SOCKET DESIGNS**

- A. Copper buss bar with punched openings.**
- B. "Z" clip, clamped to bussbar with 10-32 screw.**
- C. Stab socket on a post, attached with an 8-32 steel screw.**

Of the three types illustrated, the one shown in Figure 2-C is known to have a high probability of deteriorating and overheating of the stab socket structures when subjected to significant current flow. Each individual stab socket plate is connected to its bussbar via a post (spacer), and the assembly is held together by an 8-32 steel screw. FPE panels with this construction are prone to overheating failure. The seven panels of the present study that showed evidence of serious overheating were constructed this way. One example is shown in Figure 3.

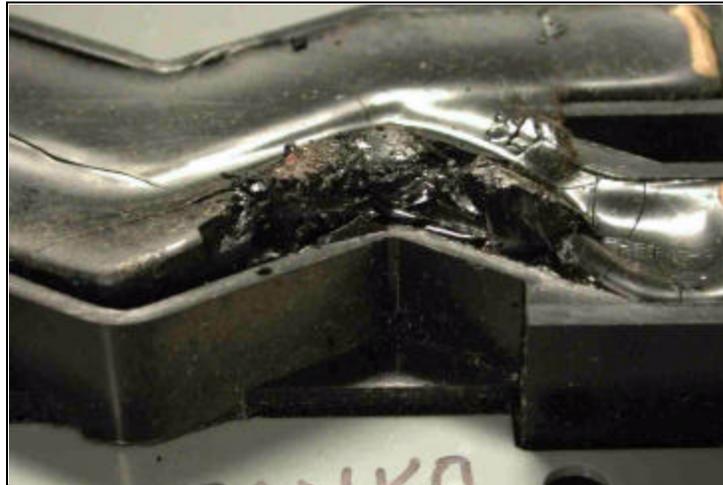
**FIGURE 3 - OVERHEATING AT THE CONTACT BETWEEN THE BUSSBAR AND THE STAB SOCKET ASSEMBLY CAUSED THIS DAMAGE TO THE INSULATION.**

(This view is of the backside of the panel. The damage cannot not be seen unless the panel is taken out of the enclosure.)

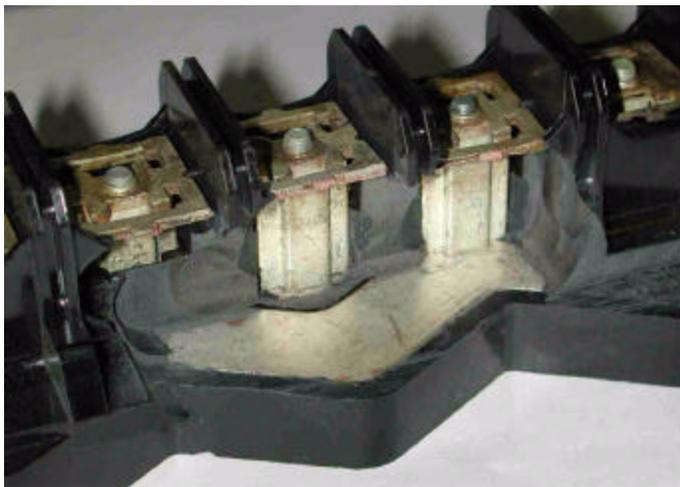
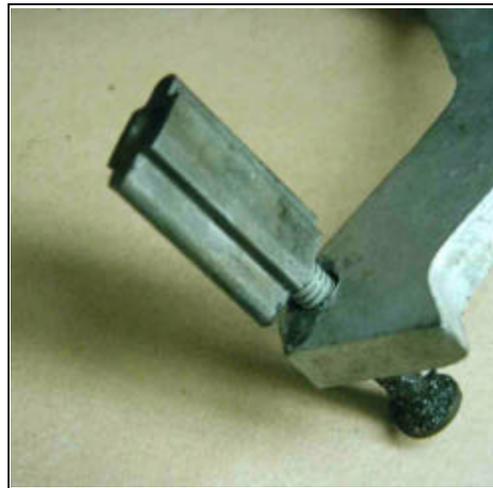
**FIGURE 4 - CONDUCTING PATH FROM BUSSBAR TO STAB SOCKET**

Various material combinations were utilized by FPE in these assemblies. Some bussbars are copper, others are aluminum. Some posts are copper, others are aluminum. The worst case (most likely to fail) is where both the bussbar and the post are made of aluminum, and the best case (least likely to fail) is where both are made of copper. Inspectors (or homeowners, or electricians) have no way of knowing which materials are utilized in any particular FPE panel with this type of construction.

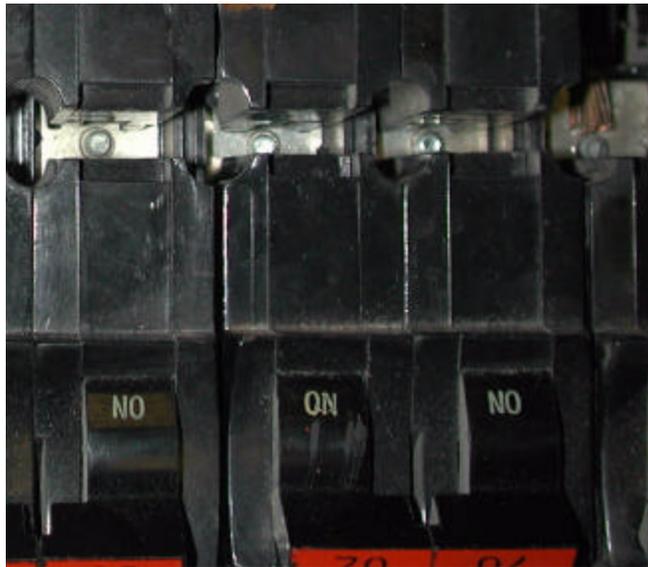
Inspectors can, however, determine if a particular FPE panel has this type of construction, and, to a limited extent, whether it has failing bussbar interconnections that have previously overheated. With the panel cover off, for this type of panel, you can see the ends of the screws holding the stab socket plate as shown in Figure 5. (Note: If you see slotted screwheads, that's a different type of panel construction.) The stab socket plates and the visible ends of the screws should have a bright metallic look. Darkening, discoloration, or signs of corrosion most likely indicate past episodes of abnormal overheating.

**FIGURE 5 - THE ENDS OF THE SCREWS HOLDING THE STAB SOCKET PLATES ARE VISIBLE BETWEEN THE TWO ROWS OF BREAKERS. THIS IDENTIFIES IT AS A PANEL OF THE TYPE SHOWN IN FIGURE 2-C**

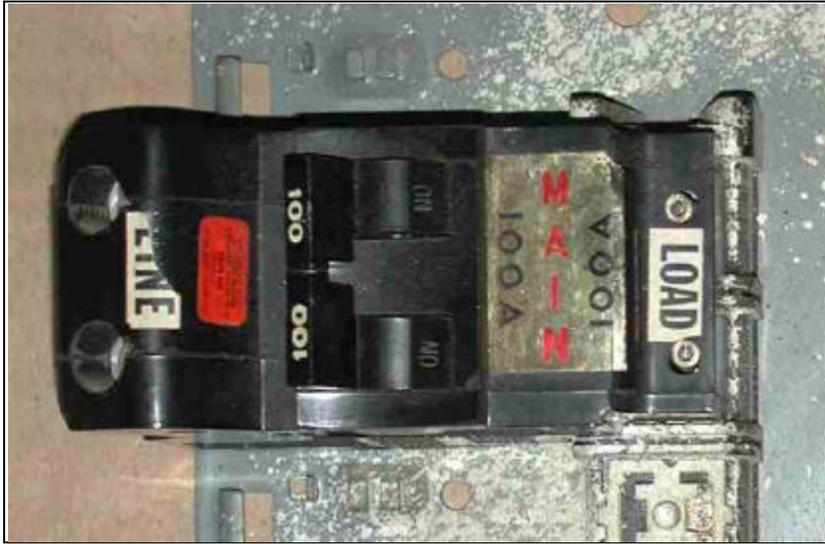
Some FPE Stab-Lok® panels have 100-amp main breakers that feed into the bussbars through the same plate and post system. In this design, the two main breaker output terminals do not have the stab type contact. Instead, each one is screwed down to a plate the same size as the stab socket plate, but which has a threaded hole in it instead of the stab openings. As with the plate and post assembly, the screws clamping the main breaker terminals are size 8-32, which is absurdly small for clamping the terminals of a 100-amp main breaker.

**FIGURE 6 - FPE 100-AMP MAIN BREAKER CONNECTS TO THE BUSBARS THROUGH THE PLATE & POST CONFIGURATION, USING ONE SOCKET-HEAD 8-32 SCREW AT EACH TERMINAL TO ATTACH TO THE CONTACT PLATE.**

**(The heads of the 8-32 terminal clamping screws are seen above and below the "LOAD" label.)**

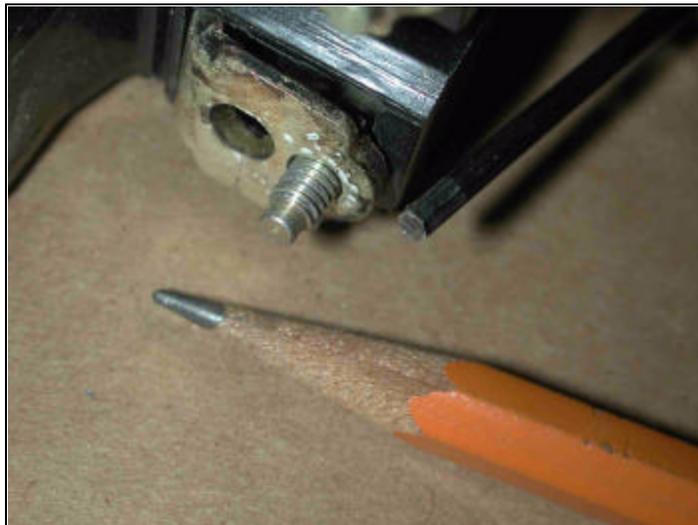
To put the diameter of the 8-32 screw in perspective, it is the same size as used on common receptacles for connecting #14 or #12 copper wire (for 15- and 20-amp circuits), and has a diameter of only about 5/32". An FPE panel and main breaker of this type is shown in Figure 6. The main breaker's output terminal mounting screws and the tiny Allen-wrench that fits them are shown in Figure 7.

**FIGURE 7 - ONE LOAD-SIDE CONTACT AND ITS 8-32 CLAMPING SCREW, ON THE FPE 100-AMP MAIN BREAKER OF FIG. 6. THE SCREW-HEAD TAKES A 3/32" ALLEN WRENCH, WHICH IS ONLY SLIGHTLY LARGER THAN THE LEAD OF THE #2 PENCIL.**

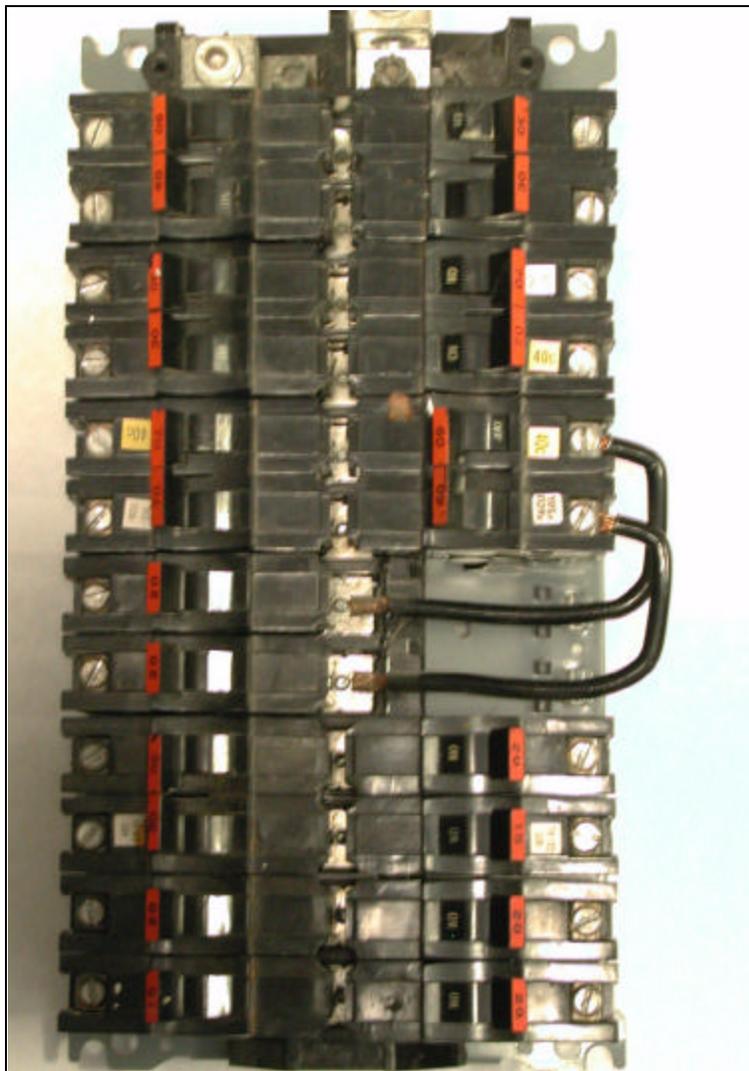
**FIGURE 8 - FPE STAB-LOK® "RULE-OF-SIX" (SPLIT-BUS) PANEL WITH NO MAIN BREAKER. THE JUMPER CABLES ON THE RIGHT SIDE FEED THE LOWER SECTION.**

There are many different design variations, but the essential element is that in these "rule of six" panels there is no main breaker, and, typically, the lower section of the panel is fed from jumpers coming from the output of one of up to six double-pole breakers in the upper section. The FPE Stab-Lok® double pole breakers have a relatively high probability of jamming when called on to trip, however, as previously demonstrated by the test results presented in Section 2. That means that the home with an FPE "rule-of-six" panel has an unacceptably high probability of having one or more circuits that are totally unprotected, in which the maximum current flow is only limited by what the transformer on the pole can deliver. This is likely to be of the order of 1,000 Amps or more.

On first glance, the FPE Stab-Lok® panel previously shown in Figure 8 looks normal. In fact, however, it clearly demonstrates several of the hazardous failure modes discussed in the previous sections. It is one of 28 collected for the recent testing. It is from a home built in 1974, whose new owners had determined in 1999 that it should be replaced. Their decision to replace it was in part prompted by information available on the internet regarding FPE breaker problems.<sup>7</sup> According to the homeowner, who sent it to me for examination and testing, *"We recently had it replaced and found the breaker to the dryer fried in just the way described. Our electrician was astonished. Two others we had bids from dismissed our concerns with contempt."*<sup>8</sup>

There is no question but that the FPE Stab-Lok® panels should be replaced. There is no practical and safe alternative.

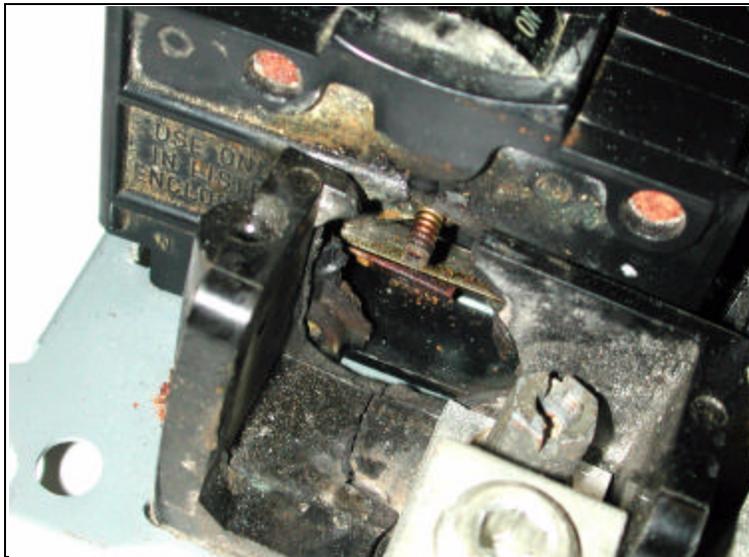
Viewing the panel from the front, some subtle signs of overheating (as previously discussed) are evident. These are subtle compared to the view looking down at the top right (dryer) breaker, as in Figure 9. The main service cable connector has been rotated out of the way for better visibility of the damage. The plastic insulator is burnt and cracked. The breaker's internal mechanism can be seen through the hole burned through its side. Figures 10 and 11 show the damage to the separate items.

**FIGURE 9 - VIEW DOWN TOWARD UPPER RIGHT OF PANEL SHOWN IN FIG. 8. THE FPE STAB-LOK® TWO-POLE 30-AMP BREAKER FED THE CLOTHES DRYER.**

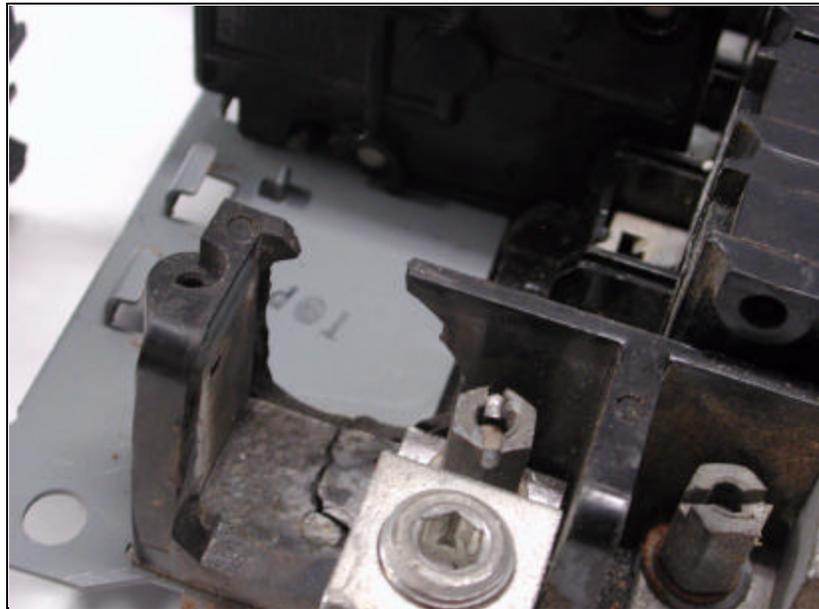
**FIGURE 10** - THE DAMAGE TO THE INSULATING STRUCTURE OF THE PANEL (FIG. 8) IS MORE CLEARLY VISIBLE WITH THE BREAKER REMOVED.

There are additional problems in this panel. Overheating damage occurred to the insulation on the backside of the panel. Further, in addition to the dryer breaker that failed (jammed) in the home, two other two-pole breakers from this same panel failed in the lab testing. All this in a panel that looked OK from the front!

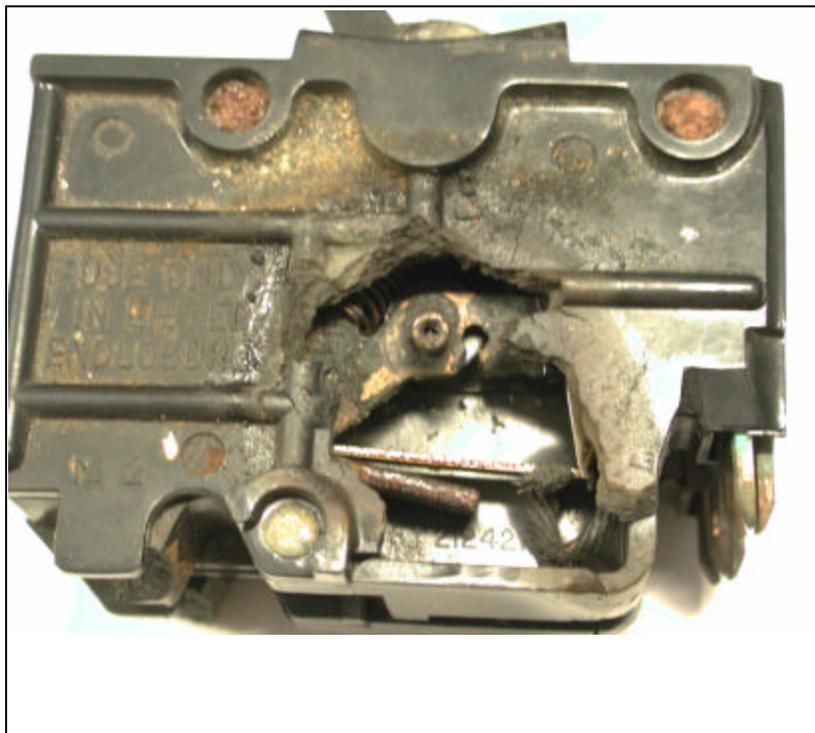
**FIGURE 11** - THE FAILED FPE STAB-LOK® DRYER BREAKER (UPPER RIGHT, FIG. 8)

The damage to the breaker, from some previous short circuit or failure event, is exactly as had been demonstrated in the tests done for CPSC.<sup>2,3,4</sup> Those tests demonstrated that, when an FPE breaker jammed and the current exceeded about 300% of the breaker's rating, the side of the breaker disintegrated and/or ignited from the heat being generated within the breaker. This is due to resistive heating of the breaker's internal current-carrying components, mainly the bimetal element and the flexible copper braid that connects to it. This is not an arcing failure, although the damage to the insulating materials of the breaker and panel sets the stage for an arcing fault to occur.

Everything in the home was functioning. The dryer worked. Why wouldn't it, since the circuit breaker was jammed with its contacts closed? Keep in mind that this panel is one of the "rule-of-six" configuration. Before they replaced this panel, the homeowners unknowingly had a situation where, essentially, the clothes dryer was wired straight through to the power line transformer on the pole, with no functional circuit protection at all.
