J. ARONSTEIN
CONSULTING ENGINEER
BME, MSME, Ph.D., N.Y.S. P.E. LIC. NO. 39860
909 LONDONDERRY CT., SCHENECTADY, NY 12309
(845) 462-6452 AronsteinJ@verizon.net

HAZARDOUS FPE CIRCUIT BREAKERS AND PANELS

(Updated March 29, 2024)

Information for Homeowners, Inspectors, and Electricians

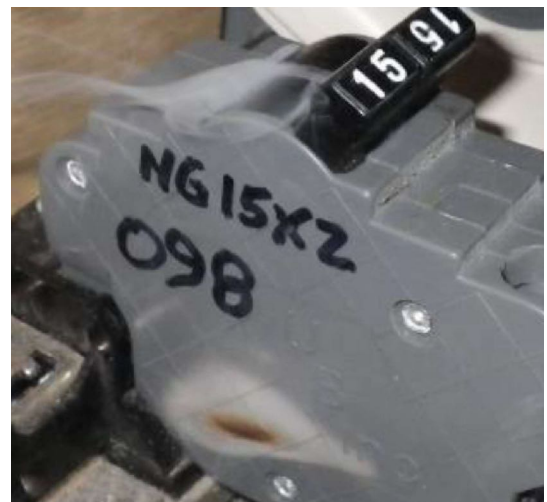
The UBI (Connecticut Electric) 15-amp double-pole breaker being tested at right is carrying 60 amps without tripping. This brand of breaker is promoted and sold as a "safe" replacement for the FPE breakers.

There is a burn mark developing on the side of the breaker from heating of an internal component, and smoke is coming out of its toggle handle slot.

FIGURE 3 - DEFECTIVE UBI 15A BREAKER CONDUCTING 60 AMPS WITHOUT TRIPPING

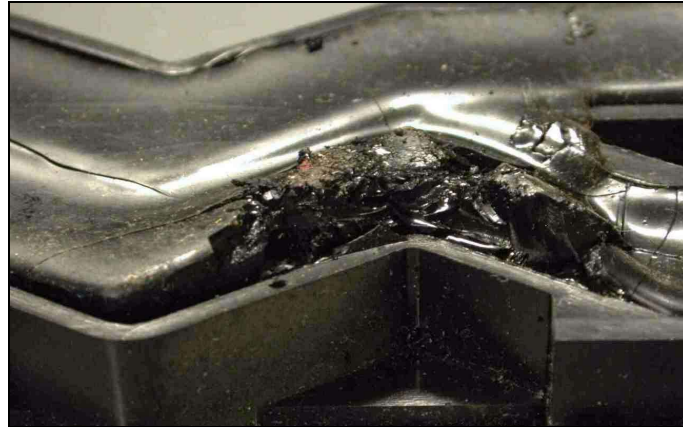
Of the three types illustrated above, the one shown in Figure 5-C is known to have a high probability of deteriorating and overheating of the stab socket structures when subjected to significant current flow. Each individual stab socket plate is connected to its bussbar via a post (spacer), and the assembly is held together by an 8-32 steel screw. FPE panels with this construction are prone to overheating failure. Eight of the panels of the present study that showed evidence of serious overheating were constructed this way. One example is shown in Figure 6.

FIGURE 6 - OVERHEATING AT THE CONTACT BETWEEN THE BUSSBAR AND THE STAB SOCKET ASSEMBLY CAUSED THIS DAMAGE TO THE INSULATION. (This view is of the backside of the panel. The damage cannot be seen unless the panel is taken out of the enclosure.)

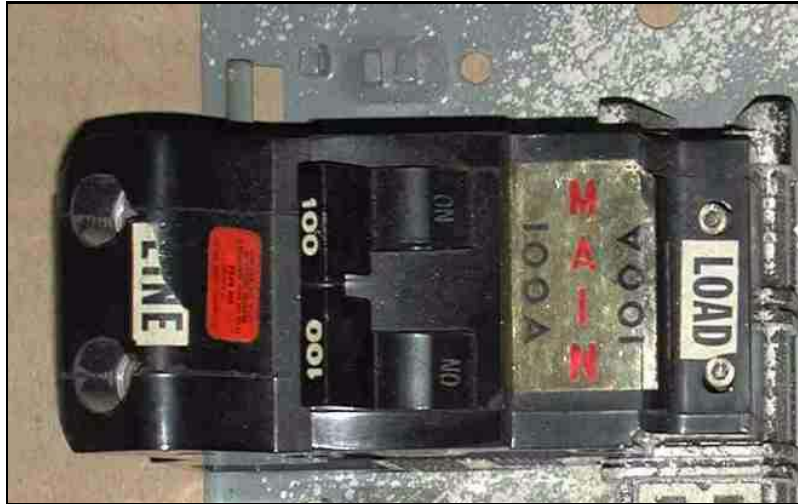
Some FPE Stab-Lok[®] panels have 100-amp main breakers that feed into the bussbars through the same plate and post system. In this design, the two main breaker output terminals do not have the stab type contact. Instead, each one is screwed down to a plate the same size as the stab socket plate, but which has a threaded hole in it instead of the stab openings. As with the plate and post assembly, the screws clamping the main breaker to the busbar assembly are size 8-32, which is absurdly small for a 100-amp main breaker connection, and this is another common point of overheating failure.

FIGURE 9 - THIS TYPE OF FPE 100-AMP MAIN BREAKER CONNECTS TO THE BUSBARS THROUGH THE PLATE & POST CONFIGURATION, USING ONE SOCKET-HEAD 8-32 SCREW FOR EACH POLE TO ATTACH TO ITS CONTACT PLATE. (The heads of the 8-32 clamping screws are seen at right, above and below the "LOAD" label.)

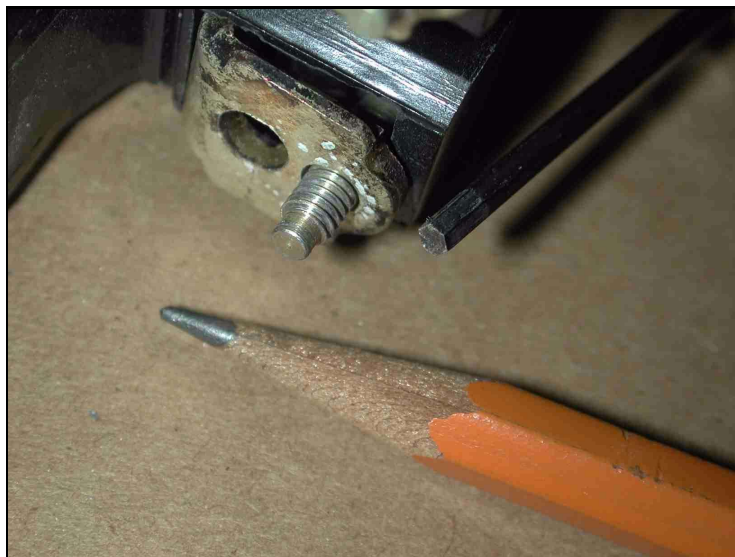
To put the diameter of the 8-32 screw in perspective, it is the same size as used on common receptacles for connecting #14 or #12 copper wire (for 15- and 20-amp circuits), with a diameter of only about 5/32". An FPE panel and main breaker of this type is shown in Figure 9. The main breaker's load output terminal mounting screws and the tiny Allen-wrench that fits them are shown in Figure 10.

FIGURE 10 - ONE LOAD-SIDE CONTACT AND ITS 8-32 CLAMPING SCREW, ON THE FPE 100-AMP MAIN BREAKER OF FIG. 9. THE SCREW-HEAD TAKES A 3/32" ALLEN WRENCH, WHICH IS ONLY SLIGHTLY LARGER THAN THE LEAD OF THE PENCIL. (The larger hole next to the clamping screw provides clearance for the end of the screw that protrudes from the mating contact plate)

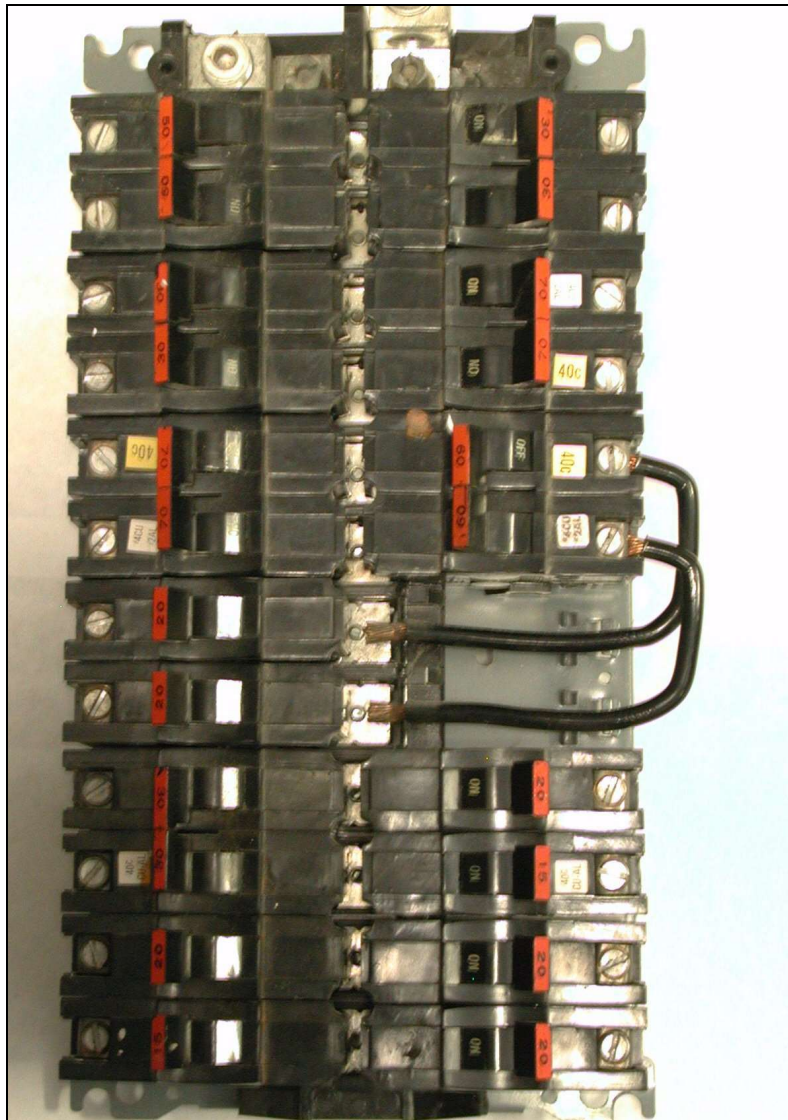
FIGURE 11 - FPE STAB-LOK® "RULE-OF-SIX" (SPLIT-BUS) PANEL WITH NO MAIN BREAKER. THE JUMPER CABLES ON THE RIGHT SIDE FEED THE LOWER SECTION.

On first glance, the FPE Stab-Lok® panel previously shown in Figure 11 looks normal. In fact, however, it clearly demonstrates several of the hazardous failure modes discussed in the previous sections. It is one of those collected for the recent testing. It is from a home built in 1974, whose new owners had determined in 1999 that it should be replaced. Their decision to replace it was in part prompted by information available on the internet regarding FPE breaker problems.⁷ According to the homeowner, who sent it to me for examination and testing, *"We recently had it replaced and found the breaker to the dryer fried in just the way described. Our electrician was astonished. Two others we had bids from dismissed our concerns with contempt."*⁸

Viewing the panel in Fig. 11 from the front, some signs of overheating (as previously discussed) are evident. These are subtle compared to the view looking down at the top right (dryer) breaker, as in Figure 12, below. The main service cable connector has been rotated out of the way for better visibility of the damage. The plastic insulator is burnt and cracked. The breaker's internal mechanism can be seen through the hole burned through its side.

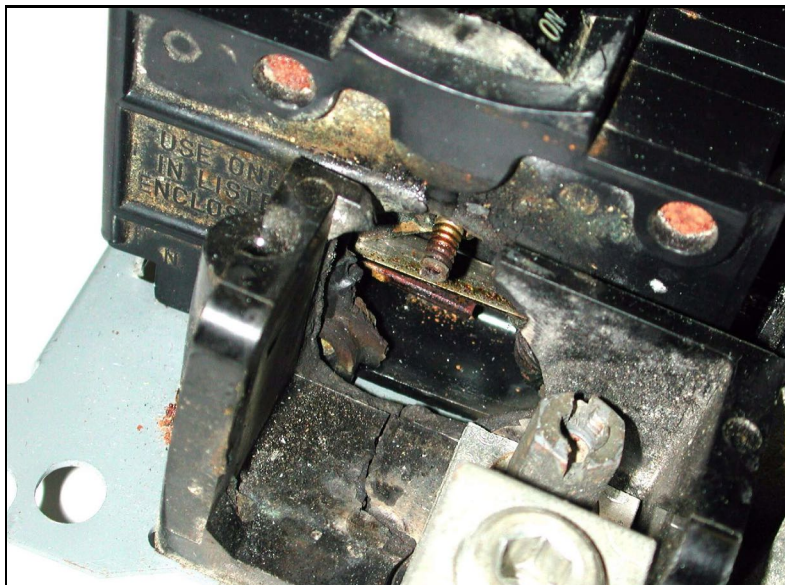
FIGURE 12 - VIEW DOWN TOWARD UPPER RIGHT OF PANEL SHOWN IN FIG. 11. THIS FPE STAB-LOK® TWO-POLE 30-AMP BREAKER FED THE CLOTHES DRYER.

The damage to the breaker, from some previous high-current overload event, is exactly as had been demonstrated in the tests done for the CPSC.^{2,3,4} Those tests demonstrated that, when an FPE breaker jammed and the current exceeded about 300% of the breaker's rating, the side of the breaker disintegrated and/or ignited (smoldered) from the heat being generated within the breaker. This is due to resistive heating of the breaker's internal current-carrying components, mainly the bimetal element and the flexible copper braid that connects to it. This is not an arcing failure, although the damage to the insulating materials of the breaker and panel sets the stage for an arcing fault to occur.

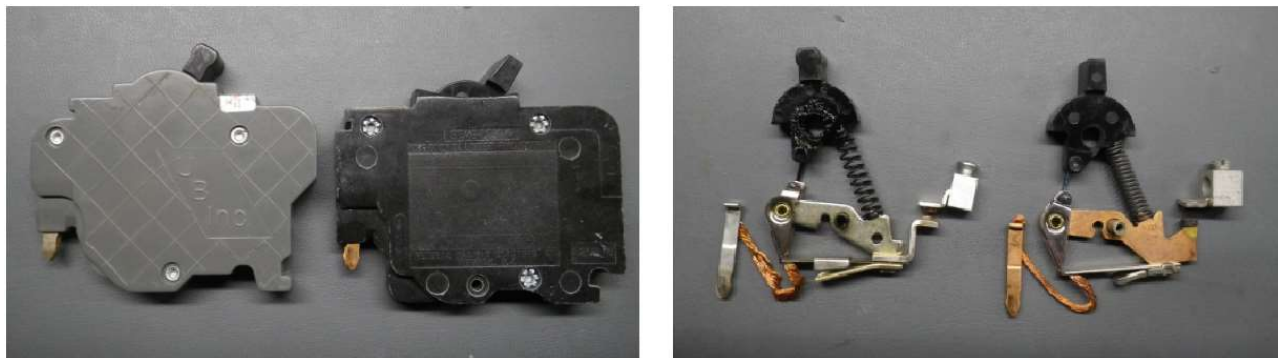
Replacing the FPE breakers with UBI-F breakers is definitely not recommended, as it is likely to result in an increased level of hazard. The UBI-F breakers, marketed by Connecticut Electric Products, are the only new breakers commonly marketed today in the U.S.A. as replacements for the FPE Stab-Lok® breakers. The UBI breaker housings look different, but internally the breakers are essentially the same design as the FPE breakers, as can be seen in Figure 13. The test results for UBI breakers are poor.

FIGURE 13 - UBI-F BREAKER AND FPE BREAKER, OUTSIDE AND INSIDE
(UBI on left, FPE on right in both photos)

Brand new UBI-F breakers have been tested. The results are presented in Section 3.D of this report. The findings demonstrate that the brand new UBI breakers and used UBI breakers from homes (Sections 3.B and 3.C) have a higher failure rate than the FPE breakers that they are intended to replace. Replacing FPE breakers with UBI breakers is a step backward in electrical safety.
