A study on the effect of iron rust on archaeological wood applied on the archaeological gun No. 7 / 14 at the Museum of Applied Arts, Helwan University

Zidan, Y.¹; El Hadidi, N.M.N.²; Abo Elgat, W.³

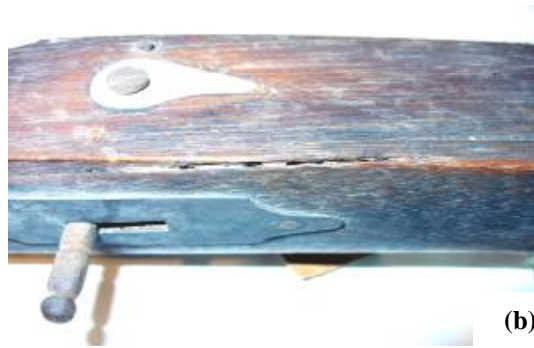
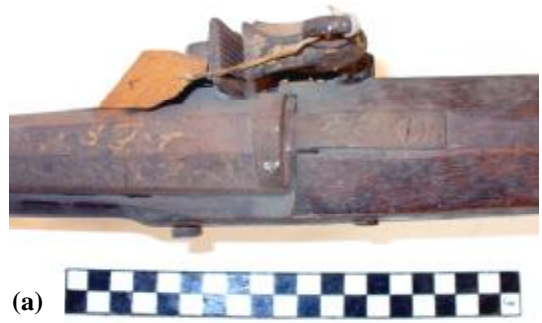
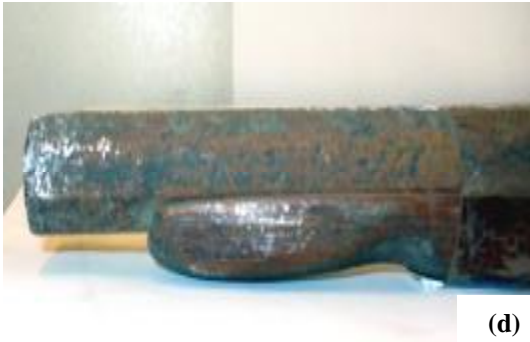
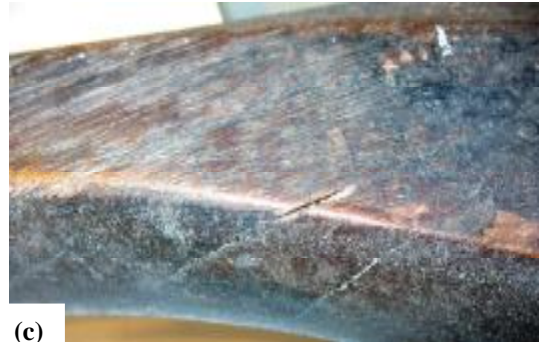
Fig.(1) shows the gun before treatment; a- shows the surface dust that distort the surface of the gun and blur the decoration, b- describes aspects of loss and separation in the gun wood next to trigger in the form of longitudinal crack, c- show damages in the form of cracks and separations in the wooden handle of the gun , d- show outputs of iron rust of red hematite and black magnetite which covers the entire body of iron barrel, especially at the open terminal end.

- 2- For treatment and restoration of the gun the following procedures were applied:
 - a - Dust layers from the initial parts of the gun (fig. 1- a,b,c) were removed internally and externally using mechanical cleaning techniques, especially different types of brushes, which were suitable for both wood and metal.

- b – The state of the gun allowed easy handling and the metal parts that had been attached to previously added wood in old restoration (fig. 1- a,b,d) were separated from the gun.

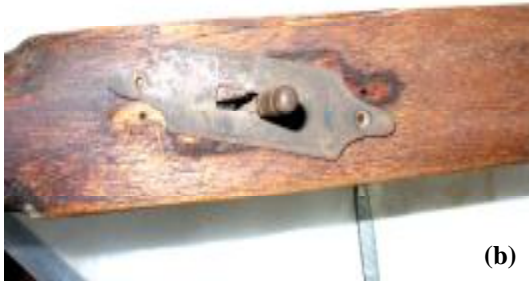
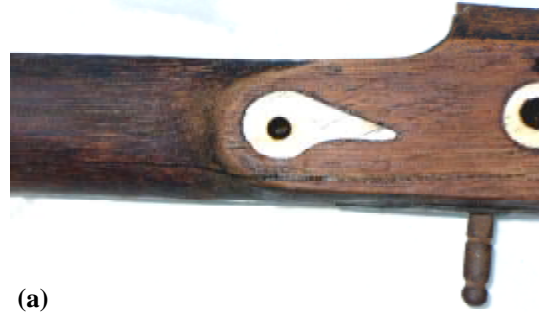
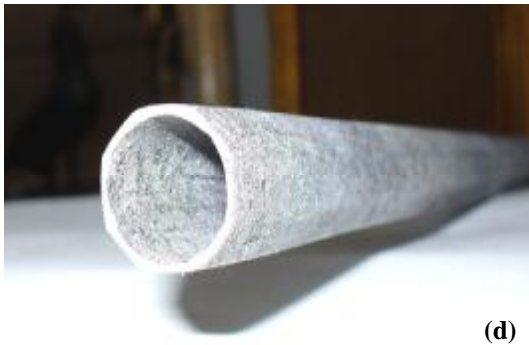
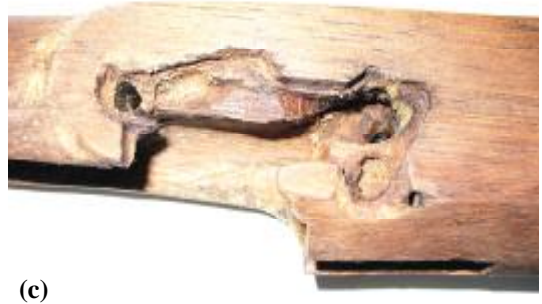
Fig.(2) shows the gun during and after treatment; a- Show part of the stages of localized initial chemical cleaning of the soot in wooden gun surface, b- Show decoder the 2 nails of metal ornament of the trigger to clean them and clean the wood parts underneath individually, c- Show part of the wood lock plate after cleaning the deposits of iron rust and adhesives residue, which was heavily spread out, d- Show iron barrel slot after cleaning.

c - Chemical cleaning and the removal of the remains of materials used in earlier repairs, was applied using distilled water and ethyl alcohol 95% with different mixture ratios 1:1, 2: 1, respectively. Ammonia solution (2%) was used to clean the dark strong dirt, as well as the use of heated distilled water to clean adhesive residue (glue as identified by FTIR) at the end of the wooden gun (fig. 2-a,b).

d - Cleaning of the remains of iron rust formed under the barrel, was applied by using a dilute solution of oxalic acid 1-2% in hot distilled water (William *et.al.* 1999), followed by washing off the parts cleaned with the acid with distilled water several times (fig. 2-c).

f - The gilded iron barrel was cleaned chemically from the outside first using a solution of citric acid 5% to remove the weak layers of rust, and then soaking in EDTA solution (Ethylene Diamin Tetracetate - Komplexon₃) to clean the layers of black rust (Sobhy, 2006), and to increase the effect of the cleaning process and remove a layer of iron oxide magnetic black (magnetite), which has a scarce solubility, the powder of Komplexon₃ was added on the black portions. After every use of chemicals mechanical cleaning was applied to remove the products of corrosion that was dissolved so as to reach the desired effect of cleaning. This was then followed by washing with distilled water hot then cold, drying with ethyl alcohol, followed by isolation of all parts of the barrel inside and outside immediately after drying using two cross layers of Paraloid B72 dissolved in toluene 4% (fig. 2- d).

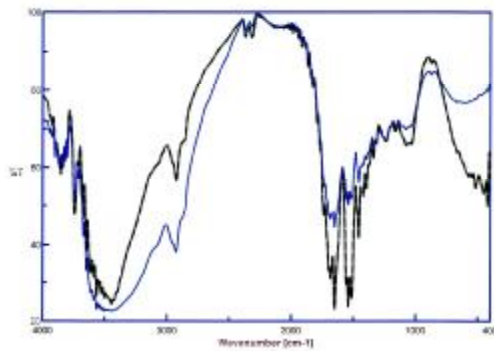
B- By comparing the results obtained from analyzing the remains of an old adhesive used on many parts of the gun with several natural glues using FTIR it turned out that animal glue was used for adhesive purposes (fig. 3, 4).

Fig.(3) shows that the sample taken from the wooden handle back and the other taken from the bottom of the iron barrel are of the same type of adhesive.

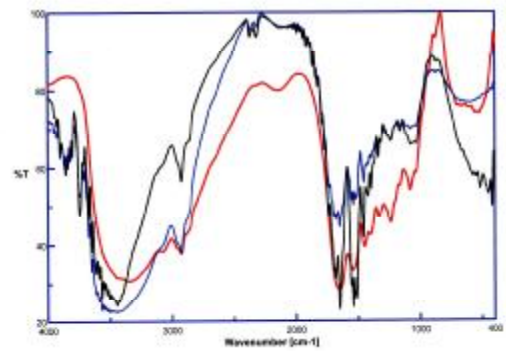
Fig. (4) shows that the spectra of sample analysis of archaeological adhesive by IR are similar to the sample spectrum of modern animal glue, which confirms that these samples of glue as well.

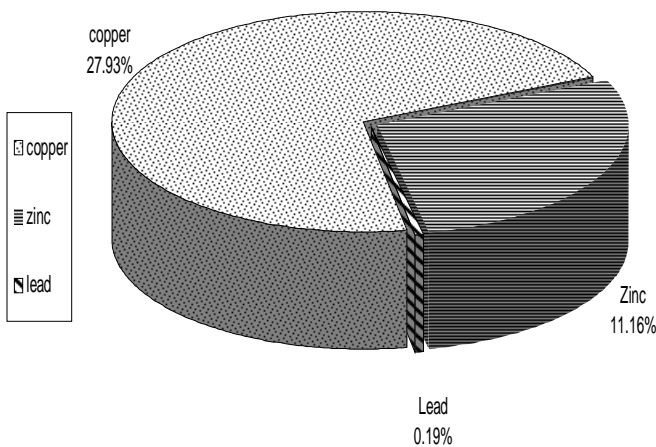
C- Analysis of metal parts from the gun by Atomic Absorption showed that the three pieces of metal that connect the wooden part with iron barrel were made of a brass alloy, whereas the lock plate and barrel were made of iron (fig. 5, 6).

Fig. (5) shows the results of the analysis sample of metal East gun by atomic absorption, and it is clear that the sample of brass alloy.

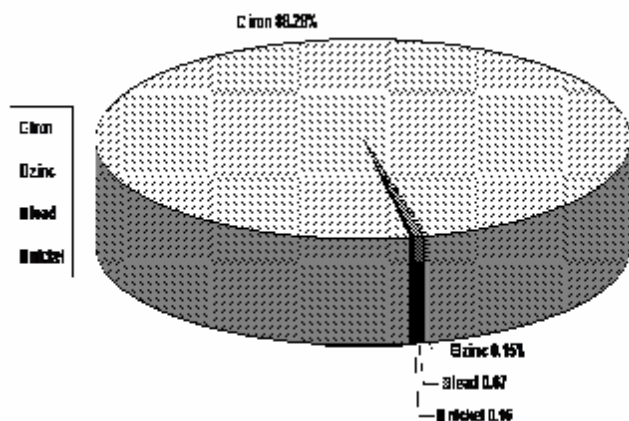
Fig. (6) shows the results of the analysis sample from the lock plate of the gun by atomic absorption, and it is clear that the sample of iron.

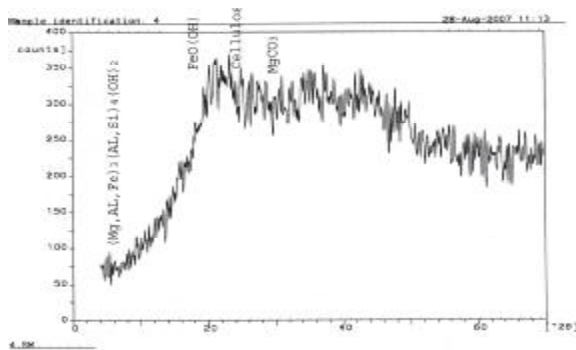
D- Samples taken from corrosion products from different parts of the gun were analyzed X-ray diffraction. it has been found an affected of wood gun and a private area of the bottom of the barrel and inside the nail holes by iron rust from iron metal parts around parts of timber as well as to the impact of air pollution in the atmosphere of the museum that increase the damage the piece (fig. 7, 8) .

Fig. (7) shows the X-ray diffraction pattern for the sample of the material filling the bottom of barrel after the disassemble all the parts of wood and shows the cellulose as a major component mixed with iron rust.

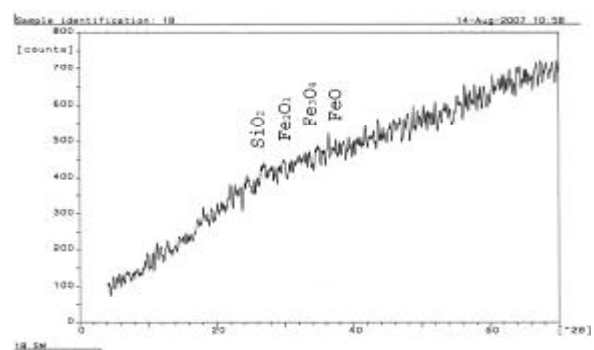
Fig.(8) shows the X-ray diffraction pattern of a sample of the lock plate and found to contain parts of the sample on the iron compounds with the remnants of dust and dust air.

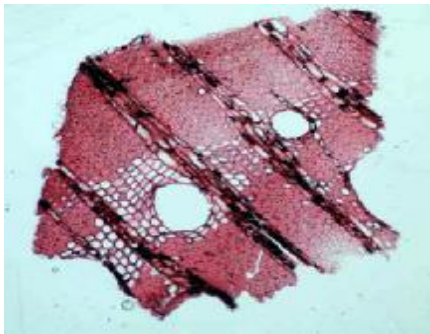
E- Examination of two samples from both the wooden handle and the end of the gun using the optical microscope proved that Oak wood (*Quercus* spp.) was used (fig. 9).

Fig. (9) shows cross section of Oak wood (*Quercus* spp.) on light microscope of sample taken from the gun (30x)

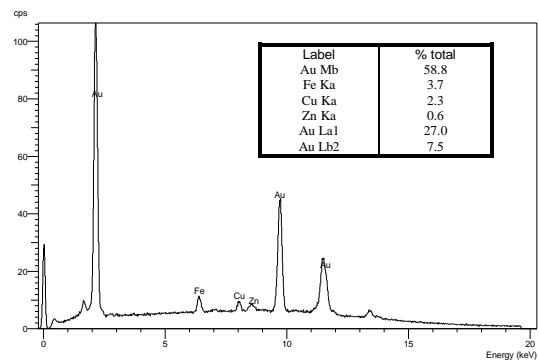
F- To make sure the components of the layer gilding on the barrel metal of the gun, it has been analyzed a small sample from gilding material by X-ray fluorescence of the elemental analysis unit attached to scanning electron microscope (EDX), It has been shown of the outputs of the analysis that the substance of gilding is made up of gold , where it appeared on more than sub-level of sample and high rates, mixed with very small percentage (2.3%) of copper, in addition to the emergence of an iron the main component of the metal barrel of the gun (fig. 10).

Fig. (10) shows the results of elemental analysis EDX of a sample of material gilding metal gun, it is clear from the gold with the appearance of some impurities

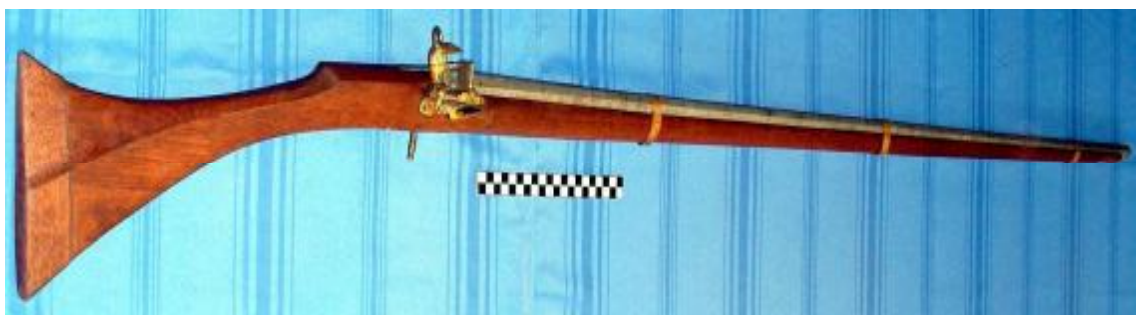
Fig. (11) Illustrates the gun after installation and assembling of the different parts, cleaned and isolated completed.

h- In the last step all the parts were reinstalled using the screws that had been previously cleaned and isolated, then parts of the copper rings were put in place along the iron barrel to link between them and the parts of wood underneath(fig. 11).
