# The Hutchinson's Buildings Nail

**A short report into the probable cause  
of the deformity to the nail**

Colin Meddes

April 2023

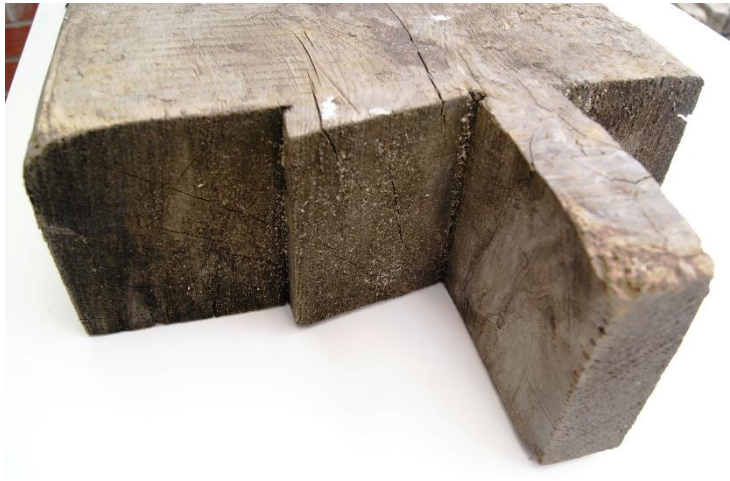
The joints appear not to be very well made with a rough finish and an over-run on some of the saw cuts on the tenon. This could be attributed to being cut by an apprentice carpenter. Surprisingly, the timber appears not to be of the best quality as the carpenter has had to cut the mortice between two knots. This could indicate that the timber was being re-used or that the standard of timber being used as Hutchinson was no longer involved in the project.

*Figure 3 – The tenon*

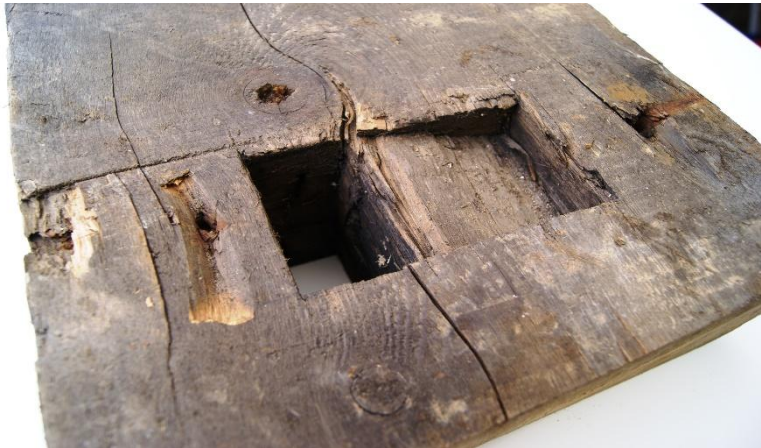
*Figure 4 – The mortice*

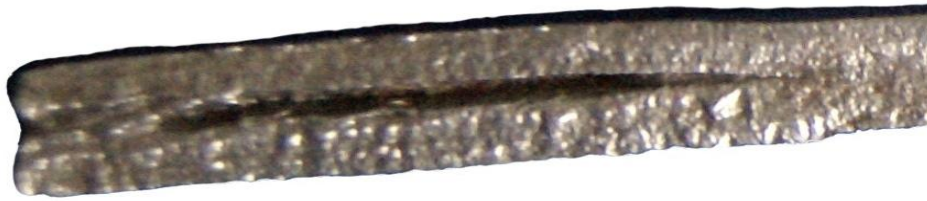
*Figure 8 – De-lamination of fibres at tip*

The partial de-bonding of the fibres and the large corbel indicate that the nail was clearly distressed at the time that it was extracted from the baulk. The corbelling could only have been created during the final insertion of the nail but the de-bonding could have been on-going from new. This could have been caused by one or a combination of the following factors:-

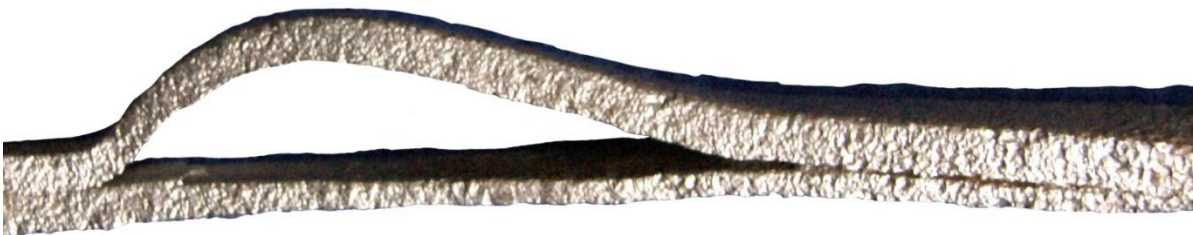
*Figure 7 – The corbel and de-bonding towards the head*

Deformities, either during manufacture or through usage before being used in *Hutchinson's Buildings*, resulted in de-bonding of some of the wrought iron's fibres so that when it was hammered in for the last time, two of the de-bonded fibres caught on a hard spot and buckled forming the corbel that it exhibits today.
