# ICLP 2000

## SOME ENLIGHTENING CASE HISTORIES ON LIGHTNING DAMAGE

**Abstract:** Lightning-related damage stories abound, but it is not always possible to document precisely the mechanisms and scenarios involved when timely, first-hand knowledge is not obtainable. From a collection of case histories accumulated by the authors, three cases are described. Each of the three illustrates a different mechanism leading to structural damage or equipment failure, in ways that might not have been obvious from a casual investigation of the damage or sites, or from second-hand reports.

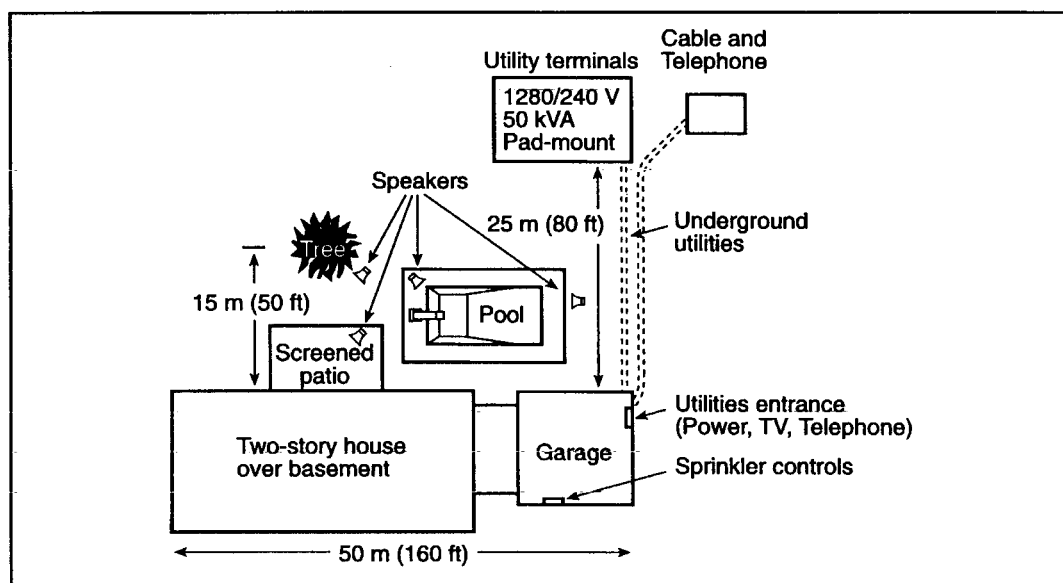
Figure 4  
Schematic configuration of the Rambling Residence

The overall physical layout of the house, damaged tree, and electronic equipment are shown in Figure 4. The tree that was struck is much taller than the house and is the tallest of the trees in the immediate area. The bark was stripped from the tree trunk for most of its height. The tree trunk is only approximately 15 m from the house and even closer to the patio, where some of the audio speakers were installed. Outdoor speakers are also located in the pool area and connecting walkways.

The visit to the installation verified this theory. The home entertainment equipment, including amplifiers, is centrally installed in the basement of the house. Speakers are located throughout the house, the patio, and the swimming pool area. The wire length between the outdoor speakers and the central amplifier is about 30 m, and some of the wires run within 10 m of the tree trunk.

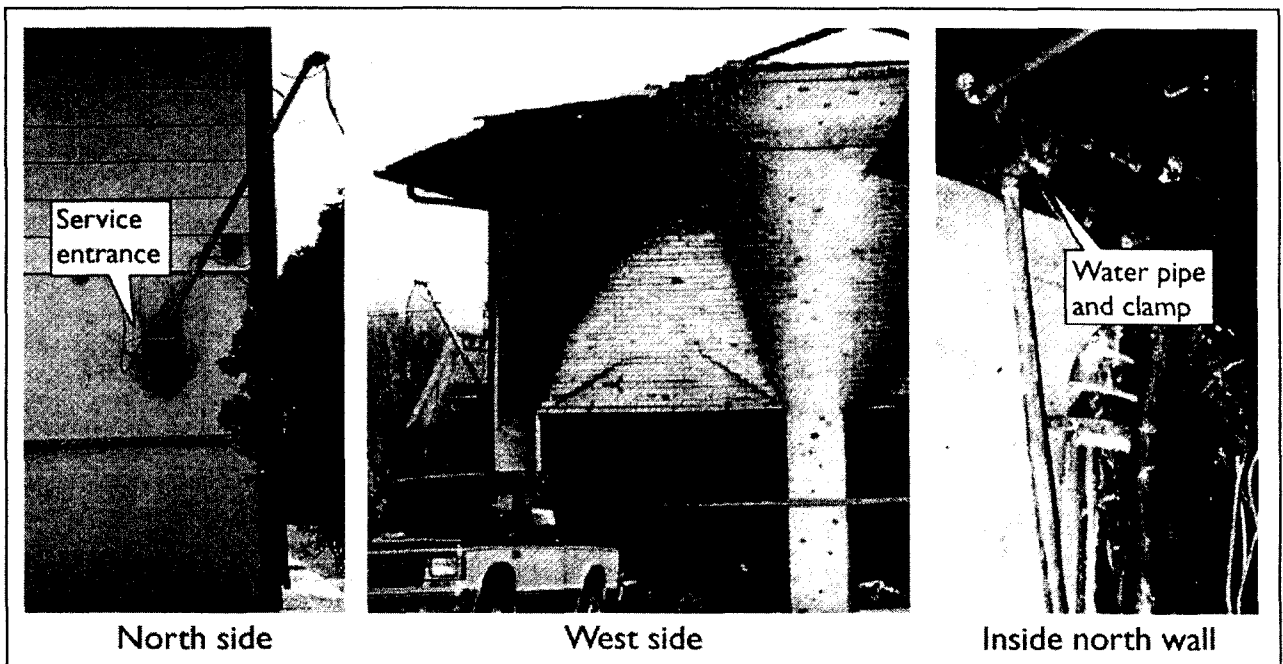
Figure 5 — The Standard Suburban aftermath

In this case, which occurred in a suburban, semi-rural hilly area, the post-strike investigation revealed that the overhead service drop to the house (involving a span of about 20 m across the street) had been severed by melting at the point of strike. From there, the current traveled to the revenue meter (typically on the outside wall in U.S. practice), where a ground conductor is normally installed with a short run to the earthing electrode of the house. Instead, according to the practice when constructed in the 1970s, a cold water pipe was allowed to be the main earthing electrode. In this case, the conductor for the earthing electrode entered the garage and was routed upward near the ceiling with several bends before it was bonded to a copper water pipe. Without any better path to earth, the lightning current had apparently followed the same route, severing the bare conductor while seeking the well-grounded water pipe (see Figure 5).

As shown in the photographs of Figure 5, the service entrances were overhead and without any direct path to earth. This type of installation would not be approved by current US practice, which requires a direct connection to a driven ground rod in addition to any other supplemental electrodes such as the cold water pipe. One of the main reasons that the practice was modified is the growing use of PVC or plastic water pipe.

On a later visit, the engineers who made the first visit were allowed to visit the repaired house. Indeed, the new service grounding point includes not only the electric power but also the telephone and cable company. The new water piping is PVC, and a driven ground rod has been installed as the primary grounding electrode.
