"WINDS OF CHANGE"

IN ASPHALT SHINGLE SPECIFICATION AND APPLICATION

BY EDWARD L. FRONAPFEL, PE

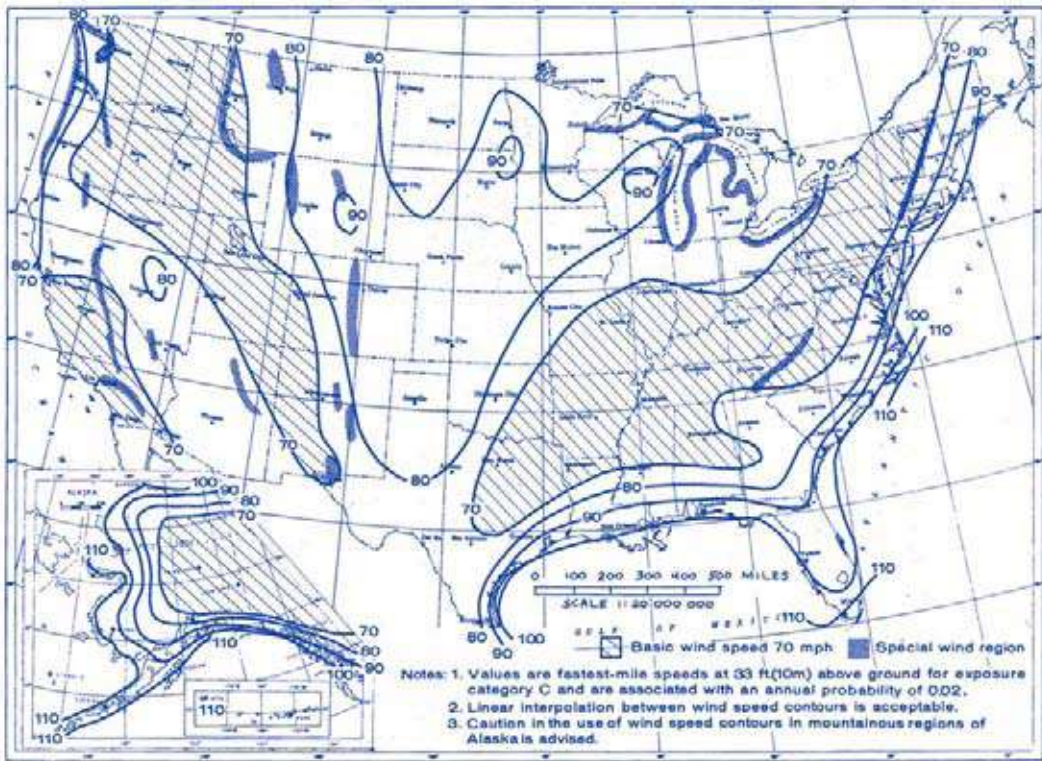
Figure 1. From American National Standard ANSI A58.1 –1992.

Note that the area shown in southern Colorado is west of the 105th Parallel. This map has an obvious flaw; the eastern down-slope hillside of the southern Colorado Front Range was not properly shown as a high wind area.

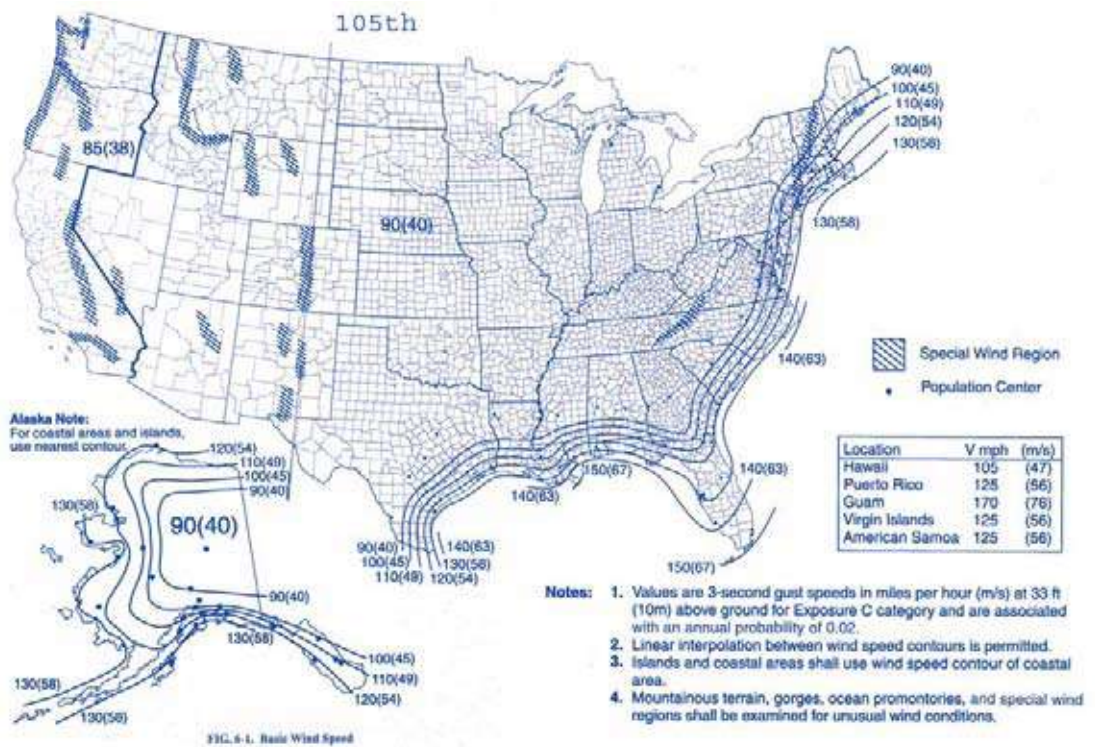
Figure 2. From ASCE Standard ANSI/ASCE 7-95, approved June 6, 1996.

International Residential Code and the International Building Code, the correct map was included (*Figure 2*). The map areas are unchanged from the 1995 ASCE document. However, common sense would dictate that the front range of Colorado, specifically parts of Douglas and El Paso Counties, should have been included and that the original map indicated the incorrect positioning of the wind zones.

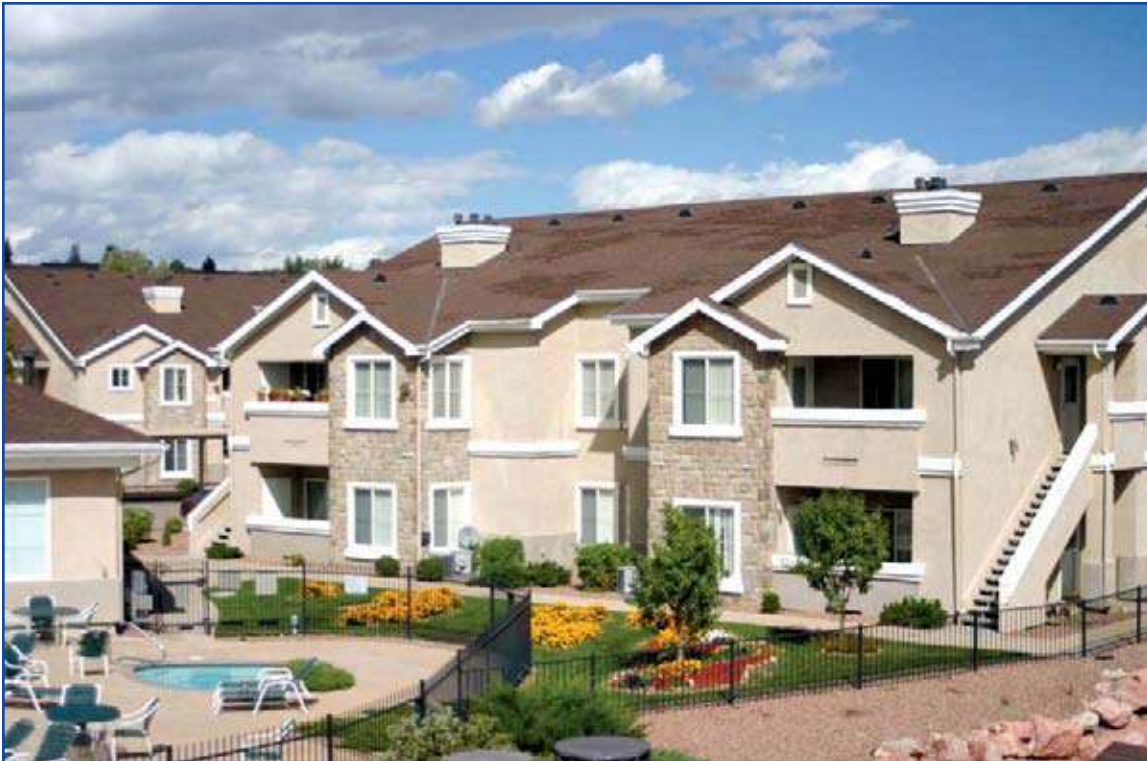
Photo 1. Overview of a building on the property, showing the loss of shingles.

As an example of this condition, PIE reviewed a project in the same area and jurisdiction that had substantial shingle blow-off. It was determined that there were often two or three causes. The nails used were not sufficient in number to deal with the design events of the 50-year recurrence, or even the "prescriptive" 85-mph-exposure

The nails used to secure the shingles were discovered to be improperly placed, and the shingle blow-offs propagated from many apparently unsealed edges. Photo 1 shows the patterns and large areas of blow-off (now replaced; see darker patched areas).

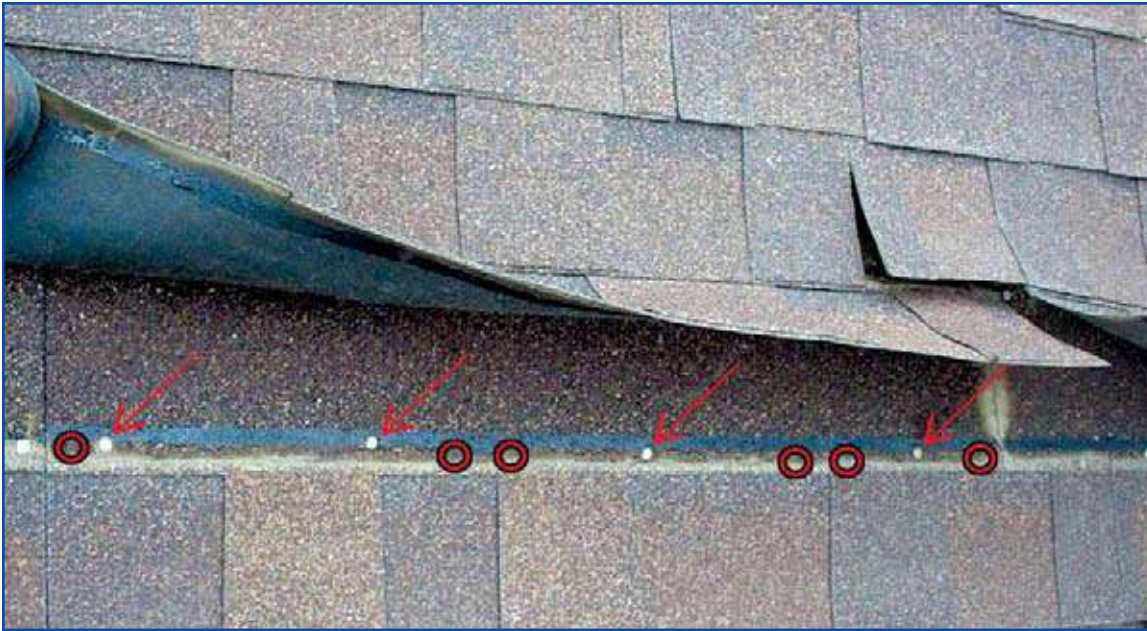
Photo 2: Discovered conditions on the buildings.

It was discovered that on the roofs that experienced blow-off, the shingles had not been installed with either a proper four-nail or six-nail pattern. Photo 2 depicts the conditions found on many of the roofs. The red circles note where the nails should have been placed in a six-nail pattern. The shingles were also found to be improperly lapped with the corresponding shingles, and many seals were loose. The nails were placed too high on the shingle. This misinstallation results in a nail that penetrates through only one laminate of the shingle. It was determined that the nails were located too far inward from the edges. The product was rated by warranty to 60 miles per hour, Exposure B. This 60-mph-rating does not meet the building code's requirement for this specific area, defined by local code as 85 miles per hour.

The shingles are, therefore, not installed to the more stringent conditions for the high wind design requirements; and, in fact, the product chosen does not meet performance requirements of the building code.

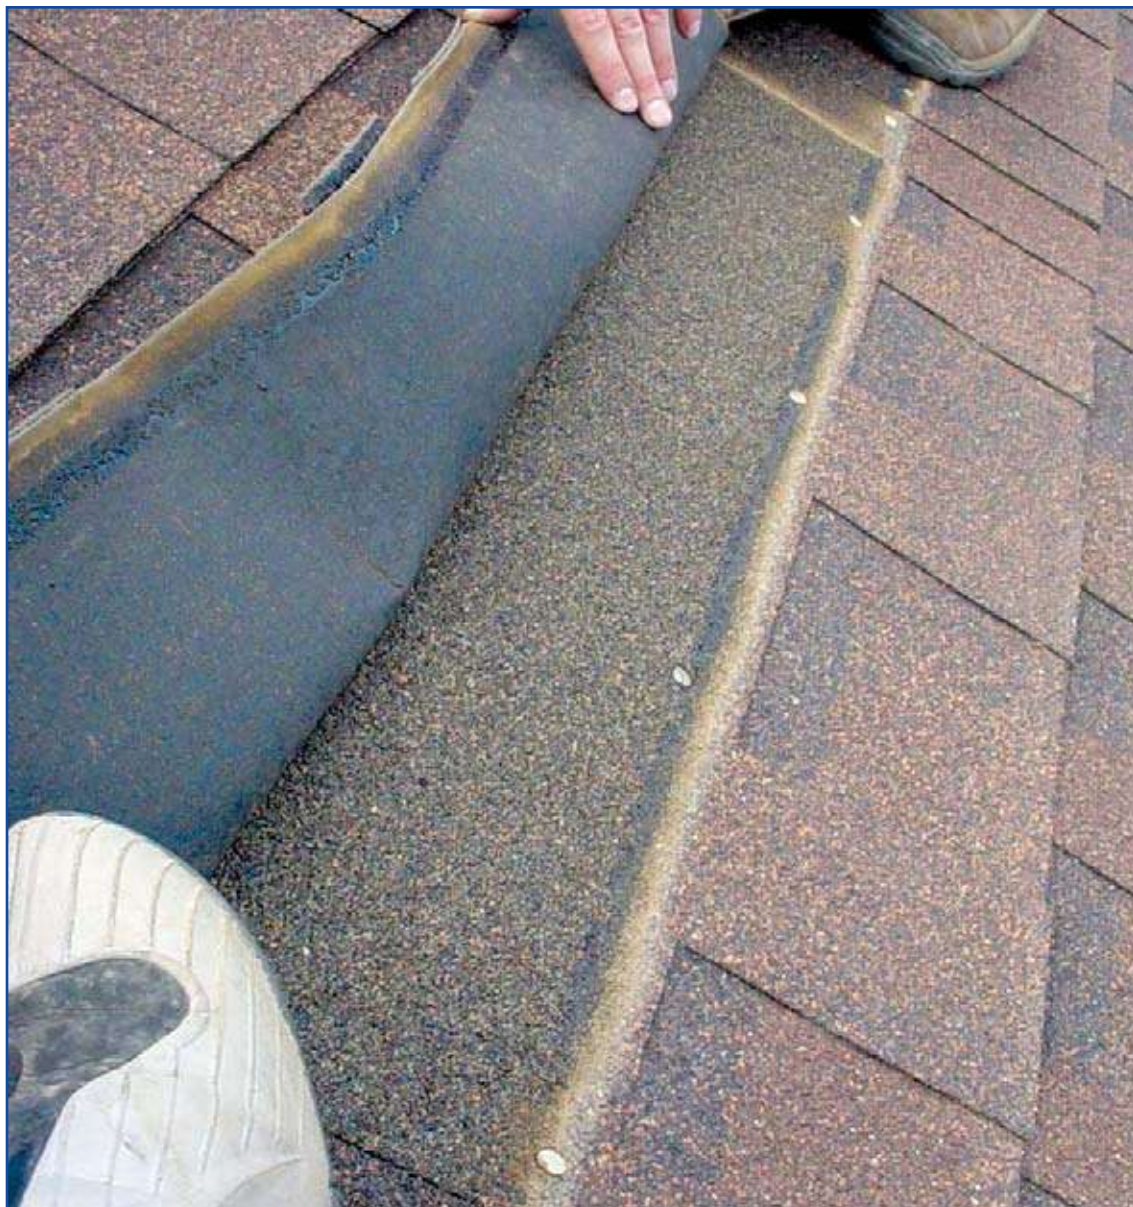
In PIE's opinion, this manufacturer's representative did not factually represent conditions that exist at this site. Not only were the nailing methods incorrect (number and placement), but there were instances of improper lapping and poor integration of roofing components, including flashings, sealants, sidewalls, chimneys, and the stucco systems.

Photo 3: The nails are placed not only in the wrong locations, but also above the asphalt seal line, resulting in penetration of only one of the laminate shingle layers.
