Christchurch CBD: Lessons Learnt and Strategies for Foundation Remediation – 22 February 2011 Christchurch, New Zealand, Earthquake

K.M. Murahidy & A.F. Sleight

Tonkin & Taylor Ltd, Christchurch, New Zealand

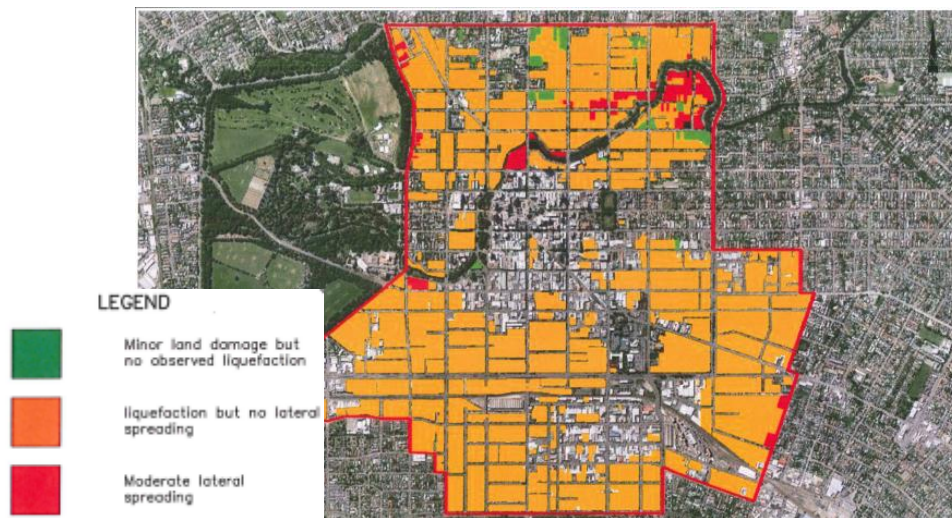
Following this event, the authors and their colleagues undertook mapping of the extent and severity of land damage within the CBD. This mapping was based largely on observed surface manifestation of the liquefaction process and included lateral spreading, the presence of ejected material (groundwater, sand and silt), ground cracking and deformation of the ground surface. Further details are provided in Murahidy et al. (2012). A simplified plan indicating the extent and level of the observed land damage reported following the 22 February 2011 event is presented as Figure 2.1.

Figure 2.1. Simplified Plan indicating Observed Land Damage following the 22 February 2011 Event

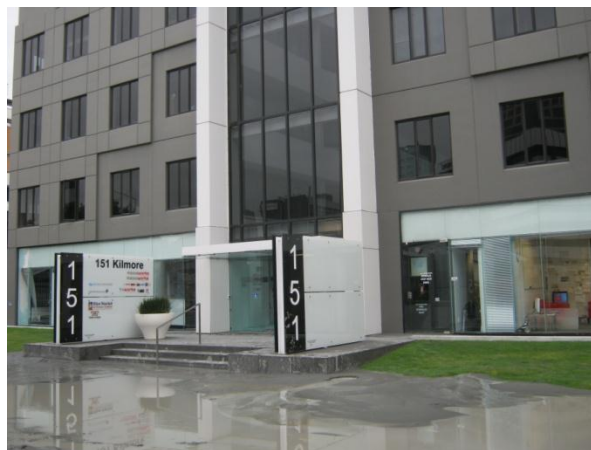
An example of the damage caused by the liquefaction process during this event is evident in the photograph taken in the northern CBD (refer Figure 2.2).

Figure 2.2. Evidence of liquefaction in Christchurch, New Zealand

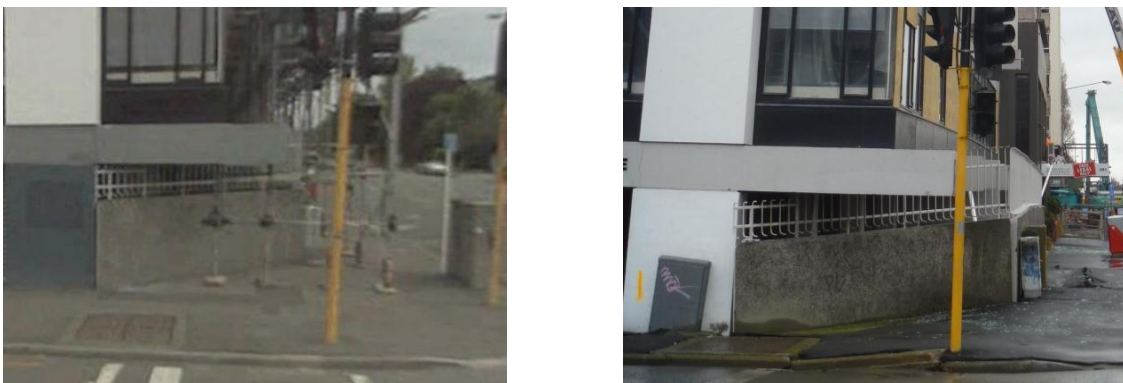
A brief survey of ground levels and beam soffit levels at 16 locations within the bottom floor carpark showed differential settlements of the beam soffits of over 300mm between the northwest and southeast of the building, and also considerable movements of the ground level.

This settlement of the ground beneath the building has caused differential settlements of the foundation elements. The photographs in Figure 5.1 illustrate the magnitude of differential settlement of the building.

Figure 5.1. Photographs showing corner of structure pre and post 22 February 2011 earthquake event (note height of metal grill above concrete wall, and corresponding damage to pavement)

The settlement has resulted in a loss of function of the structure (i.e. the building is no longer able to be used in the manner in which it was intended) and structural distress (i.e. beam and column cracking). The total and differential settlements due to seismic consolidation were safely tolerated by the structure without collapse.
