Tech Notes

NUMBER 2

Restoring Metal Roof Cornices

32 EAST 64TH STREET New York City

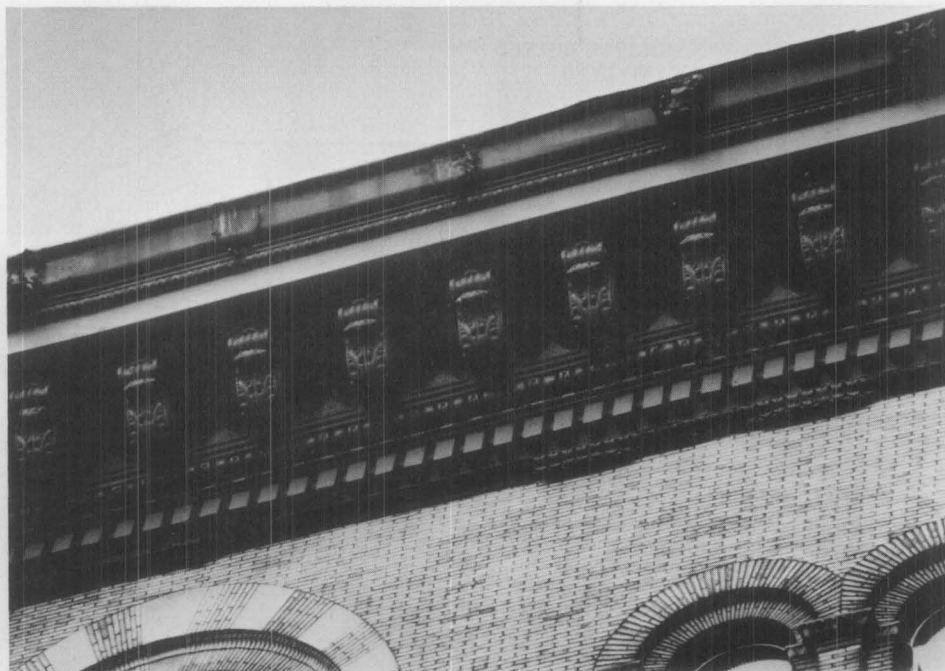
Figure 6. Three of the components of the metal cornice which required replacement because of serious deterioration are shown in this view. They are the lions' heads on the crown molding (several are missing due to failed soldered joints), modillions, and the egg and dart molding at the base of the cornice. The brake-formed galvanized steel that comprised the lineal moldings of the cornice, the soffit and dentil band were in sound condition. Photo: Richard Pieper.

Inspection showed that the galvanized steel facing of the cornice was in repairable condition but that much of the applied zinc ornament was not salvageable. The trusses supporting the cornice, the steel tee purlins and the structural clay tile were generally in excellent condition. Budget estimates were prepared for repair-in-kind and for replacement of the cornice. The architects considered two replacement alternatives; one with new metal and one with glass-fiber reinforced plastic. Repair of the existing cornice facing was the most economical alternative. The New York City Landmarks Preservation Commission also favored repair rather than replacement. Repair of the cornice included replacement of all modillions and nearly all applied zinc moldings; installation of new galvanized steel crown molding and cornice roof edge details; placement of new roofing on the top of the cornice; insertion of new rod hangers to supplement existing wire hangers supporting the face of the cornice, and repainting both the interior and exterior (see figure 6).
