SEISMIC PERFORMANCE OF MASONRY BUILDINGS DURING RECENT EARTHQUAKES IN TURKEY

A. Doğangün¹, A. Ural² and R. Livaoglu³

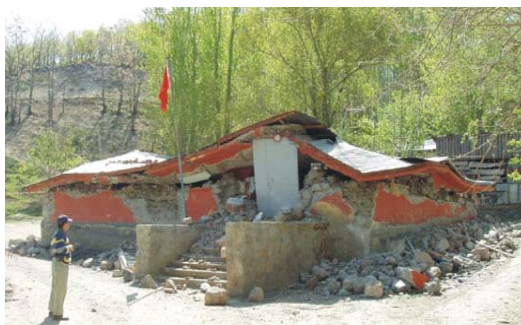
Mortars to be used in load-bearing walls shall be lime mortar enhanced with cement (cement/lime/sand volumetric ratio=1/2/9) or cement mortar (cement/sand volumetric ratio=1/4) according to TEC (2007). But it is not generally observed that mortar quality was the same one defined in the codes. Poor quality mud or cement mortar caused in the disintegration of masonry units and loss of support to floors as shown in Fig. 7. Especially, mud-stone masonry structures collapsed or were heavily damaged even in small earthquakes due to poor mud mortar and insufficient anchorage between mud and stone. Many people and animals have lost their lives under debris of these structures. So, this structural system should not be constructed in the earthquake zones or some wood structural elements should be inserted in this system adequately to prevent total collapse.

(a) Poor cement mortar in the elementary school building (Emre et al, 2003)

Figure 7 Collapsed and damaged masonry units due to poor mortar during Bingöl Earthquake

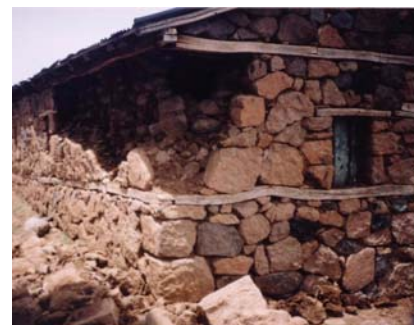
(b) Poor mud mortar

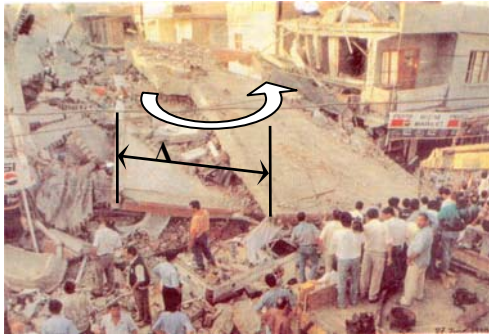
Load-bearing walls of masonry buildings must be arranged in plan, as much as possible, regularly and symmetrically in respect of the two main axes. Fig. 8a shows a collapsed three-storey masonry building subjected to torsion opposite of clockwise.

(a) Damaged during Ceyhan Earthquake (Tezcan & Boduroğlu, 1998)

Figure 8 Collapsed three-storey masonry building and RC storey resting on stone masonry storey

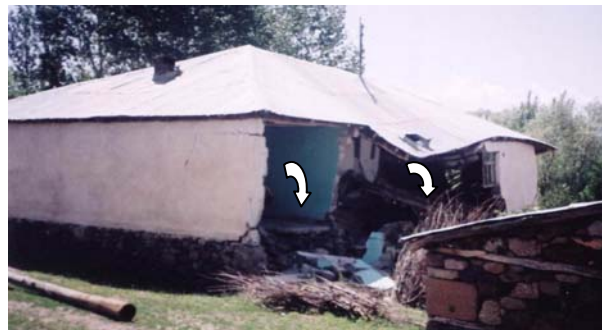
Unreinforced masonry buildings are the most vulnerable to flexural out-of-plane failure. If the connection between the walls and floors is not adequately restrained, the whole wall panel or of a significant portion of it will overturn due to seismic excitation in the perpendicular direction to the wall plane. Fig. 11 shows a view of out-of-plane collapse of load bearing walls. Added vertical R/C confining elements contribute to earthquake resistance of the wall; in this manner, out-of-plane failure does not easily occur.

Figure 11 A view of load bearing walls collapsed in the out-of-plane direction during Bingöl Earthquake

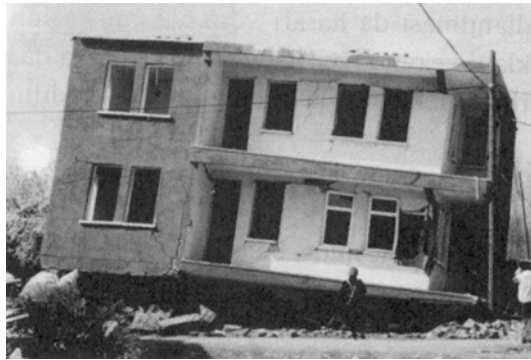
The first storey collapse is the common type of mechanism for the reinforced concrete structures known as *soft storey* and *weak storey* behaviours (Durmuş et al, 1999; Doğangün, 2004). The first storey collapse is also occurred in the masonry structures as a consequence of limited ductility capacity and poor strength of masonry unit materials. Fig. 14 shows a first storey collapse of a building with hollow clay tiles.

Figure 14 A collapsed building with hollow clay tiles during Sultandağı Earthquake (Ulusay et al, 2002)
