U. S. FOREST SERVICE RESEARCH PAPER • FPL 18 • DECEMBER 1964

## *STRESSED SKIN PANEL PERFORMANCE*

*AFTER  
TWENTY-FIVE  
YEARS  
OF  
SERVICE*

By OTTO C. HEYER, Engineer, and R. F. BLOMQUIST<sup>1</sup>, Chemist

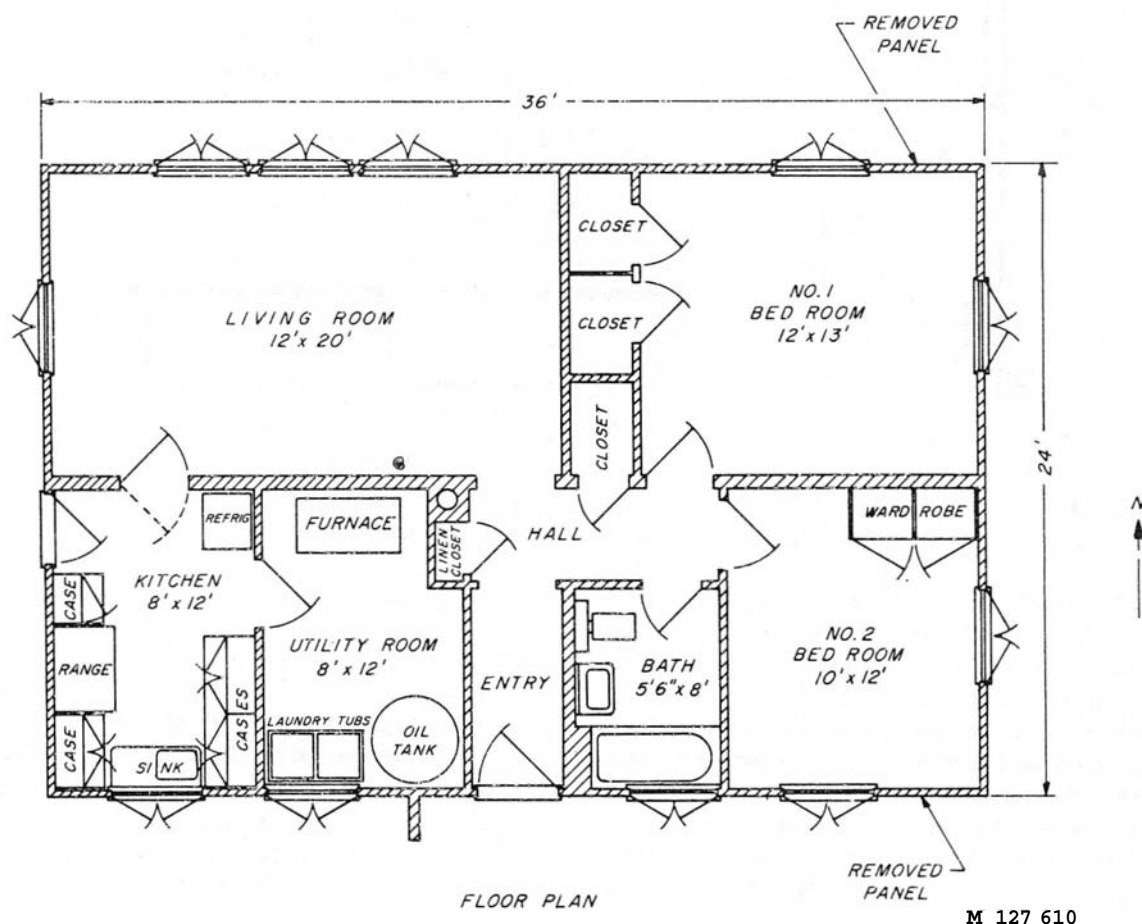
Figure 3.—Room layout of the one-story prefabricated house and location of the removed panels.

Two panels were taken from the one-story prefabricated house--one from the northeast corner of the north wall and the other from the

southeast corner of the south wall (fig. 3).

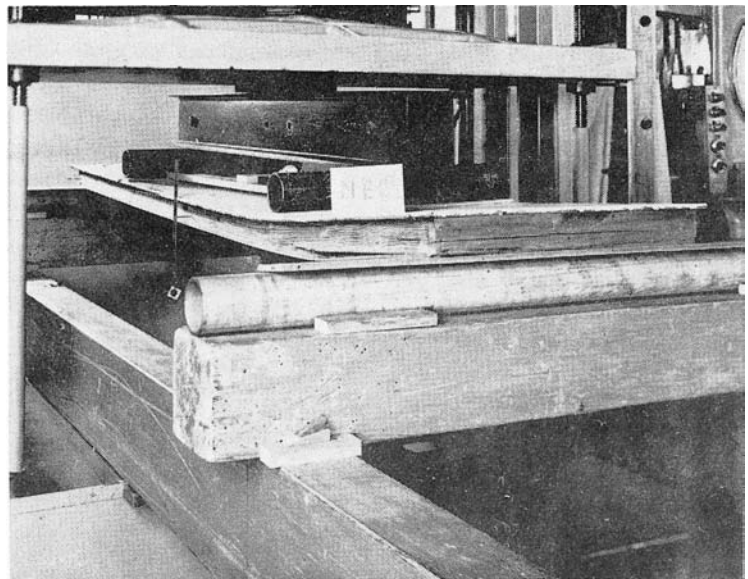
M 122 557

Figure 9.--Final failure of half panel removed from northeast corner of the experimental prefabricated house. Failure consists of a tension failure of framing member and horizontal shear maximum load was 284 pounds per square foot. This is a standard method of testing wall panels with load applied at the quarter point of the span.

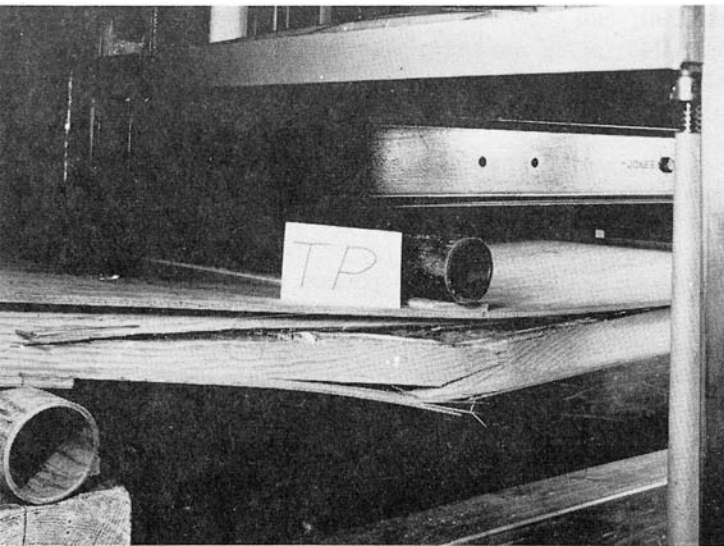
M 122 512

Figure 10.--Final failure of prototype panel, similar in construction to replacement panel, using plywood facings. Failure consists of a tension failure in framing member and horizontal shearing of the framing member. Maximum load was 239 pounds per square foot.
