THE LAND TITLE BUILDING Philadelphia, Pennsylvania

PRESERVATION Tech Notes

MASONRY NUMBER 2

Stabilization and Repair of a Historic Terra Cotta Cornice

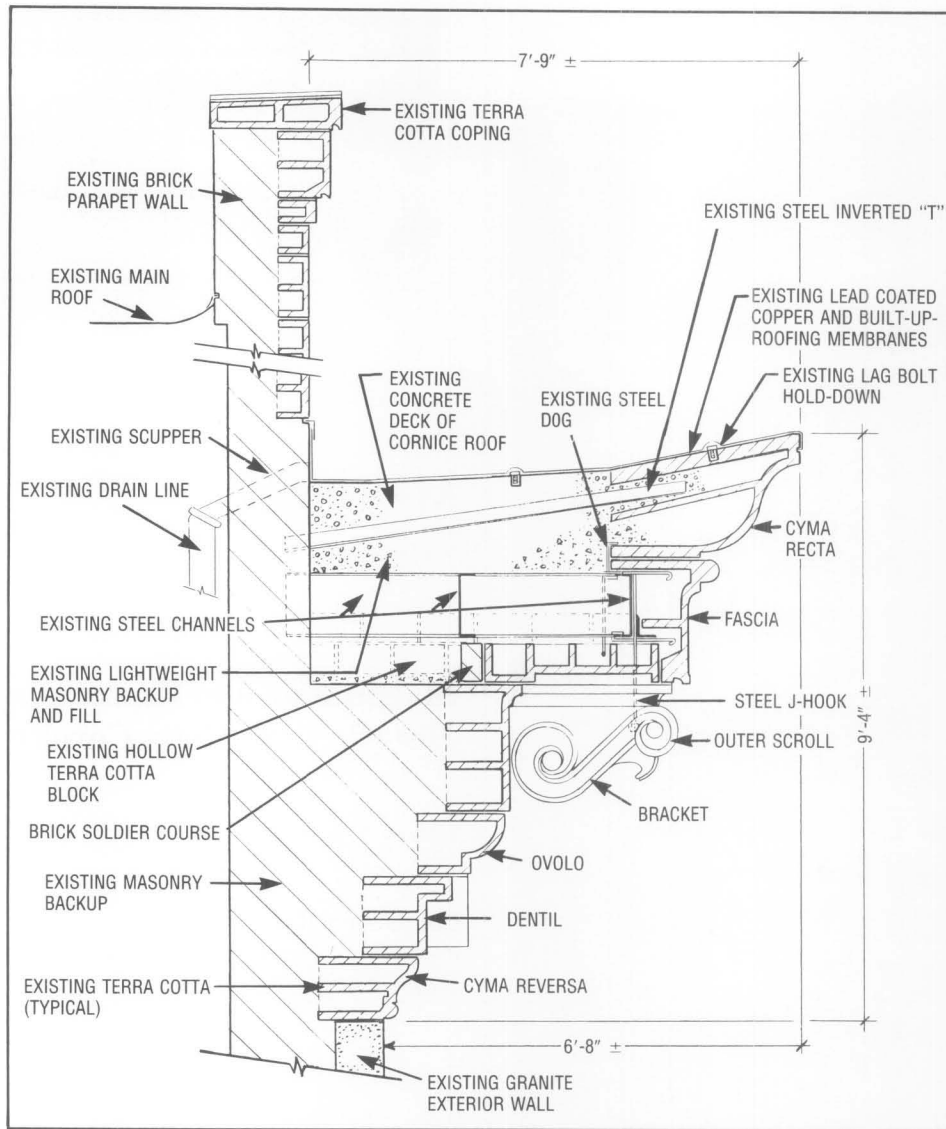
Figure 1. Section through the cornice and the parapet showing the structure's construction and attachment to the building. The inverted T's are embedded in concrete and act in friction to help support the cyma recta unit from rotating outward. The test openings did not penetrate below the soffit level of the cornice. Drawing by Jeffrey S. Levine.

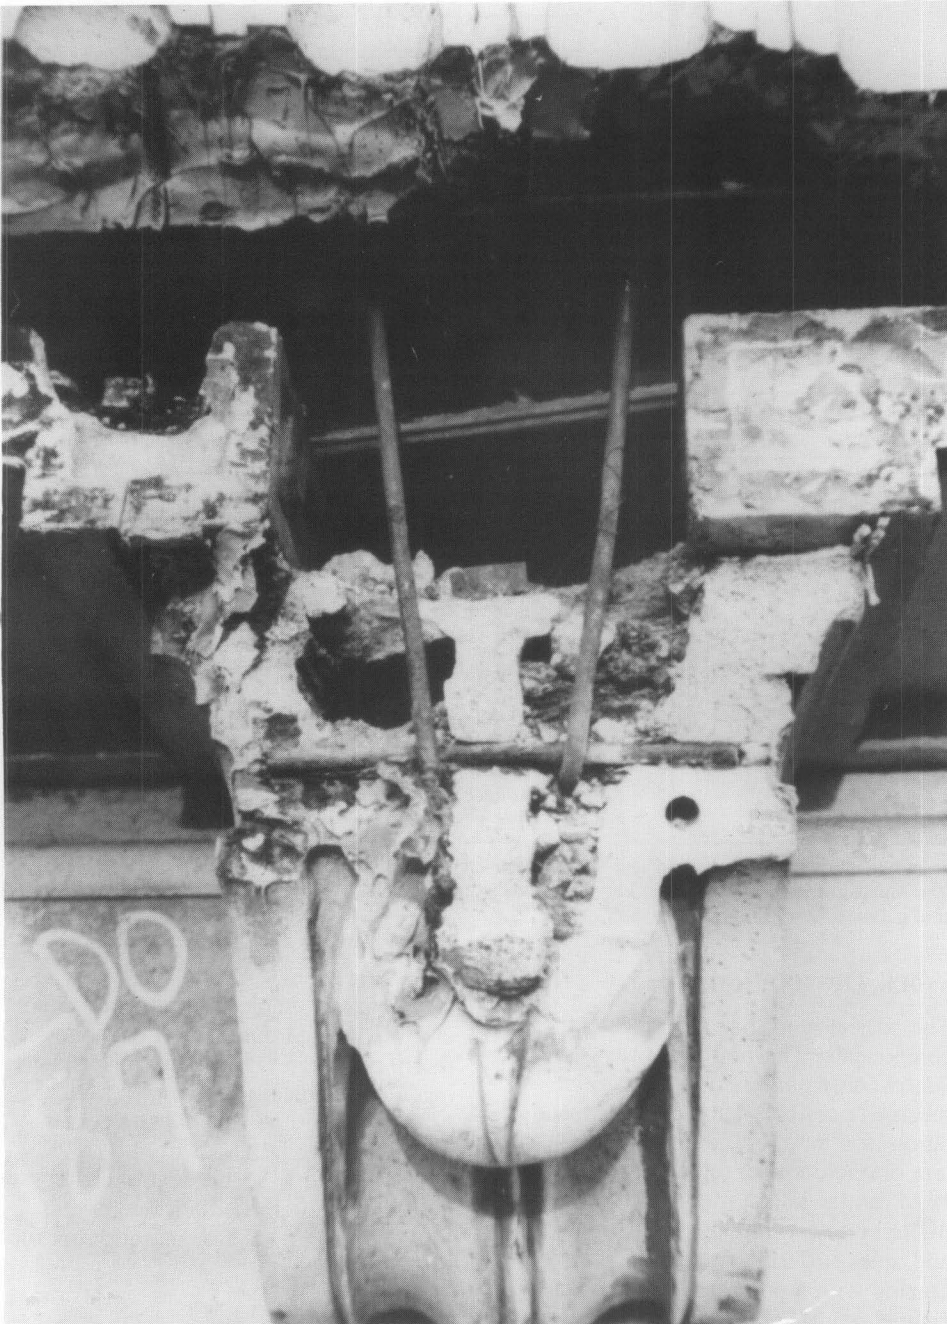
Visual inspection of the terra cotta revealed four common types of deterioration: spalls, glaze crazing, cracking, and open mortar joints. In addition, sounding the terra cotta units with a wooden mallet indicated that roughly 10% of the terra cotta units had cracked internal webs. Deterioration resulting in loss of material appeared with less frequency and was found principally at the outer scroll of the brackets (see figure 3) and at the scalloped fascia (see figure 4).

Figure 3. Numerous brackets were found to be missing their outer scrolls due to oxide jacking of the steel J-hooks, steel pencil rods, and temporary support wires located within the units that were used for installation. Cracking in the brackets whose outer scrolls had not yet broken off indicated potential for further loss of material if stabilization measures were not undertaken.

During the original construction of the cornice, the brackets were hoisted into place and temporarily supported by the wires cast into the nose of the bracket units. J-hooks were then dropped down from the outermost steel channel above into the upper and outermost cells formed by the unit's internal webbing. A steel rod was then inserted horizontally through holes cast into the exterior sides and internal webs of the unit such that, with minor adjustment in the length of the J-hooks, the rod sat in the trough of the J-hooks; the weight of the bracket were thereby transferred to the J-hooks (see also figures 1 and 5). Photo by Jeffrey S. Levine.

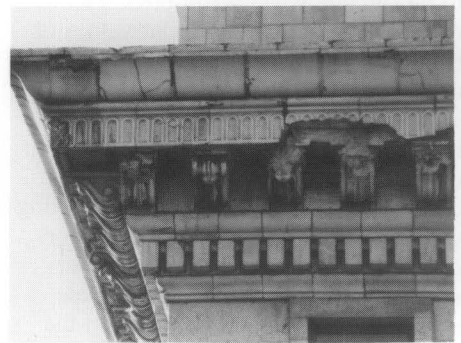
Figure 4. Extreme loss of material was noted in the scalloped fascia above the brackets at the south end of the east elevation of the cornice. This deterioration and corresponding cracking in other fascia units was due to rusting of the structural steel angle iron which supports the fascia units at their center webs (see figure 1). A likely point of water entry was a large open joint located immediately above the fascia, at the bed joint of the cyma recta units. Photo by Jeffrey S. Levine.

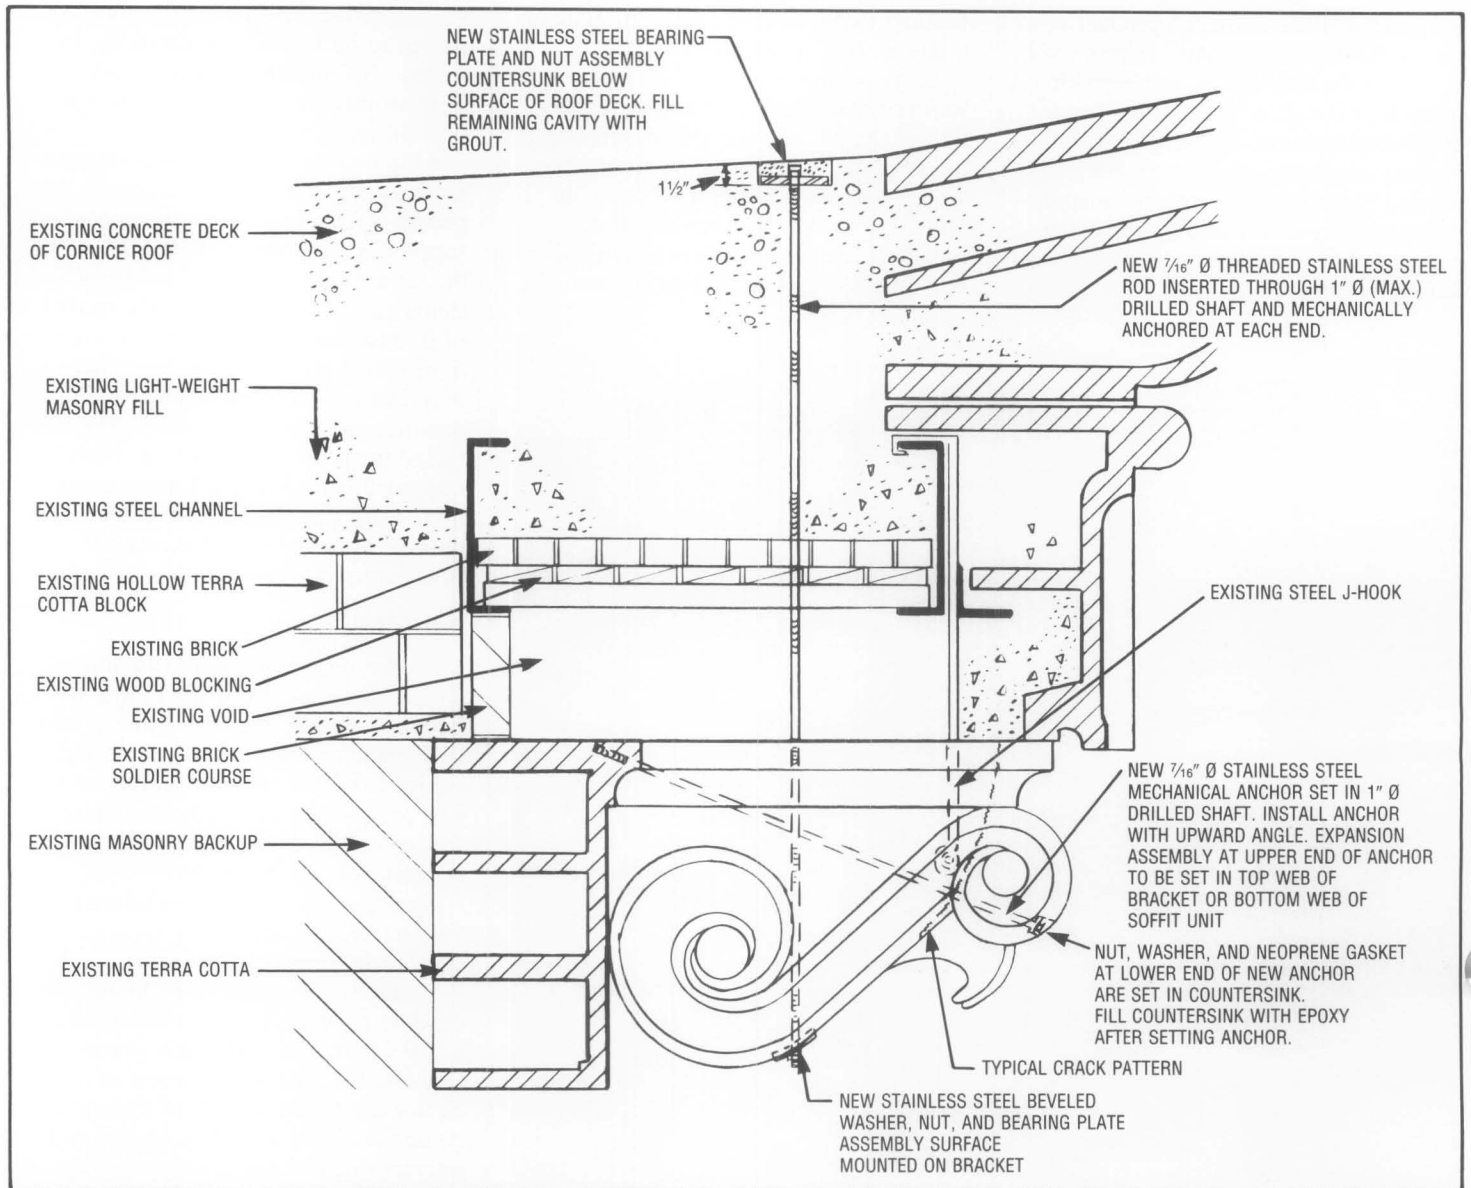
Figure 5. Detail section through the cornice showing the manner in which the vertical and angled outer scroll anchors were installed in the bracket units. The vertical hash-marks represent a typical crack pattern found in brackets which had not yet lost their outer scrolls. All 128 brackets received angled outer scroll anchors and about 80 received vertical anchors. Drawing by Jeffrey S. Levine.

to be suitable when set in brick backup or in structural steel. Pull-out values of from 500 to 1,800 psi were obtained in these materials, without any slippage or failure. These values were sufficiently high to provide a working safety factor of four times the weight of the terra cotta unit being supported. After making the decision to use mechanical anchors, drilling tests were conducted to determine anchor depths and backup materials at typical anchor locations on the cornice. Because the depth of penetration of the bracket units into the backup masonry could not be verified by non-invasive means, it was decided to anchor all brackets which had lost their outer scrolls or which had cracked internal webs. Given the condition of the light weight fill, this could only be achieved by extending vertical anchors through the roof (see figure 5).

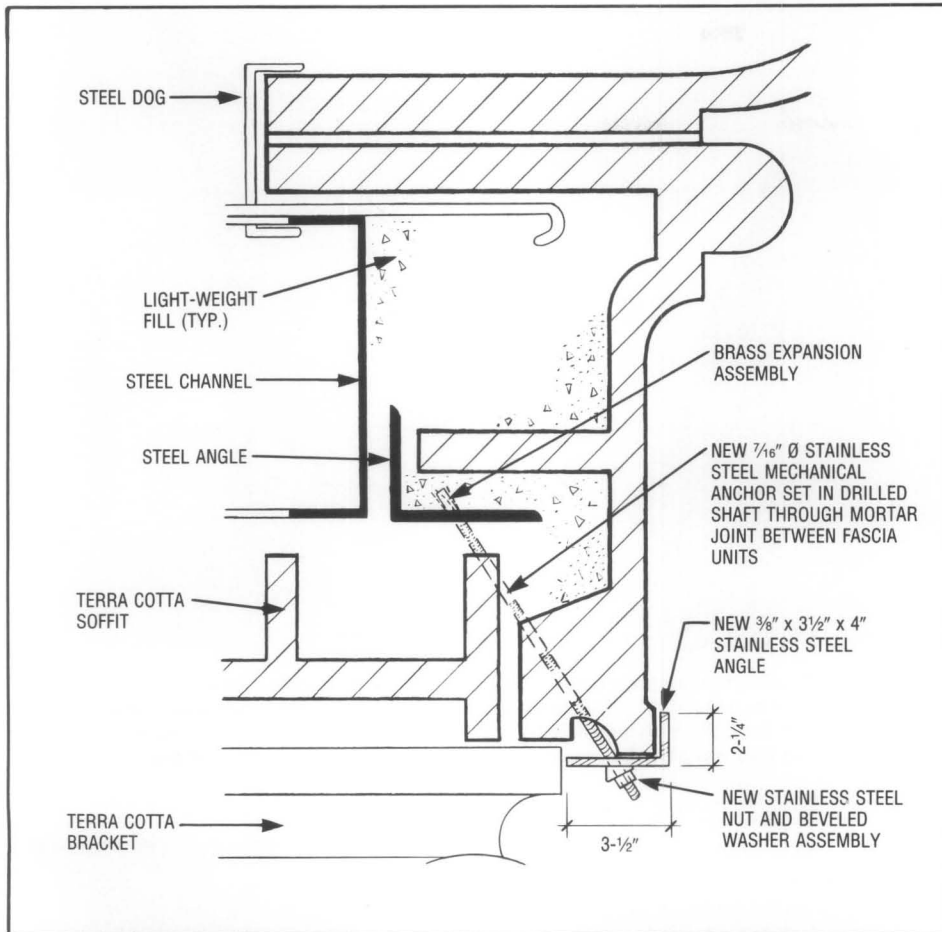
Figure 6. Detail section through the fascia of the cornice showing the installation of a fascia clip-angle anchor. Clip-angles were placed in the joints between fascia units—128 total. Drawing by Jeffrey S. Levine.

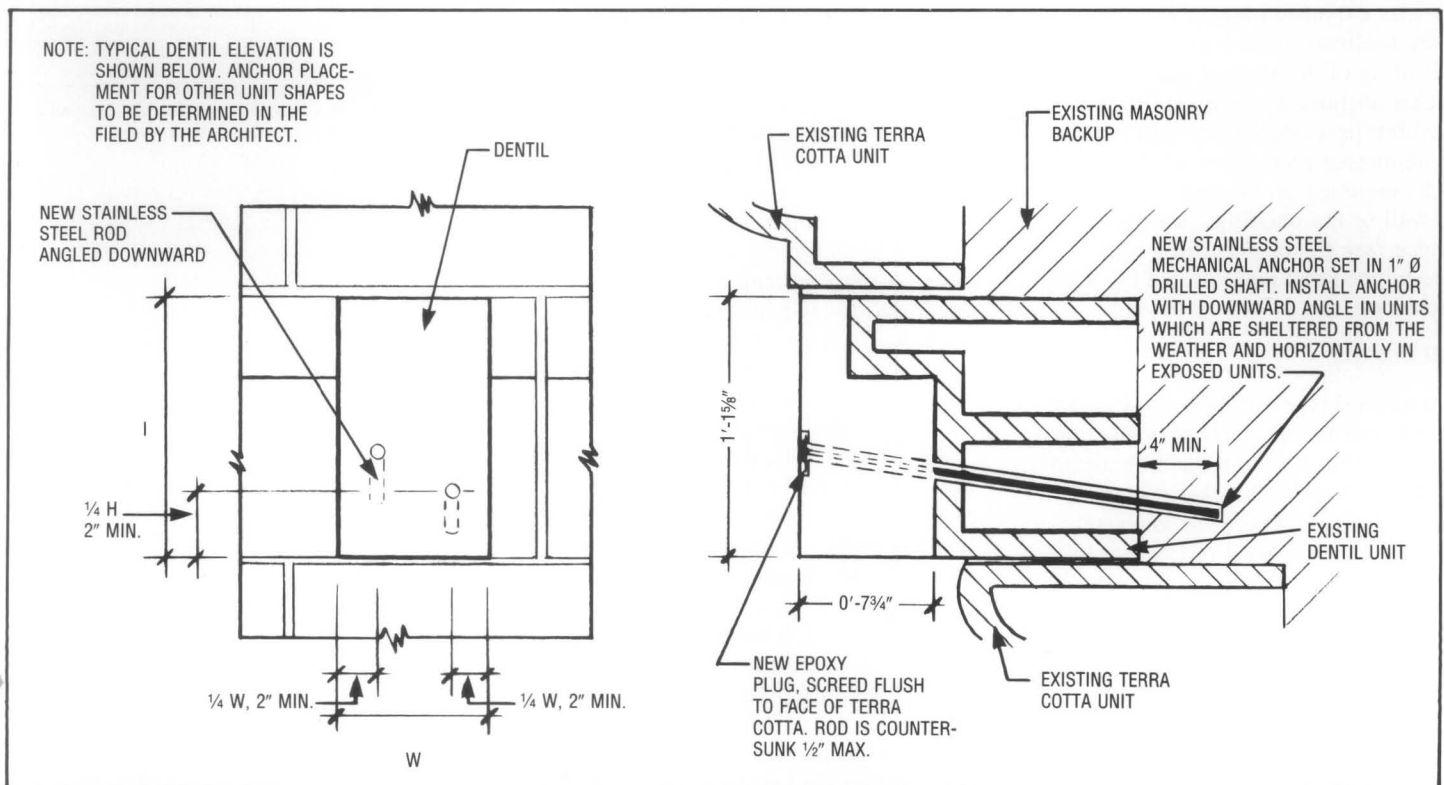
Figure 7. The typical terra cotta anchor detail is shown here for a dentil unit. Other terra cotta units with cracked internal webs were anchored in a similar fashion. Roughly 30% of all terra cotta units, exclusive of the brackets, were anchored in this manner. Drawing by Jeffrey S. Levine.

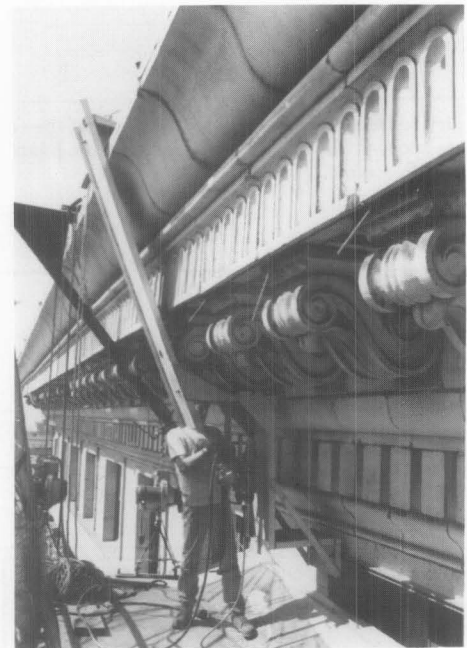
Figure 9. Drilling 6' long vertical holes through the cornice, in a variety of materials, was a delicate operation requiring great skill and specialized drilling equipment. The aluminum drilling jig provided the precise alignment needed to drill the holes for the vertical and angled bracket anchors. Drilling of a vertical anchor is shown. To create an angled outer scroll anchor hole, the drill was mounted on the angled portion of the jig, which passed directly in front of the bracket. Hand-drilled holes could be completed in 15-30 minutes, depending on the depth of the hole and the type of backup material encountered (e.g., brick, terra cotta, light-weight concrete, steel). Holes drilled with the jig required more time, 30-60 minutes, as alignment was more critical and it took time to set the jig in the proper position. Photo by Jeffrey S. Levine.

Drilling of the vertical and angled bracket anchors was accomplished using a drilling jig custom-fabricated out of $\frac{1}{4}$ " aluminum plate. The jig slid on tracks mounted on the roof deck and on the wall of the building, just below the cornice (see figure 9). All other holes were aligned and hand drilled by skilled mechanics.

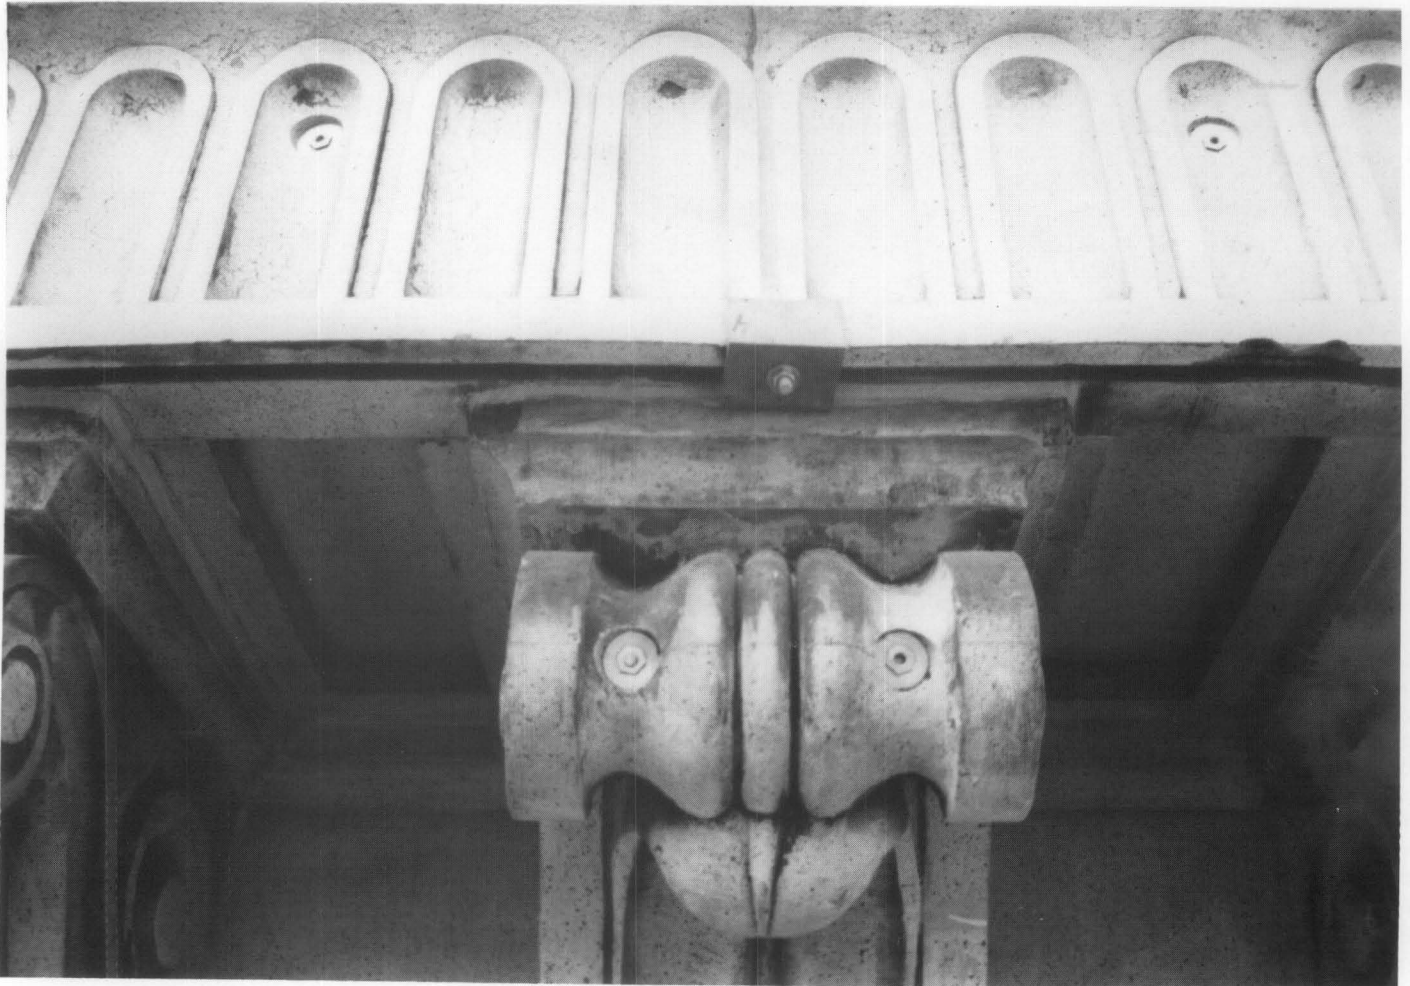
Figure 11. Completed anchor installations at a fascia and bracket. The countersink holes penetrate no more than half the thickness of the outer wall of the terra cotta and were filled later with epoxy.

As it turned out, the cornice construction was not very consistent and anchor placement varied according to the location of cracks. As soon as the initial order of fixed length anchors was used up, the drilling crew resorted to using all variable length anchors since these could easily be cut to the exact length required for any given situation (see figure 11).
