## USES OF THE BOREHOLE CAMERA IN HYDROLOGIC INVESTIGATIONS RELATED TO COAL MINING<sup>1</sup>

Jay W. Hawkins<sup>2</sup> and Robert S. Evans

Proceedings America Society of Mining and Reclamation, 2004 pp 847-859

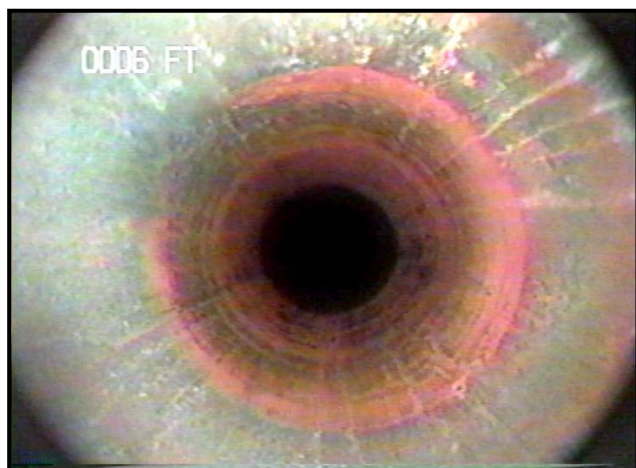
The borehole camera was used to view the condition of a significant number of the wells. In the course of inspecting the condition of the wells, historic water levels (Fig. 1) were ascertained

Figure 1. Iron oxide ring indicating the historic water level.

from the upper limit of extensive iron staining and casing corrosion in several wells. Most of the wells had iron concentrations exceeding 1.0 mg/L, which is well above the threshold for iron precipitation and staining. The observed water level for wells where a historic water level was determined was between 14 and 24 feet lower.

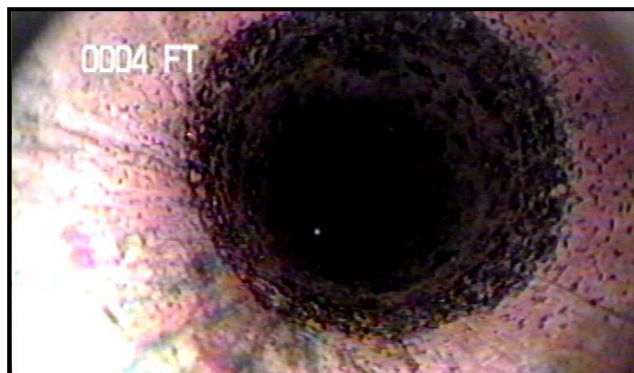
Figure 2. Upper limit of a corrosion zone on steel casing.

The location of the staining or corrosion (Fig. 2) is an indication of the average water level over time. While the notation of staining or corrosion may not be conclusive as to what the exact water level was prior to mining in any single well, observing this phenomenon in several wells in close proximity to one another is strong evidence that there has been a widespread change in

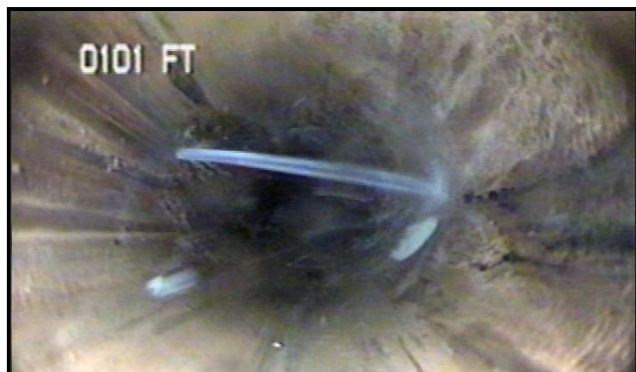
Figure 3. Rupture in PVC casing allowing mine water to enter water well.

The borehole camera was employed to help determine the cause of the change in water quality. At the 102-foot level a rupture

(Fig. 3) in the casing was observed. Mine water under high pressure was streaming through a break in the PVC casing and then flowing unimpeded downward. The reason for this casing breach is not known.

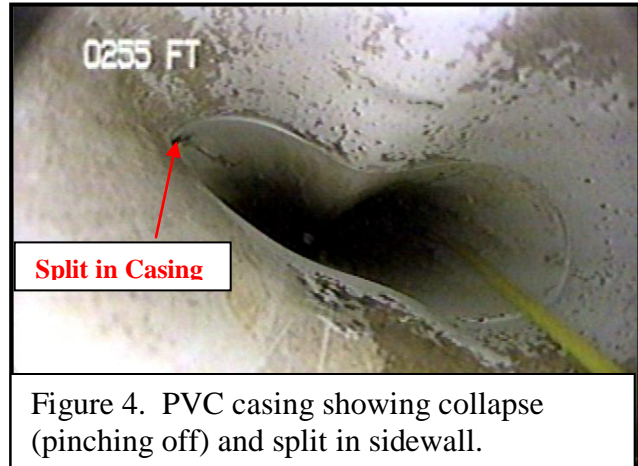
and to determine the possibility of extracting the transducer. At the 256-foot level the casing (schedule 40 PVC) had collapsed or pinched (Fig. 4). The process of pinching off the casing, a split formed at a joint and a significant ground water inflow from overlying aquifers recharged the monitoring well bore. This was the source of the rapid rise in water level observed. The collapse of the casing is what prevented the removal of the pressure transducer.

It is likely that additional subsidence movement above the mine (several years) after abandonment was the cause of the casing failure. This well has been replaced with a new well using steel casing.

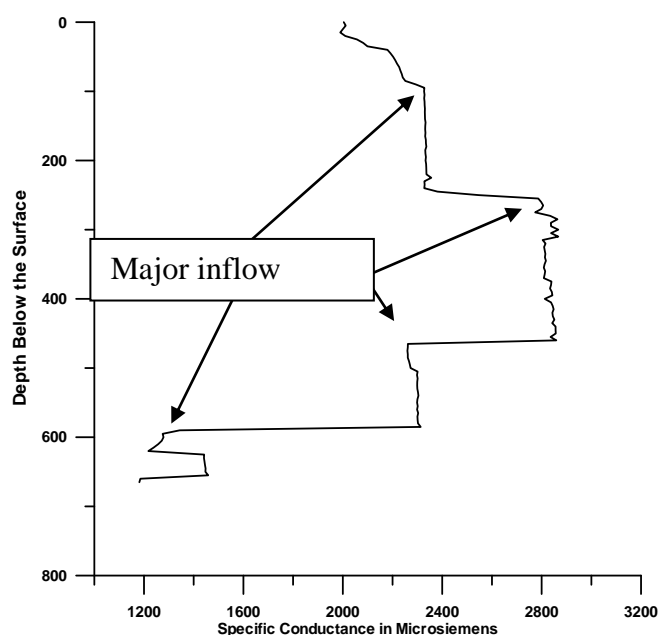
Figure 6. Specific conductance log showing the major inflow points.

Using the camera with a neutral-buoyancy piece of tape, we were able to determine that the artesian well had no less than four discrete major inflow points and several more minor inflow points. These inflow points were confirmed with a specific conductance meter, which was used to log the hole at five-foot intervals. Figure 6 is the specific conductivity log of the

artesian well with the location of the major water-bearing fractures indicated by changes in specific conductance.

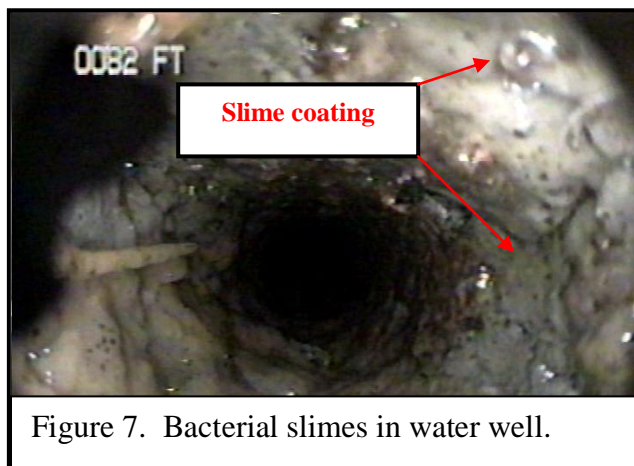
During a routine inspection of a domestic water well in the course of an investigation of alleged yield loss, the presence of massive bacterial colonies (slimes) were noted (Fig. 7). The well is located on ridge adjacent to an underground (longwall) mine panel in Washington County, Pennsylvania.

The bacterial slimes exhibited a variety of colors including translucent white, gray, pink, yellowish, and orange. The well was located in the middle of a horse pasture, so the nutrient source for the large bacterial colonies is likely the nitrates from the horse manure.

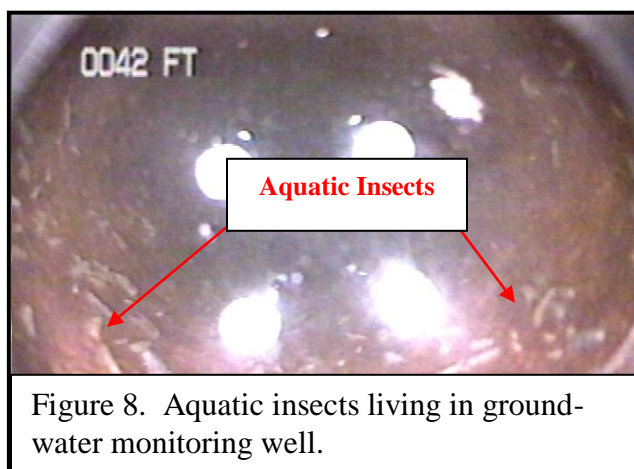
determine its potential for monitoring of a flooding underground mine. The well which had been used for many years no longer had records for the construction details and total depth. While not really a problem in terms potability, this well had a colony of aquatic insects living near the surface of the water (Fig. 8). Although the species of these insects is not known, they

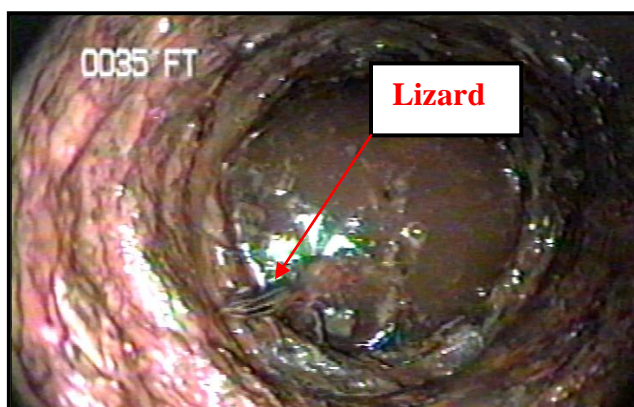
One of the abandoned wells was being capped with a rock. When the rock was lifted a large lizard came out from beneath the rock and unfortunately scurried into the open hole (Fig. 9).

Figure 9. Lizard in domestic water well.

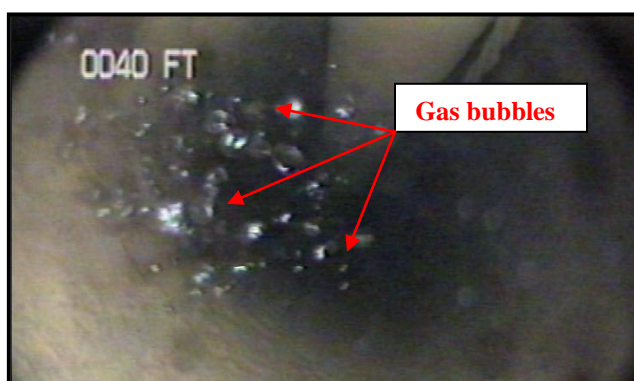
Figure 10. Gas bubbles in municipal water well.

The investigation of potential dewatering of a well field for a small municipal water supplier in Guernsey County, Ohio revealed significant influxes of hydrogen sulfide from fractures intersected by the borehole (Fig. 10). In this well, gas inflow occurred near the 46-foot level and was in the form of periodic

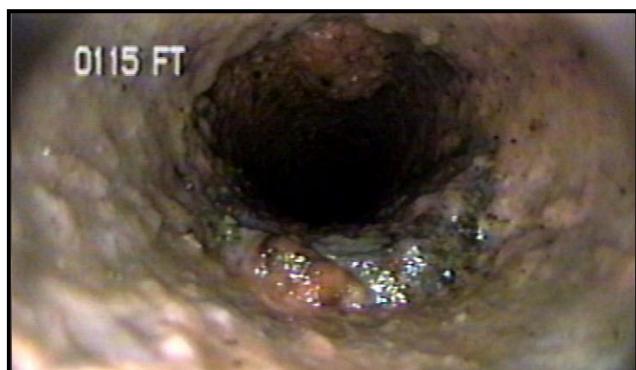
One of the more subtle changes includes slight offsets (Fig. 11) of the borehole caused by adjacent mining. In one case from Washington County, Pennsylvania, an undeveloped domestic

Figure 11. Offset in rock layers caused by subsidence.

water well was situated adjacent to a completed longwall panel. The tensile stresses created by the subsidence caused a 2 to 3 inch offset in the well bore. The offset is partially concealed by bacterial slime.

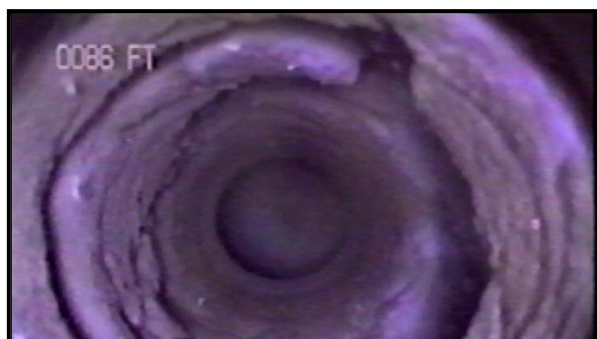
Fractured overburden for an abandoned partially subsided underground mine was viewed using the borehole camera. The fractures (Fig. 12, Fig. 13) are characteristically irregular, sharp edged, and indicative of fairly recent movement. They tend to exhibit an openness that signifies a downward movement caused by tensile stresses from gravitational forces. The fractures tend to be an accentuation of pre-existing horizontal fractures (bedding plane separations) or are an oblique angle.

Figure12. Accentuation of horizontal fractures in borehole.

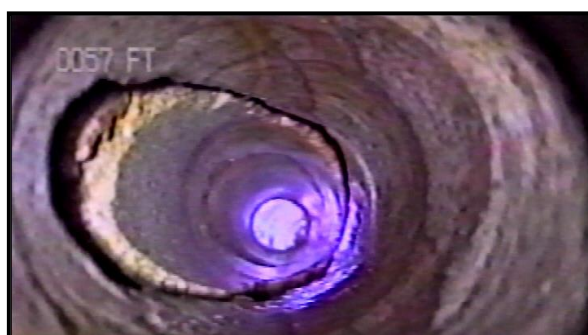
Figure13. Accentuation of oblique fractures in borehole.
